## ZEFFERT & ASSOCIATES

### Accessibility Site Visit (Master)

<b>Project Name</b>	Sample Property
<b>Visit Type</b>	1
<b>Date of Inspection</b>	01-15-2020
<b>Inspector</b>	Brian Jones
<b>Site Visit Accompaniment</b>	Kevin House/ Julio Perez
<b>Next Action Required:</b>	Physical Site Visit
<b>City</b>	Aiken
<b>State</b>	South Carolina
<b>Number of Buildings</b>	23
<b>Total Number of Units</b>	47
<b>Number of HC Accessible Units</b>	3
<b>Number of A/V Units</b>	1
<b>General Project Notes:</b>	NOTE – Element Findings at Time of Inspection: This inspection report indicates individual elements as Yes, No, or N/A. Each element listed as Yes is compliant and requires no action. Each element listed as No is not compliant and requires action. Each element listed as N/A is non-applicable and requires no action or not installed at the time of inspection.

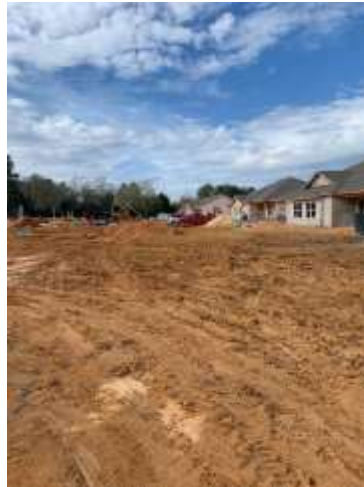
Location of Parking	Throughout Property
HC Parking Status	Under Construction
Accessible Parking Photos

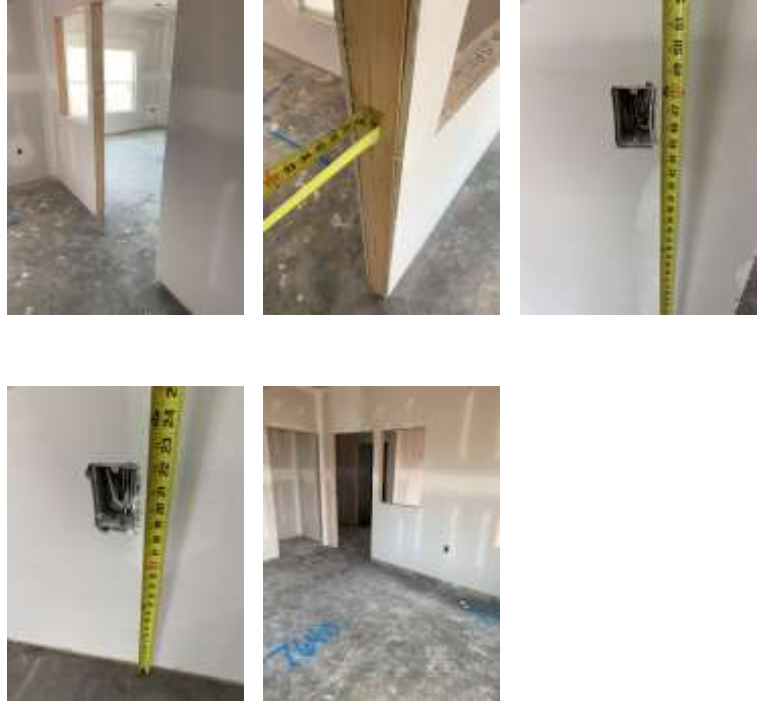
### Leasing Office Photos

<b>Status of this area</b>	Drywall stage
<b>Doorway has a clear opening width 32" min. (ADA 404.2.3)</b>	Yes
<b>Electric switches 48" max. AFF and outlets 15" min. (unobstructed) (ADA 308.2.1)</b>	Yes

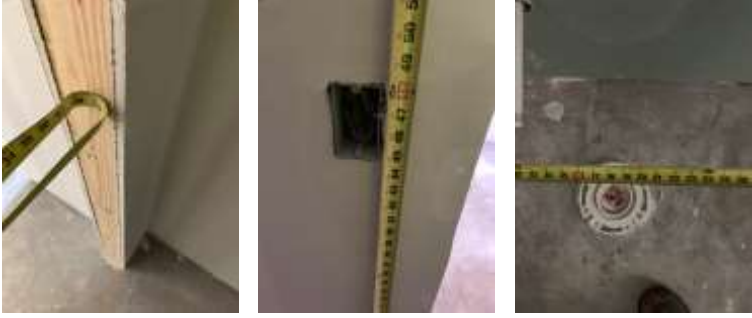
<b>Public Restroom Description</b>	Community Building Men's
<b>Status of this area</b>	Drywall stage
<b>Restroom Photos</b>

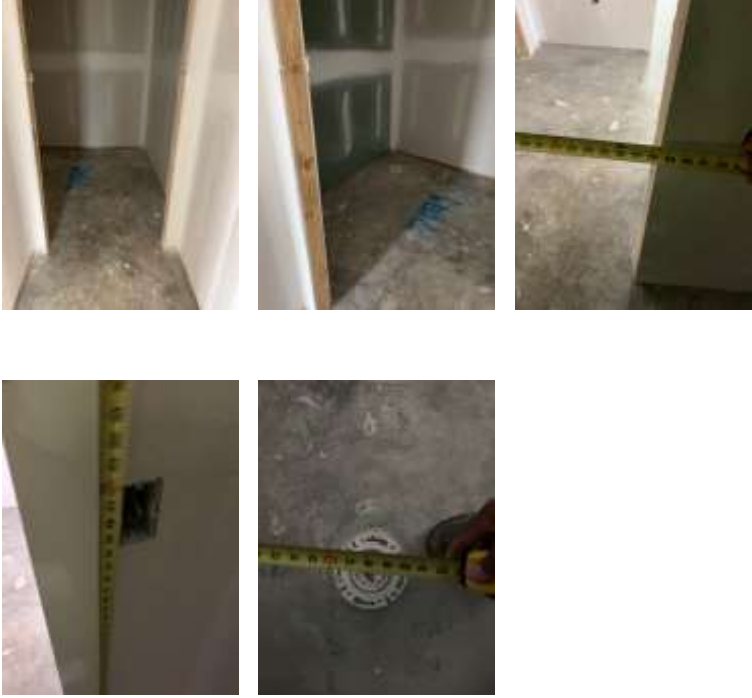
<b>Public Restroom Description</b>	Community Building Women's
<b>Status of this area</b>	Drywall stage
<b>Doorway has a clear opening width 32" min. (ADA 404.2.3)</b>	Yes
<b>Restroom Photos</b>

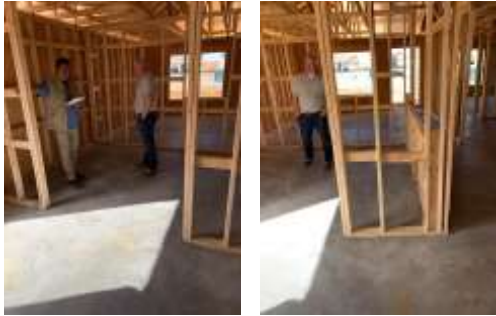
<b>Entry and/or door 32" min. (UFAS 4.13.5)</b>	Yes
<b>Additional Comments for HC Unit Kitchen</b>	No electrical installed at the time of inspection
<b>HC Unit Kitchen Photos</b>

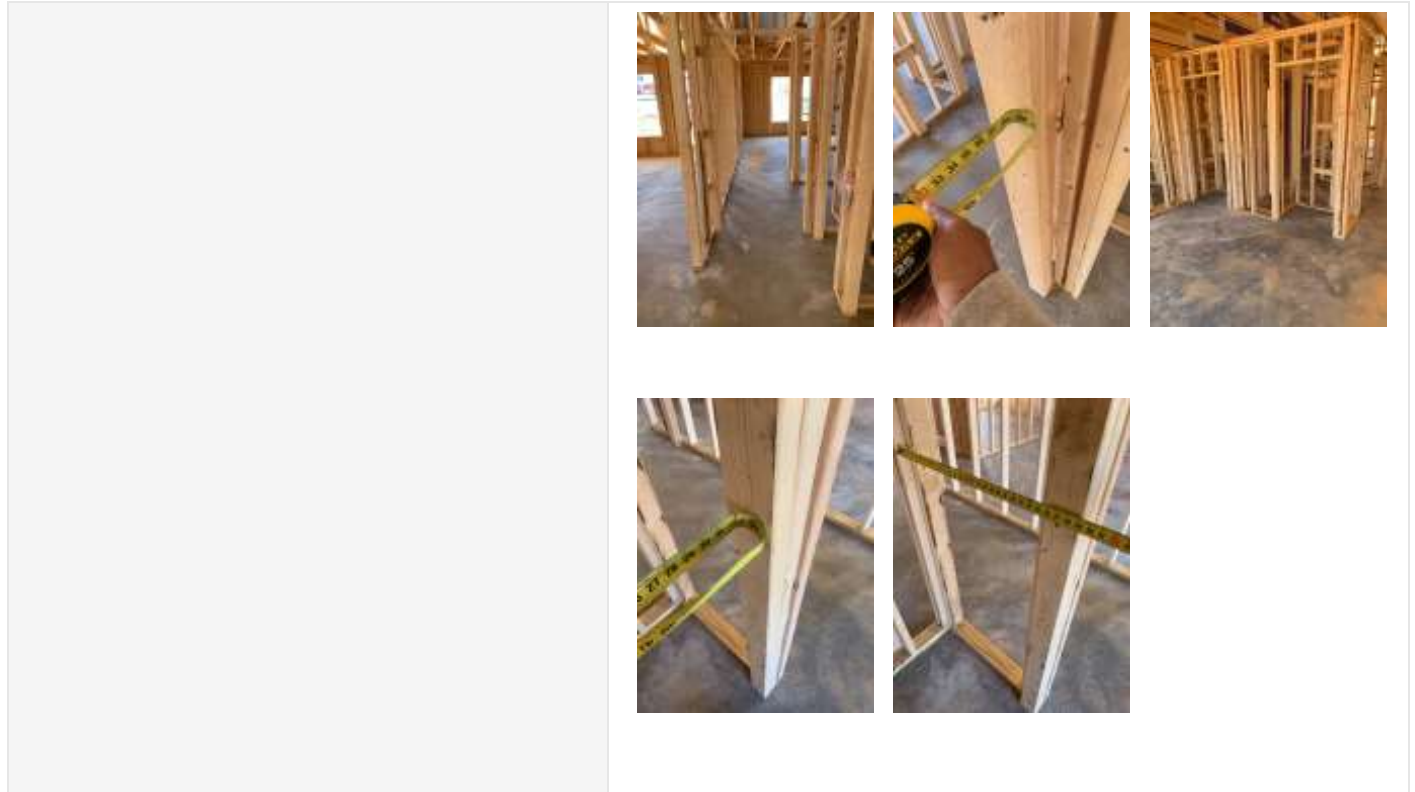
<b>Bedroom Description</b>	Bedrooms 1-2
<b>Status of this area</b>	Framing stage
<b>Doorway has a clear opening width 32" min. (UFAS 4.13.5)</b>	Yes
<b>Closet - depth and door opening compliant (UFAS 4.13.5)</b>	Yes
<b>Additional Comments for HC Bedroom</b>	No electrical installed at the time of inspection
<b>HC Bedroom Photos</b>	Three photographs documenting the framing of a bedroom. The first photo on the left shows a doorway with wooden framing. The middle photo is a close-up of a doorway where a yellow measuring tape is being used to verify the clear opening width. The third photo on the right shows another corner of the room with the wooden studs in place.

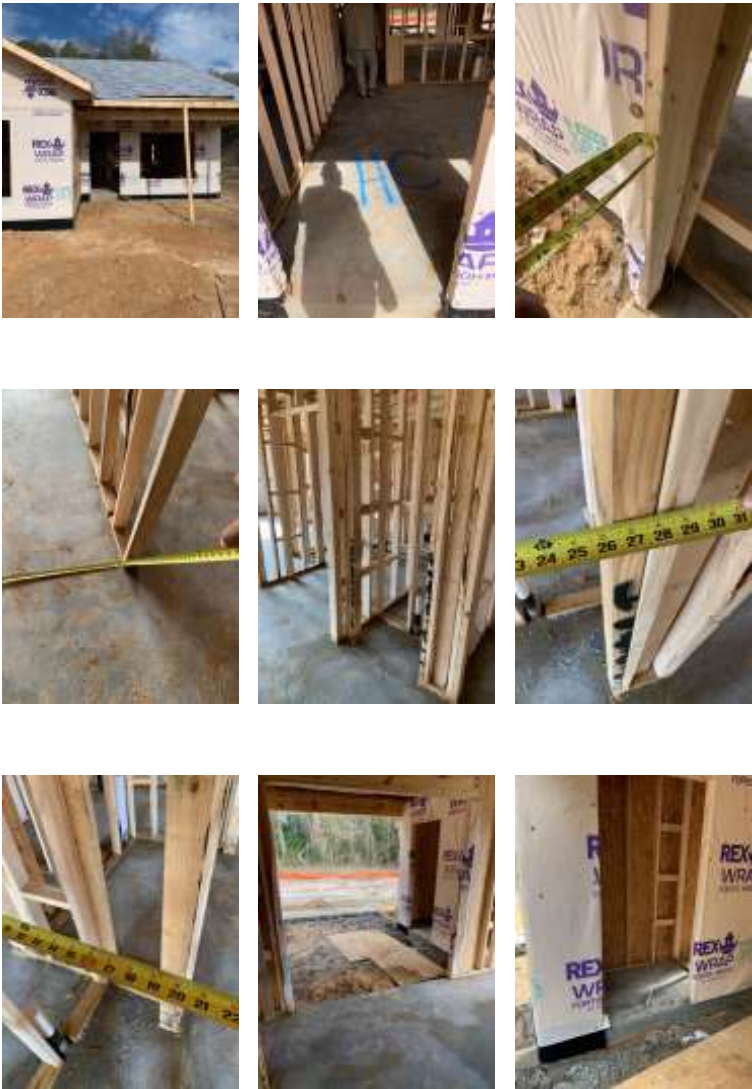
<p><b>36" min width accessible route through dwelling unit (UFAS 4.34.2 (3), 4.3)</b></p>	<p>Yes</p>
<p><b>Comments for HC Unit Misc.</b></p>	<p>No electrical installed at the time of inspection</p>
<p><b>Photos for HC Unit Misc.</b></p>

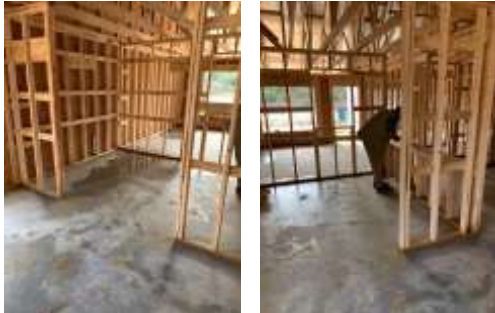
<b>Status of this area</b>	Framing stage
<b>Additional Comments for HC Unit Kitchen</b>	No electrical installed at the time of inspection
<b>HC Unit Kitchen Photos</b>
