Physical Needs Assessment

**Project Number:
TCN5067B2051**

**Arrington Manor Apartments
2225 College Street
Columbia, SC 29205**

**Re: Physical Condition Assessment of the
Arrington Manor Apartments located at
2225 College Street, Columbia, SC 29205
Gill Group, Inc. Project No. TCN5067B2051**

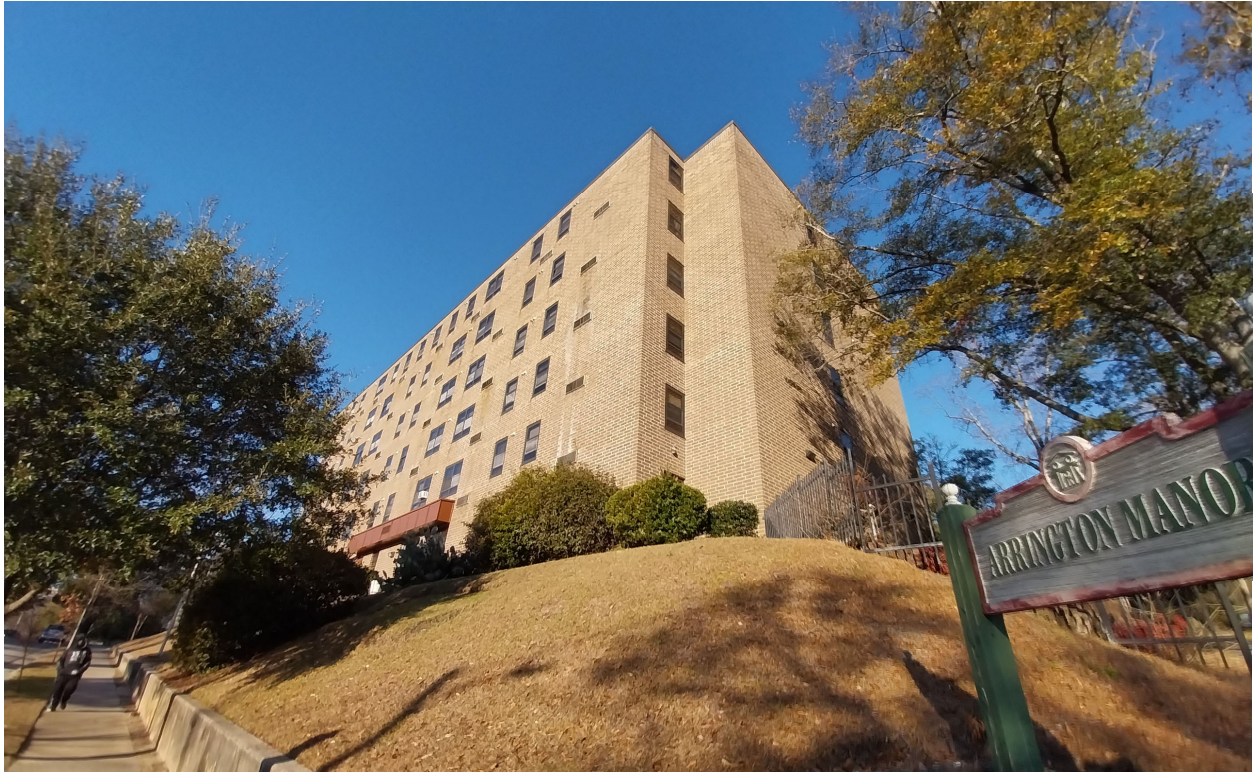
No. 1

Subject property monument sign

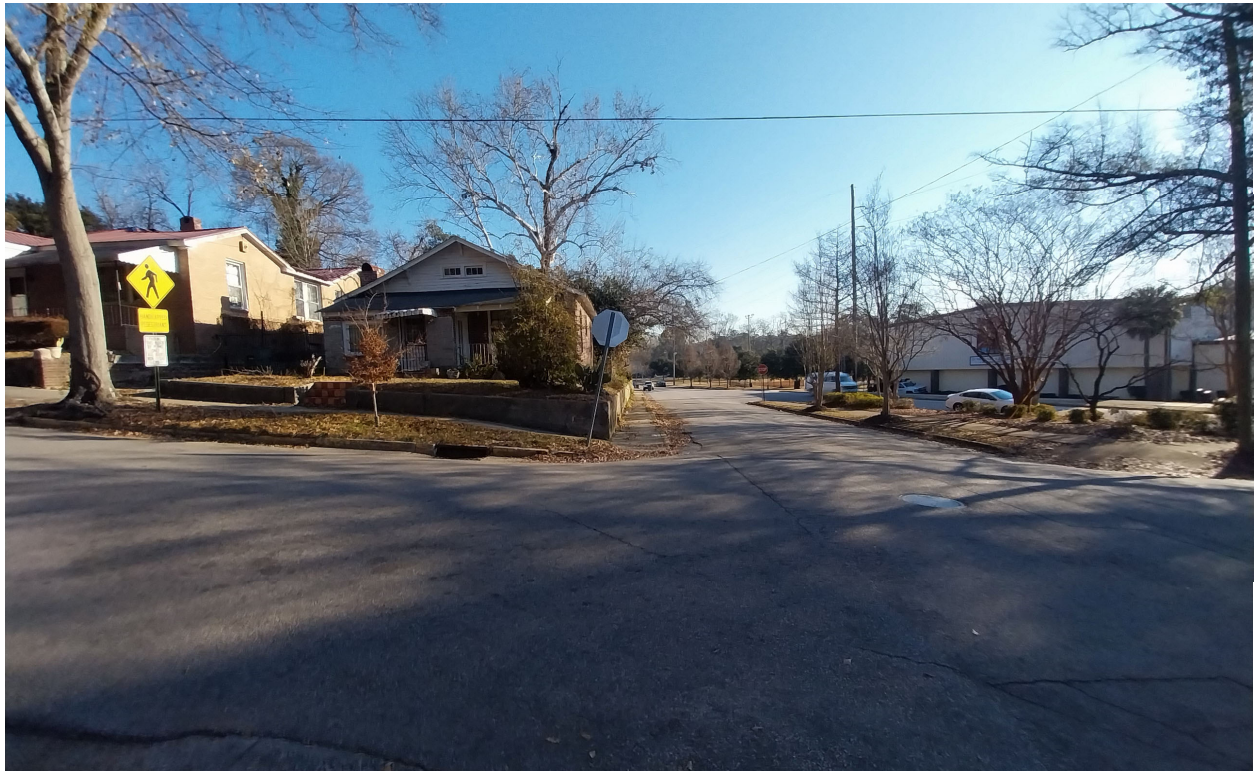
No. 2

Subject property road frontage

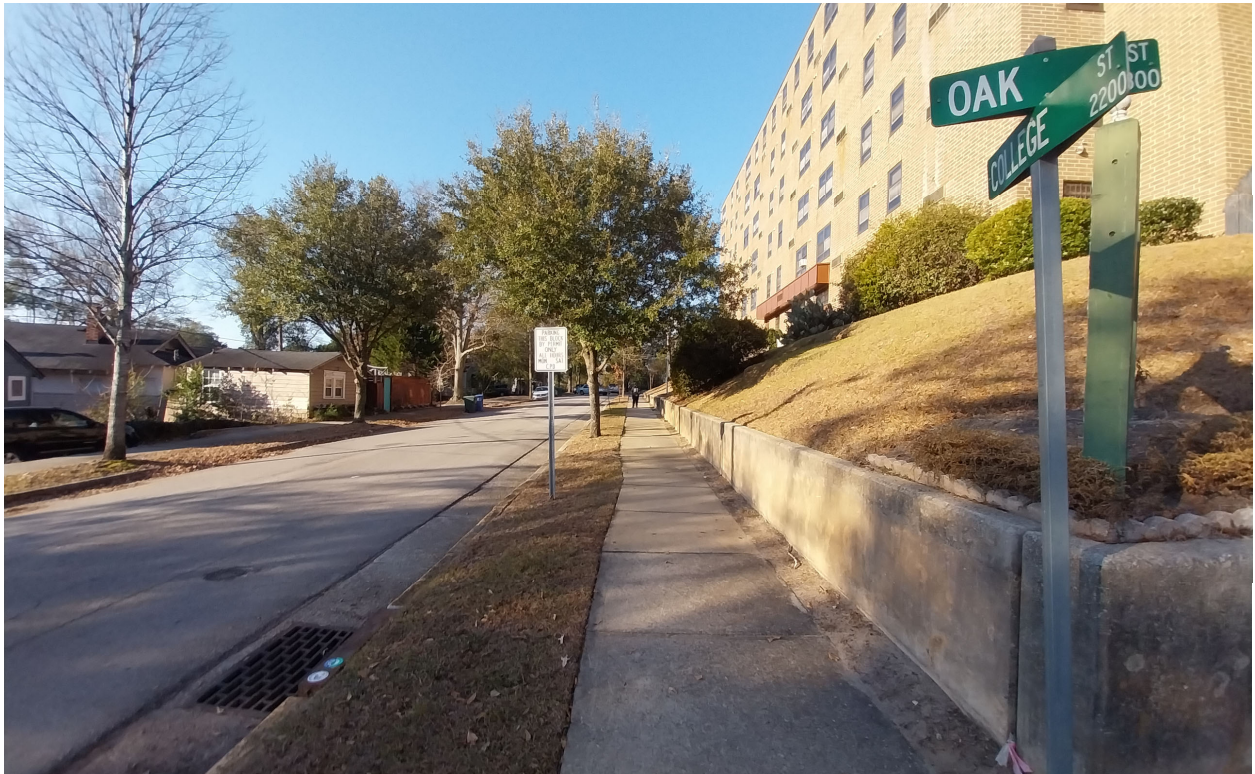
No. 3

Subject property road frontage

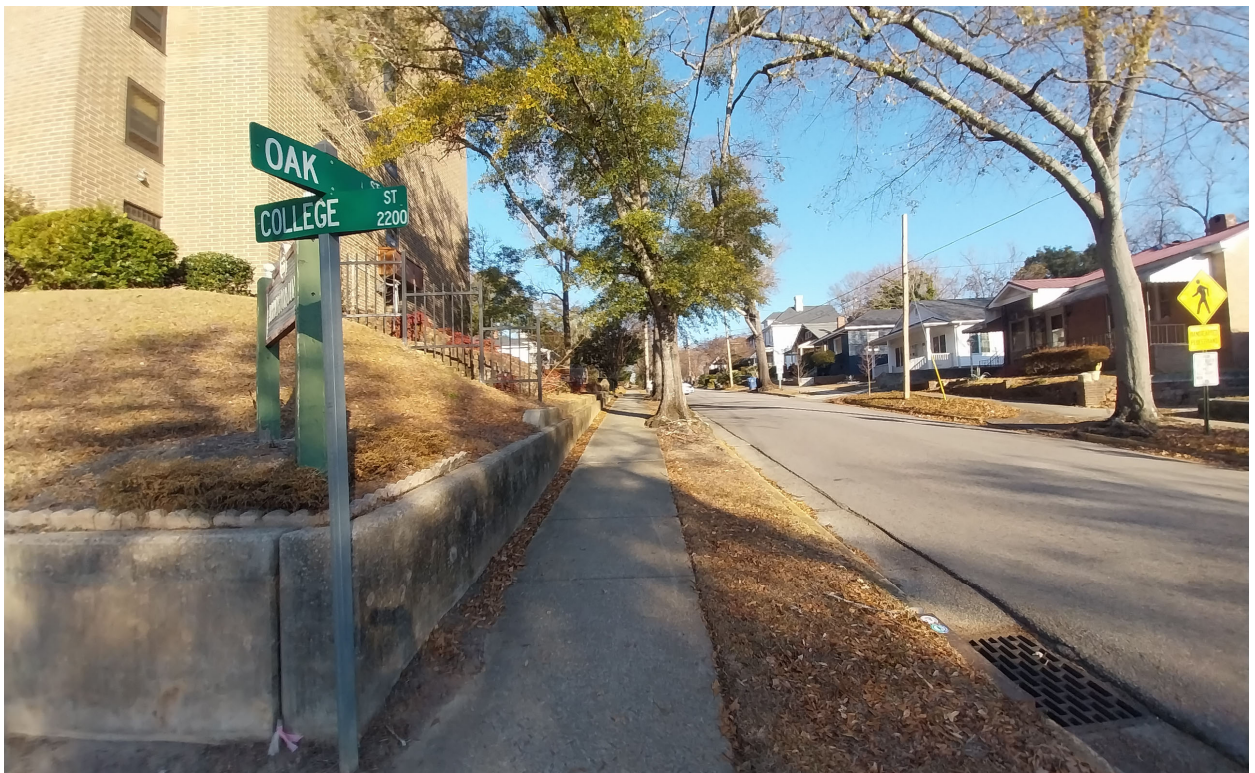
No. 4

Subject property road frontage

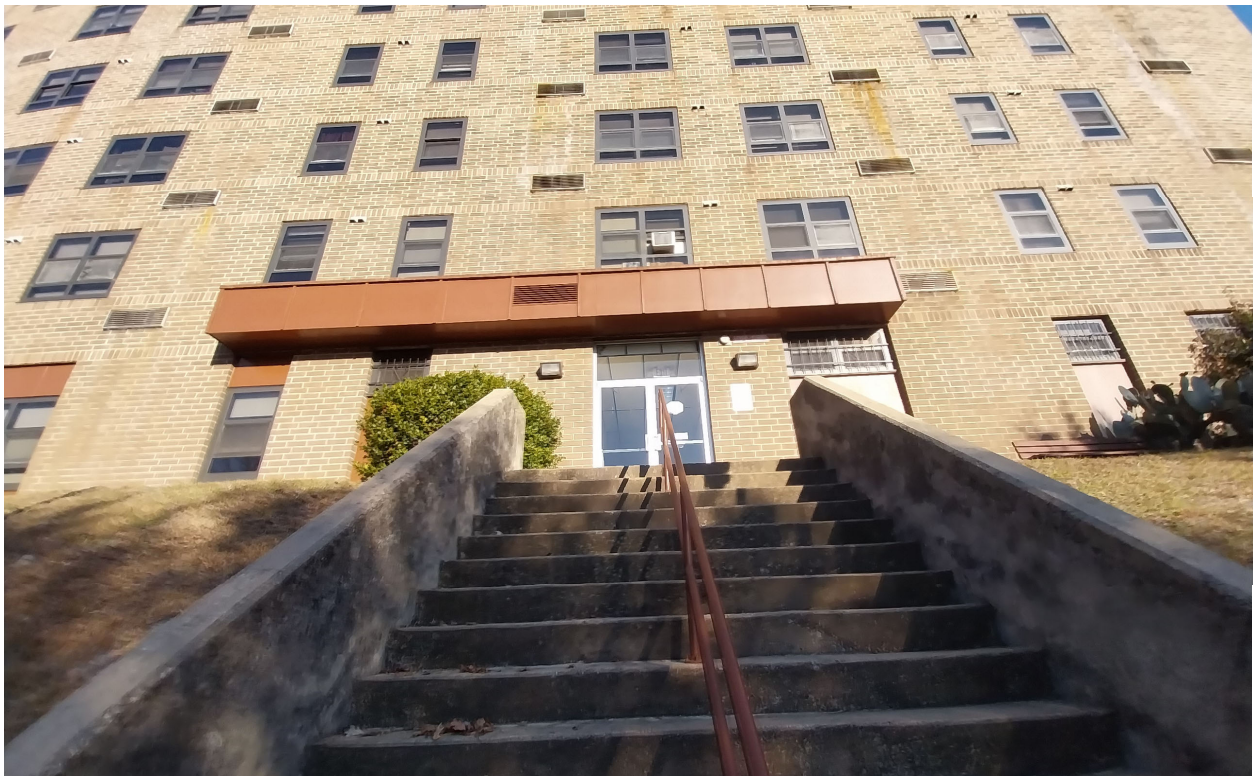
No. 5

Subject property exterior stair

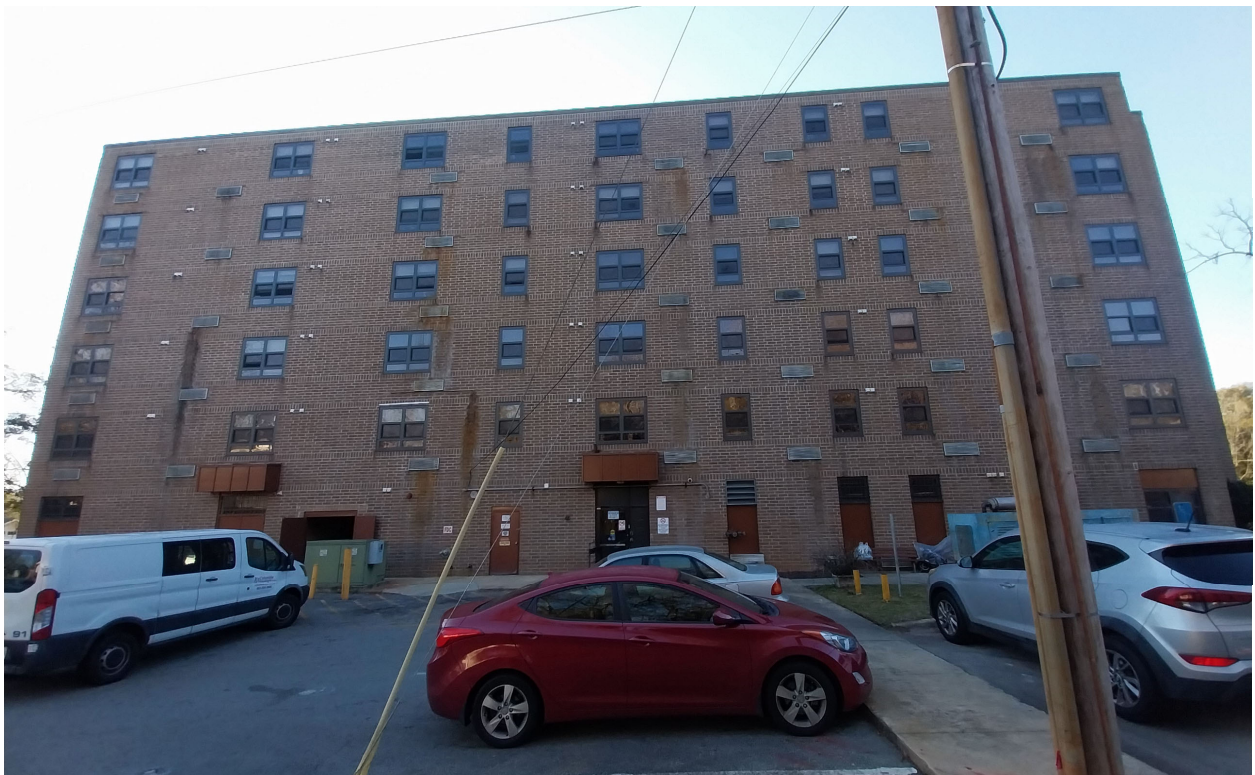
No. 6

Subject property exterior

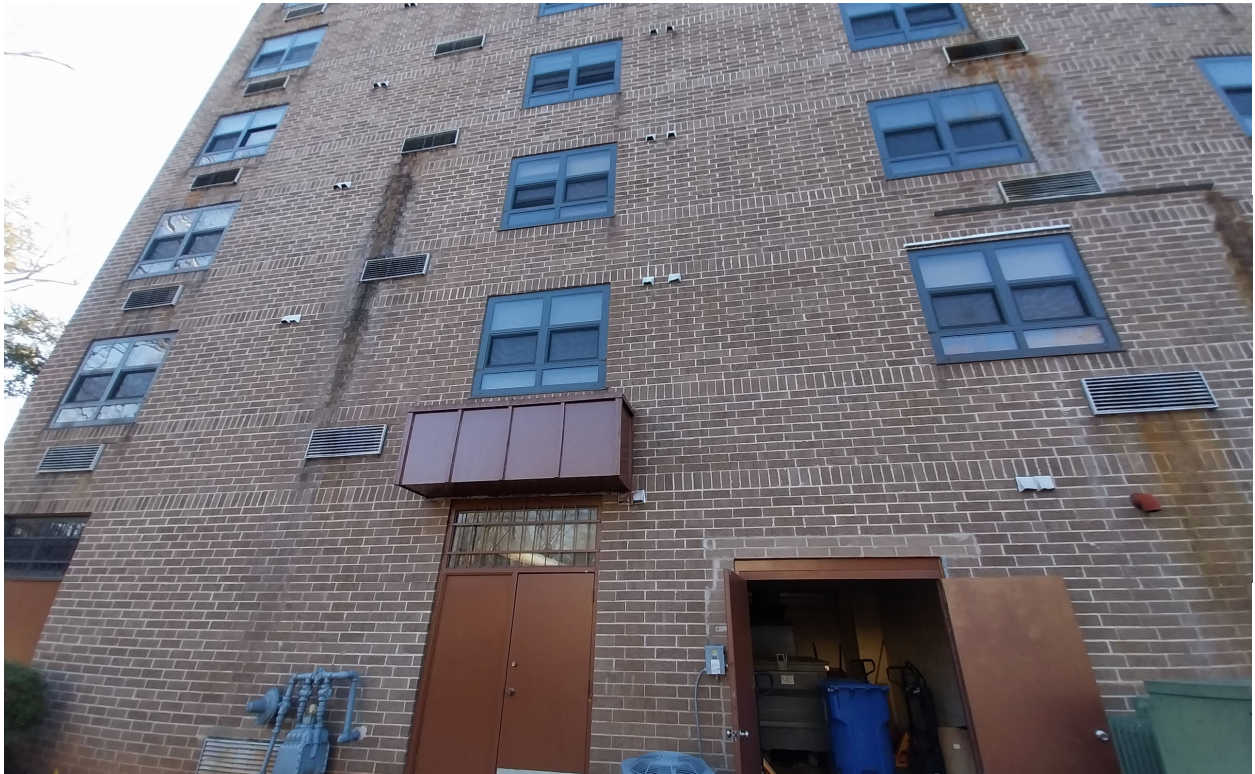
No. 9

Subject property exterior

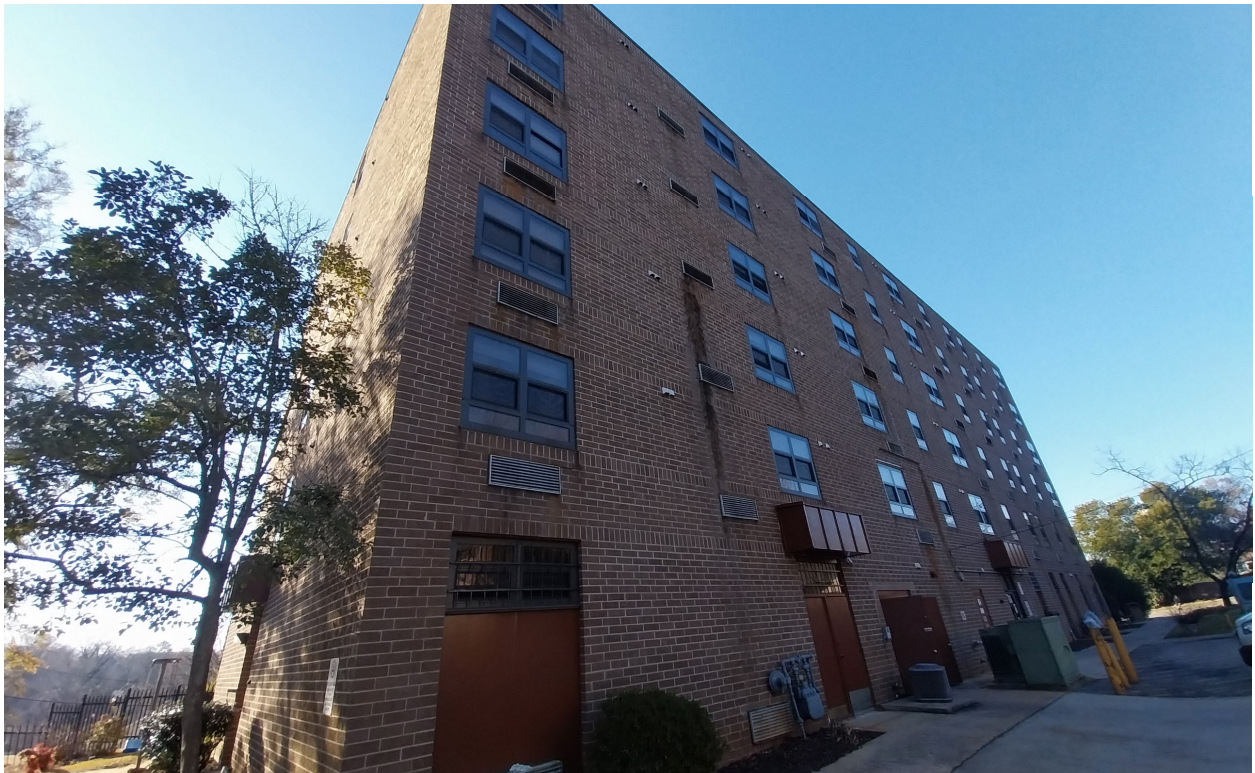
No. 10

Subject property exterior

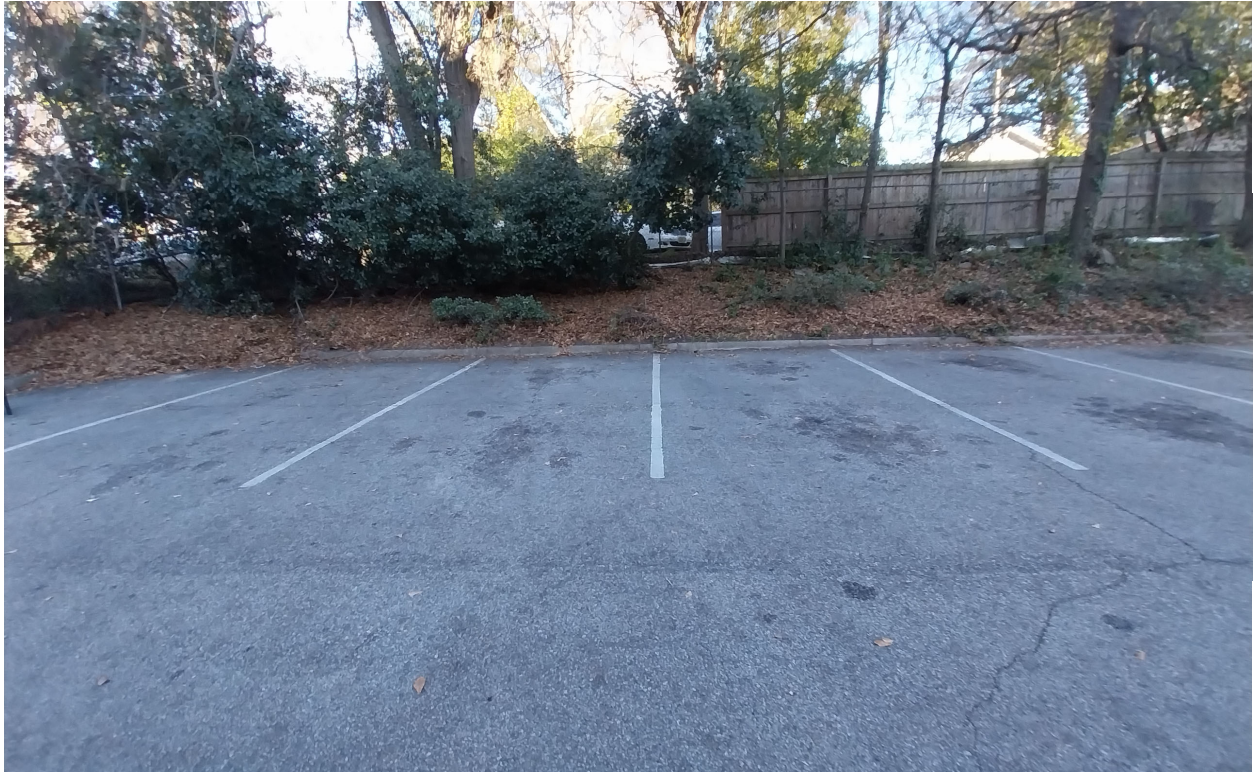
No. 11

Subject property parking area

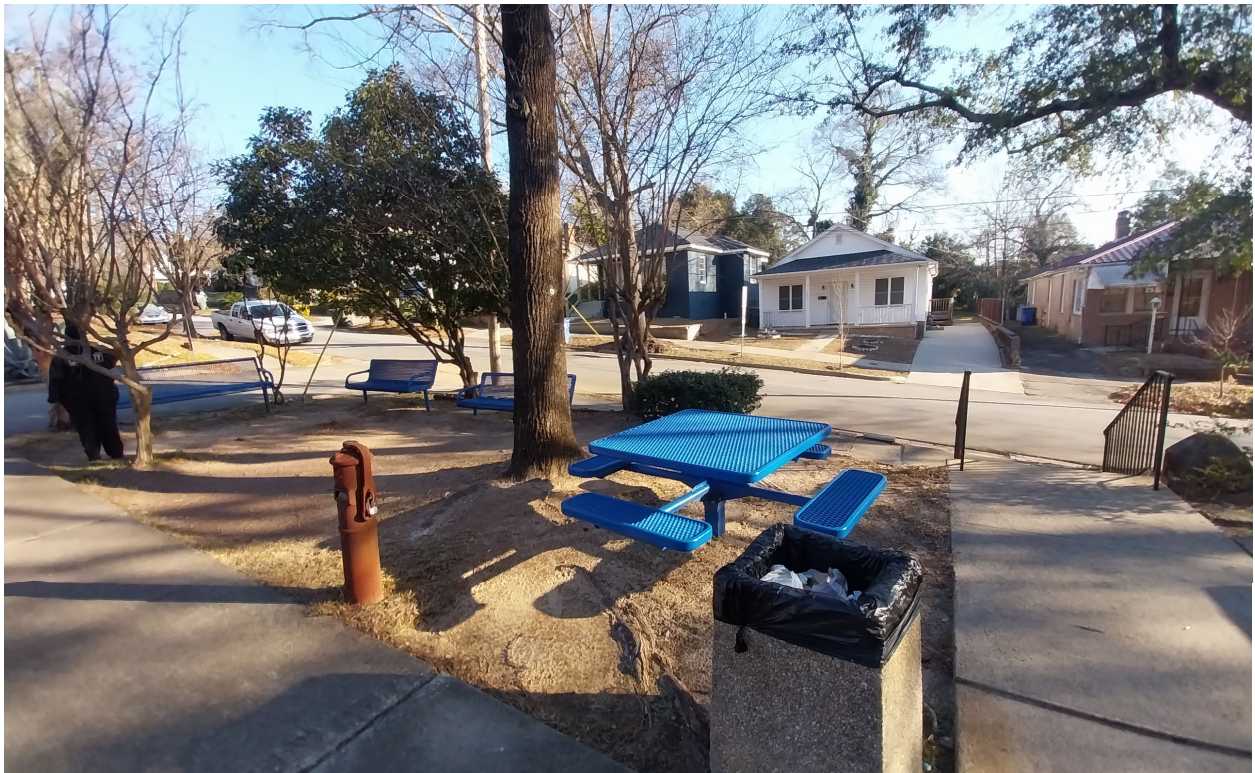
No. 12

Subject property sitting area

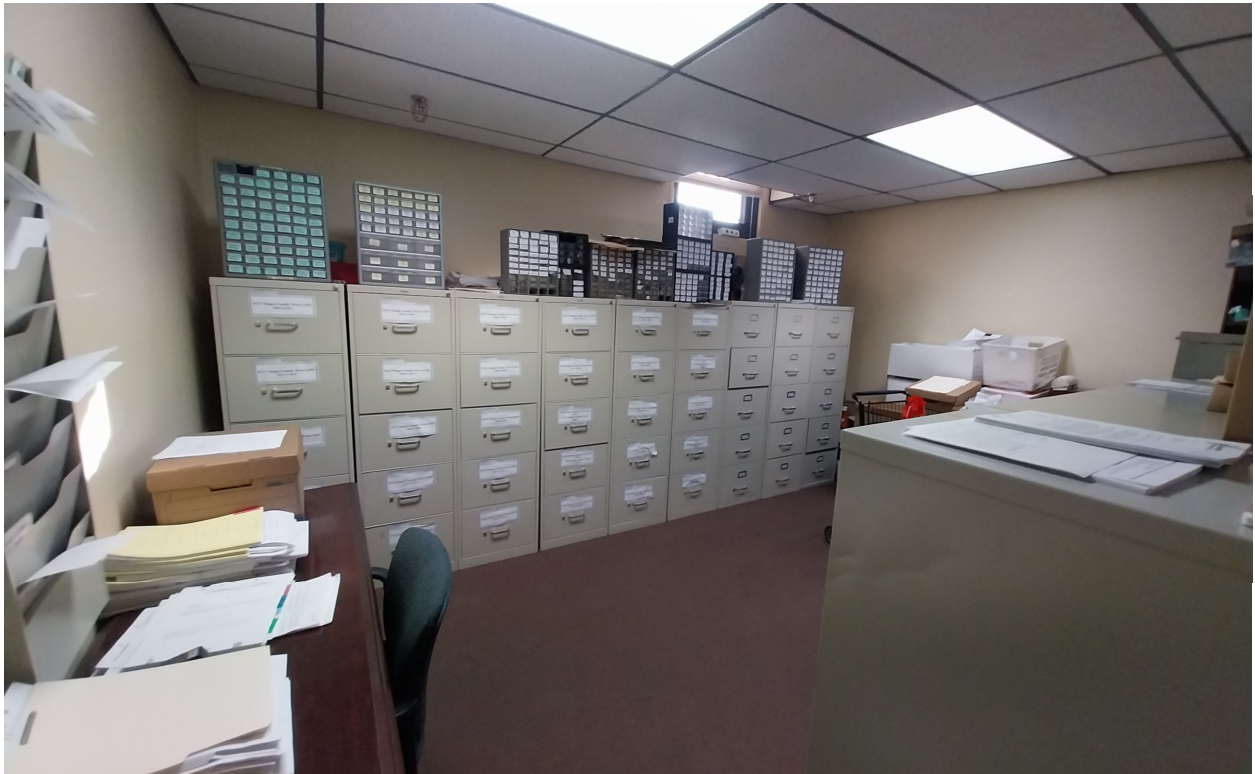
No. 13

Subject property file office

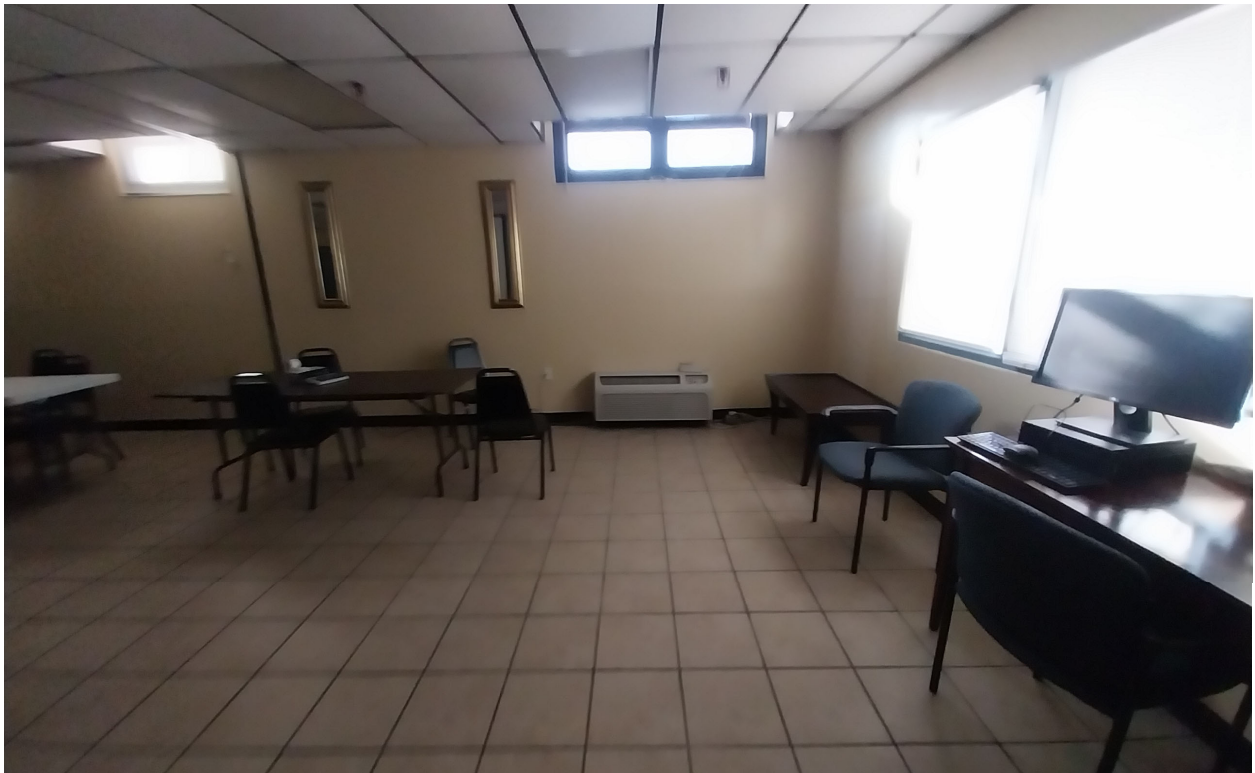
No. 14

Subject property community room

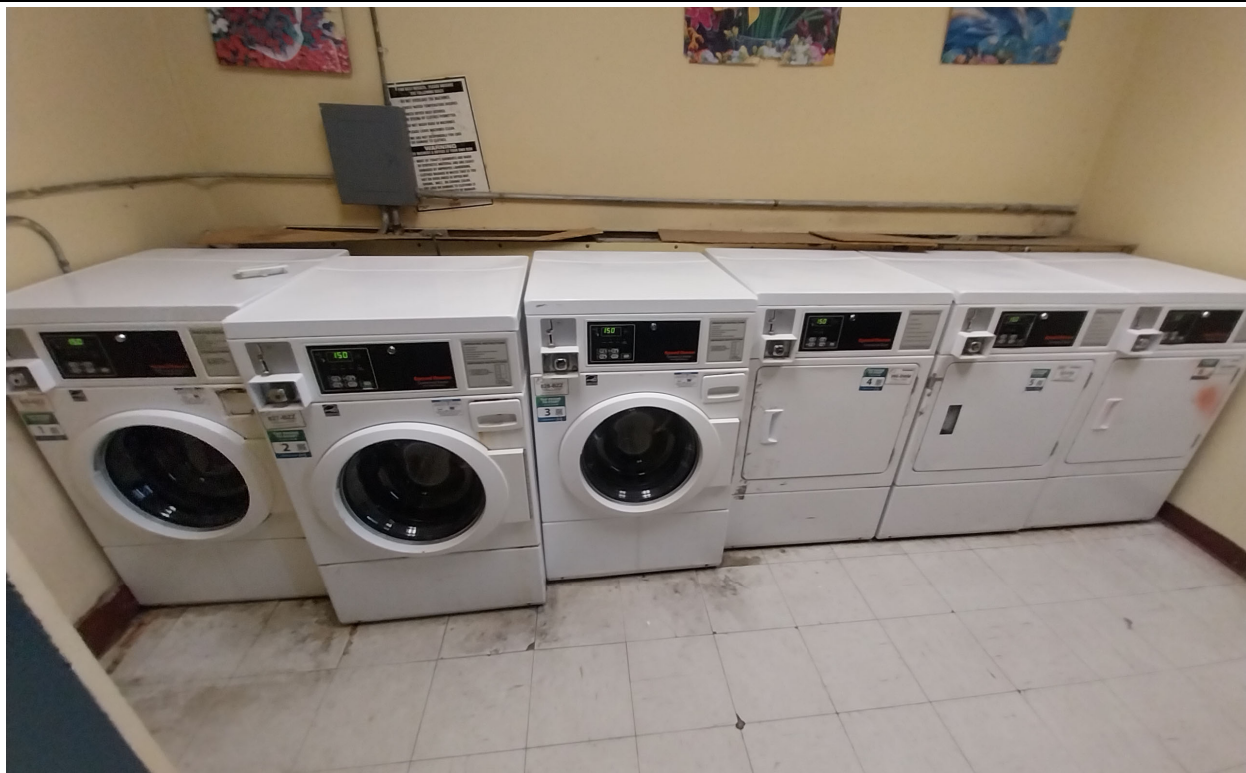
No. 17

Subject property common laundry

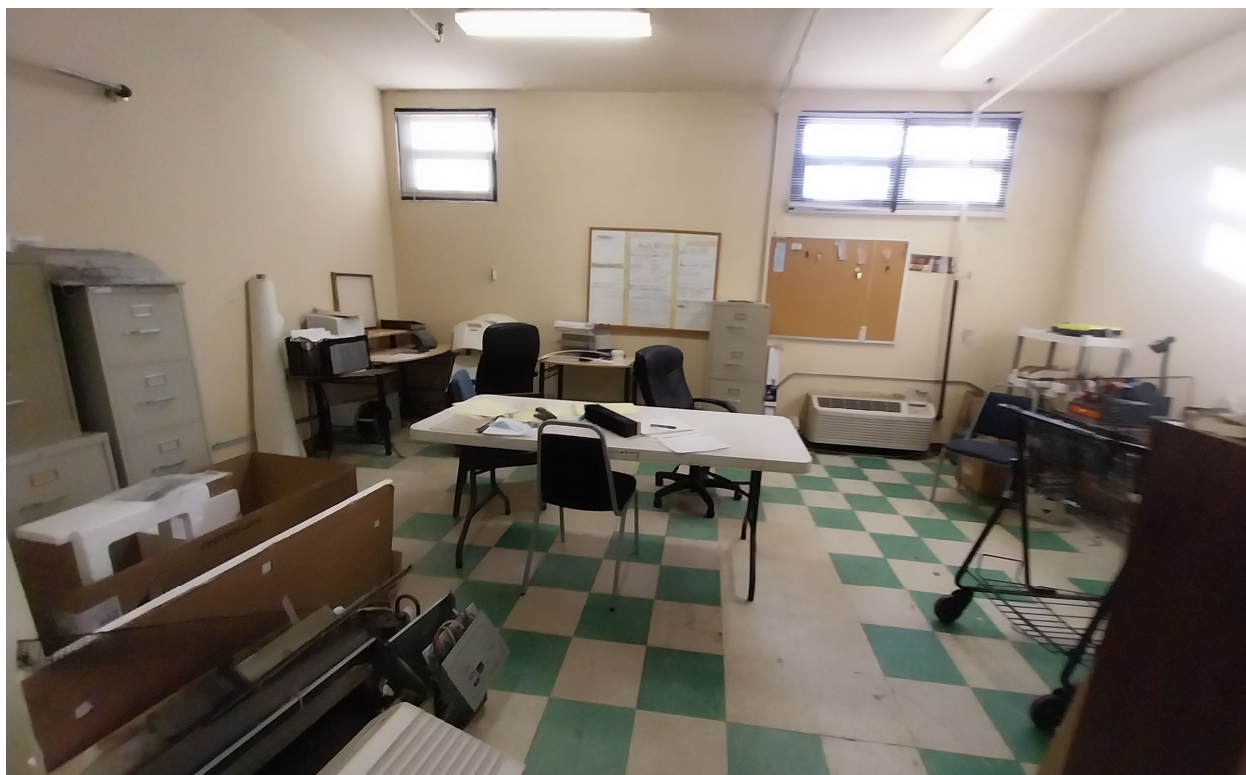
No. 18

Subject property rec room

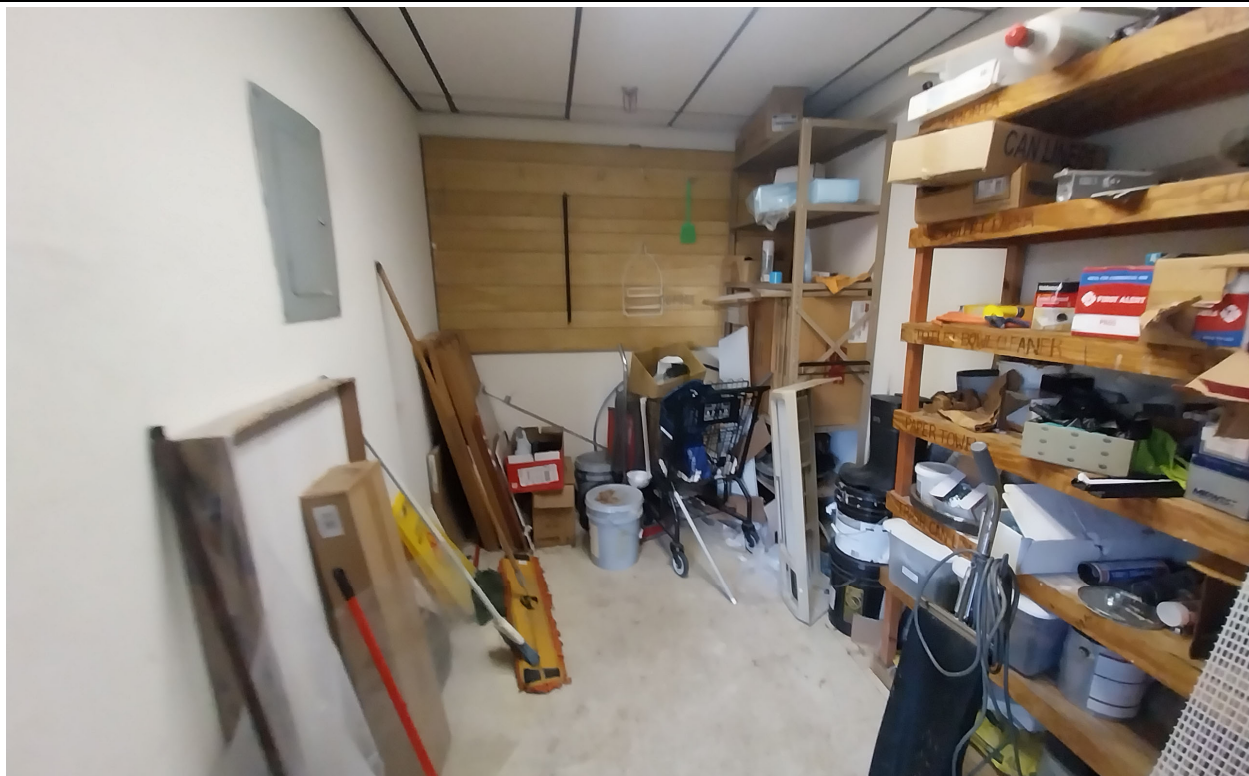
No. 19

Subject property storage area

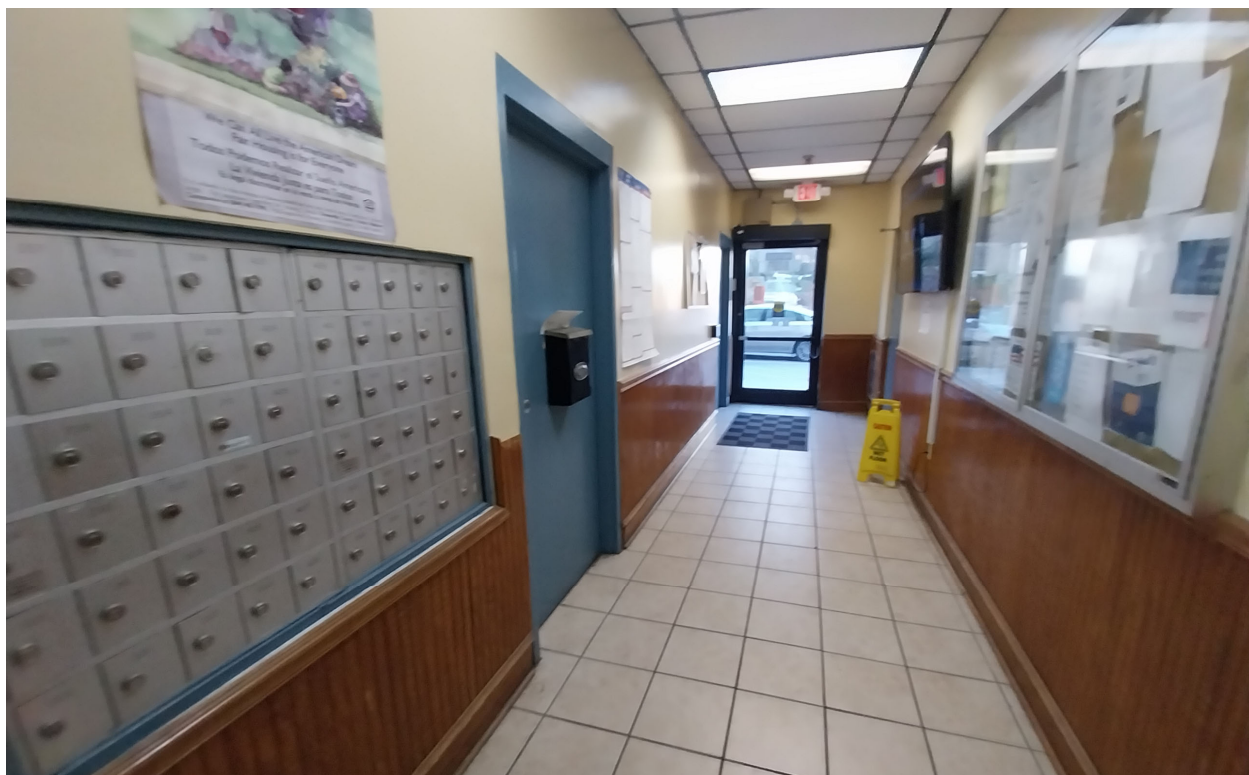
No. 20

Subject property mail kiosk

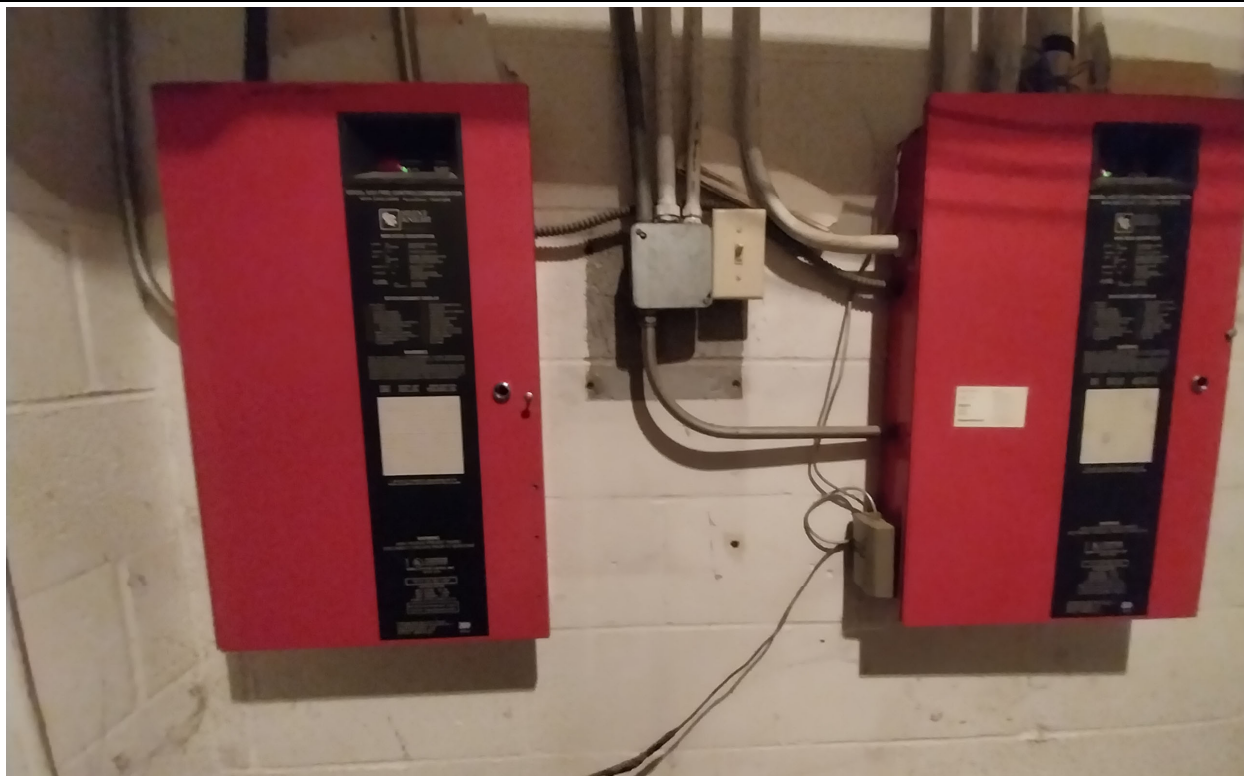
No. 21

Subject property fire panel

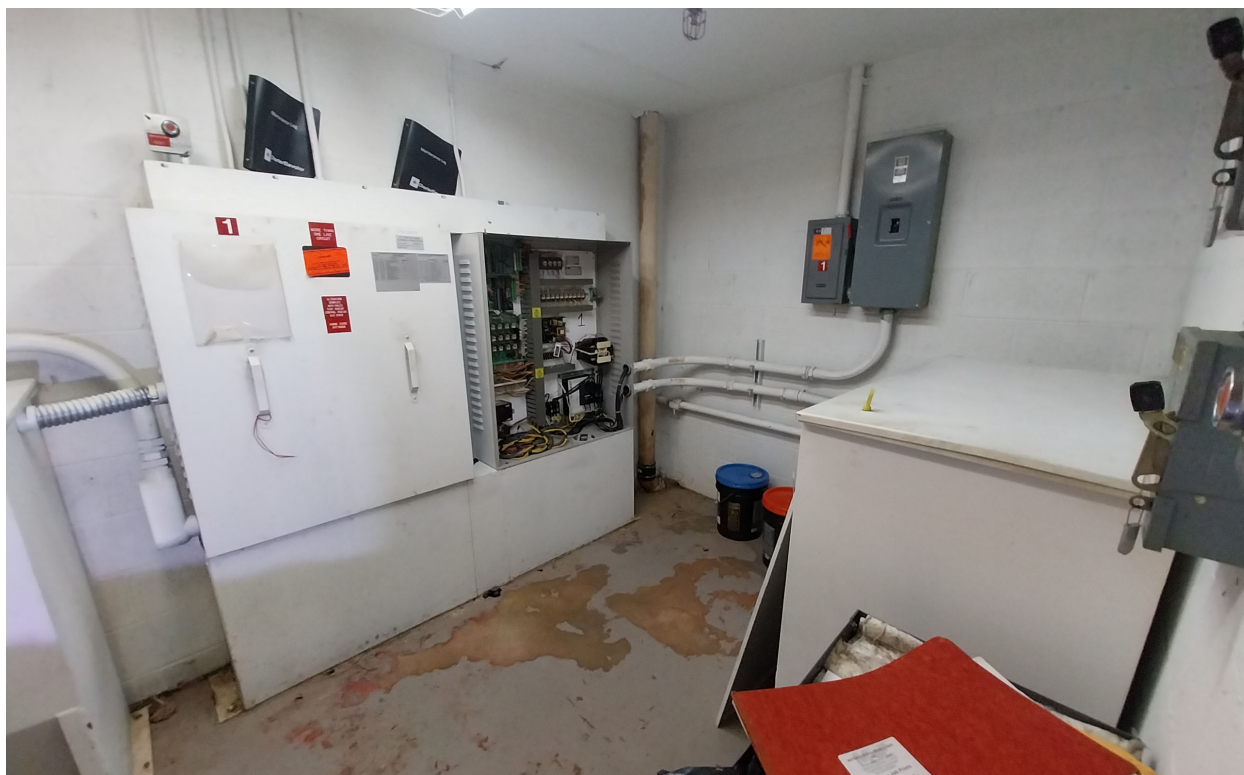
No. 22

Subject property elevator room

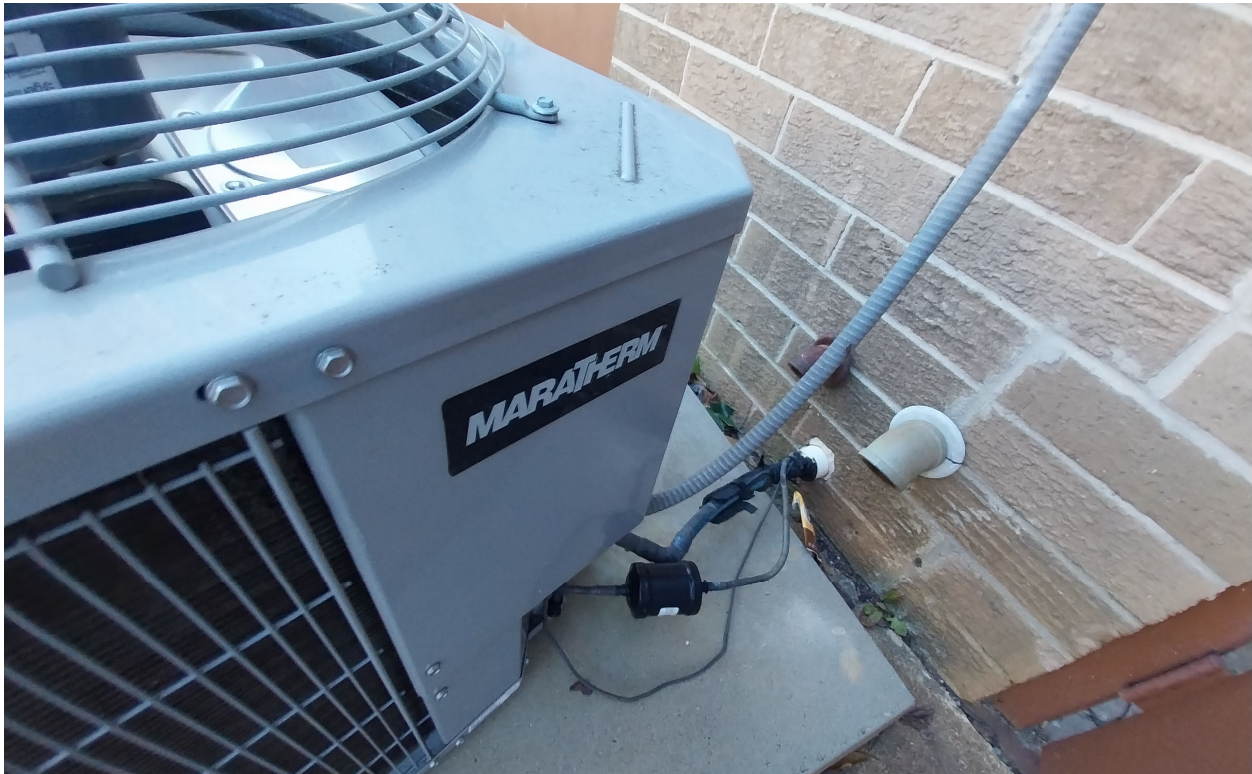
No. 23

Subject property typical ac condensor

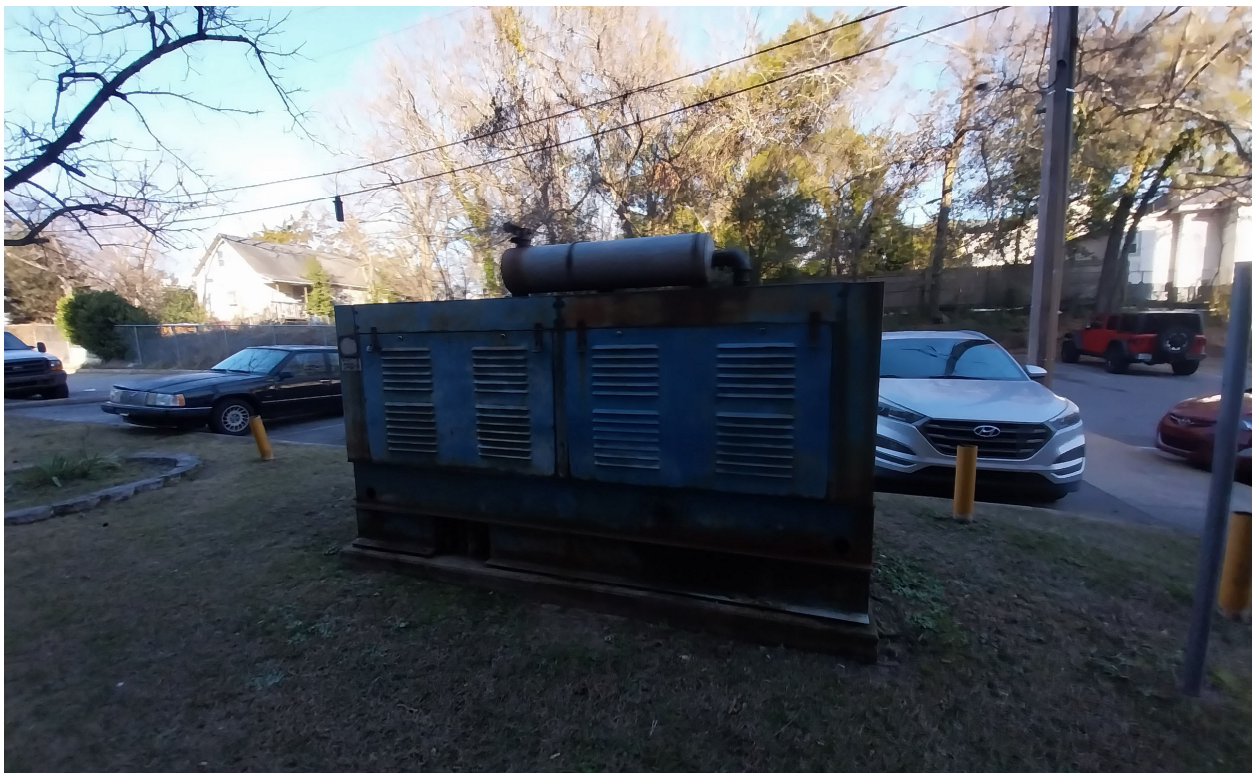
No. 24

Subject property generator

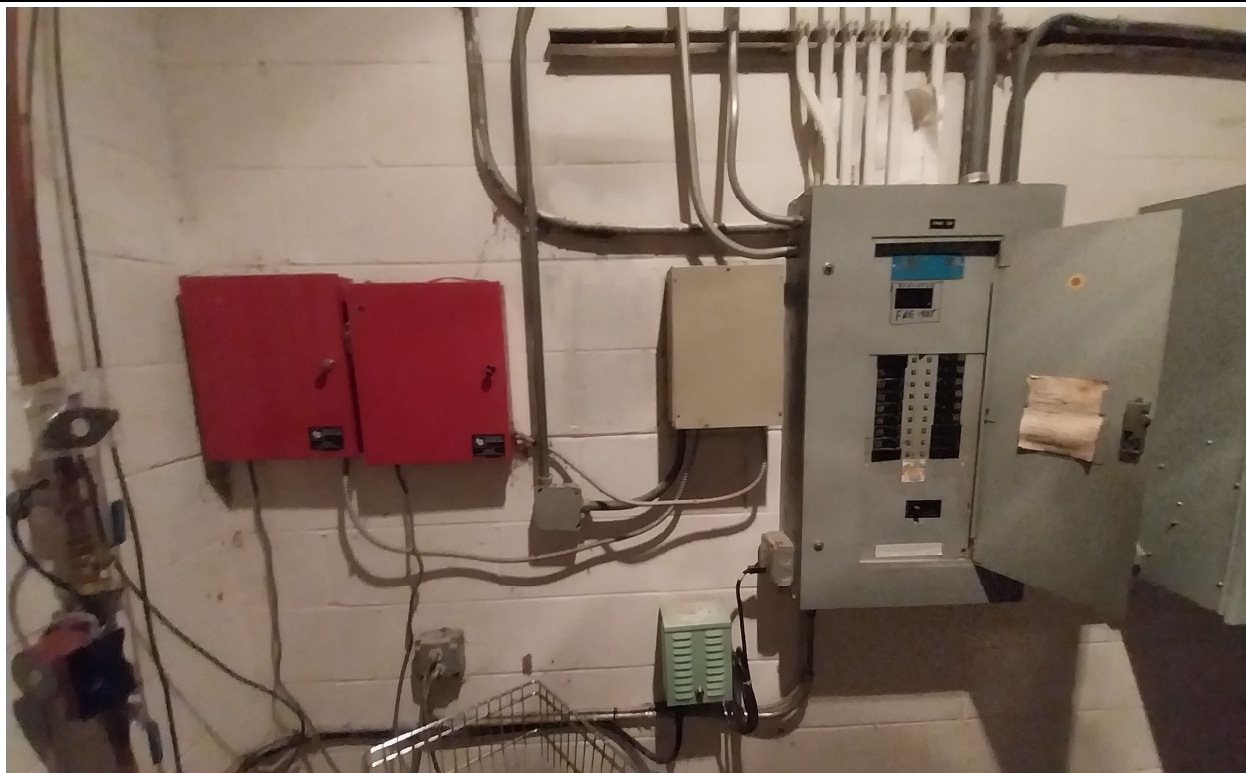
No. 25

Subject property electric room

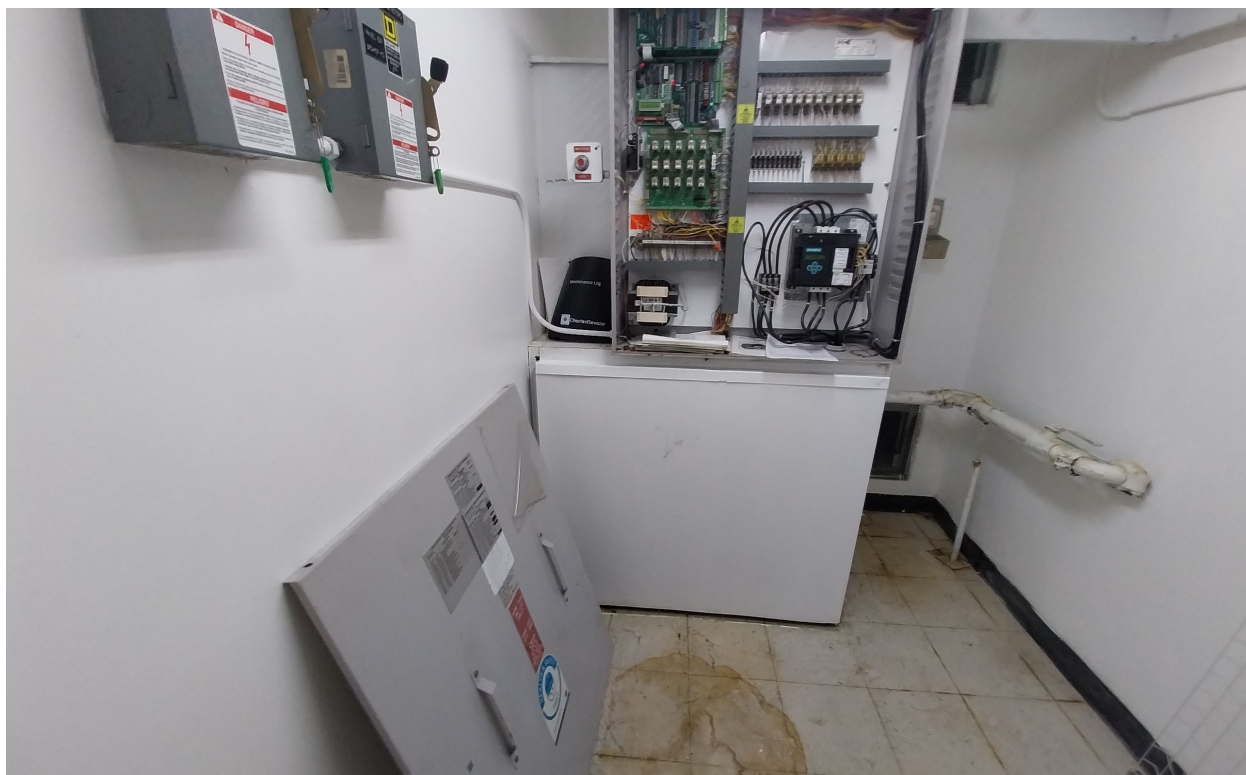
No. 26

Subject property electric room

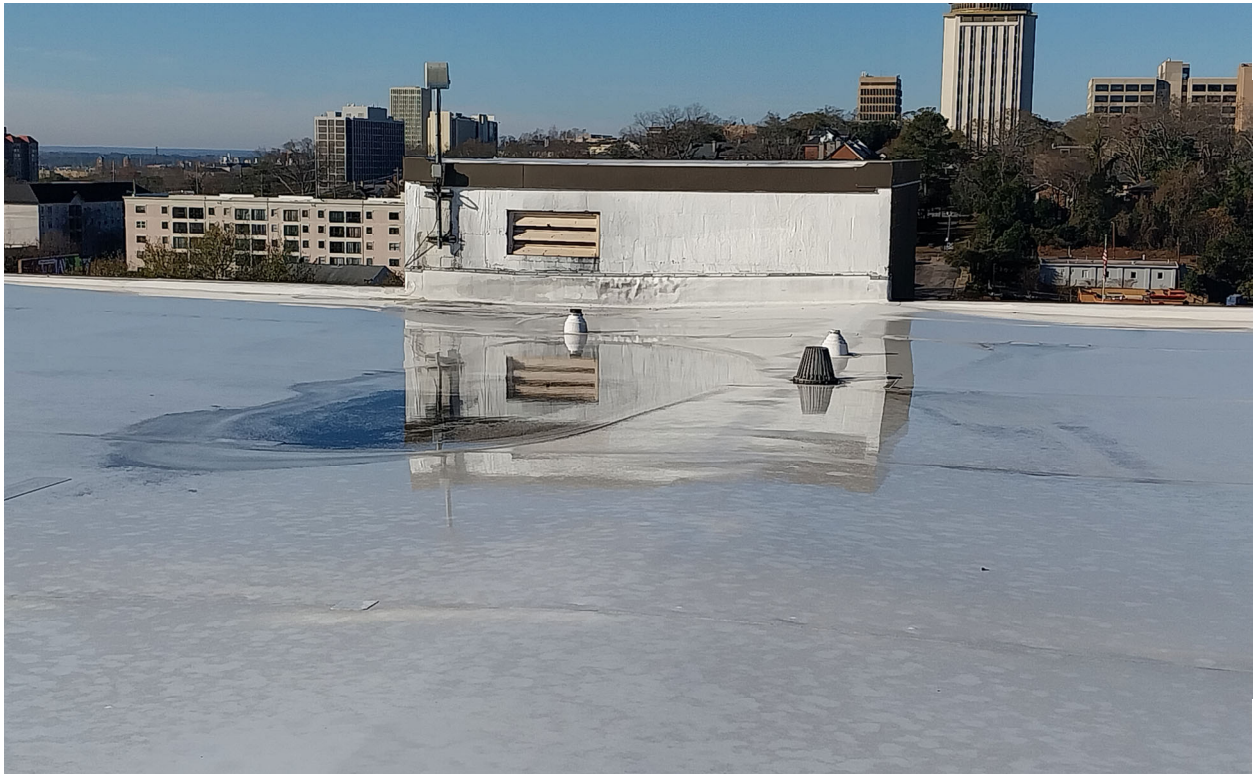
No. 27

Subject property roof
