Physical Needs Assessment

**Project Number:
TCN5067B2051**

**Arrington Manor Apartments
2225 College Street
Columbia, SC 29205**

**Re: Physical Condition Assessment of the
Arrington Manor Apartments located at
2225 College Street, Columbia, SC 29205
Gill Group, Inc. Project No. TCN5067B2051**

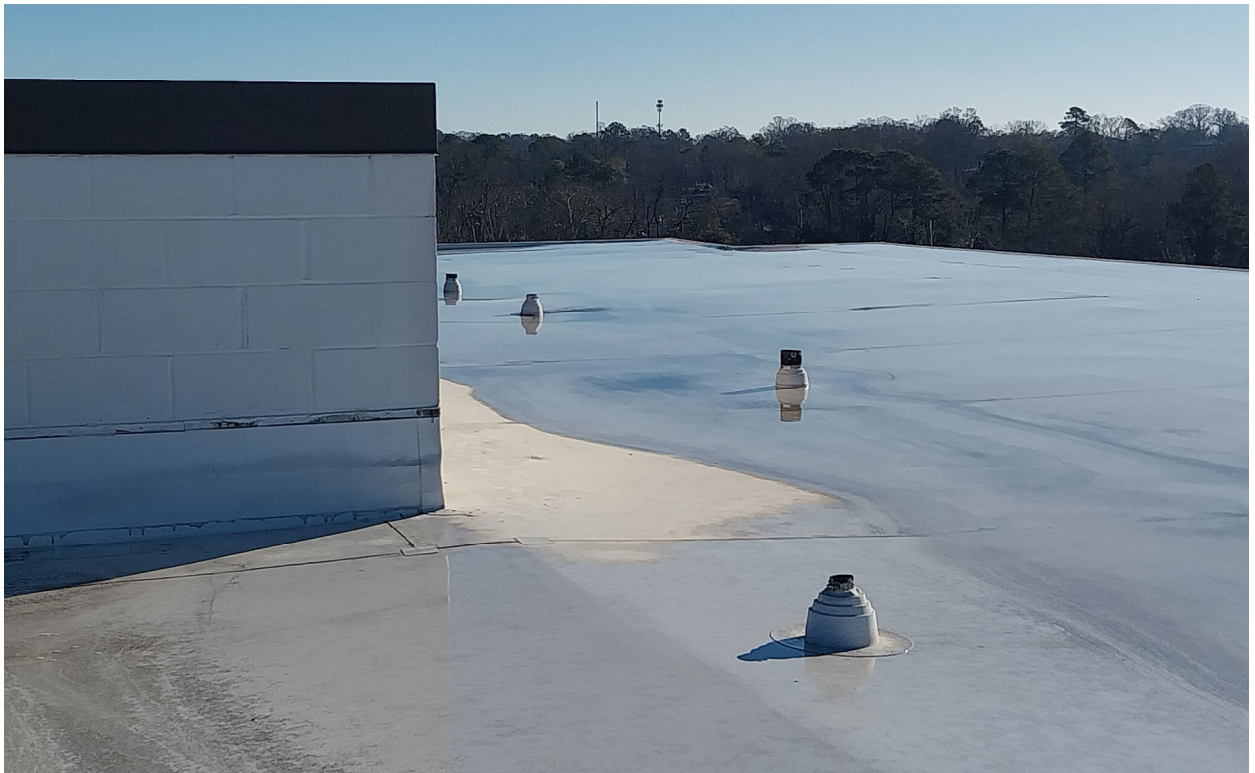
No. 28

Subject property roof

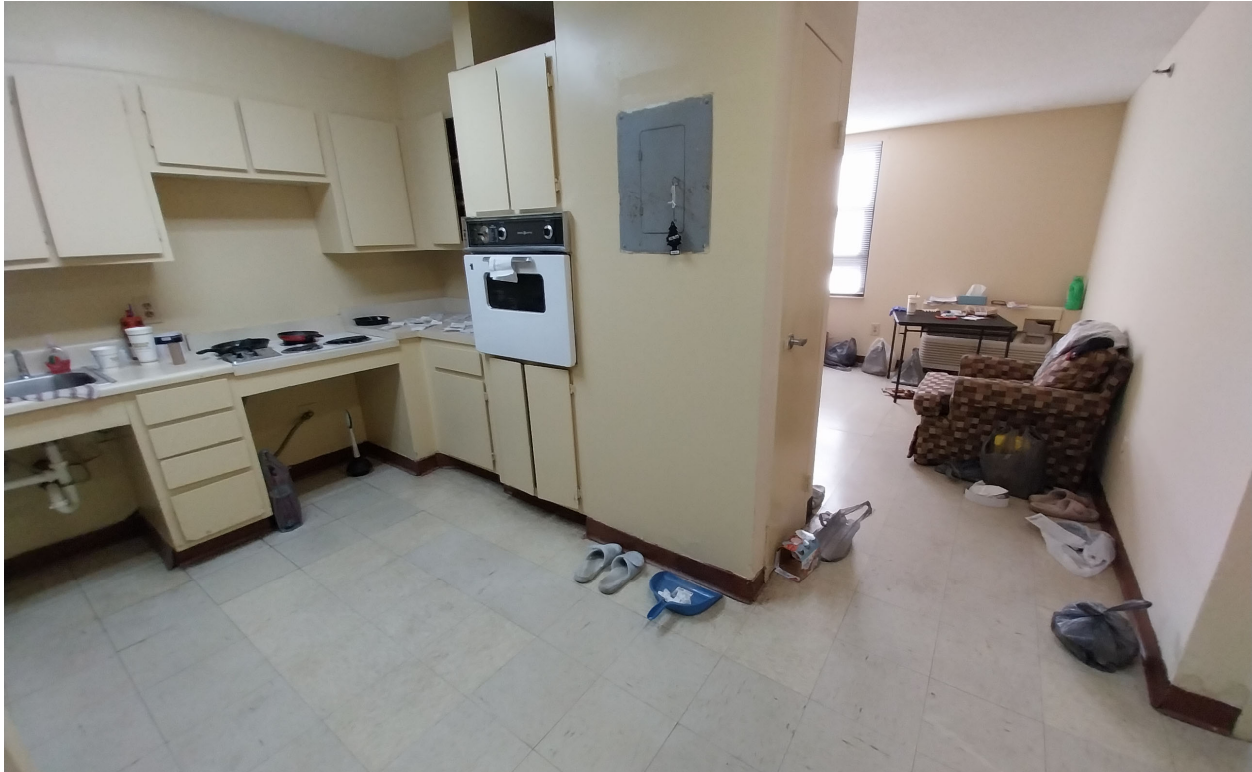
No. 29

Subject property typical unit interior

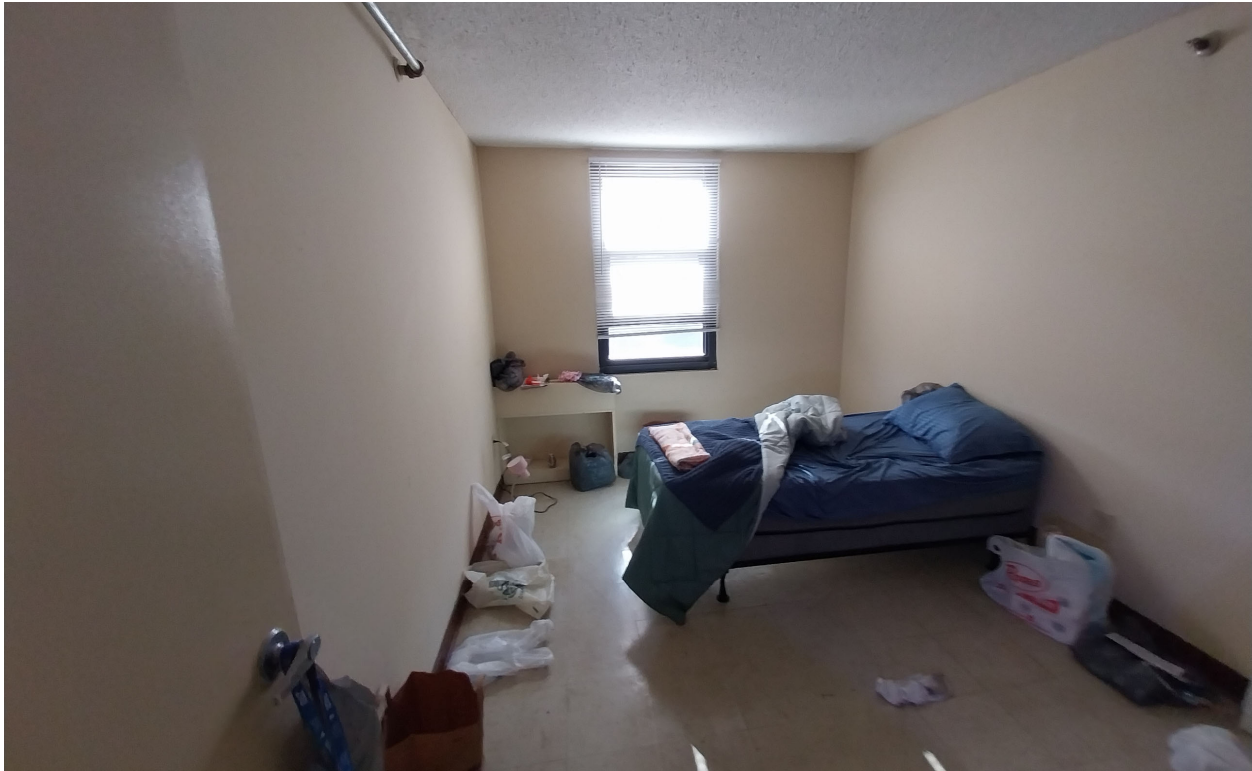
No. 30

Subject property typical unit interior

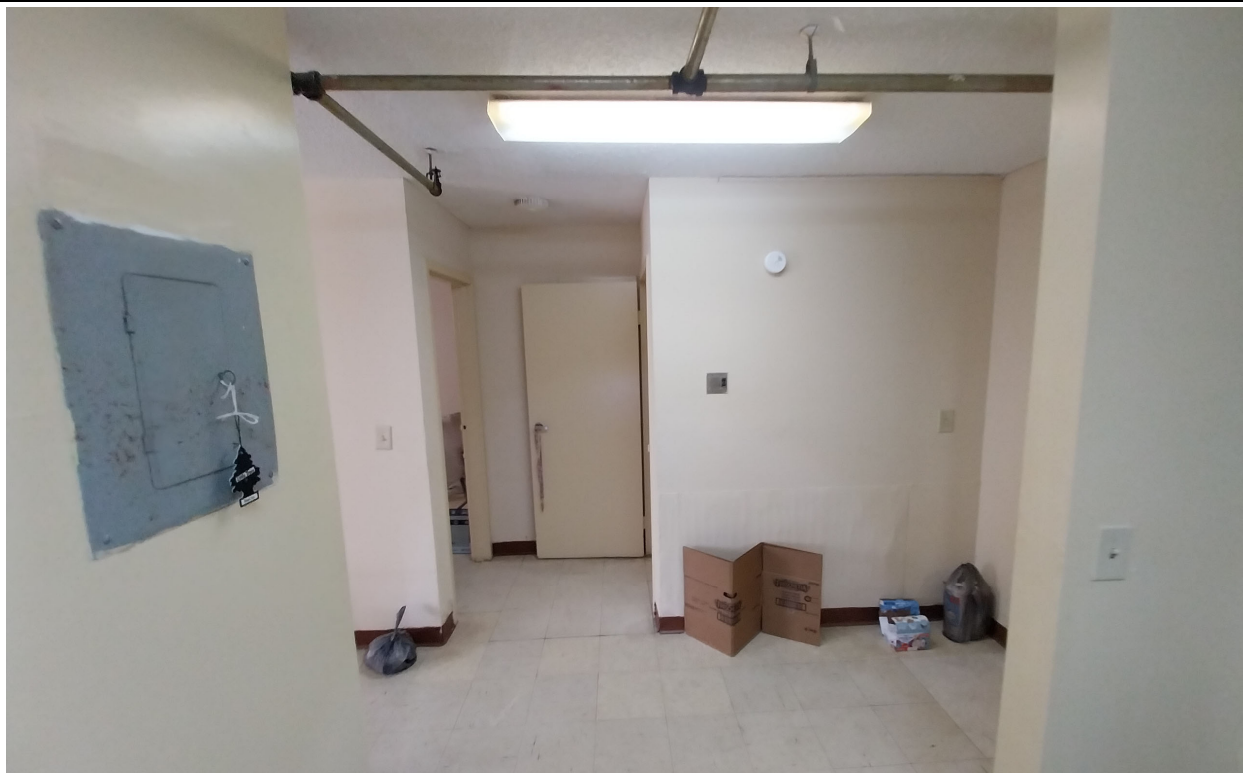
No. 31

Subject property typical unit interior

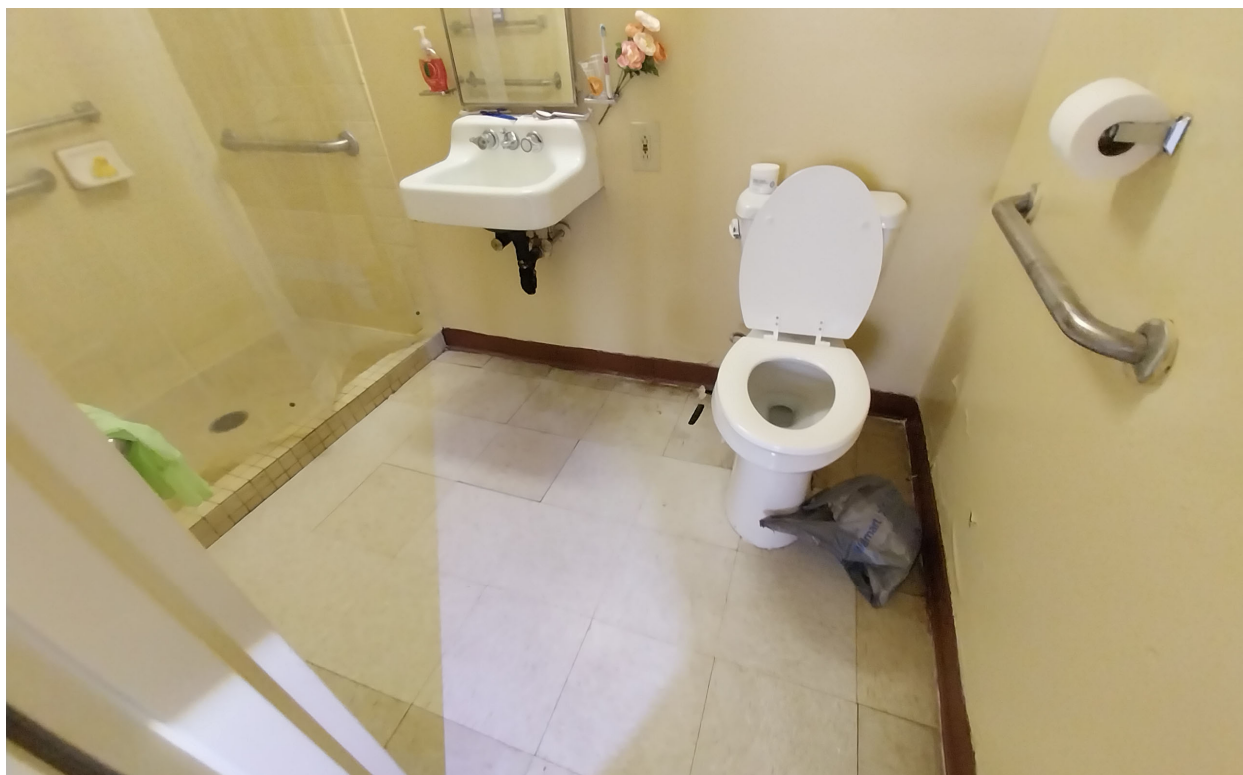
No. 32

Subject property typical unit interior

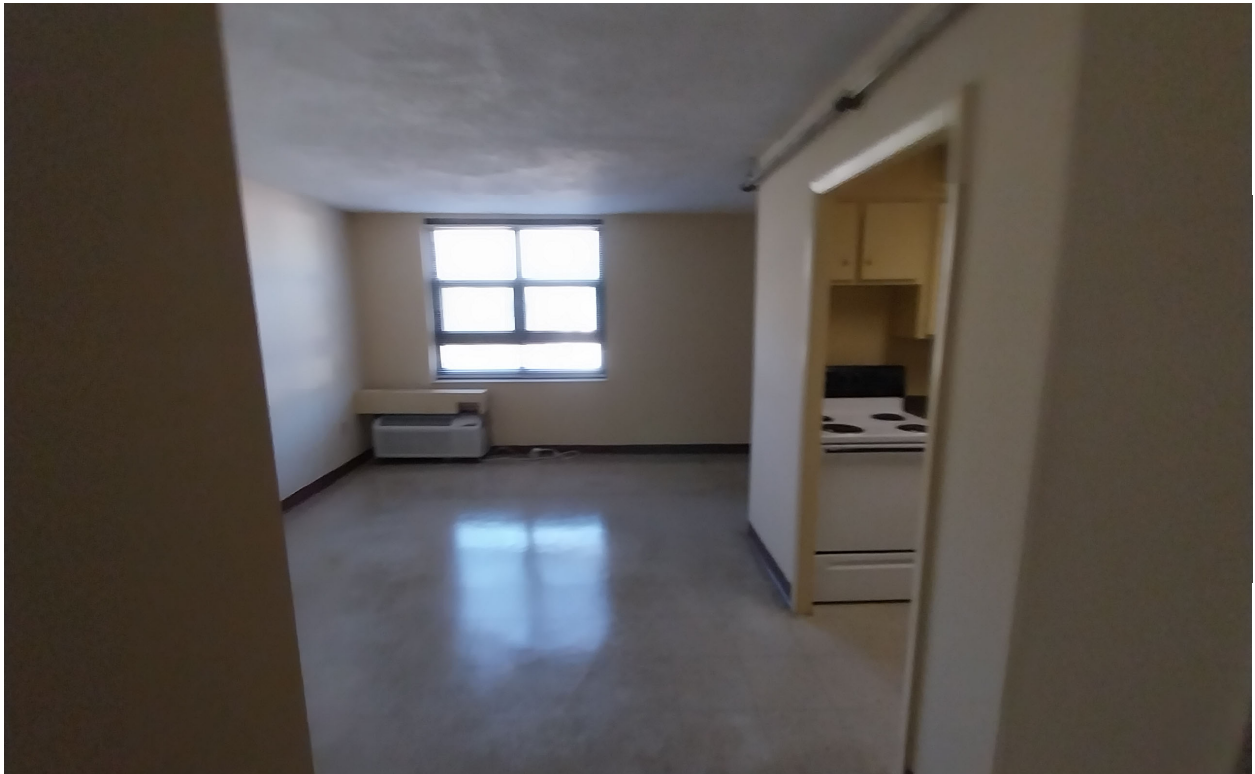
No. 33

Subject property typical unit interior

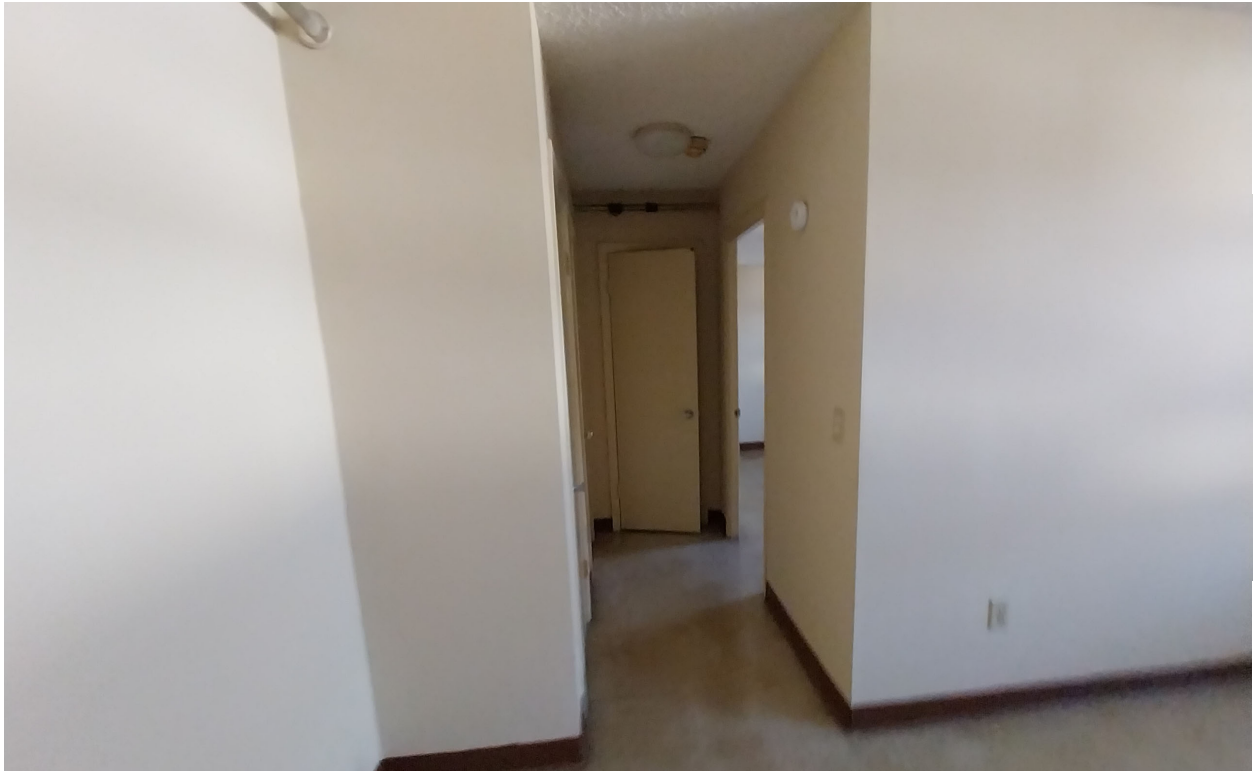
No. 34

Subject property typical unit interior

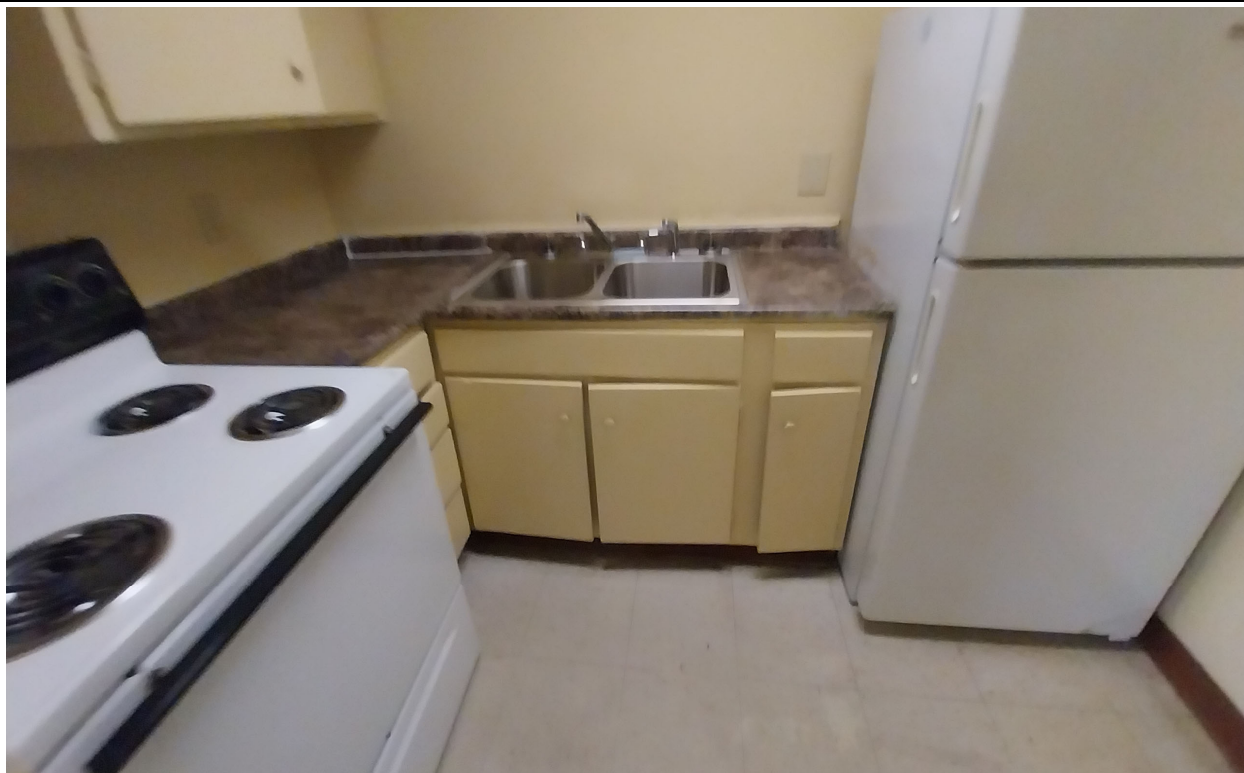
No. 35

Subject property typical unit interior

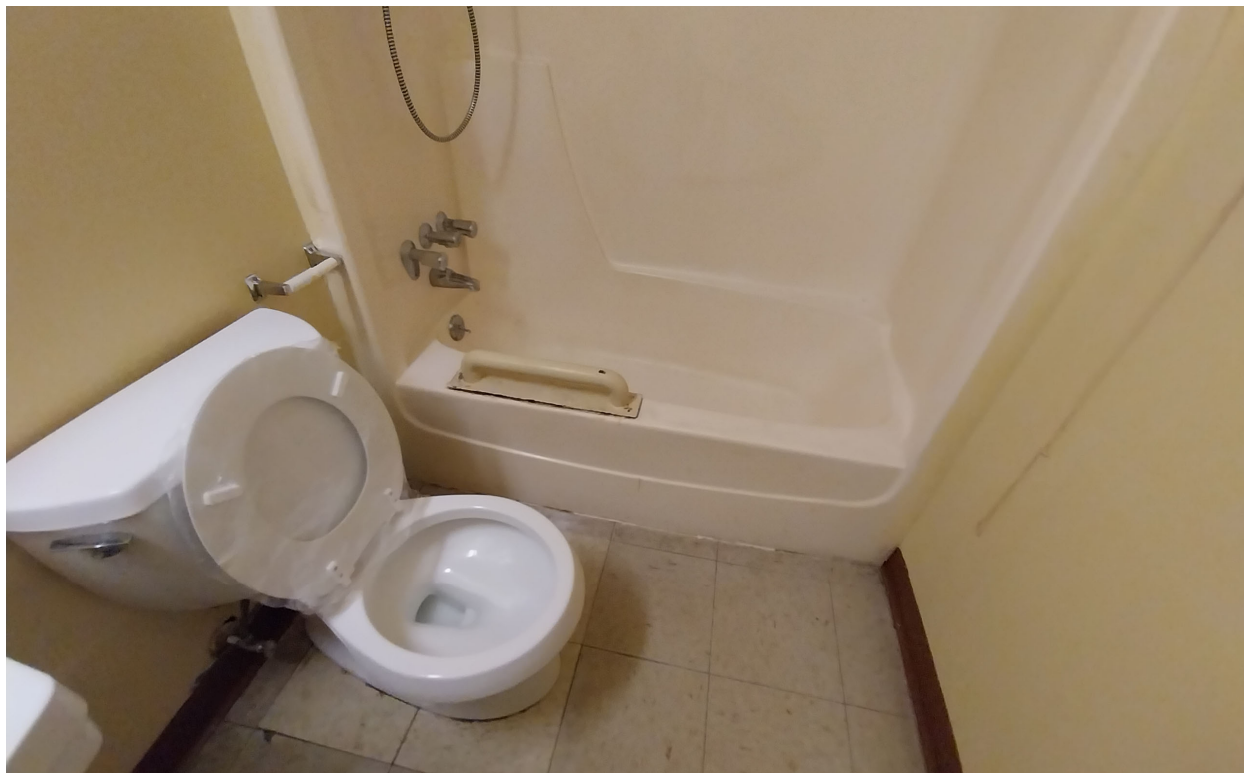
No. 36

Subject property typical unit interior

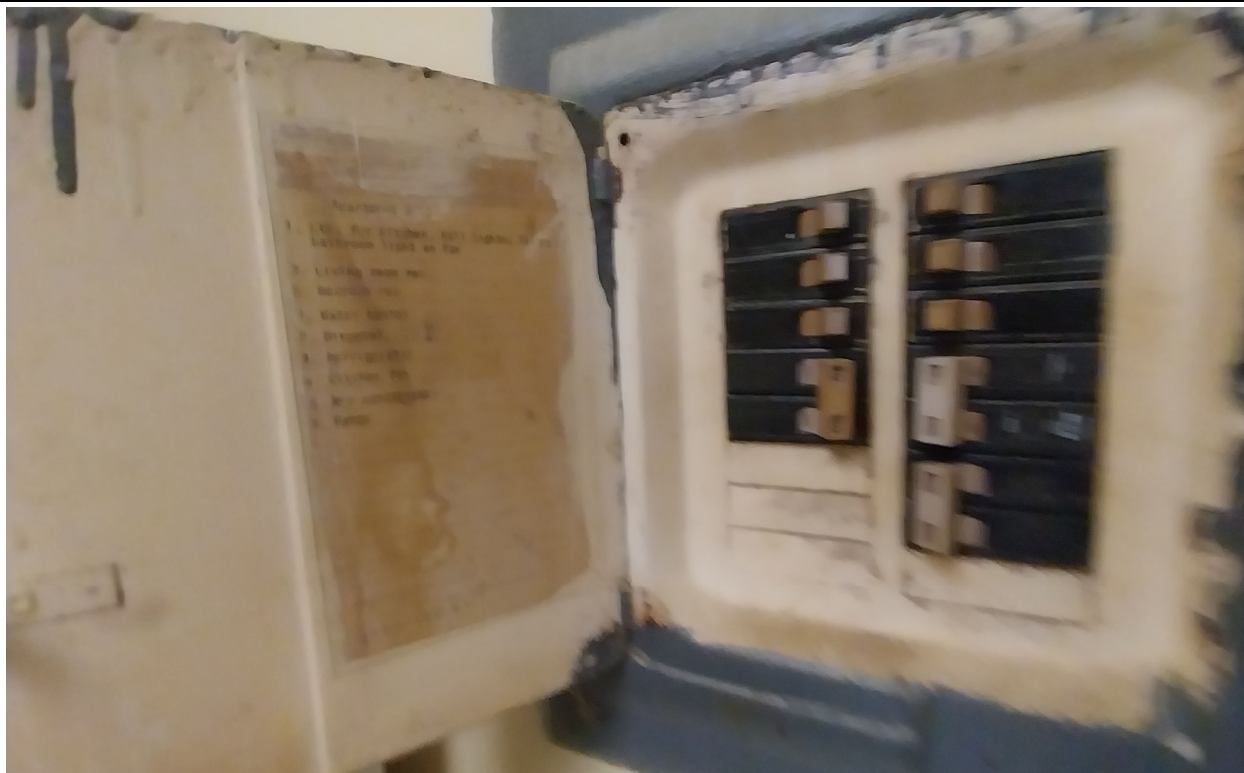
No. 37

Subject property typical unit interior electric panel

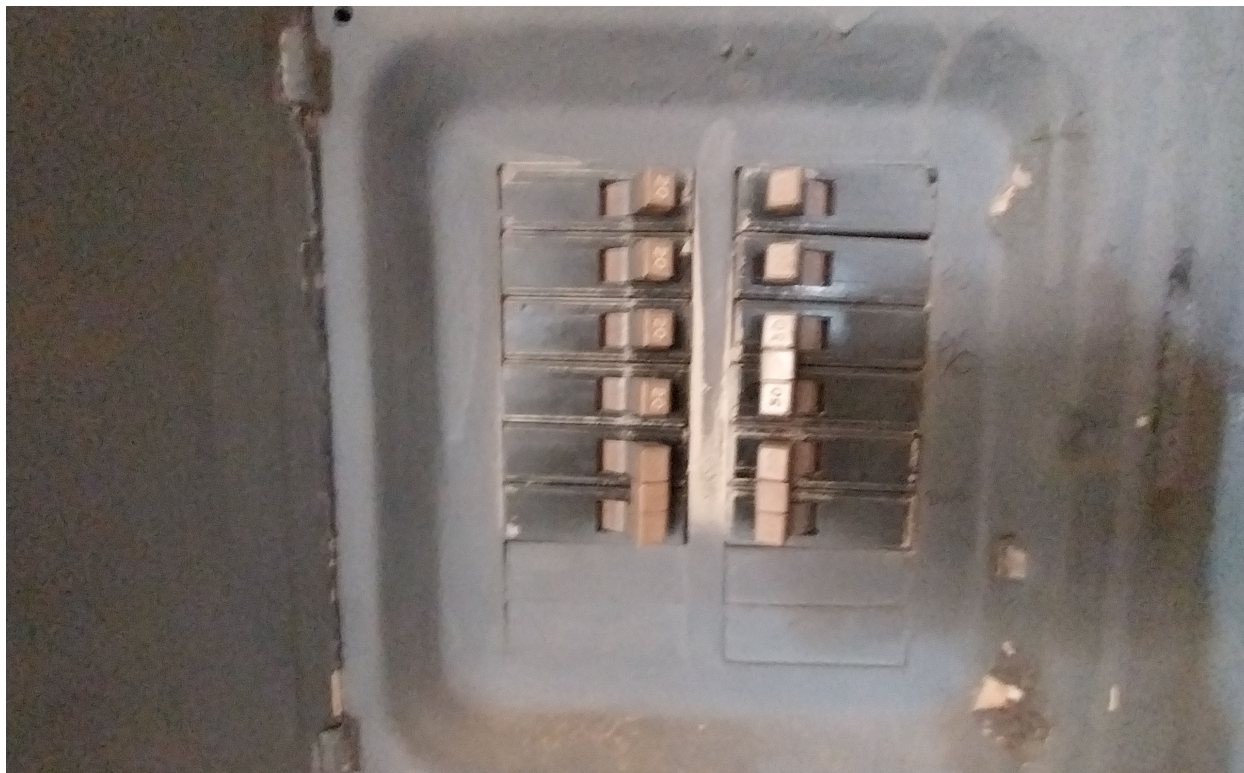
No. 38

Subject property typical unit interior electric panel
