## Arrington Mannor

### Evaluation of the Structural Framing and Facade

#### FINAL REPORT

October 11, 2024  
WJE No. 2024.5543

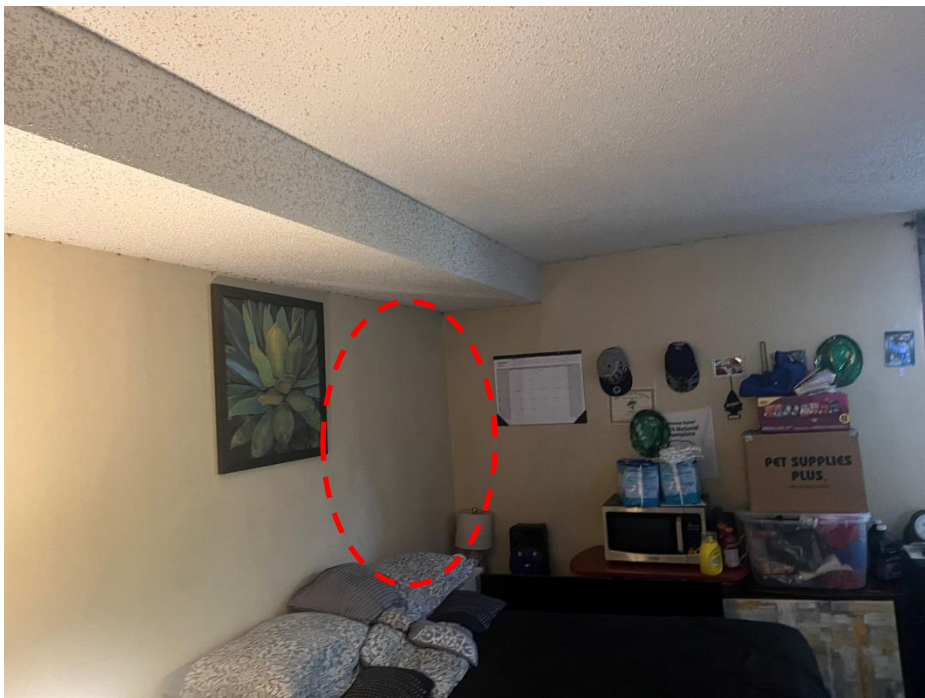
1. Unit 201 –Mildew staining is present on the west partition wall (Figure 7).
2. Unit 208 - Water stains were observed around the window (Figure 8) and at the interior corner of the portion CMU wall (Figure 9).

Figure 7. Area of mildew developing on the wall, Unit 201

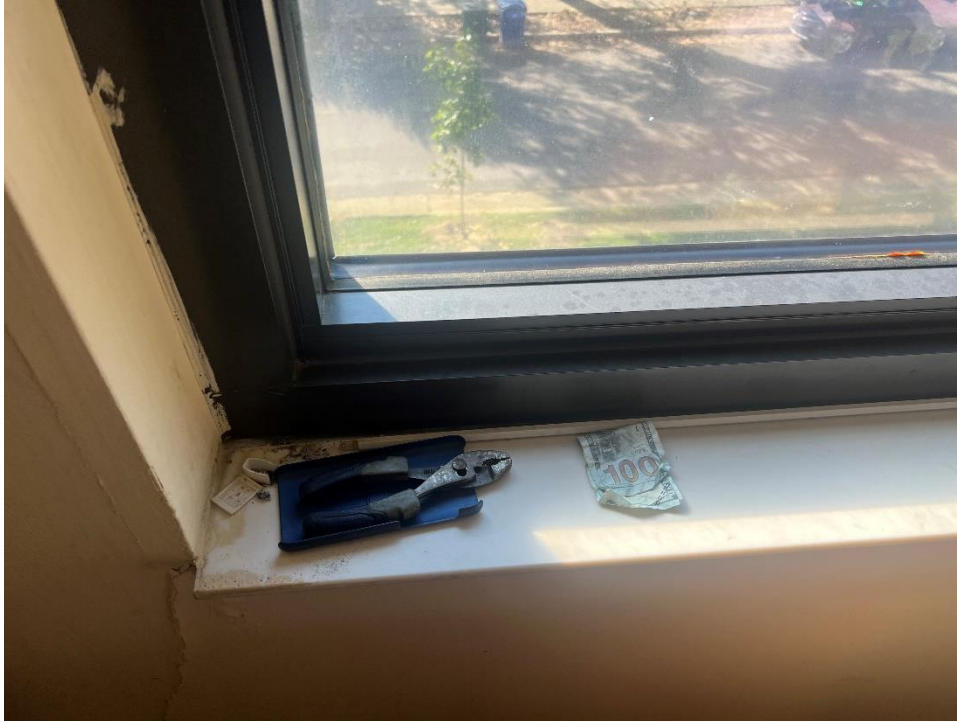
Figure 8. Water damage at the base of the window, Unit 208

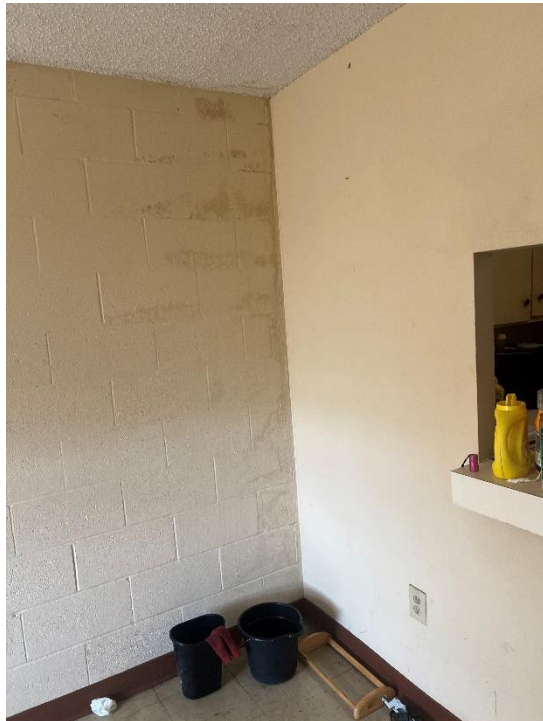
Figure 9. Water damage at the interior corner of the CMU partition wall

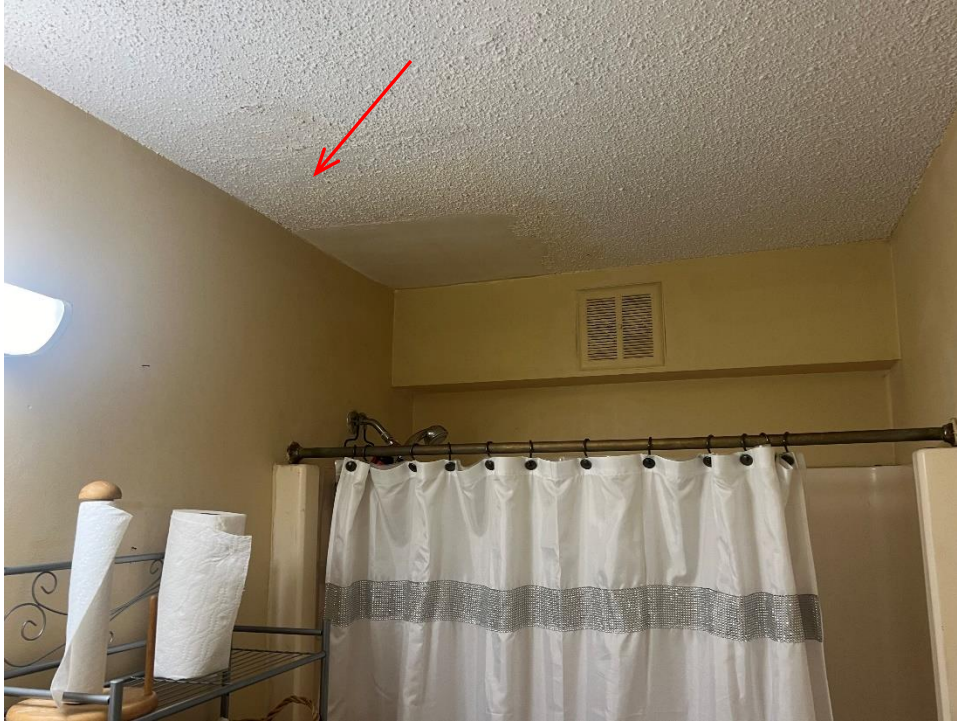
3. Unit 303 – Water staining is present adjacent to repaired area at the bathroom’s ceiling (Figure 10).
4. Unit 404 – New water stains are present adjacent to repaired ceiling area in the bathroom (Figure 11).

Figure 10. Water staining is present adjacent to repaired area at the bathroom's ceiling, Unit 303

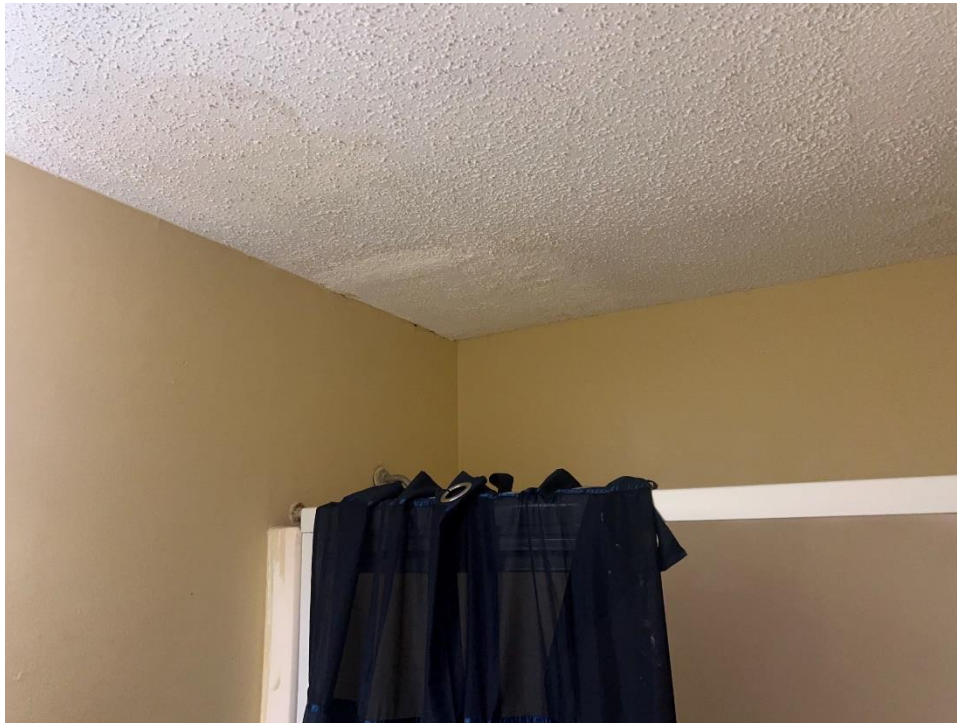
Figure 11. Water staining is present adjacent to repaired area at the bathroom's ceiling, Unit 404

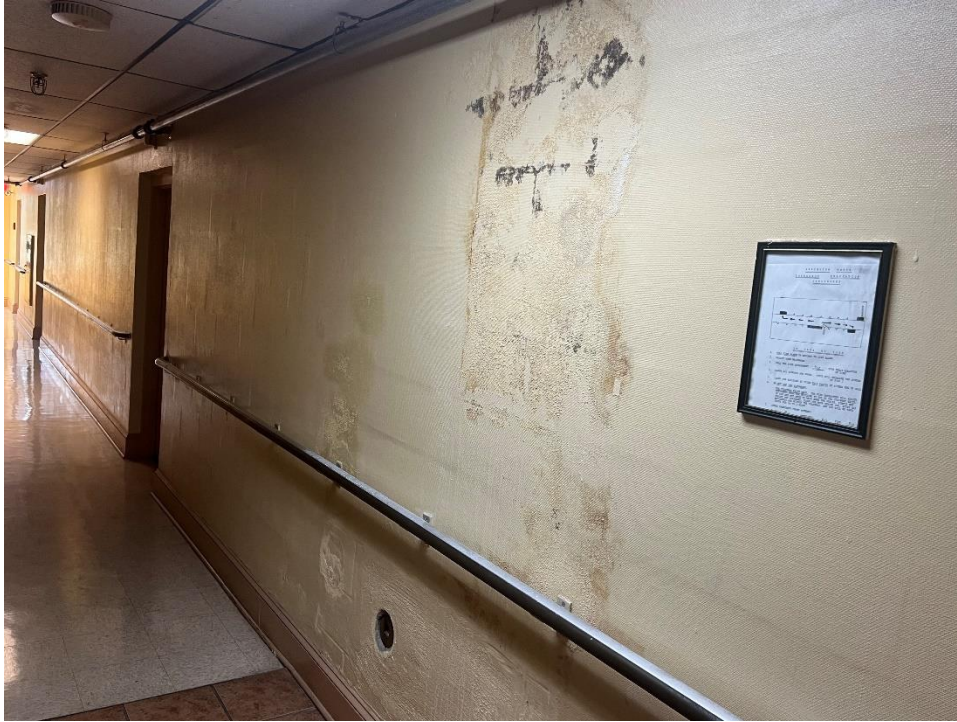
5. Hallway at 4<sup>th</sup> floor – Water damage was observed on the south wall of the hallway (Figure 12).
6. Unit 410 - Drywall above the window has a water damage (Figure 13).

Figure 12. Water damage in the wall at fourth floor hallway

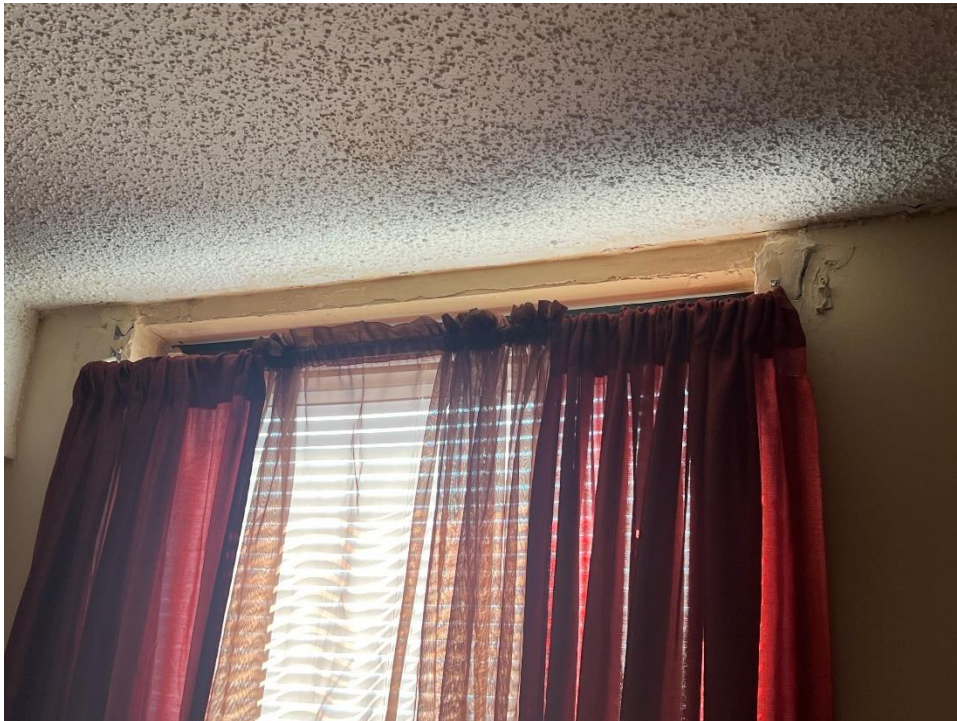
Figure 13. Water damage above the window in Unit 410

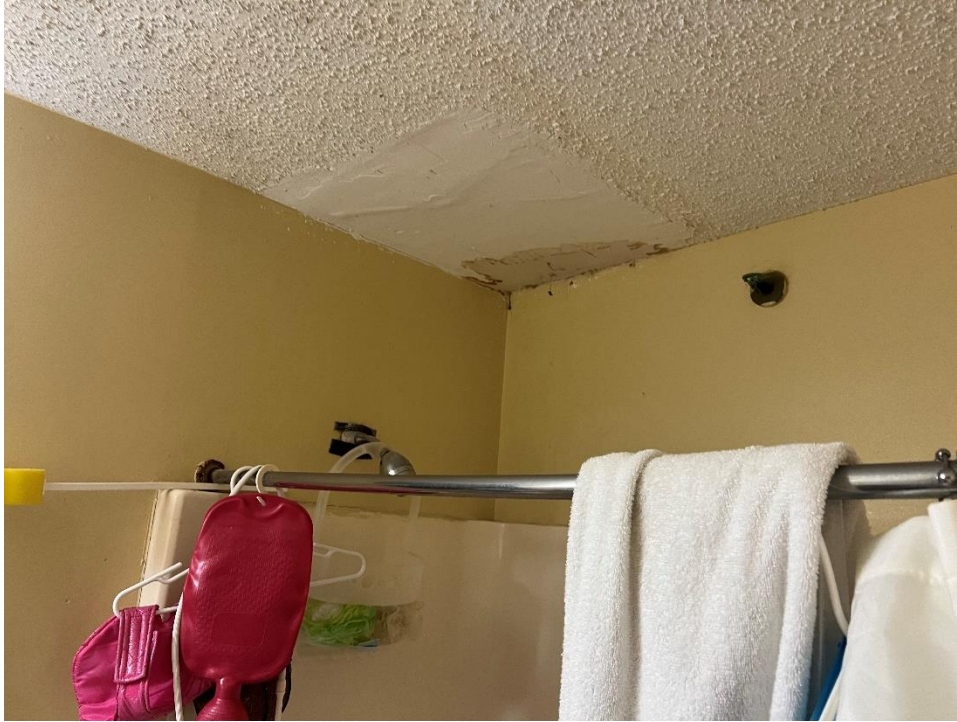
7. Unit 501 – New water damage is present adjacent to the repaired ceiling in the bathroom (Figure 14).
8. Unit 502 – Water staining was observed at the ceiling along the exterior wall (Figure 15). Water damage is present above the bedroom window (Figure 16).

Figure 14. New water leak adjacent to the repaired area of the bathroom ceiling, Unit 501

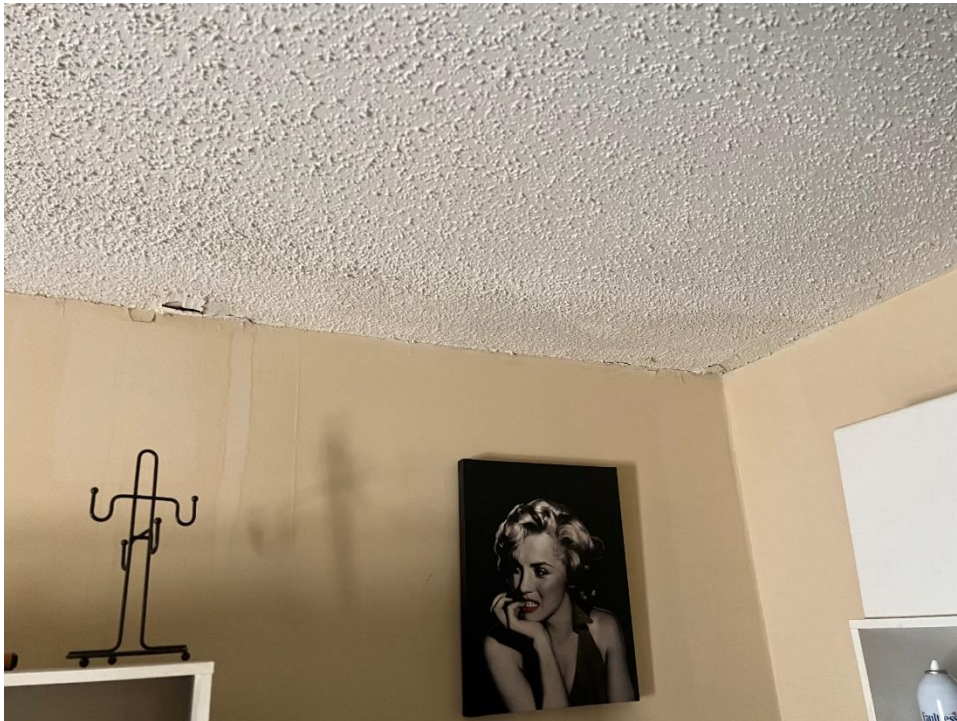
Figure 15. Stains from water leak along the edge of the ceiling against the exterior wall, Unit 502

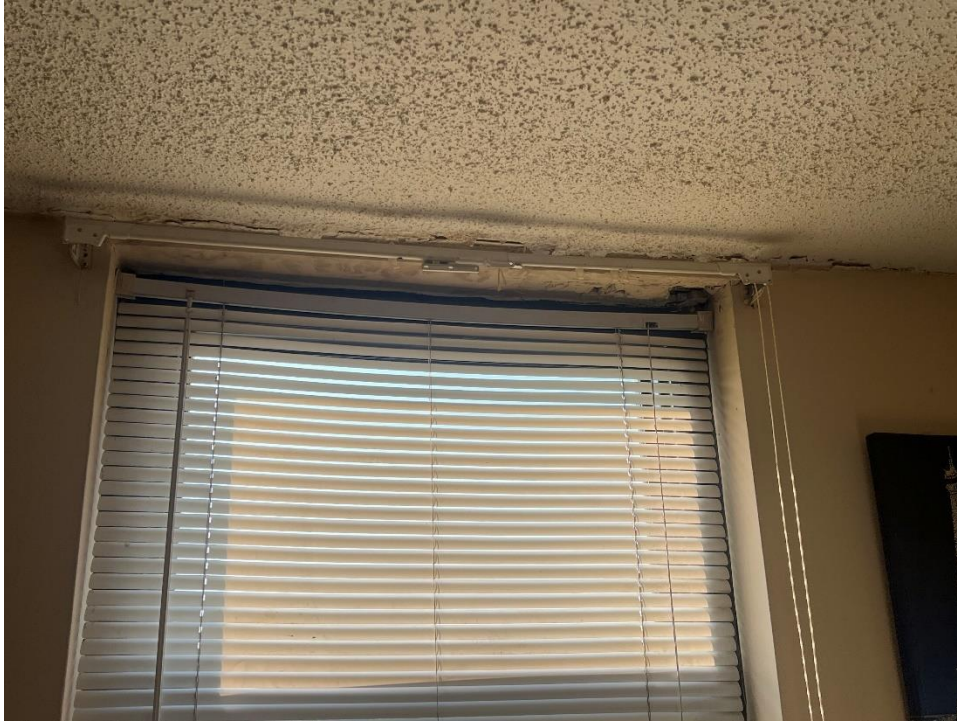
Figure 16. Water damage present above the bedroom window, Unit 502

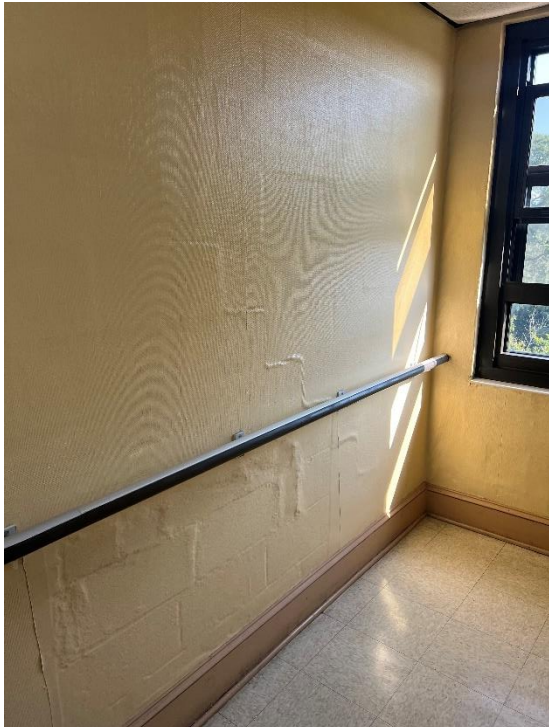
9. Hallway at 5<sup>th</sup> floor - Step crack is present in the CMU wall (Figure 17).

Figure 17. Step crack in the CMU wall at fifth floor hallway

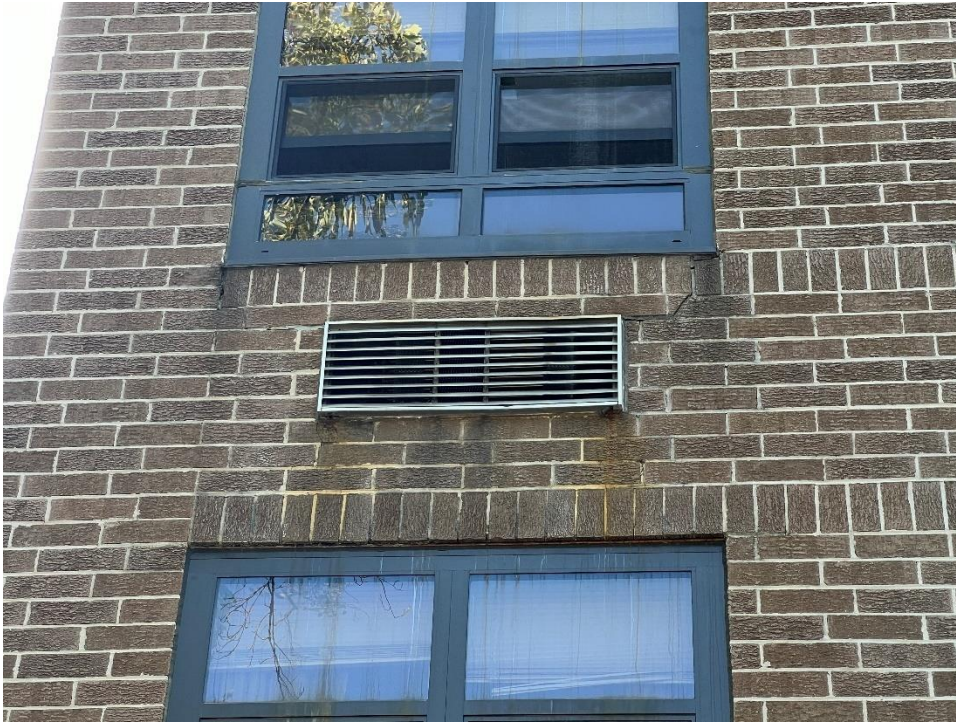
1. Cracking of brick masonry and significant corrosion build up was observed at embedded steel lintels above A/C sleeves on the east end of the north elevation (Figure 18). Masonry wall between windows and A/C units has visible corrosion stains. This is the only portion of the building where A/C sleeves are positioned directly below the windows.
2. Significant staining at brick masonry was present towards the east end of the north elevation below A/C sleeves. This staining trickle from the third floor down to the ground level and water is infiltrated electrical room through the exterior wall (Figure 19).

Figure 18. Cracks in brick masonry and corrosion build up at embedded steel lintels above A/C sleeves on the east end of the north elevation

2. Replace deteriorated steel lintels at windows and A/C units at the east end of the north elevation where corrosion build up is present at approximately 10 windows and 15 A/C units.

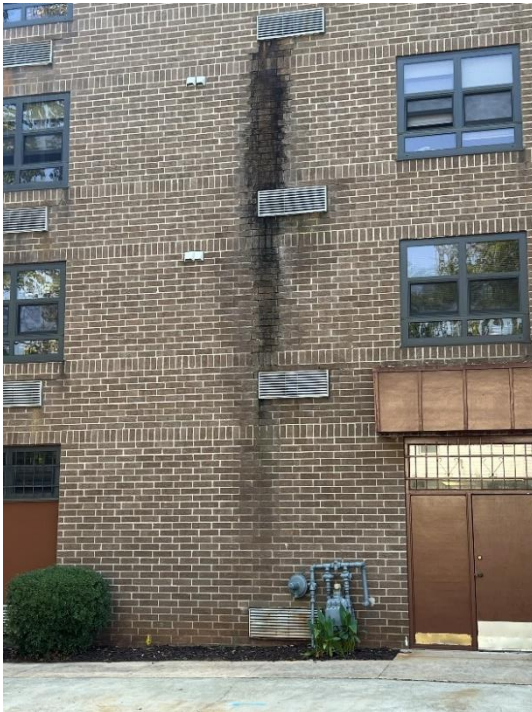
Figure 19. Staining at brick masonry at the east end of the north elevation below A/C

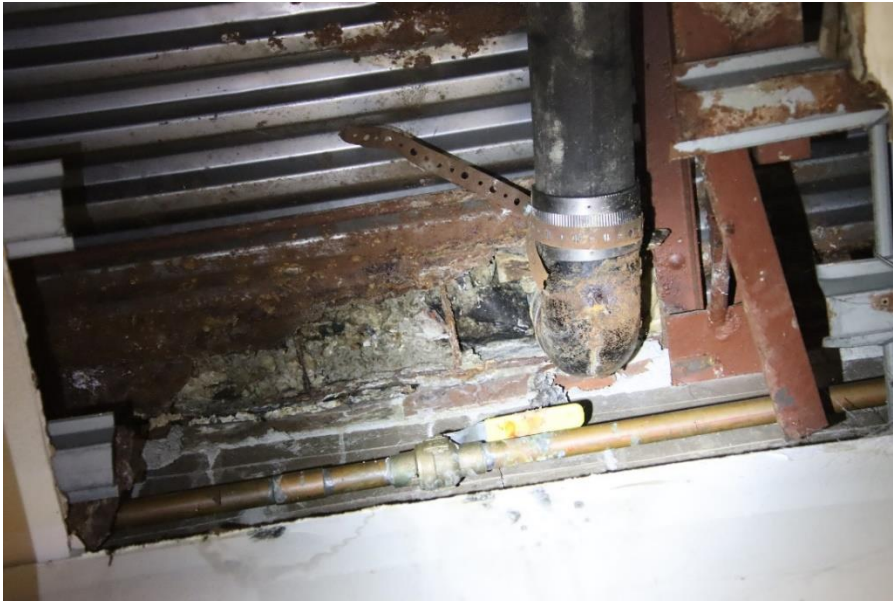
Figure 13. Deteriorated composite deck with section loss around the second floor bathroom drain pipe

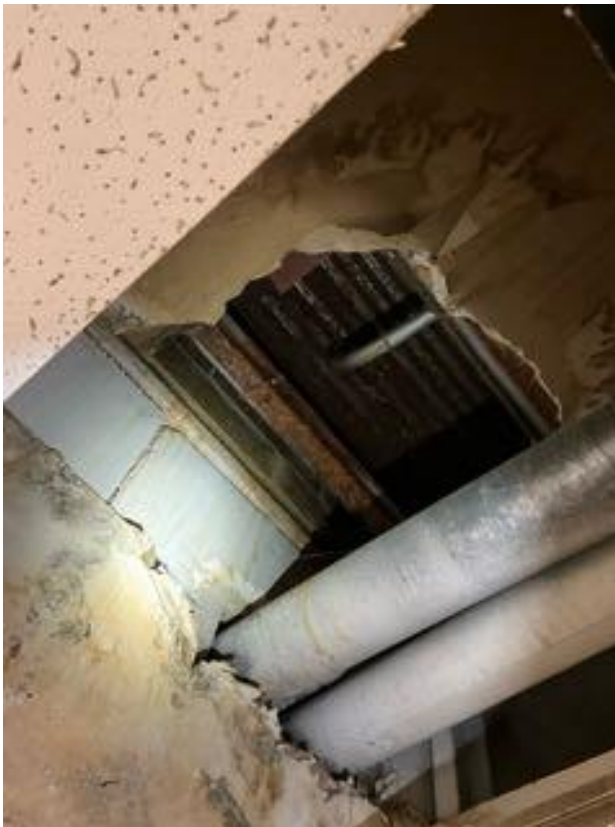
Figure 14. Corroded underside of the second floor composite deck by the exterior wall at the southeast corner of the building

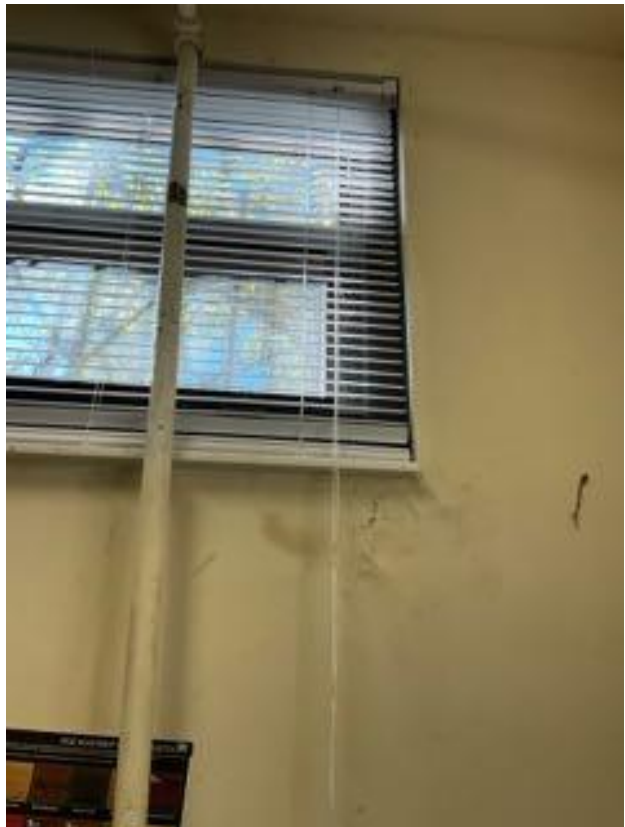
2. Water damage on the drywall was observed at the east window at the office on the east end of the building (Figure 15) at the first floor.
3. Water is infiltrating the top of the mechanical room through the exterior west wall at the ground level (Figure 16). At this location electric conduit is penetrating the wall.

Figure 15. Water damage on the east wall in the office by the south community room, first floor

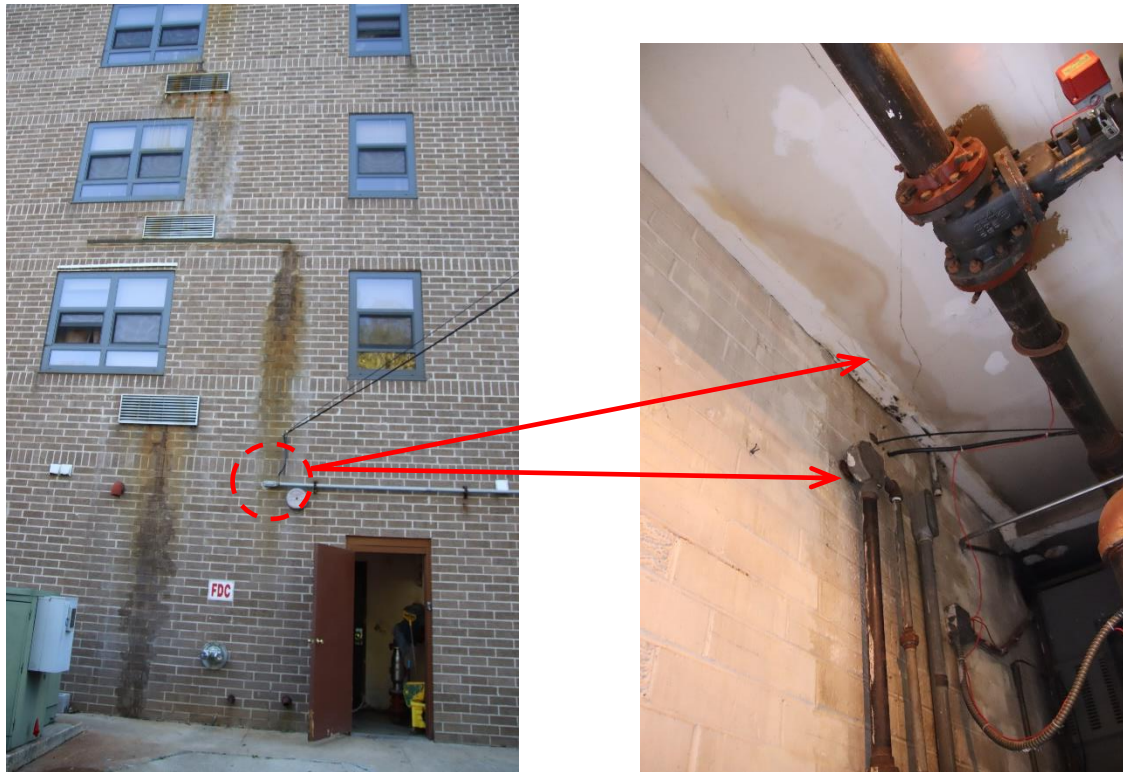
Figure 16. Leaks observed in the mechanical room (exterior and interior side of wall), north elevation

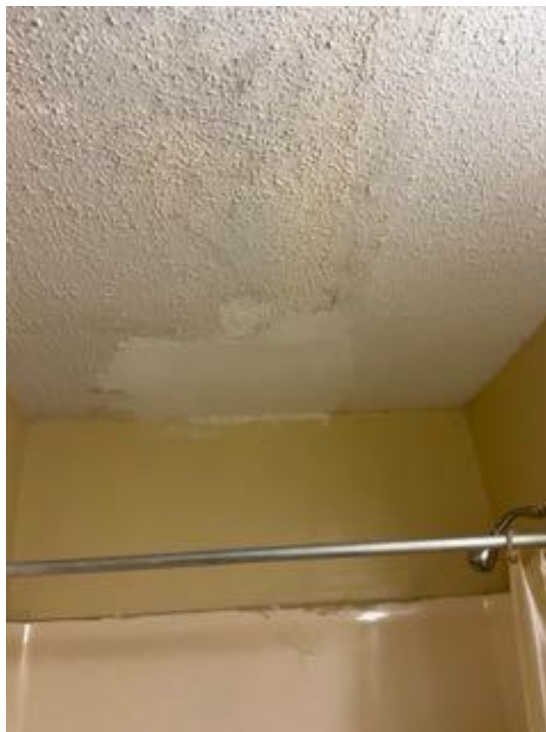
4. Water damage was observed at the base of both bathroom walls in the west portion of the corridor at the first floor.
5. Water damage was observed in the ceiling of each bathroom from the second through fifth floor. Typical observed condition is shown in Figure 17. Damaged areas were typically at locations directly above bathtub drains and toilets.

Figure 17. Typical condition of ceilings in bathrooms

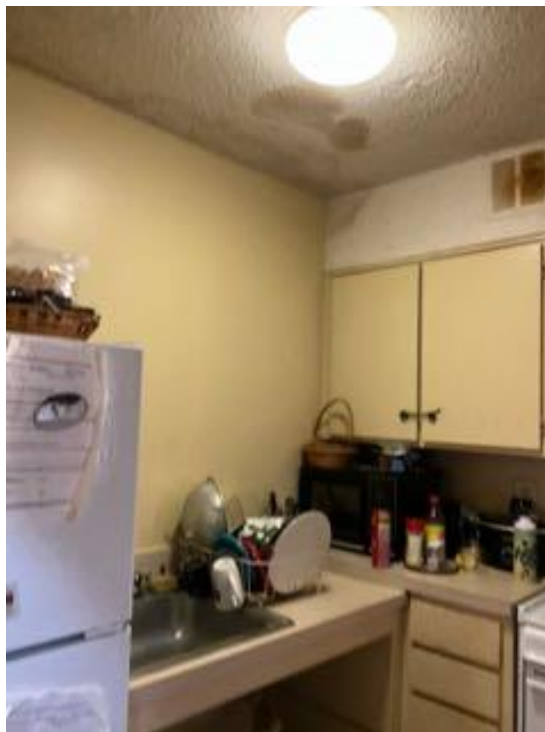
6. Water damage was observed in the ceiling of each kitchen from the second through fifth floor. Typical observed condition is shown in Figure 18.
7. In many kitchens cabinets areas below sinks have stains from water leaks (Figure 19).

Figure 18. Typical condition of ceilings in kitchens

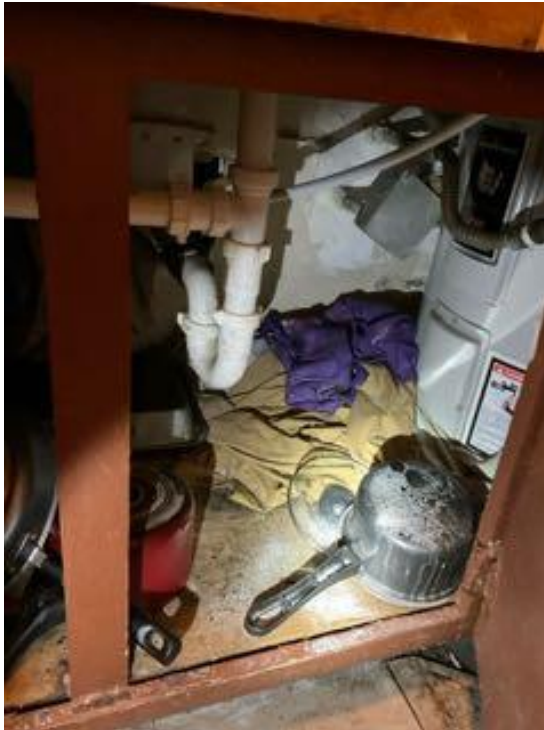
Figure 19. Water damage inside kitchen cabinet from past leaks

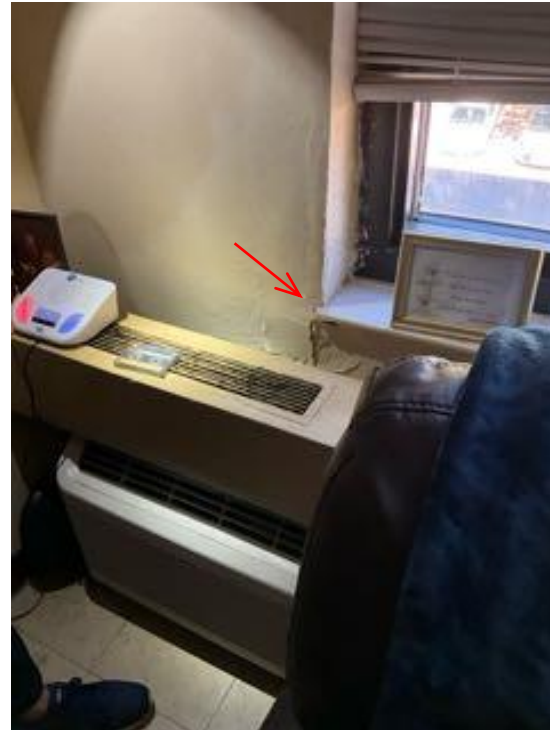
8. Deteriorated concrete floor slab was observed inside the kitchen where the water heater tank is stored, Unit 305 at the third floor.
9. Water damage around windows was observed in Units 101, 206, 303, 305, 307 (Figure 20).

Figure 20. Water damage around window in Unit 303

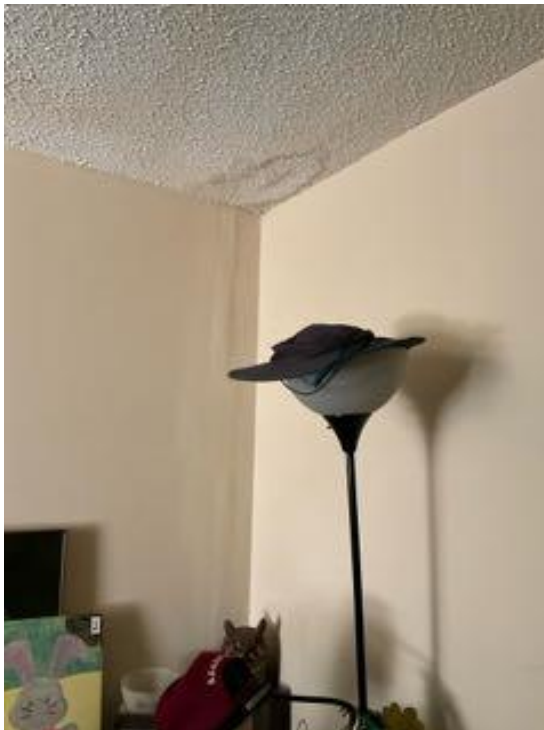
10. Water damage was observed in the drywall at walls and ceilings adjacent to the exterior wall in Units 101, 102, 205, 206, 218, 307, 404 and 410 (Figure 21). Water damage was observed in the ceiling of Unit 508 approximately two feet inside the unit from the exterior wall. The metal deck visible from the hole in the ceiling was corroded (Figure 22).

Figure 21. Water damage in drywall at ceiling by the exterior wall, Unit 218

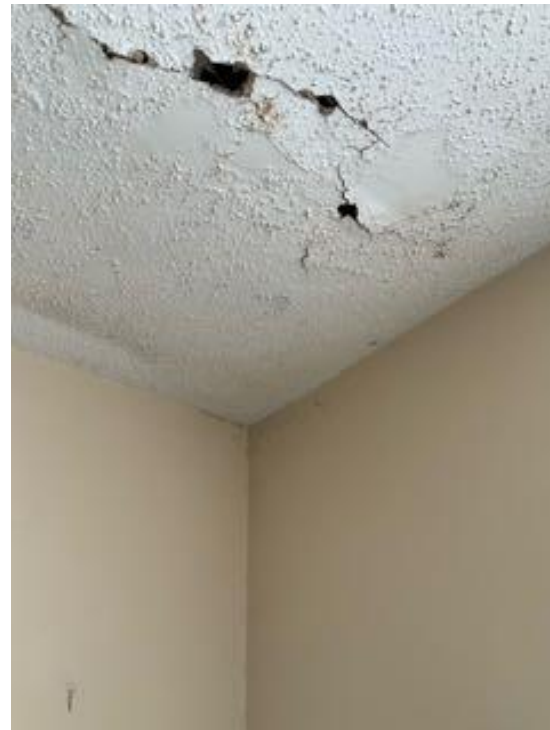
Figure 22. Damaged ceiling due to water infiltration two feet from the exterior wall, Unit 508

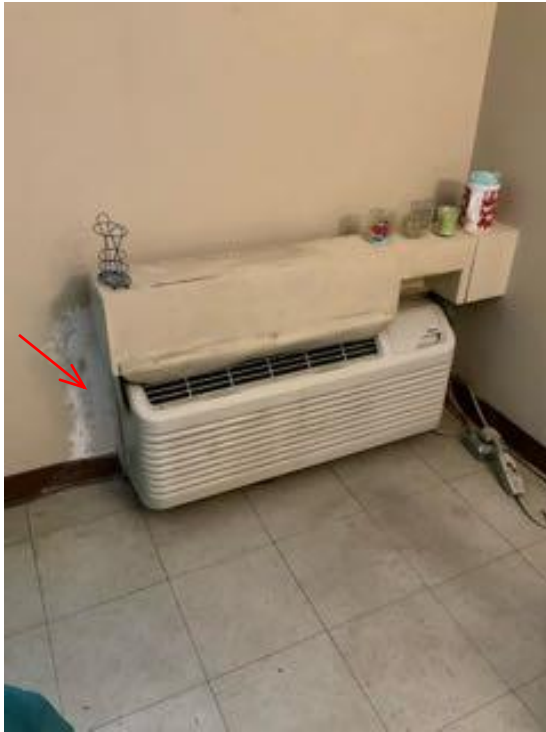
11. Water damage was observed in the drywall around A/C units in Units 100, 205, 218, 303, 307, 404 and (Figure 23).
12. Mold on the walls and ceiling was observed in the bathroom of Unit 101, on the bedroom walls in Unit 201 (Figure 24) and in the bedroom walls in Unit 303. In Unit 201 mold was also present on the drywall covering the exhaust duct installed along the ceiling (Figure 25).

Figure 23. Water damage around A/C unit typ.

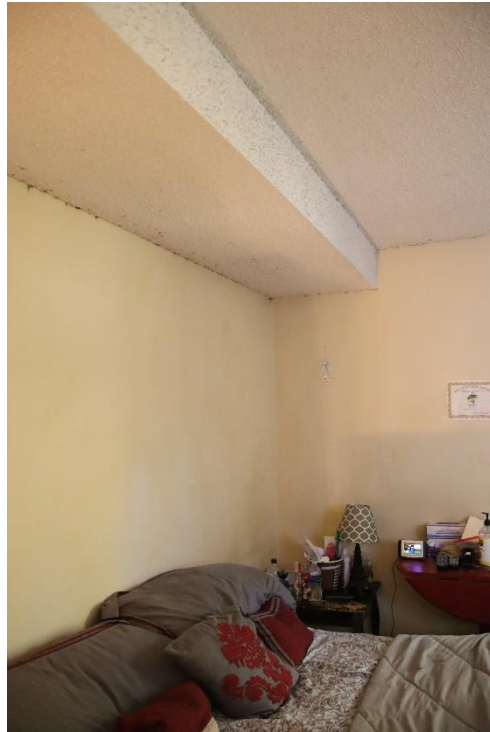
Figure 24. Mold observed on walls in Unit 201

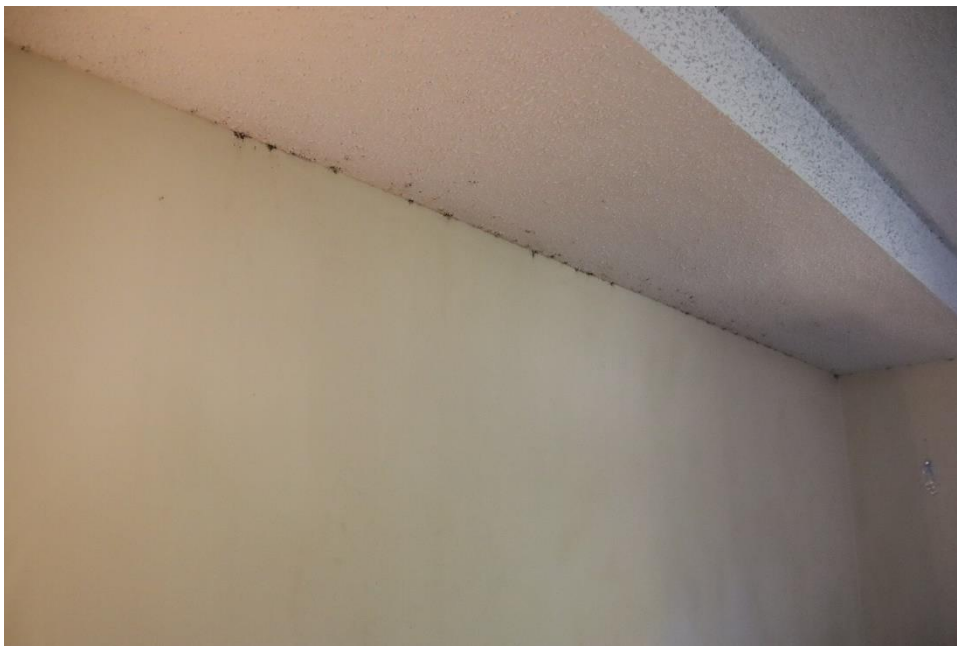
Figure 25. Mold present along the duct and in the wall below it in Unit 201

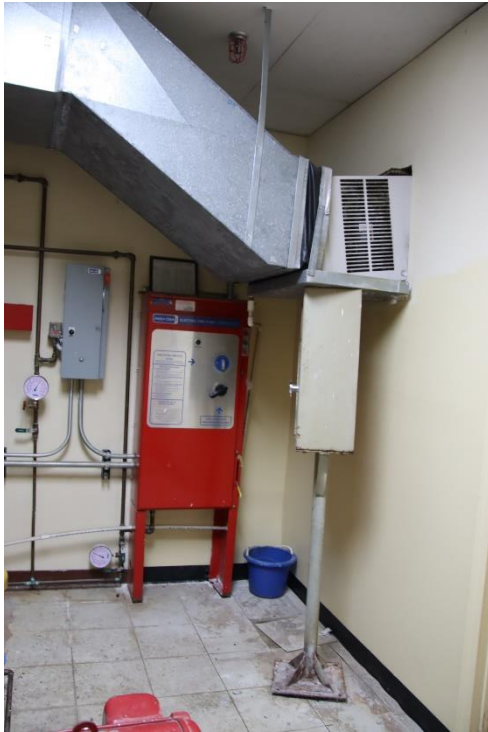
15. Vent duct in the mechanical room adjacent to the laundry room is bearing on improvised support (Figure 26).
16. Surface corrosion staining was observed on the underside of the steel stringers supporting west stairway landings at their southeast corners on the second, fourth and fifth floors (Figure 27). Surface

Figure 26. Improvised duct support in the mechanic room adjacent to laundry room

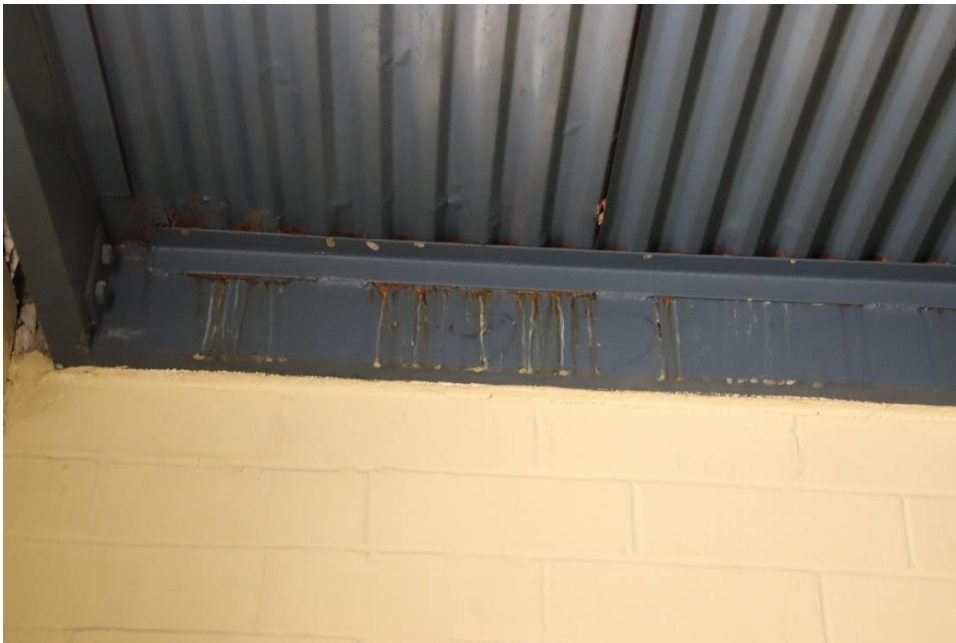
corrosion was also observed on the steel channel at the midfloor landing on the second floor that abuts the exterior wall. At those locations end of the composite metal deck is starting to corrode.

Figure 27. Surface corrosion present on the underside of the sixth floor stairway landing

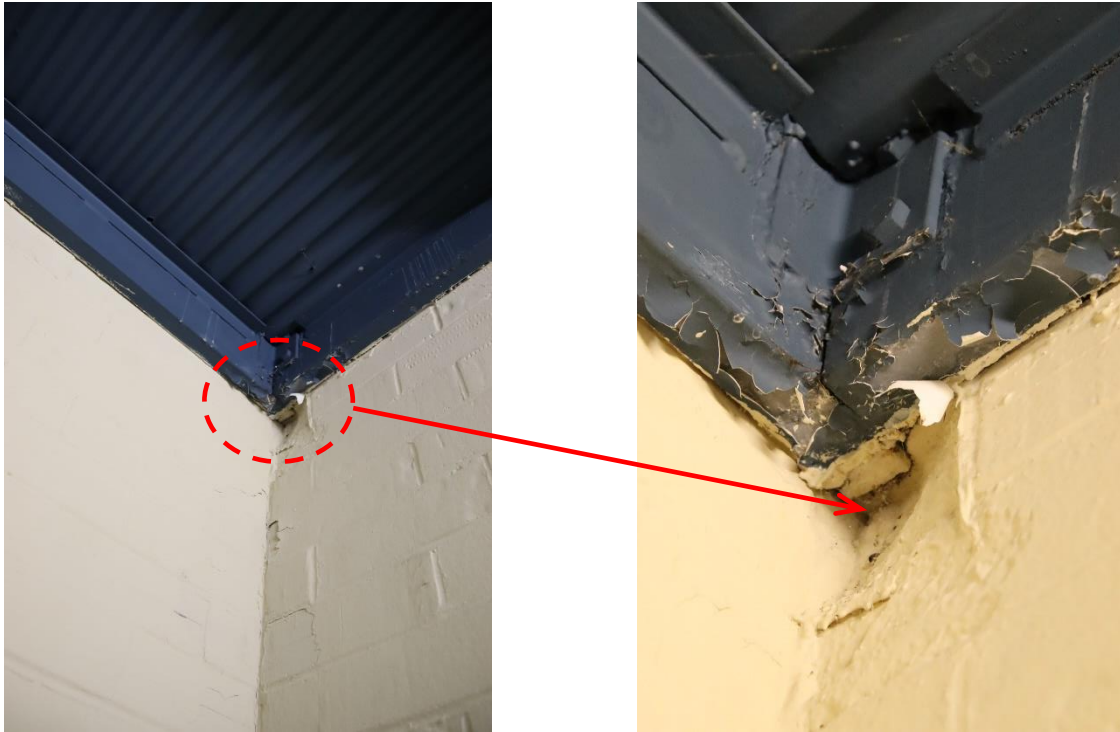
17. Spalled brick masonry is present below the steel stinger bearing in the east stairway at mid landing between the first and the second floor (Figure 28). The paint was peeling off the steel members in that corner and very minor rust staining has started to form.
18. Daylight could be seen at the exit door threshold on the ground level at the west stairway.
19. Paint on the top of the canopies has been peeled of, exposing remains of the previous paint coats.

Figure 28. Overall and close-up views of spalled CMU below steel girder bearing in the east stairway, at mid-landing between first and second floor

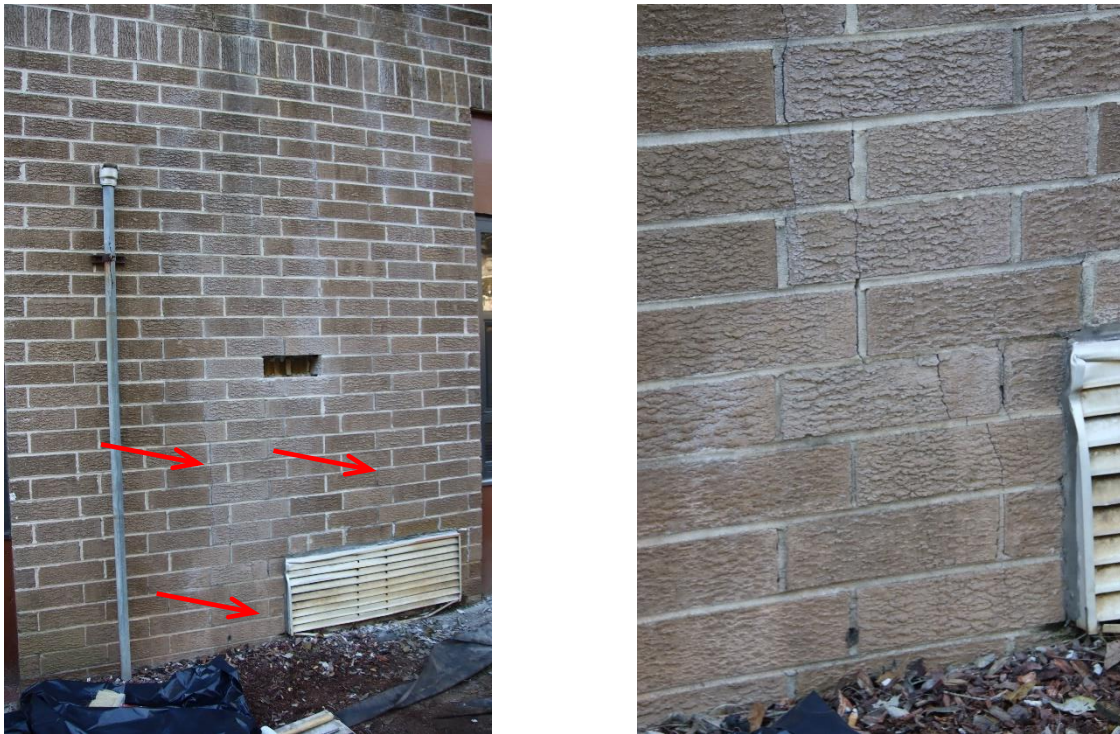
1. Cracks in brick masonry were observed at one location above and around the A/C sleeve at the west part of the north elevation at the first floor (Figure 29). Embedded steel lintel angle above A/C unit is corroded and joint around it has widened. The sealant in joints around A/C is deteriorated.

Figure 29. Overall and close-up views of cracks observed in the north exterior wall.

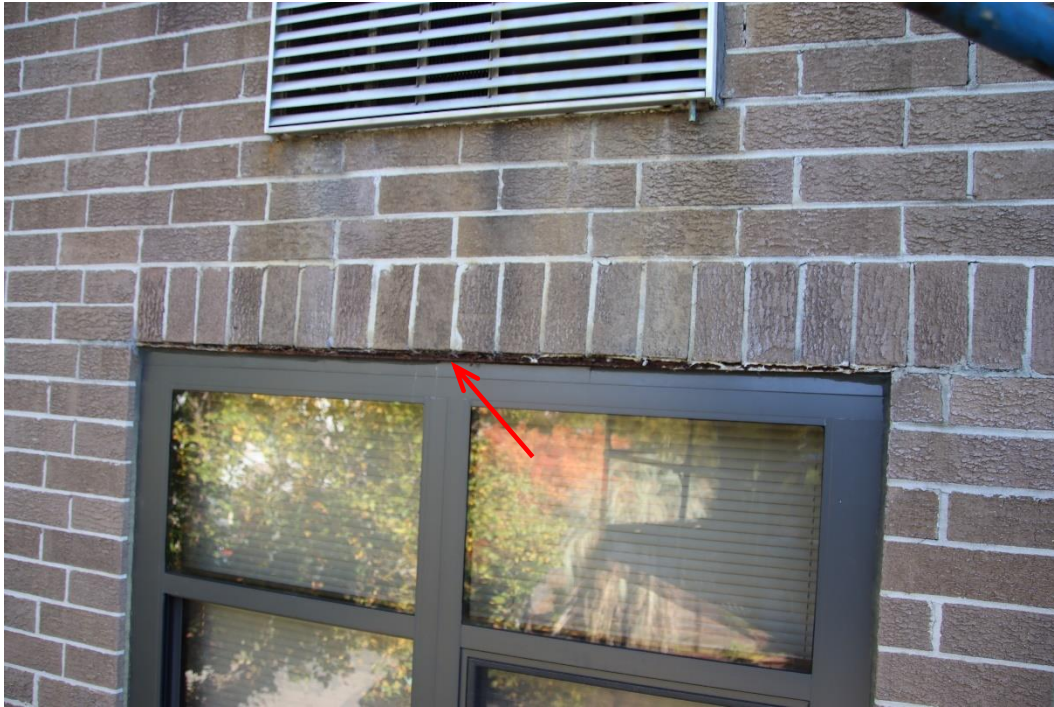
2. Significant corrosion build up was observed at steel window lintels (Figure 30) and at embedded steel lintels above A/C sleeves (Figure 31) at the east end of the north elevation. Masonry wall between windows and A/C units has visible corrosion stains. This is the only portion of the building where A/C sleeves are positioned directly below the windows.

Figure 30. Corroded steel window lintel with packed rust

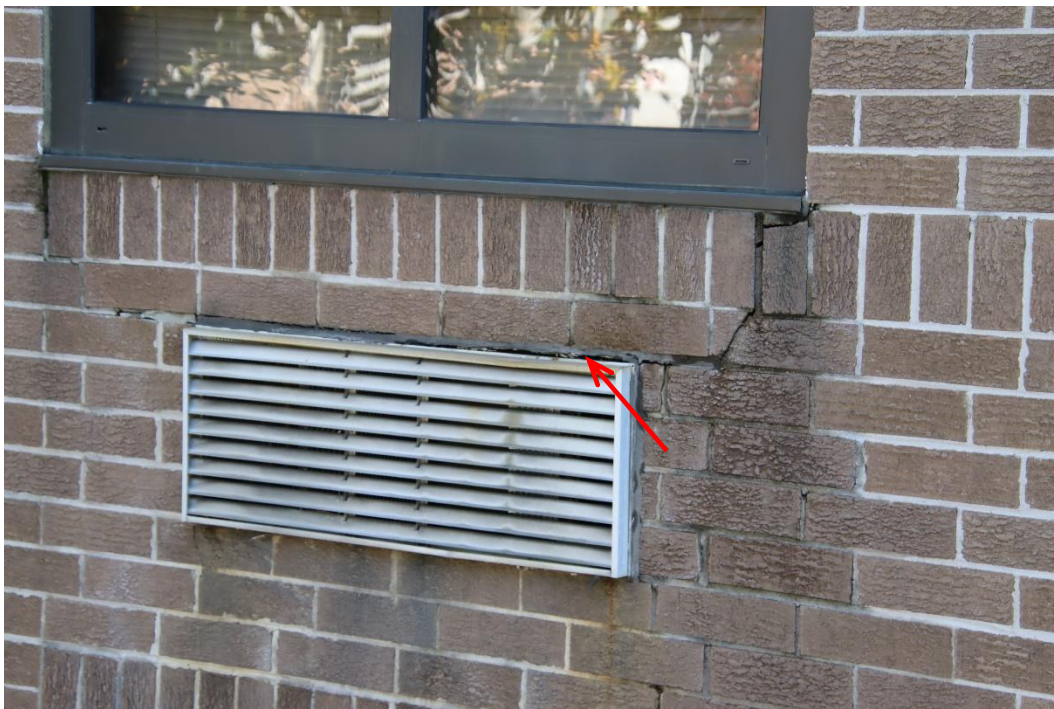
Figure 31. Corroded steel A/C lintel with packed rust

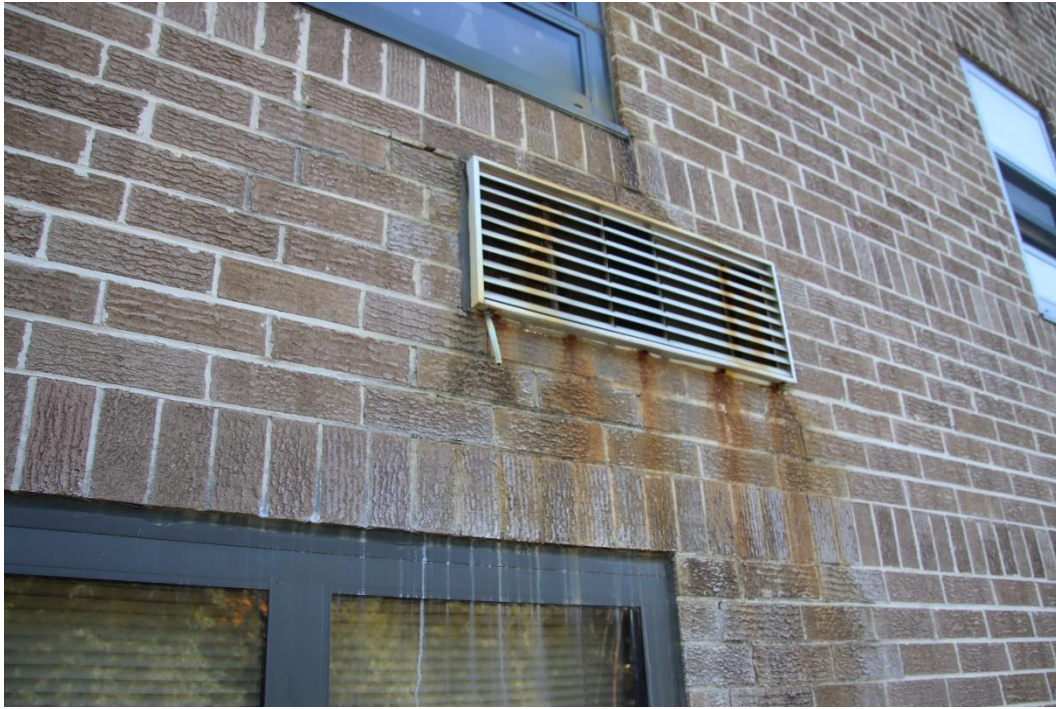
Figure 32. Weeps at A/C sleeves and rust stains below them

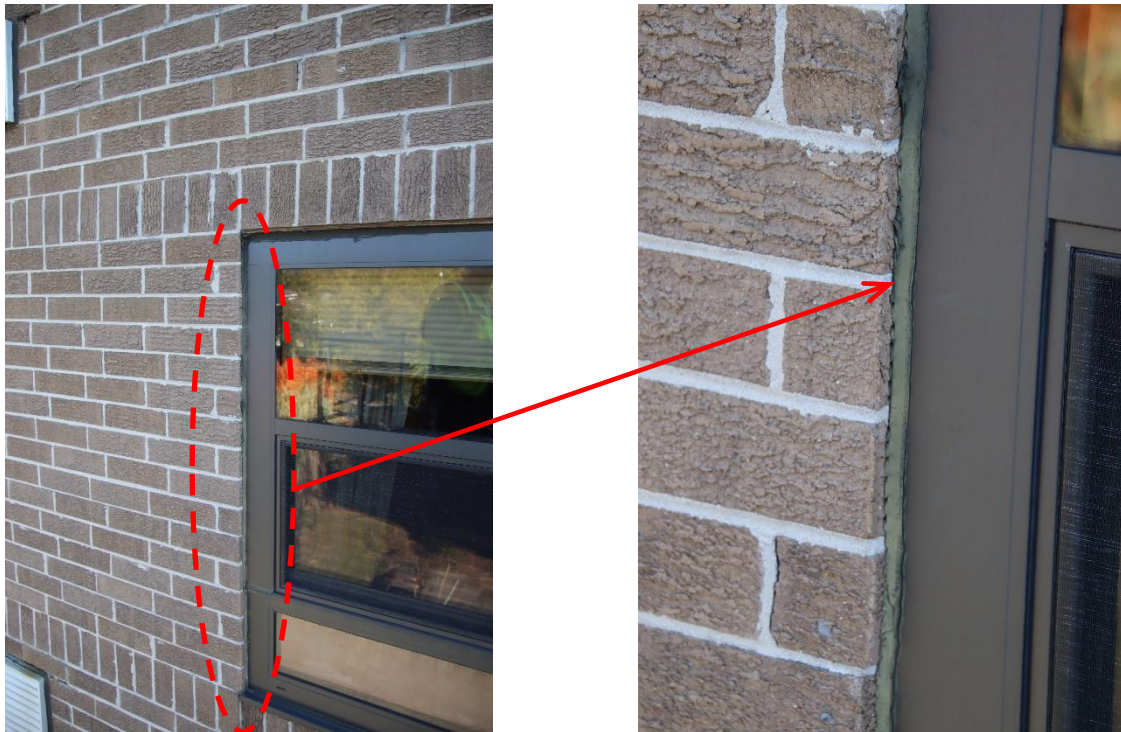
6. Sealant around all windows is deteriorated (Figure 33).
7. Sealant around all A/C louver covers is deteriorated (Figure 34).
8. Grouted infill between door frame and adjacent brick masonry is cracked on one side of the door at the mechanical room on the ground level.

Figure 33. Overall and close up views of debonded sealant around window frames

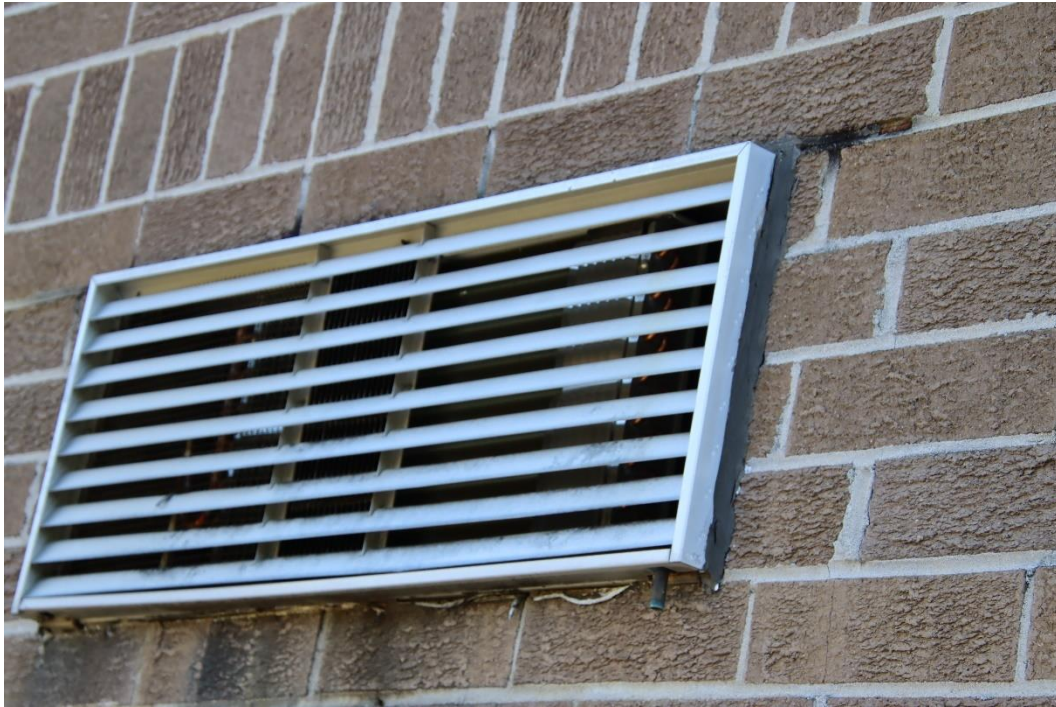
9. Mortar in joints was debonded from the brick and appeared eroded at select locations (Figure 34).
10. Deteriorated sealant was observed at perimeter joints between canopies and brick masonry wall on both north and south elevations (Figure 35).

Figure 34. Deteriorated sealant around A/C louvers
