## Arrington Mannor

### Evaluation of the Structural Framing and Facade

#### FINAL REPORT

October 11, 2024  
WJE No. 2024.5543

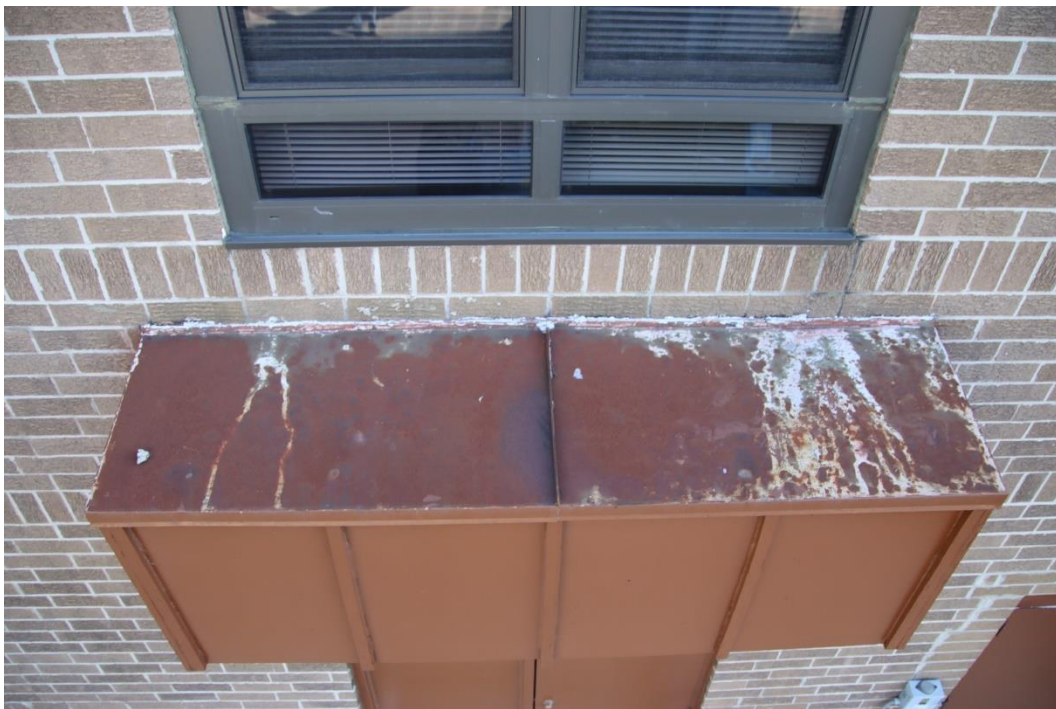
9. Mortar in joints was debonded from the brick and appeared eroded at select locations (Figure 34).
10. Deteriorated sealant was observed at perimeter joints between canopies and brick masonry wall on both north and south elevations (Figure 35).

Figure 35. Deteriorated sealant between canopy and exterior wall and worn out paint at the top of the canopy

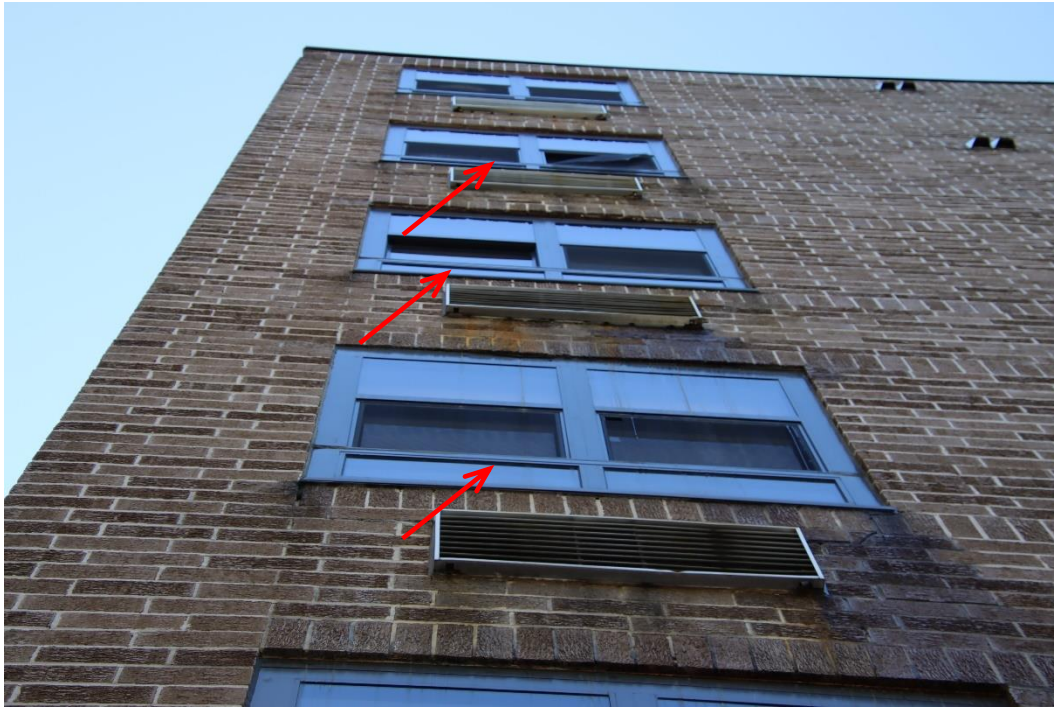
Figure 36. Windows appear distorted out of plane, pushed inward above bottom sash

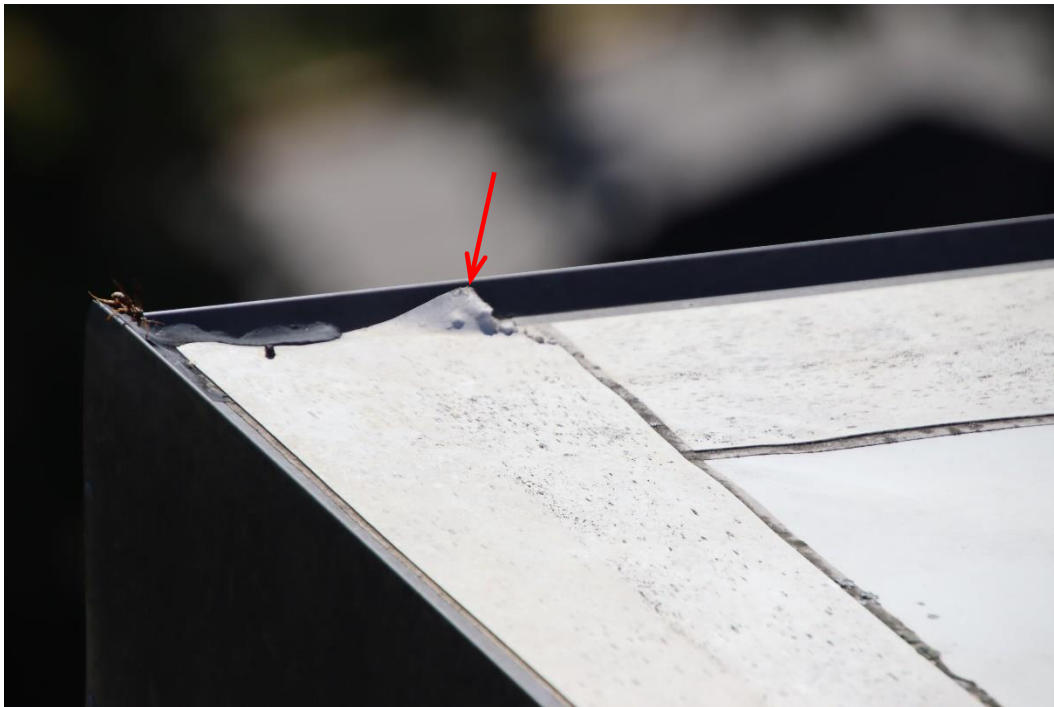
1. Debonded edge of the PVC roof membrane was observed in the southeast corner (Figure 37).
2. Water is ponding along the midline of the roof away from the roof drains.

Figure 37. Debonded edge of PVC membrane

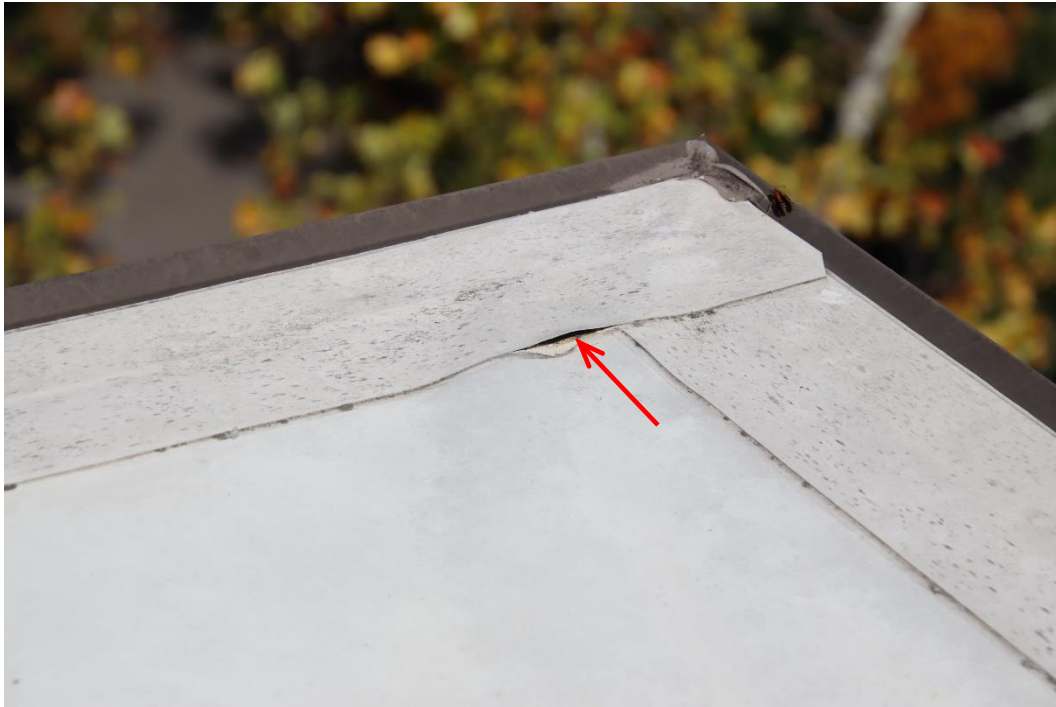
Figure 38. Open seam

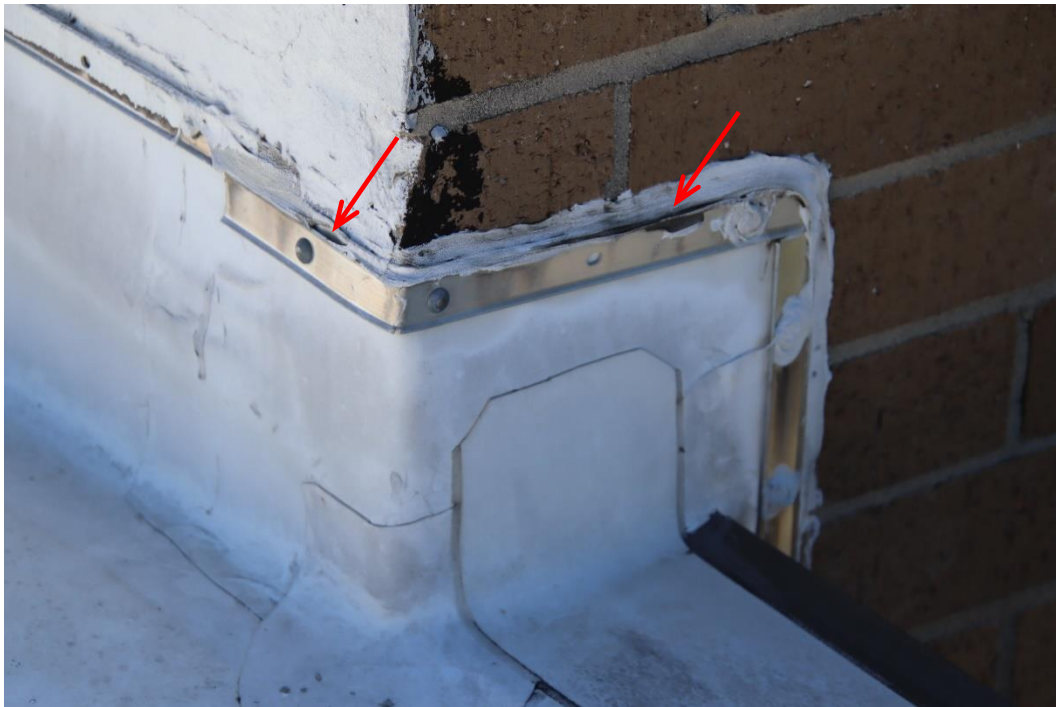
Figure 39. Debonded sealant at termination bar

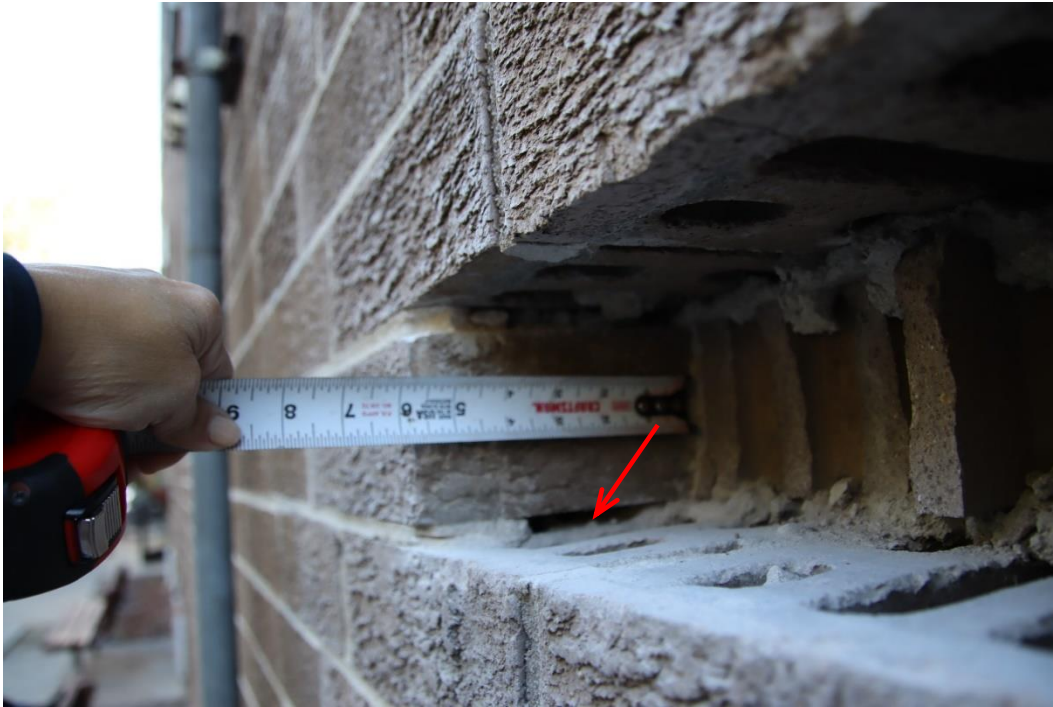
- Opening #1 – The location of this opening was selected based on present vertical cracks in brick masonry towards the west end of the north elevation (Figure 29 and Figure 40). The single wythe brick masonry unit was removed partially as it broke off. The masonry unit was hollow. The unit was not fully set in mortar bed. One inch of the face of joists were filled with mortar in both head and bed joints. The rest of the joints had voids. Mortar appeared soft to the touch (Figure 41).

Figure 40. Exploratory opening #1. Voids in mortar at bed joint and hollow cells of masonry units

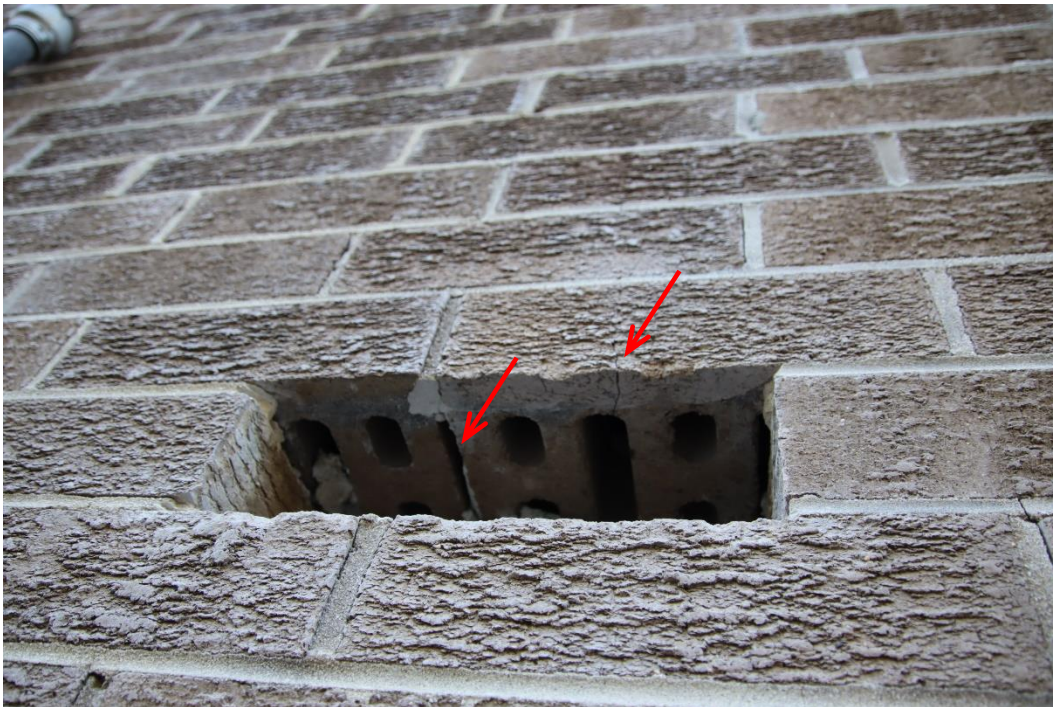
Figure 41. Exploratory opening #1. Voids in mortar at head joint, hollow cells of masonry units and crack in masonry unit

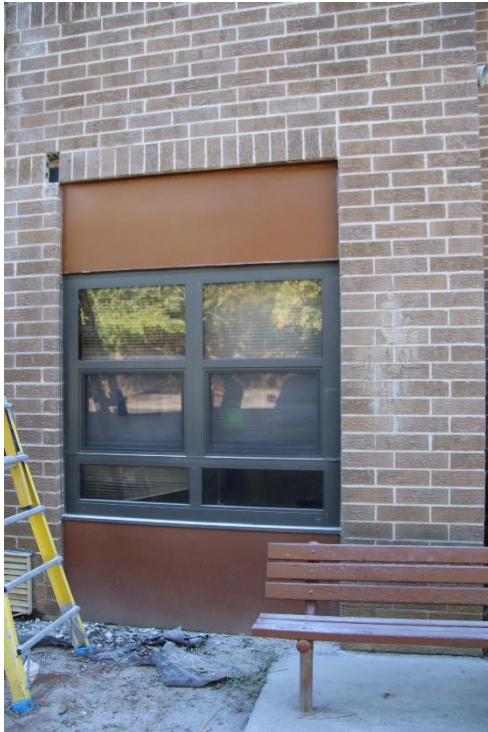
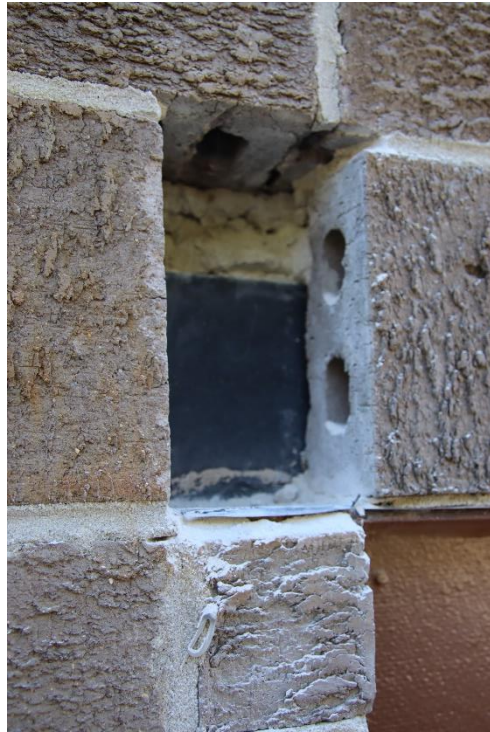
- Opening #2 – Soldier brick masonry was removed directly above the steel window lintel to expose the flashing. The flashing was not shown on design drawings. The painted steel window lintel bearing 8 inches on the brick masonry was exposed. The PVC type of flashing was wrapped over the lintel (Figure 42). No end dam was present at the end of the flashing. The steel lintel was in good condition.

Figure 42. Exploratory opening #2. Overall and close-up views of PVC flashing over steel lintel

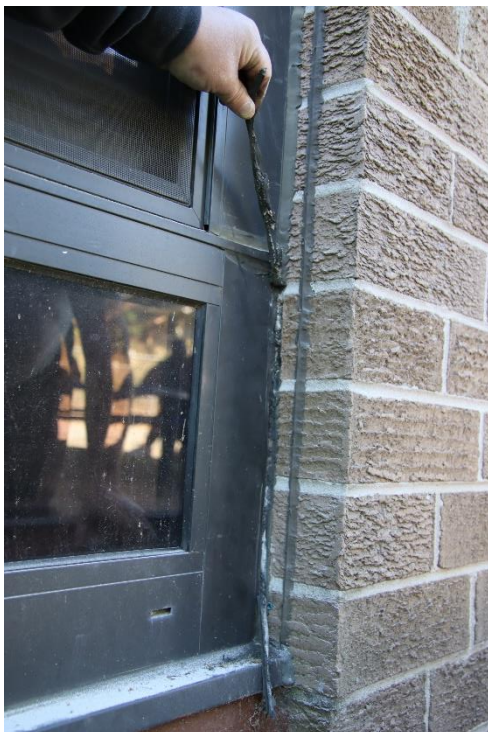
- Opening #3 – Portion of the sealant was removed from the cove joint between the window frame and masonry wall at the westmost window on the north elevation at the first floor (Figure 43). Sealant was deteriorated. After the sealant was removed it was revealed that windows frame was installed snug against the brick masonry, leaving no room for compressible joint filler to be installed inside the joint. The sealant present in cove joint could be easily pulled off. It was failing both cohesively and adhesively when tried to be remove. It appeared that no surface preparation of the substrate was done or bond breaker tape installed prior to its installation.

Figure 43. Exploratory opening #3. Removed sealant. No compressible joint filler present between window frame and brick masonry

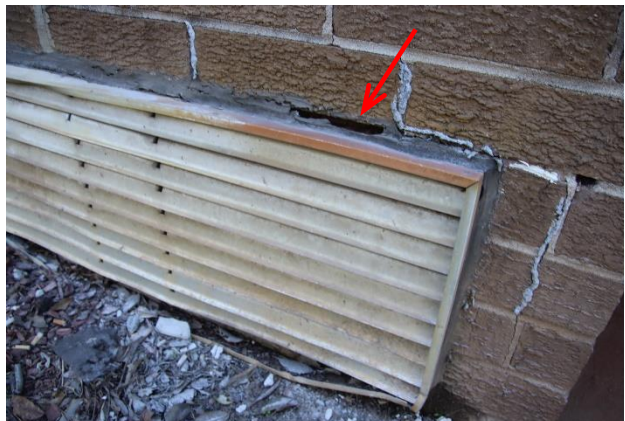
- Opening #4 - Portion of the sealant was removed from the joint between the A/C sleeve and brick masonry at the level of the embedded steel lintel (Figure 44). Sealant at the joint was deteriorated. Exposed steel lintel behind it was corroded and had a significant corrosion built up causing jacking of the brick around it.

Figure 44. Exploratory opening #4. Sealant and compressible joint filler present over corroded steel lintel above A/C sleeve
