PROPERTY CONDITION ASSESSMENT

Duncan Village
100 Duncan Street
Duncan, SC 29334

Report Date: May 7, 2024

GRS Project #: 22-60832.4

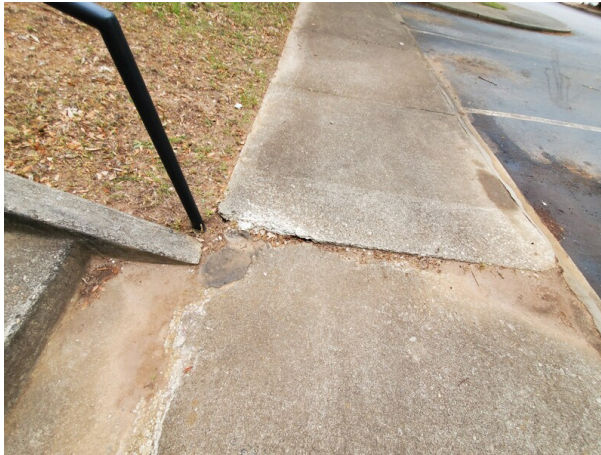
Sidewalks: *Immediate Repairs* - Sidewalks are generally in good condition; however, a concrete trip hazard was observed near unit I4. GRS recommends repairing the trip hazard as an Immediate Repair. This work is planned in the near future and budgeted for completion within the *Construction Budget*.

Trip hazard at I4

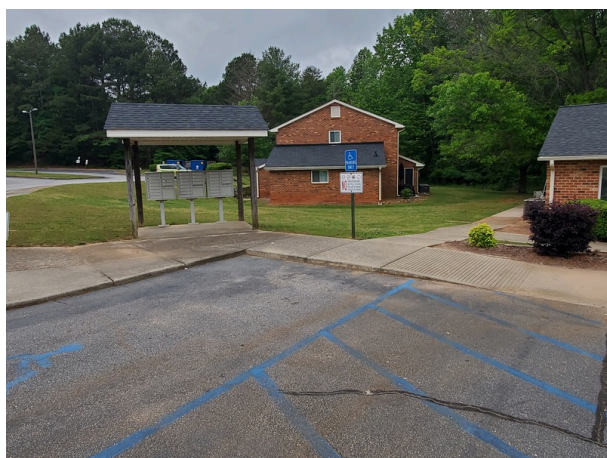
Missing van-sign at leasing office space

The scope of the planned renovation work includes modifications, upgrades, and replacements to accomplish compliance with mandates of the ADA, Section 504, and UFAS. While these modifications are recommended, the *Construction Budget* includes allowances for this work to be completed during the planned scope of renovation.

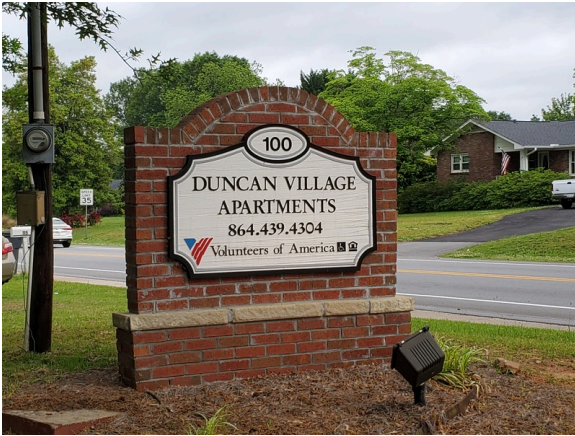
1

Exterior Signage: The signage at the entrance to the property is in fair condition, and appears to have exceeded its useful life expectancy. ADA parking signage is not in place. Signage replacements and upgrades are recommended at this time. Based on review of the attached scope of work for rehabilitation, these items are planned to be replaced as part of the rehabilitation.

Property sign

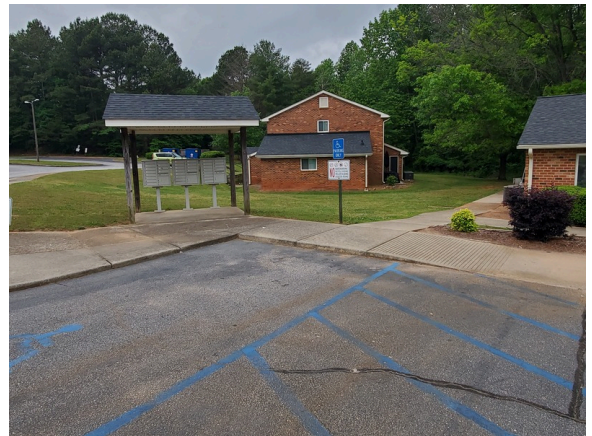
10

Missing van-sign at leasing office space

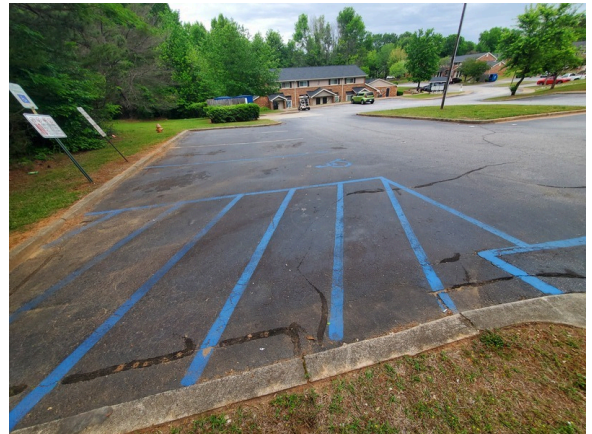
12

Asphalt Pavement: *Immediate Repairs* - GRS observed a generally faded seal coat with worn surfacing, and the absence of parking stall striping due to fading throughout the pavement areas. Seal coating and re-striping is required immediately to eliminate more costly repairs in the near future and to provide clearly marked parking accommodations at this site. ADA access ramps should be provided to access the leasing office. Additionally, the dumpster enclosure should be repaired at this time. This work is planned in the near future and budgeted for completion within the *Construction Budget*.

Pavement condition

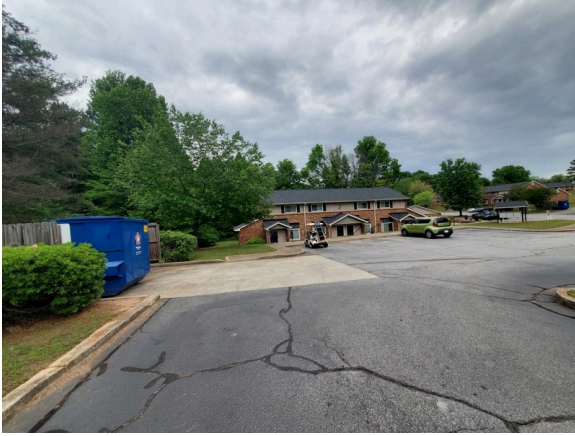
13

Pavement condition and dumpster

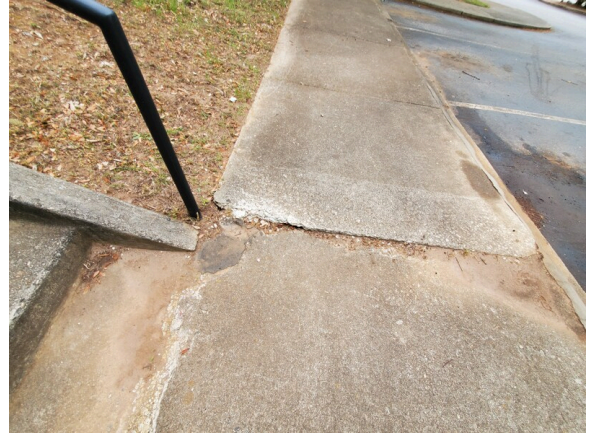
Trip hazard at 14

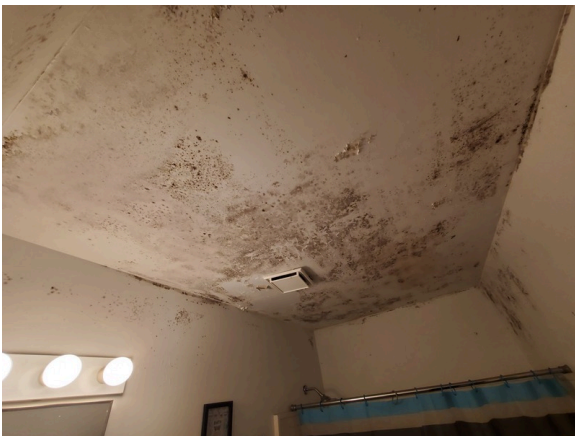
29

Mildew growth in bathroom of F4

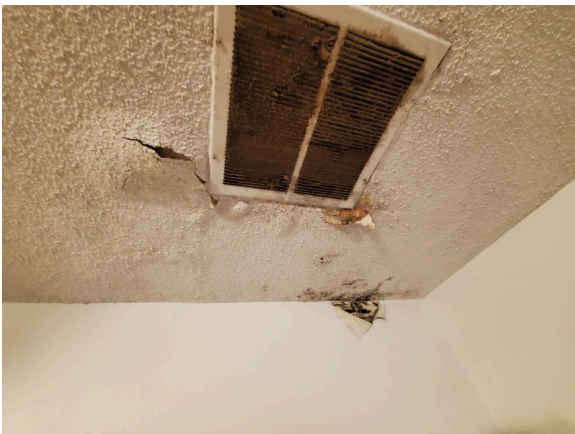
35

Tub Piping: Replacement Reserves - According to management, as the property ages, some leaks are occurring at tub drains/piping and leaking onto the returns and ceilings of some of the units. GRS observed a small amount of water damage at Unit H3's living room ceiling from a past leak. GRS recommends repair of the leak above the ceiling. The *Construction Budget* includes allowances for significant plumbing work to be completed during the planned scope of renovation, and therefore, additional funds are not included in the Immediate Repairs table for this concern. The *Construction Budget* includes allowances for significant plumbing repairs and rehabilitations, including new finishes, sinks, fixtures, faucets, valves, tubs/showers, toilets, and sewer line repairs. Routine maintenance is anticipated during the reserve term.

Water damage around return at H4

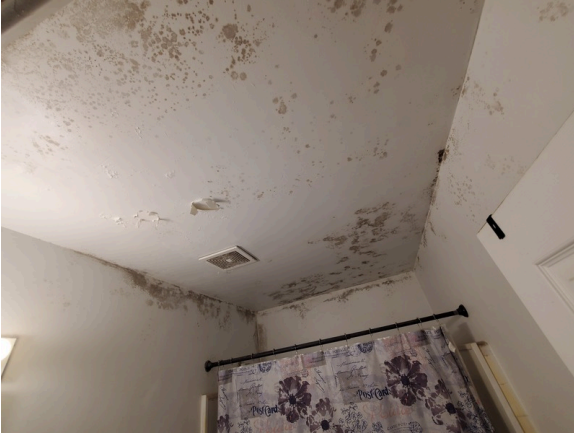
Microbial growth in bathroom of E3
