PROPERTY CONDITION ASSESSMENT

Lancaster Manor
201 Chesterfield Avenue
Lancaster, SC 29720

Report Date: May 7, 2024

GRS Project #: 22-60832.5

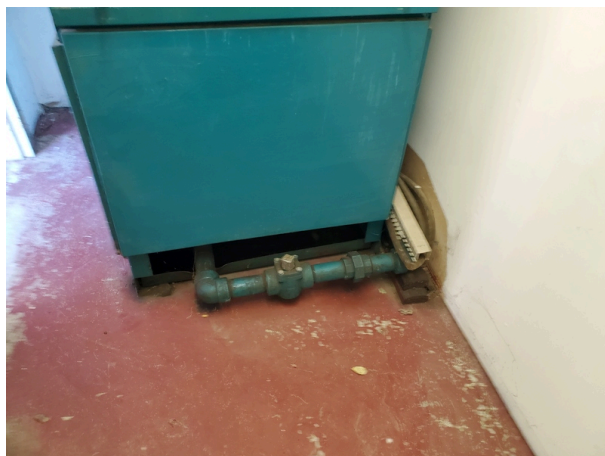
Elevator equipment room

therefore recommended as an immediate repair. Based on a review of the attached scope of work for rehabilitation, rebuilding the elevator, and refurbishing the elevator cab, are planned as part of the rehabilitation.

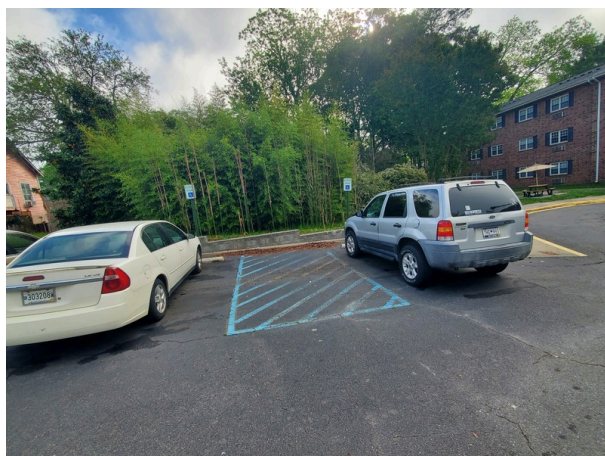
Accessible parking (missing van sign)

The scope of the planned renovation work includes modifications, upgrades, and replacements to accomplish compliance with mandates of the ADA, Section 504, and UFAS. While these modifications are recommended, the *Construction Budget* includes allowances for this work to be completed during the planned scope of renovation.

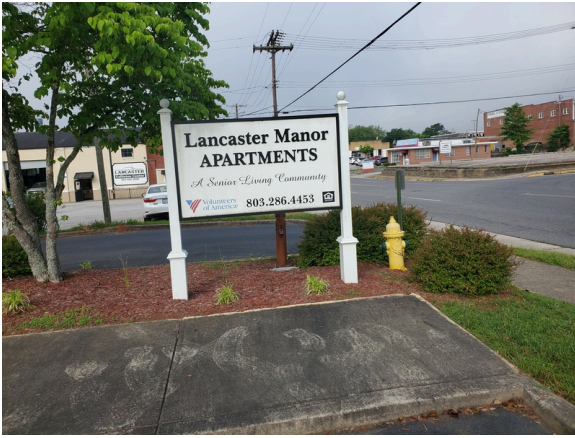
1

Exterior Signage: The signage at the entrance to the property is in fair condition, and appears to have exceeded its useful life expectancy. ADA parking signage is not in place. Signage replacements and upgrades are recommended at this time. Based on review of the attached scope of work for rehabilitation, these items are planned to be replaced as part of the rehabilitation.

Property sign

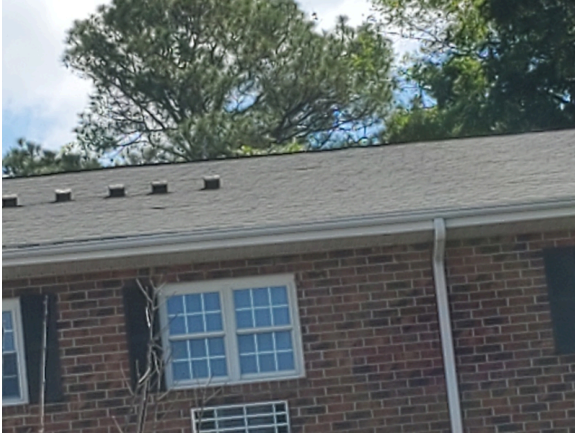
7

Roofing: The roofing is in fair overall condition. The *Construction Budget* indicates that all roofing will be replaced in the near future during the planned renovation work, with a budget in place for full roofing and underlayment replacement. Following completion, based on typical useful life expectancies, only routine maintenance is anticipated.

Roof

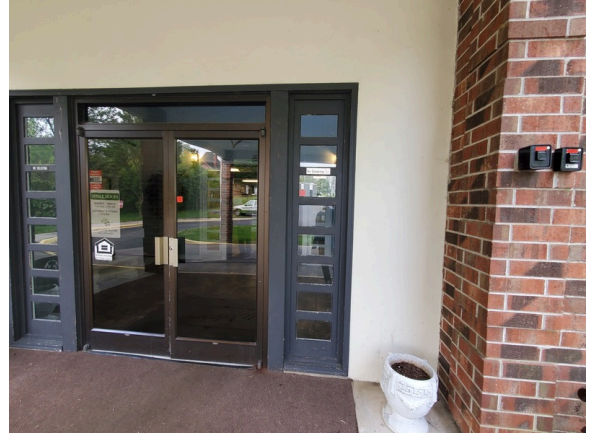
8

Exterior Entry Doors: The exterior entry doors and entry hardware are generally in fair to poor condition, and have exceeded their useful life expectancies. Based on these conditions, it is recommended that these doors and all hardware be replaced and doors painted as part of immediate needs. Immediate replacement costs have been included in the immediate needs table. Based on review of the attached scope of work for rehabilitation, this immediate repair item is planned as part of the rehabilitation.

Entrance doors

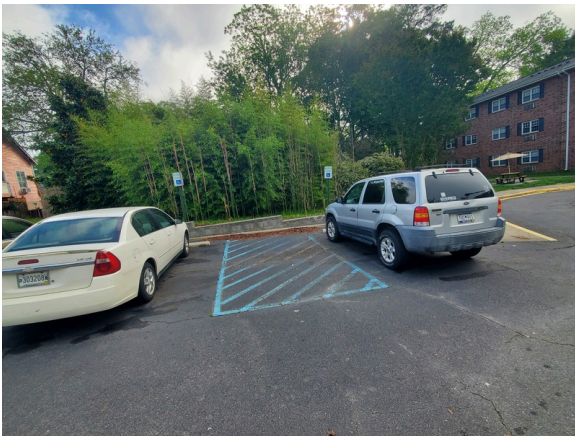
9

Accessible parking (missing van sign)

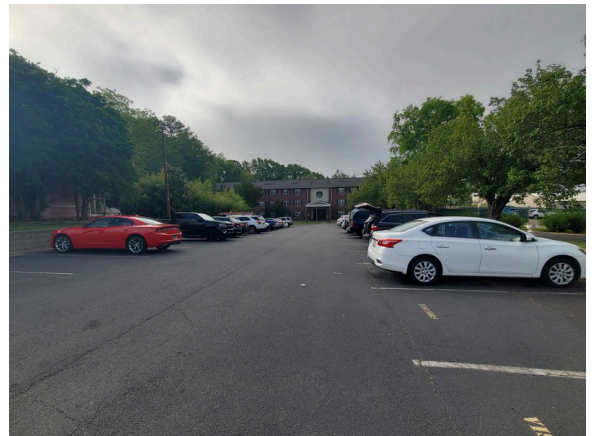
10

Asphalt Pavement: *Immediate Repairs* - GRS observed a generally faded seal coat with worn surfacing, and the absence of clear parking stall striping due to fading throughout the pavement areas. Seal coating and re-striping is required immediately to eliminate more costly repairs in the near future and to provide clearly marked parking accommodations at this site. ADA access ramps should be provided to access the leasing office. Additionally, the dumpster enclosure should be repaired at this time. This work is planned in the near future and budgeted for completion within the *Construction Budget*.

Asphalt pavement condition

Asphalt Pavement: *Replacement Reserves* – The asphalt pavement will require periodic seal coating and re-striping during the reserve term.

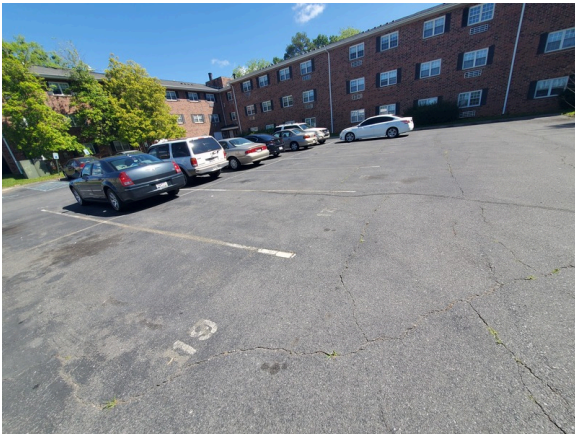
11

Asphalt pavement condition

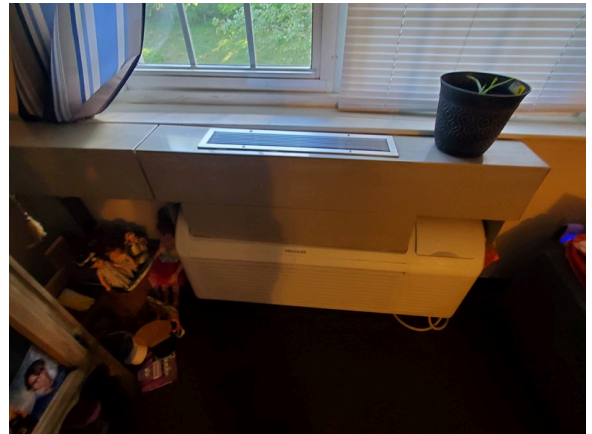
12

HVAC PTAC Units & Split Systems - Replacement: The PTAC and split system HVAC units (furnaces and condensing units) appeared to vary in age and condition. The *Construction Budget* indicates that all PTAC units and split systems will be replaced with new heat pump systems in the near future during the planned renovation work, with a budget in place for heat pump replacements. Following completion, based on typical useful life expectancies, the new heat pumps are anticipated to perform adequately throughout the end of the reserve term with only routine maintenance as needed.

PTAC unit

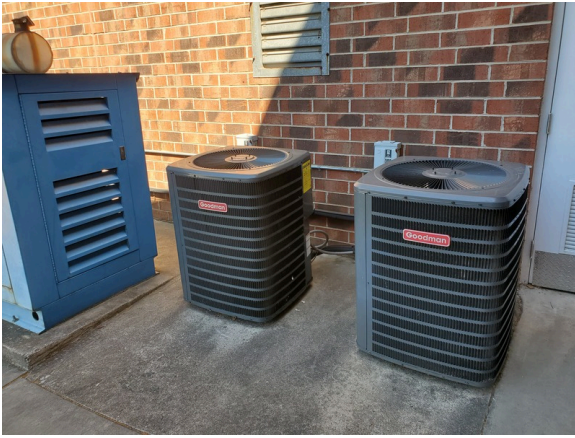
13

Condensers

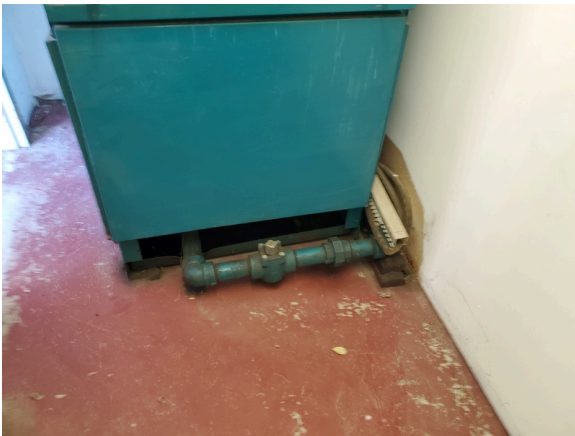
15

Elevator equipment room

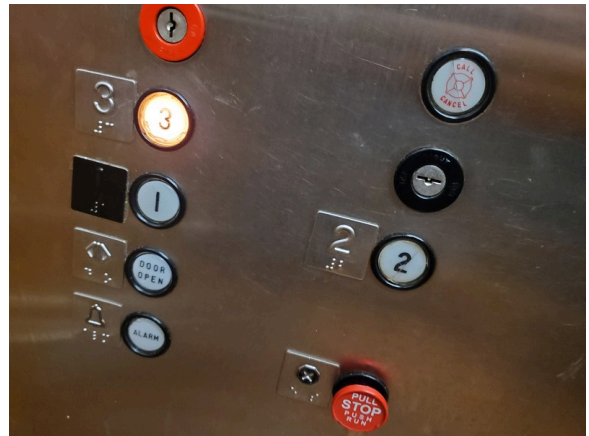
16

Elevator controls

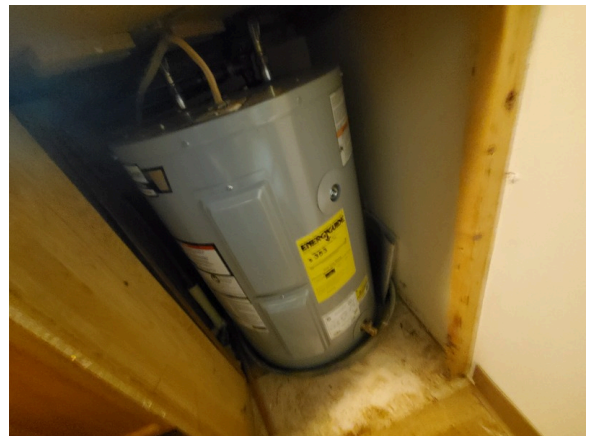
18

Plumbing & Hot Water: Shut-off valves at sinks, toilets and plumbing fixtures appear to have exceeded their EUL. Water supply valves and plumbing fixtures should be installed at each bathroom. The current hot water heaters are not energy and water conserving units, and do not appear to meet current energy standards. Many of the individual hot water heaters have exceeded or are approaching the end of their useful life expectancies. Apartment unit toilets, bathtubs and surrounds, shower valves, shower heads, kitchen and bathroom faucets, and sinks all vary in condition and should be replaced in the near future. Based on our review of the attached scope of work for rehabilitation, these items are planned as part of the rehabilitation.

Water heater

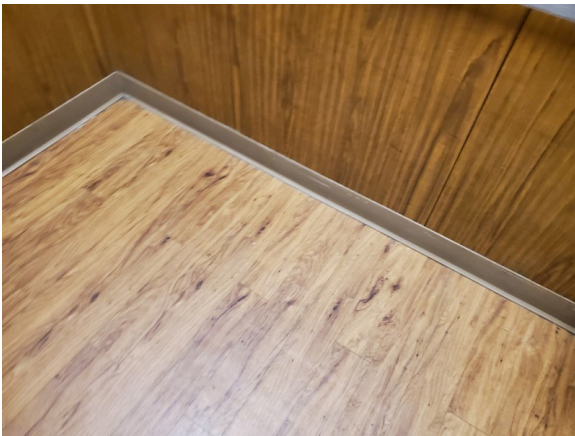
33

Elevator cab finishes
