PROPERTY CONDITION ASSESSMENT

Pageland Place
205 Magnum Street
Pageland, SC 29728

Report Date: May 7, 2024

GRS Project #: 22-60832.6

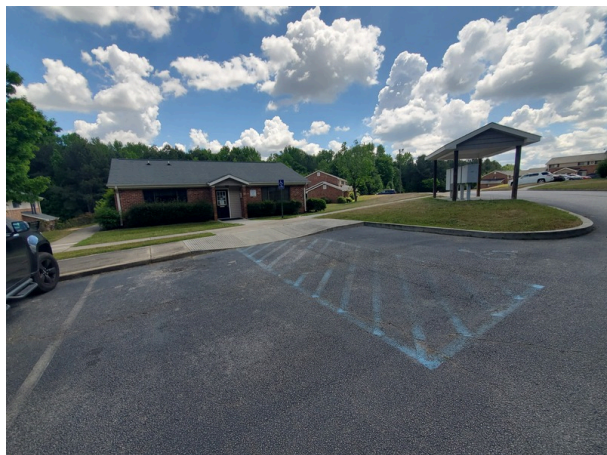
Asphalt Pavement: *Immediate Repairs* - GRS observed a generally faded seal coat with worn surfacing, and the absence of parking stall striping due to fading throughout the pavement areas. Seal coating and re-striping is required immediately to eliminate more costly repairs in the near future and to provide marked parking accommodations at this site. ADA access ramps should be provided to access the leasing office. Additionally, the dumpster enclosure should be repaired at this time. This work is planned in the near future and budgeted for completion within the *Construction Budget*.

Pavement condition

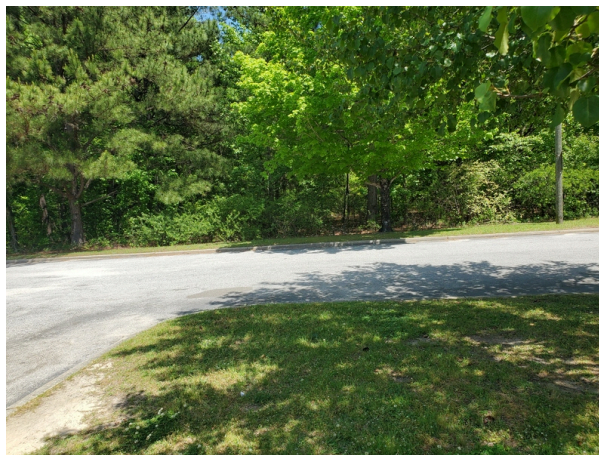
Asphalt pavement condition

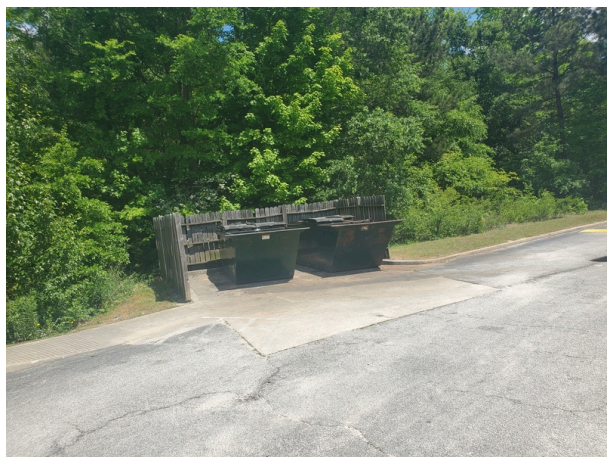
Dumpster enclosure and pavement condition

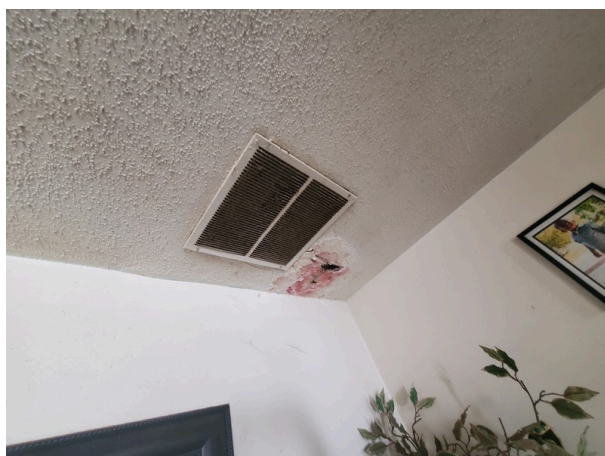
Waste Piping: *Immediate Repair* - A current leak appears to be present above the ceiling in unit E5. Water damage is present at the ceiling. GRS recommends repair of the leak above the ceiling. The *Construction Budget* includes allowances for significant plumbing work to be completed during the planned scope of renovation, and therefore, additional funds are not included in the Immediate Repairs table for this concern. The *Construction Budget* includes allowances for significant plumbing repairs and rehabilitations, including new finishes, sinks, fixtures, faucets, valves, tubs/showers, toilets, and sewer line repairs. Routine maintenance is anticipated during the reserve term.

Hole in ceiling at unit E5

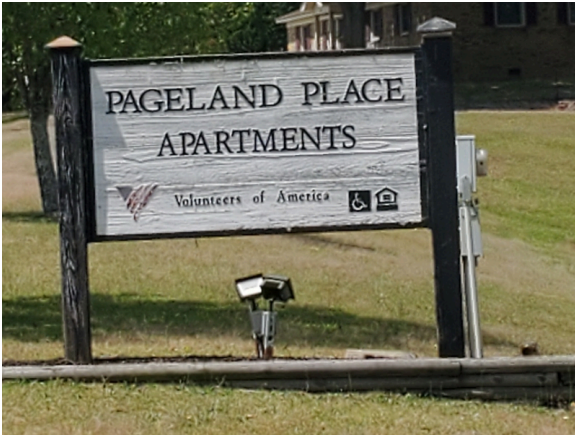
1

Exterior Signage: The signage at entrance to property is in fair condition, and appears to have exceeded its useful life expectancy. ADA parking signage is not in place. Signage replacements and upgrades are recommended at this time. Based on review of the attached scope of work for rehabilitation, these items are planned to be replaced as part of the rehabilitation.

Property sign

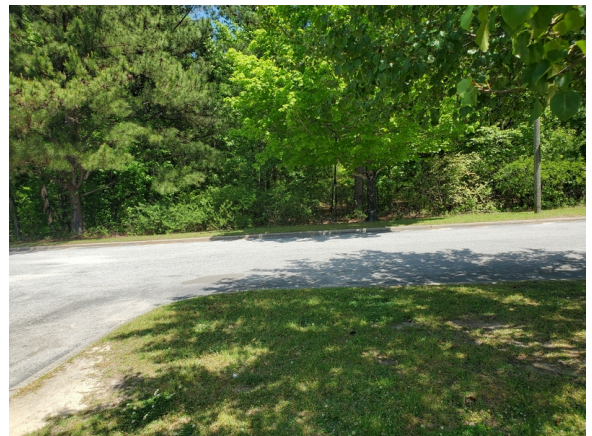
12

Asphalt pavement condition

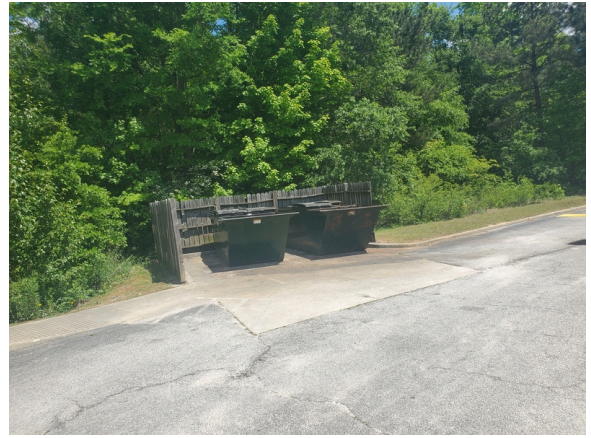
14

Dumpster enclosure and pavement condition

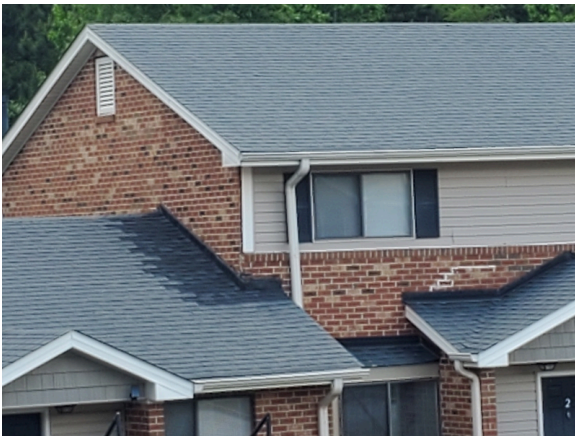
15

Roofing: The roof surface is in fair overall condition and is expected to reach the end of its useful life expectancy soon, when replacement will be required. The *Construction Budget* indicates that all roofing will be replaced in the near future during the planned renovation work, with a budget in place for full roofing and underlayment replacement. Following completion, based on typical useful life expectancies, only routine maintenance is anticipated.

Roofing

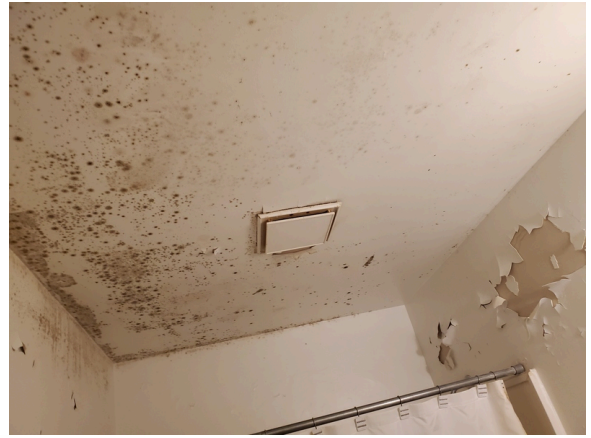
32

Mildew in shower at unit H1

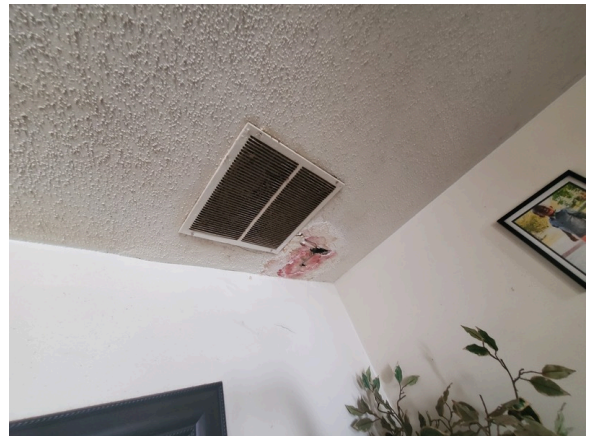
34

Hole in ceiling at unit E5

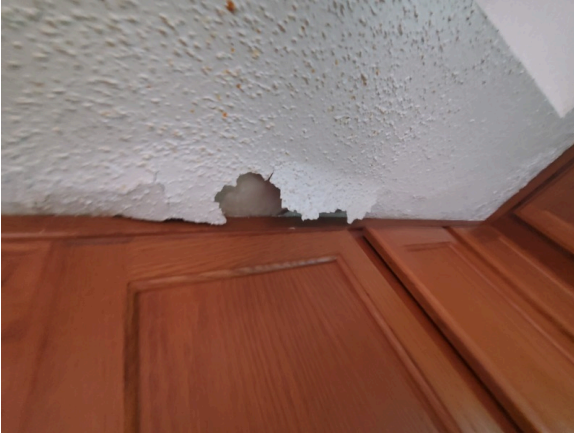
Typical ceiling peeling paint
