**Physical Needs Assessment
As Is**

Swann Meadows Apartments

1091 Parkland Place Rd
Greenwood, SC 29646

Report Date- 05/14/2025

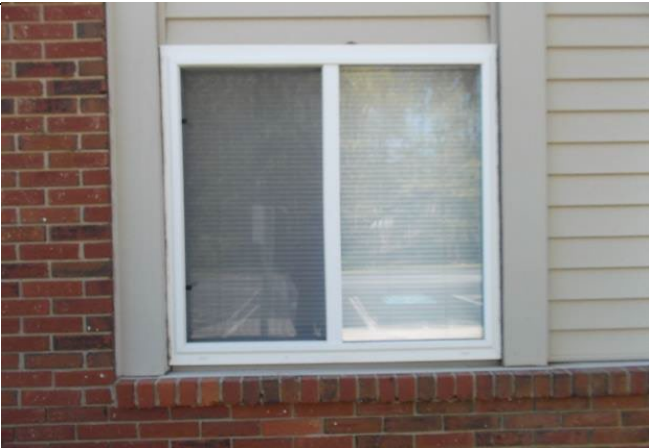
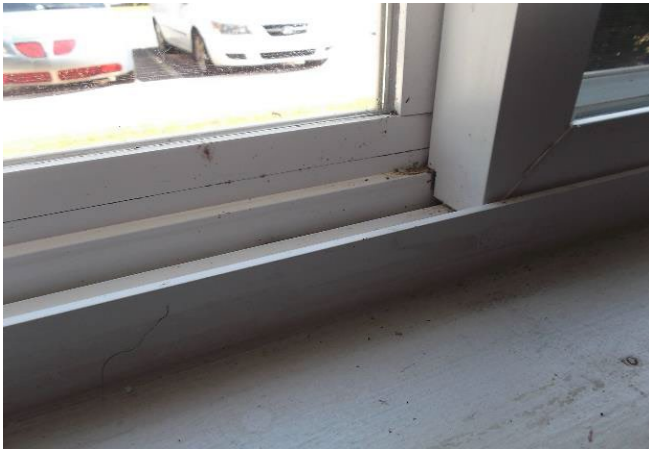
Dwelling Unit Window

Roof	The building has a pitched roof system with architectural shingles that were probably replaced during the rehab in 2003. The roof was inaccessible thus not inspected but management and the tenants we talked with did not report any active roof leaks. Based on the estimated age replacement of the roofing material is anticipated over the term thus a cost has been included in the Capital Needs Over the Term Spreadsheets.
Windows/Doors	<p>The exterior doors that access each dwelling unit is a solid core wood door set in a wood door frame. The interior access doors consist of standard hollow core hinged doors and the closet doors are wood bi-fold doors set on metal tracks. Replacement of the doors is anticipated. Dwelling unit windows consist of single hung windows set in vinyl frames that are original to the property.</p> <p>The interior and exterior doors appeared to be well maintained and in good condition. Based on the effective remaining life of the exterior and interior doors, replacement is anticipated during the term, thus a cost has been included in the Capital Needs Over the Term Table. The staff replaces the window glass when necessary. Based on the effective remaining life of the remaining windows replacement is anticipated.</p>

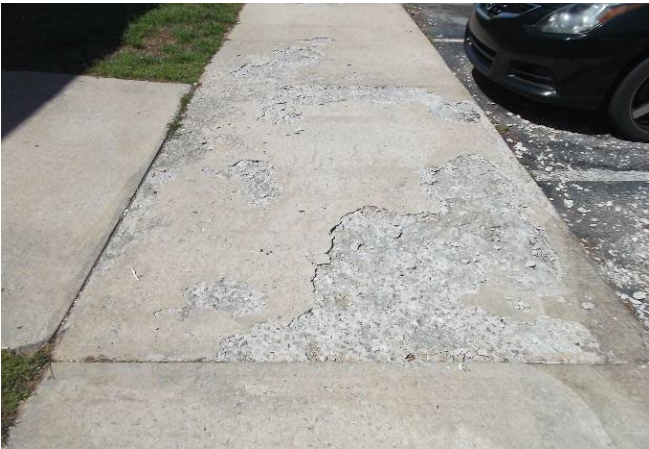
Damaged Sidewalk

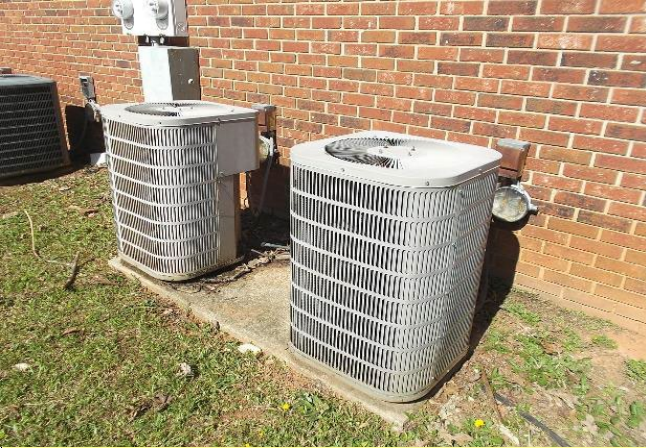
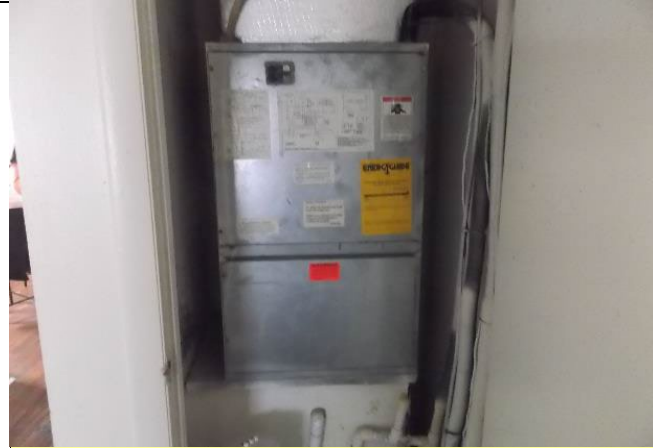
HVAC

Item	Observations/
HVAC	Each dwelling unit at this property is equipped with electric HVAC air conditioning system. The HVAC system seemed to be in good condition with no signs of damage and are older units that were fully functional. Replacement of the heating and air systems is anticipated thus a cost has been included in the Capital Needs Over the Term.

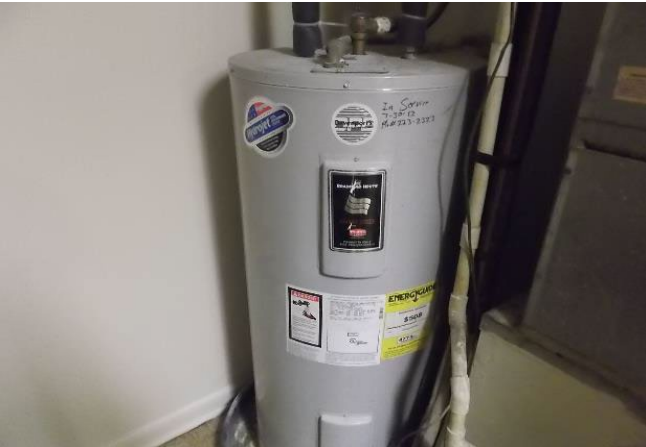
Hot Water Heater

Each dwelling unit is equipped with one 40 gallon hot water heater located in the utility closet in each unit. All of the inspected units showed a mix of older and newer hot water heaters. Based on the age of the hot water heaters replacement is anticipated thus a cost has been included in the Capital Needs Over the Term Spreadsheets.

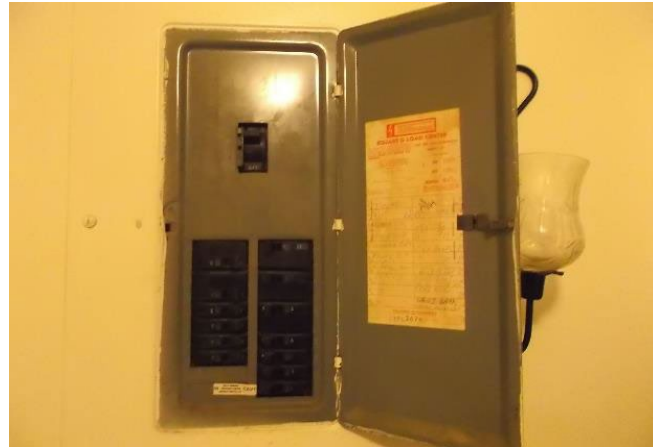
Electrical Panel Box

Electrical	<p>The electrical service is provided underground from pad-mounted transformers that feed electrical meter mounted with main disconnect panels on the exterior of the buildings.</p> <p>The electrical service to each unit is rated at 100 amps, 2 pole, 240 volt rating. The branch circuit distribution wiring is reportedly copper. A GFI outlet is provided in the kitchens and bathrooms. On the day of the inspection, it was noted that several units had GFI outlets there were not functional but management was in the process of replacing all non-functional units.</p> <p>No problems with system capacity or the circuit breakers were reported. The equipment appears to be in generally good condition. Based on the effective remaining life, routine maintenance is anticipated during the term.</p>
