## Kingston Pointe I

Anderson, South Carolina

Project #R-7125

April 9, 2026

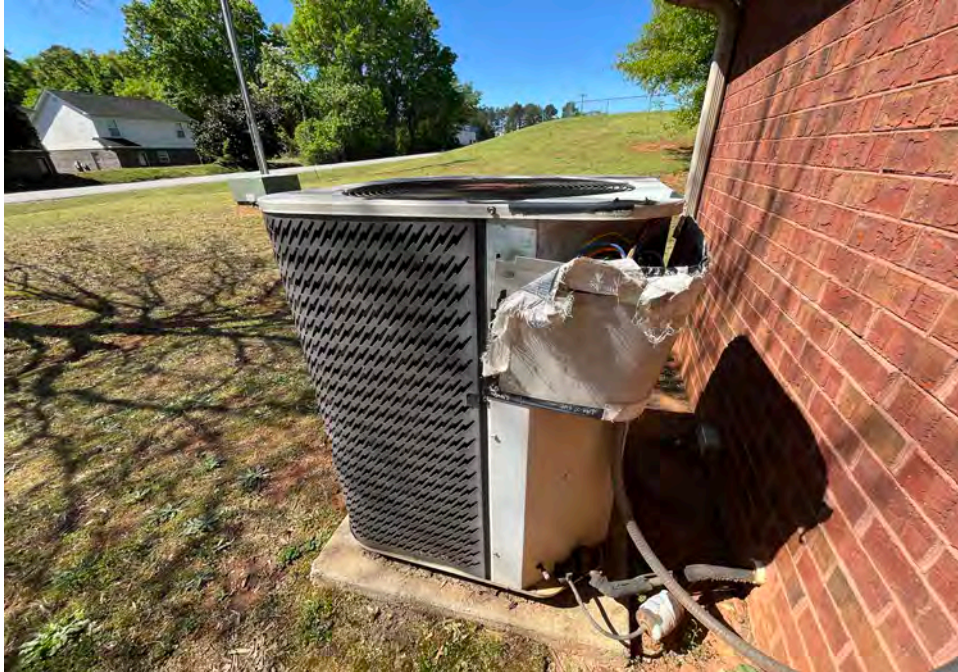
11 – The panel is damaged and hanging off of the condensing unit at the community building

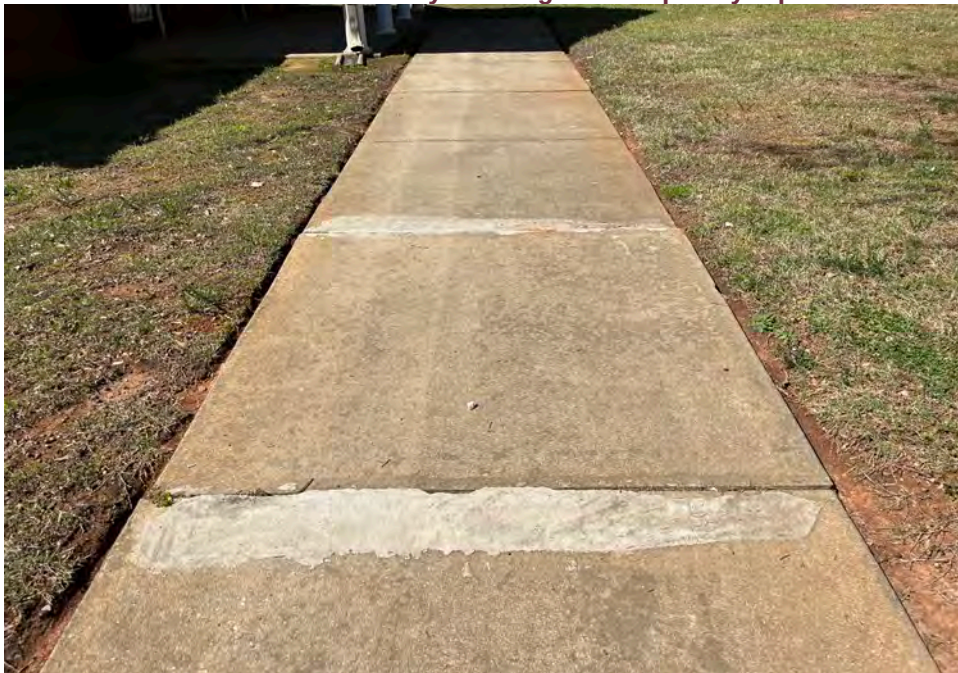
12 – The sidewalk near the community building has temporary repairs from settling

2. Concrete sidewalk repairs at the walkways throughout the property (Estimated Cost = \$2,750.00)
3. Replace/repair covers at the tele/data boxes and water service disconnect boxes (Estimated Cost = \$1,250.00)

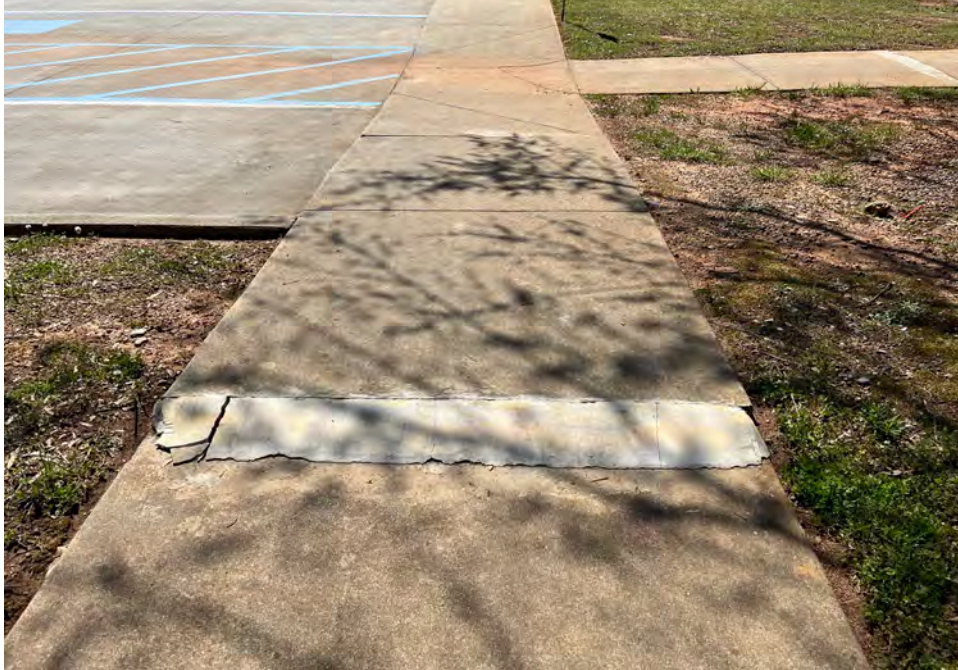
15 – Temporary repairs are in place throughout various areas of the sidewalks

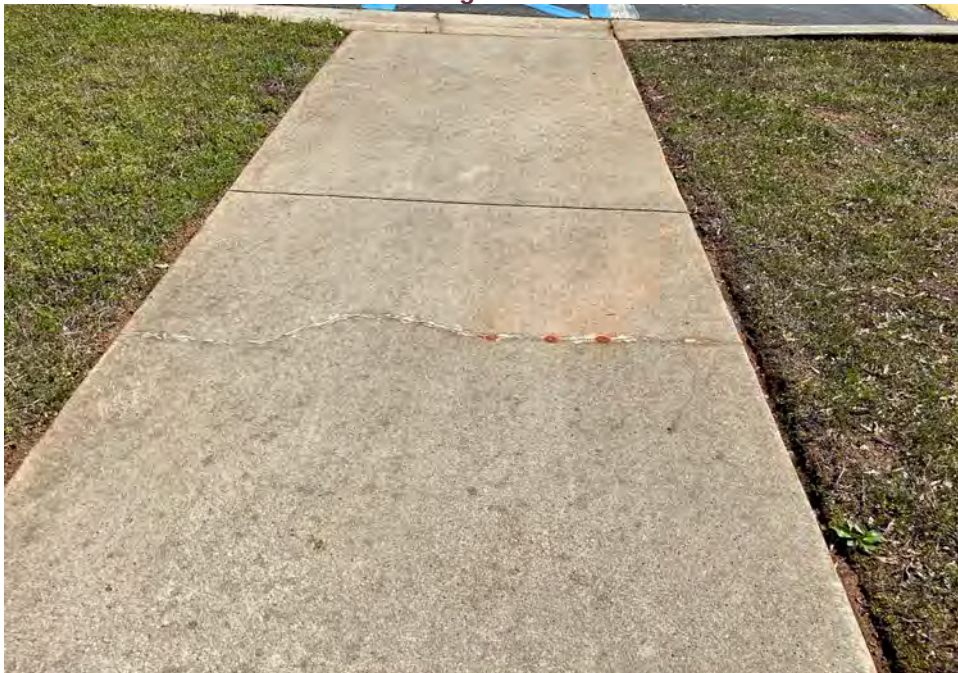
16 – View of additional cracking from settlement at the sidewalks

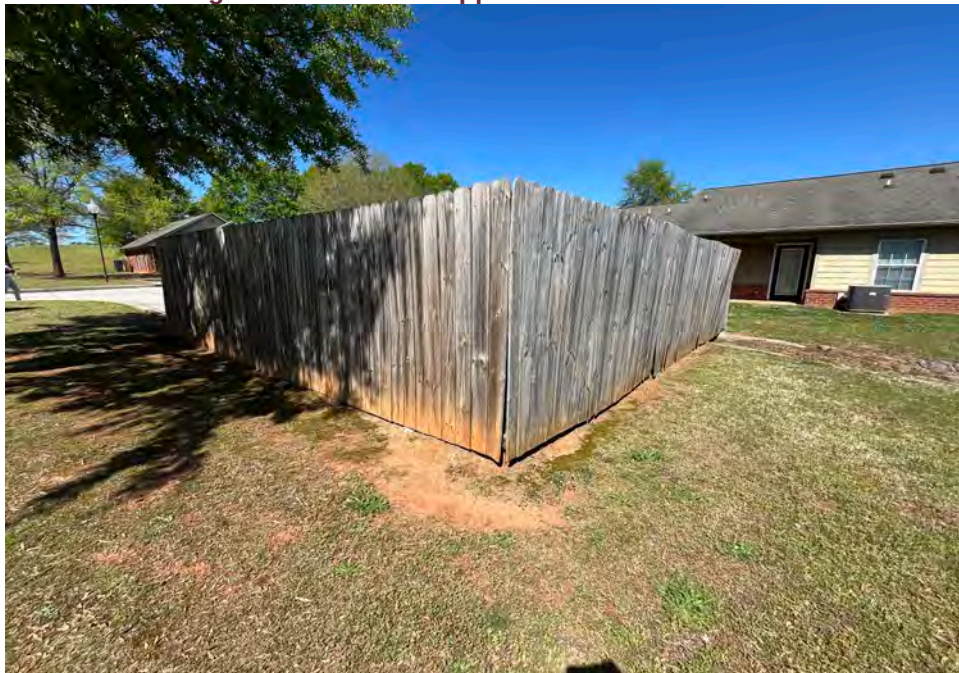
The heavy-duty concrete at the trash enclosure appears to be in good condition, however, the wood fence is at the end of its useful life and should be replaced.

18 – The fencing at the enclosure appears to be at the end of its useful life

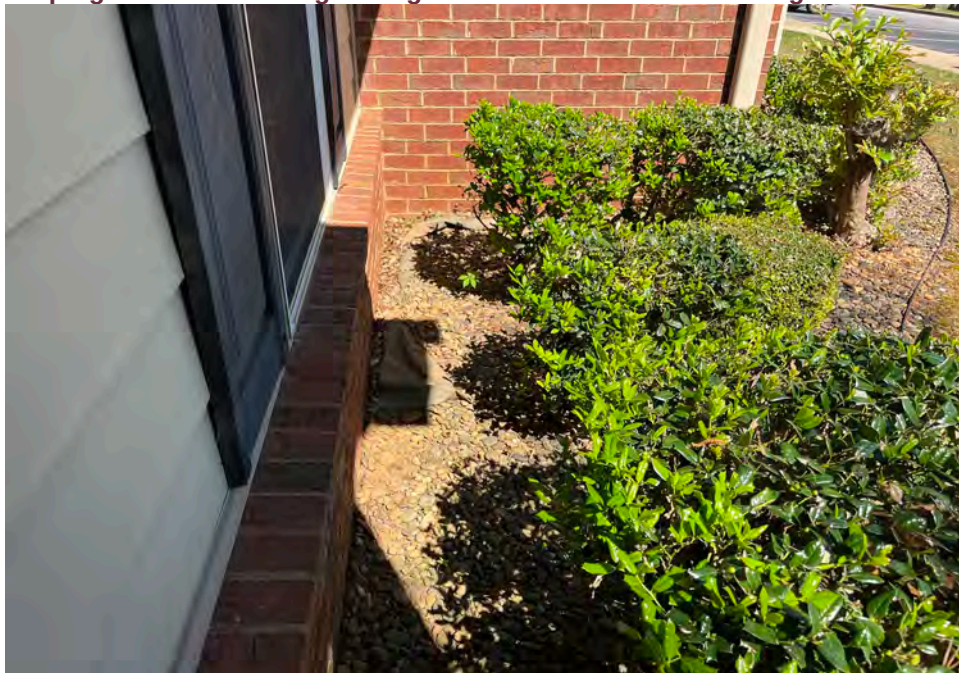
20 – The landscaping fabric is showing through the stone and could cause growth near the foundation

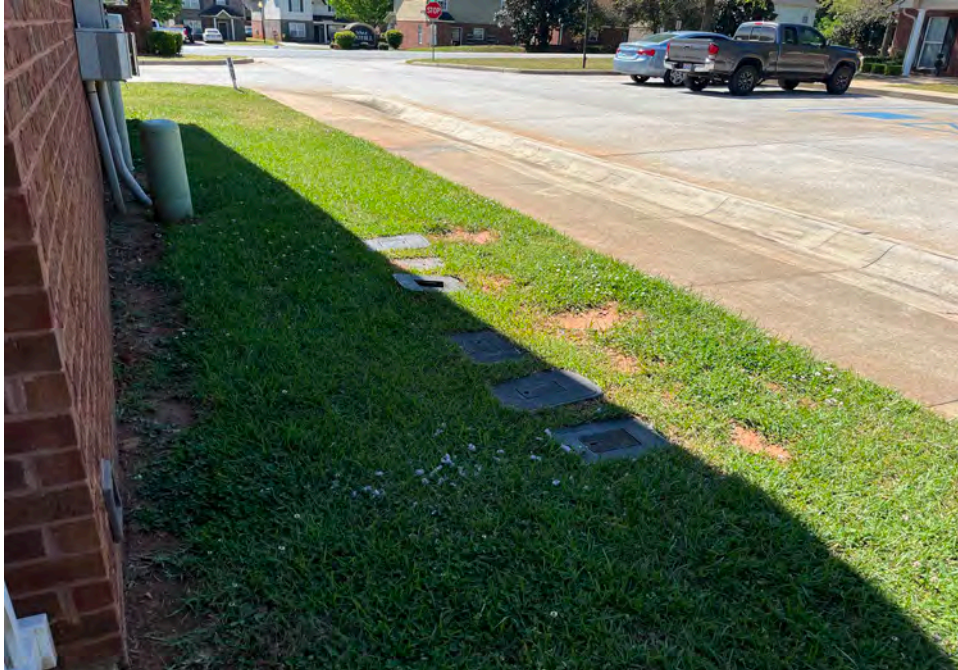
31 – Several water connection box covers are damaged and should be repaired

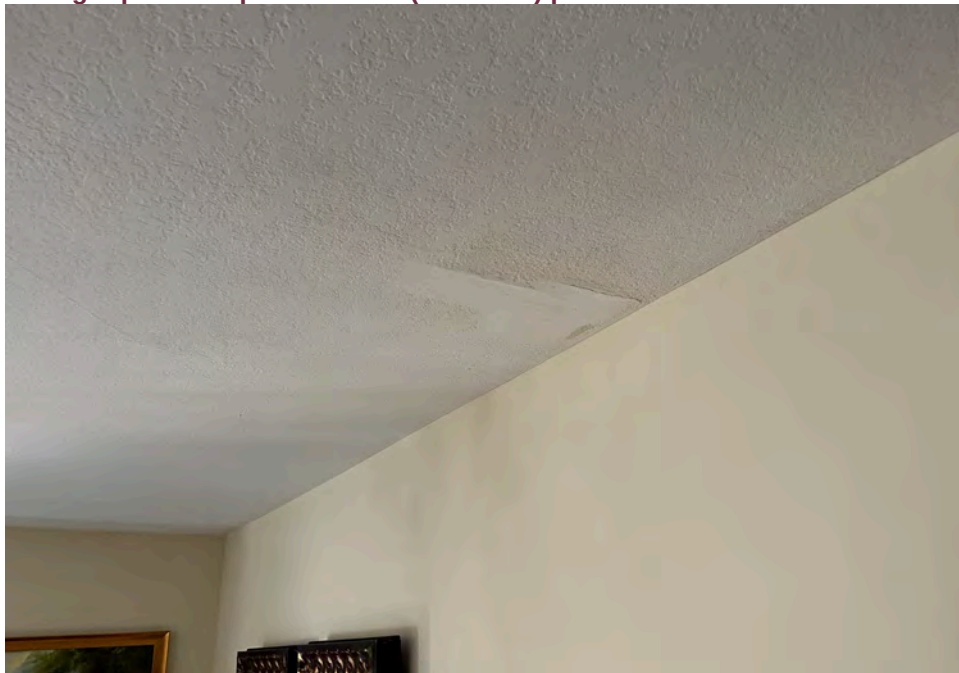
38 – Ceiling repairs are present from (assumed) past water intrusion from roof leaking

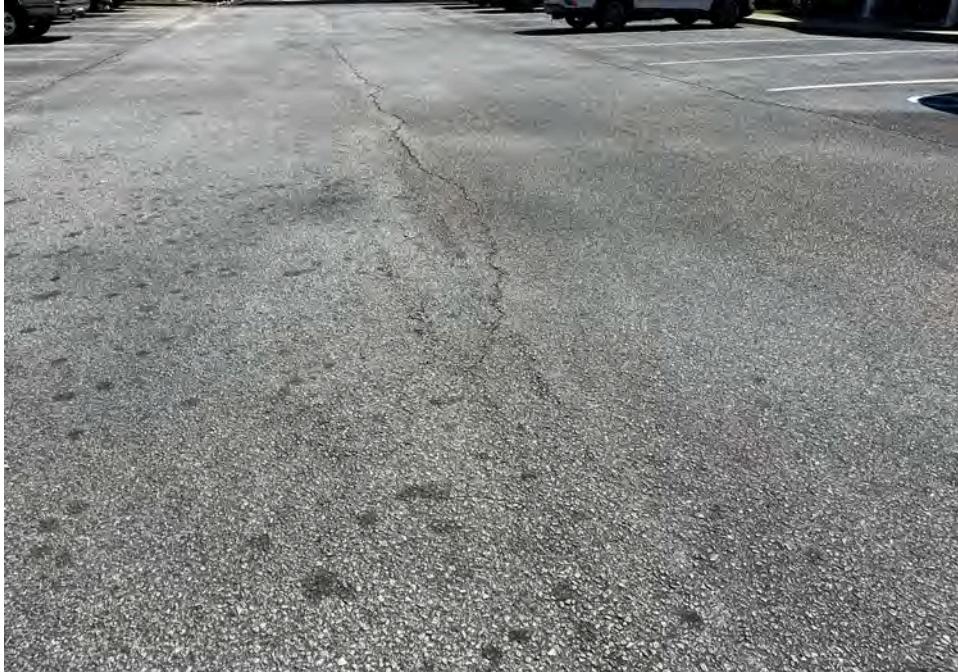
We observed a series of widening cracks within the asphalt extending across the main entrance driveway as well as some areas appearing to have been patched and thickened through the north interior driveways near the cul-de-sac. A short-term repair to the cracks would utilize a crack-sealer bituminous filler which would reduce the chance of further water intrusion.

39 – Several areas of the parking lot are cracking and spalling

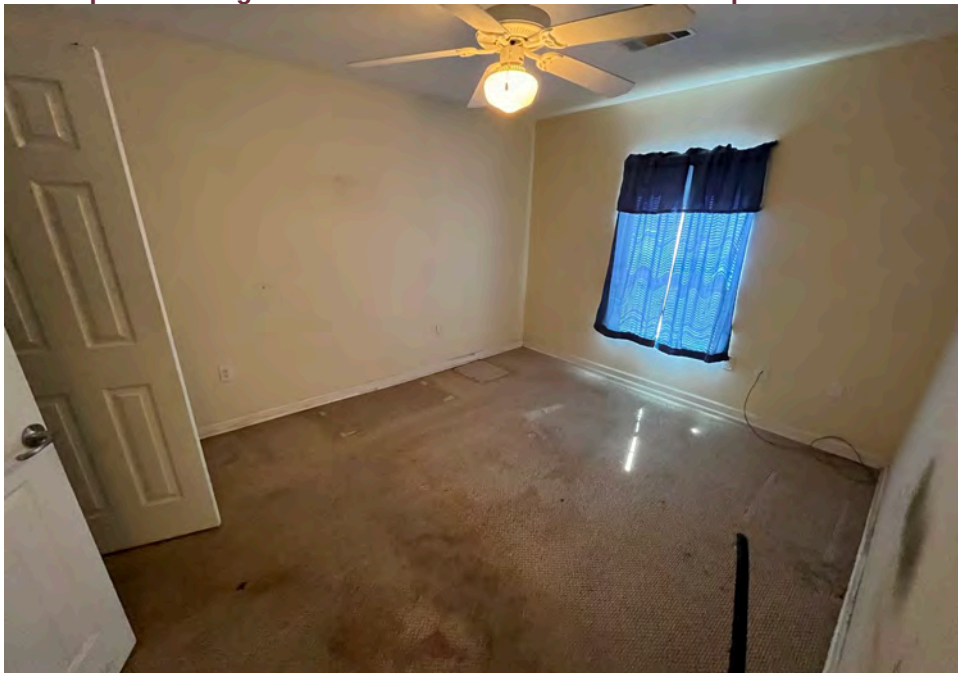
42 – The carpet is damaged in the vacant unit and should be replaced between tenants

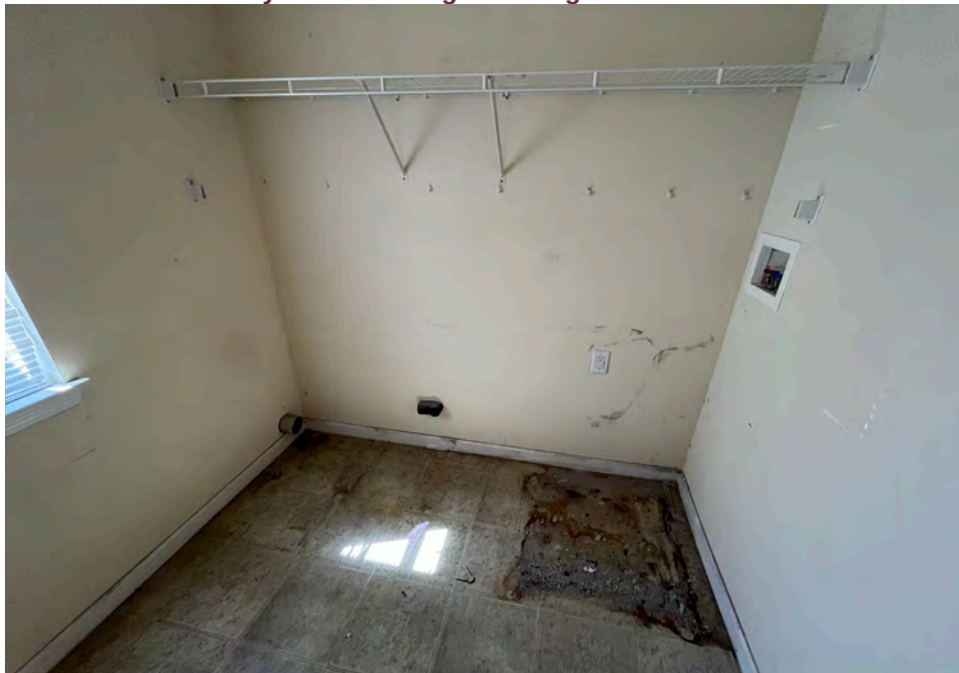
48 – A section of the laundry room flooring is damaged in Unit 124 and should be repaired

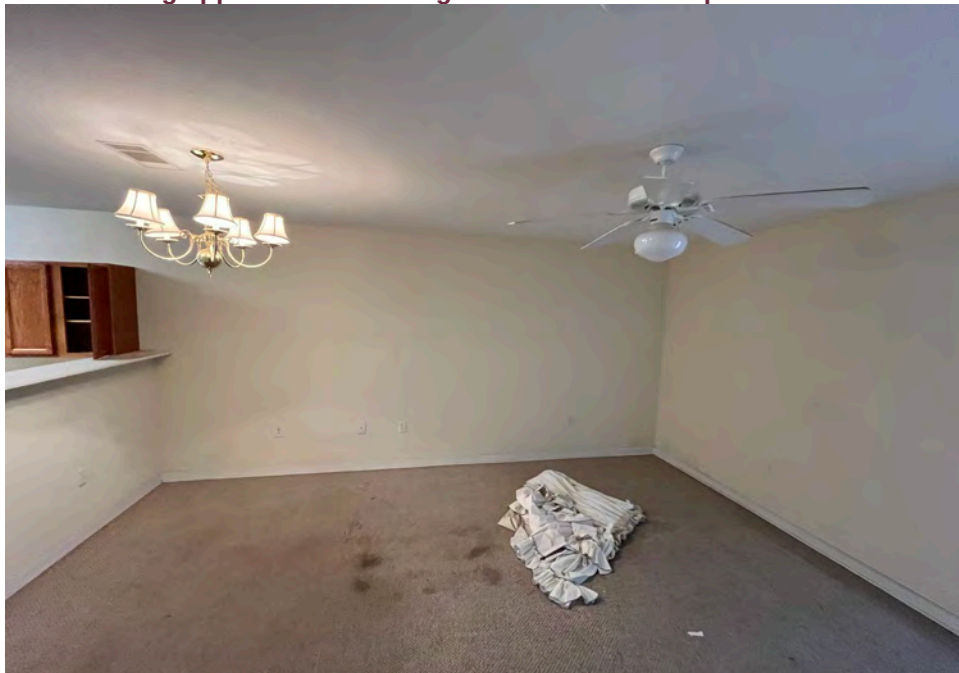
52 – The flooring appears to be damaged and should be replaced between tenants

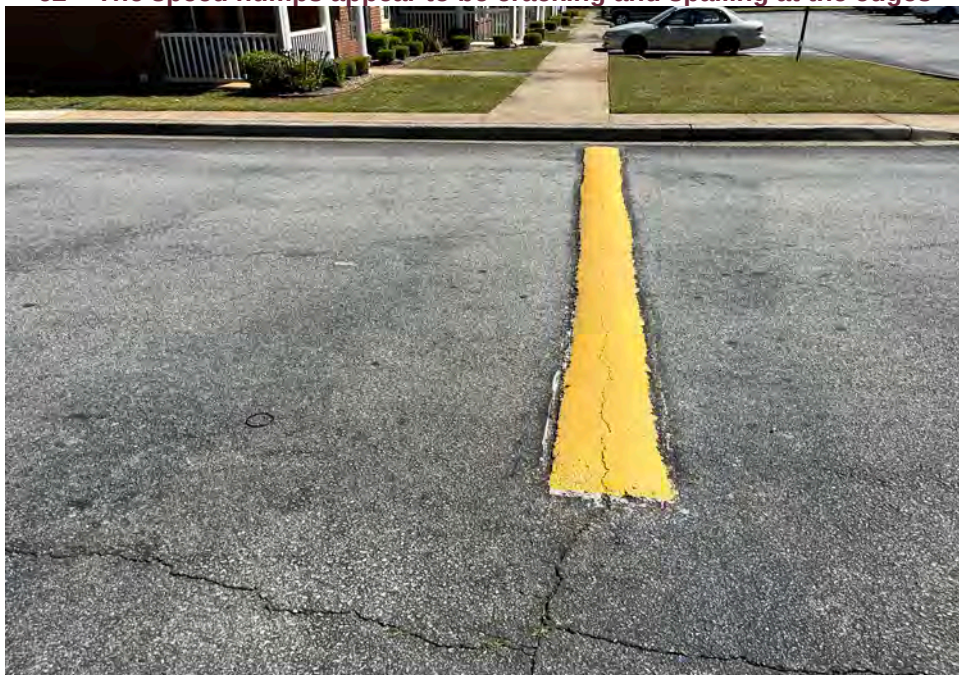
62 – The speed humps appear to be cracking and spalling at the edges

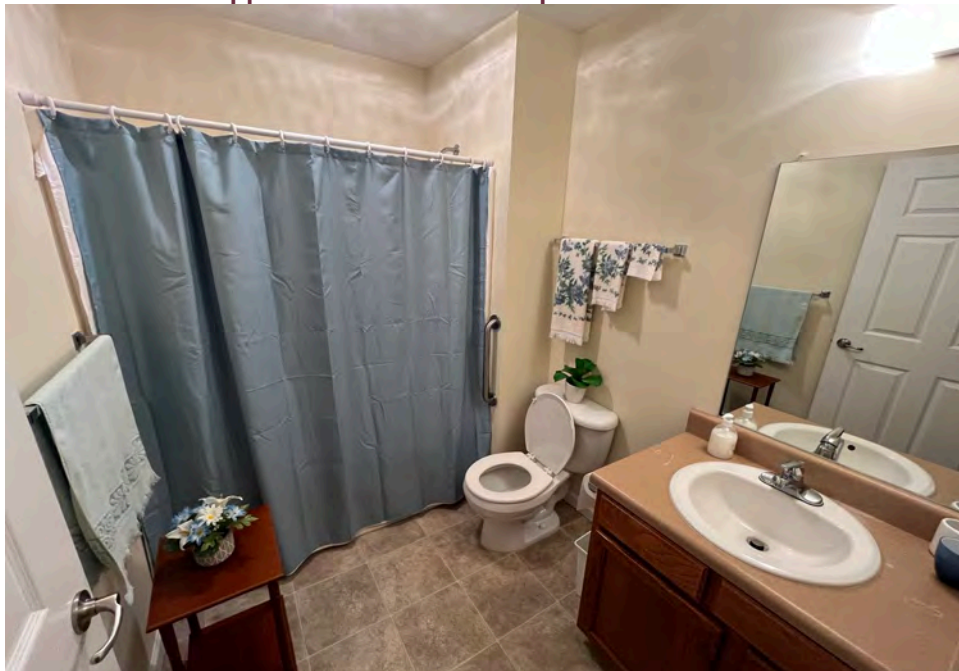
66 – The toilets appear to be dated and replacement should be considered

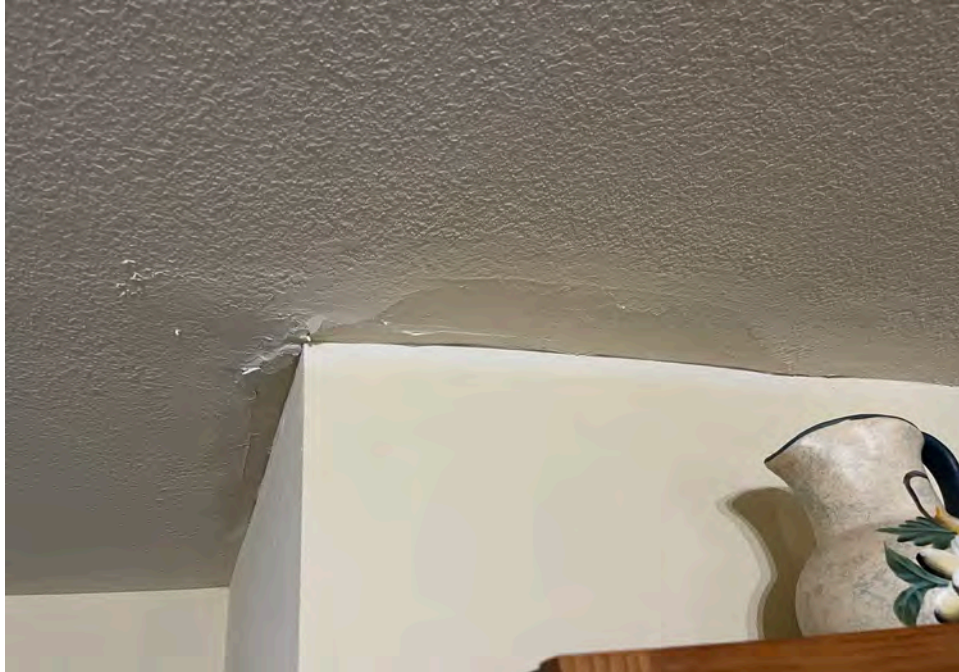
69 - Ceiling repairs are present from (assumed) past water intrusion from roof leaking

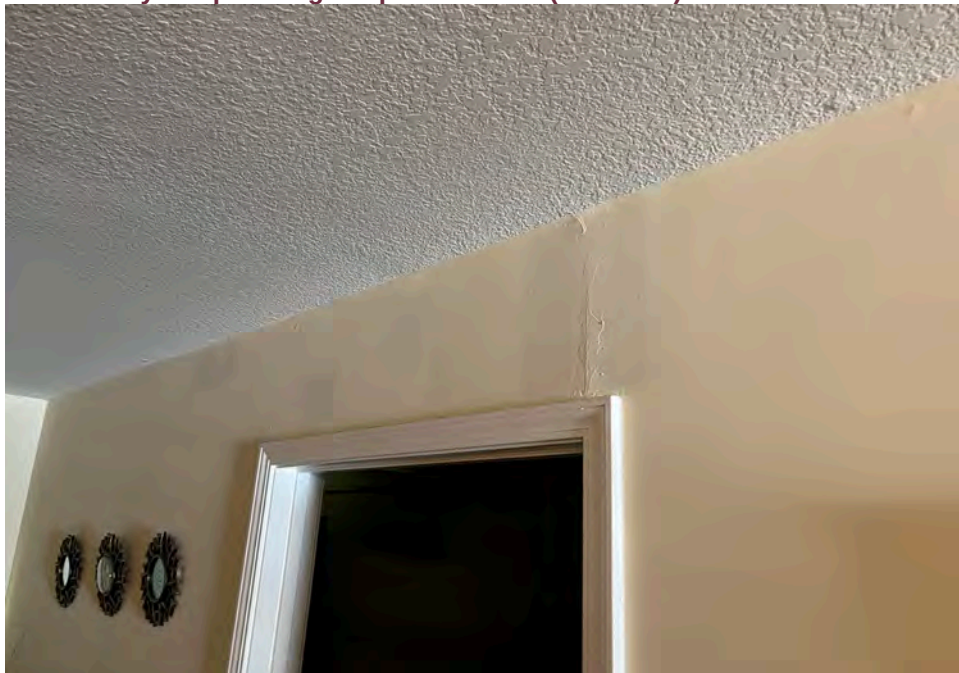
76 – Areas of drywall patching are present from (assumed) water leaks and settlement

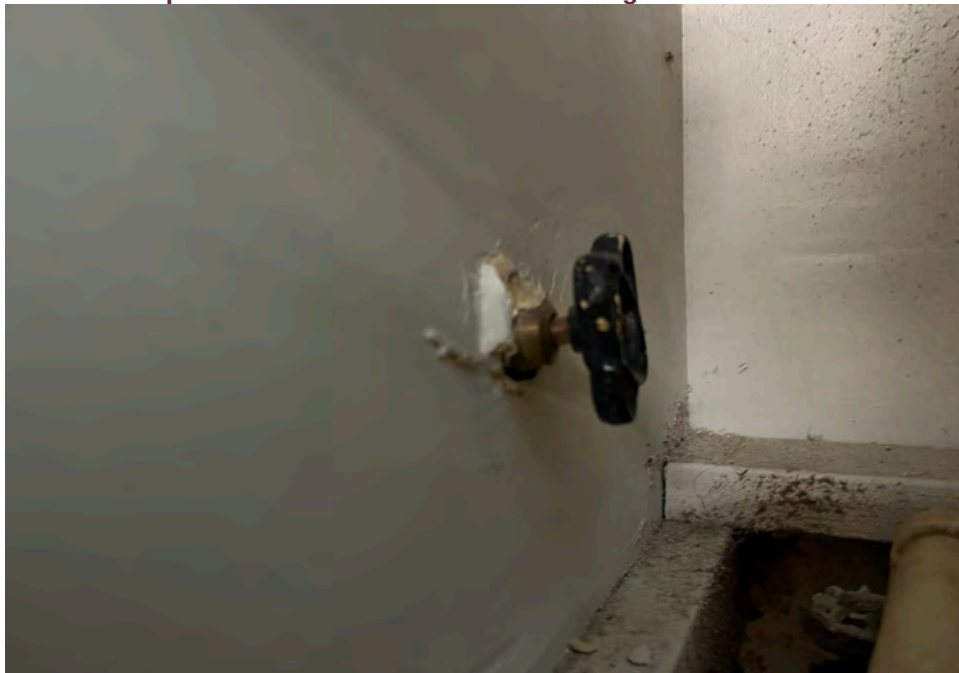
78 – Some penetrations are not sealed including this water shutoff valve

4. Repair the ceiling at the gazebo area and repair/replace rotting wood and repaint select areas of the gazebo. (Estimated Cost = \$2,500.00)
5. Seal all penetrations in the unit mechanical rooms and fasten electrical disconnects (48 units) (Estimated Cost = \$1,250.00)

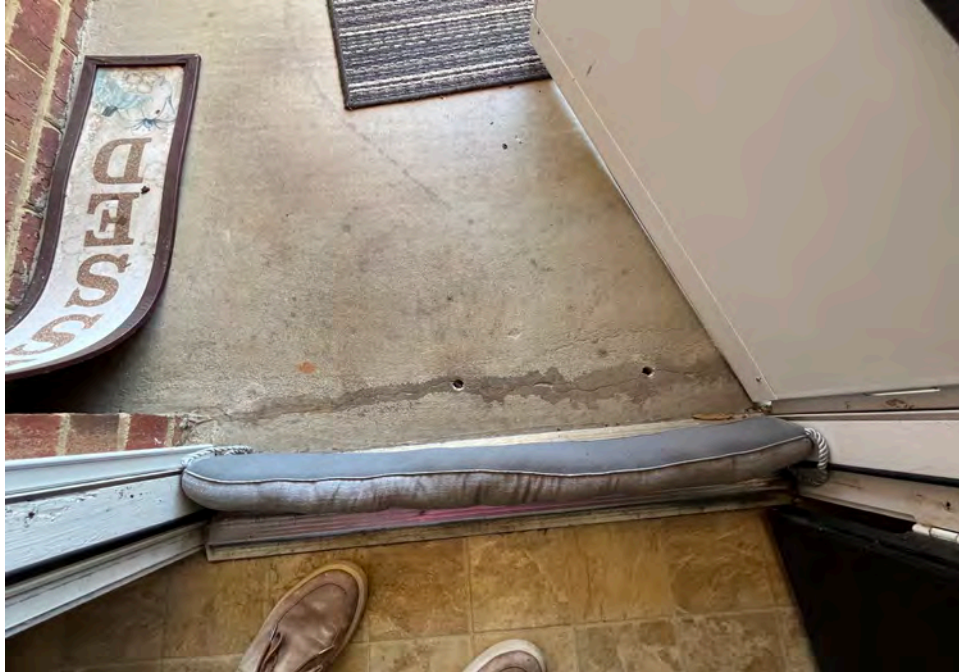
No settling or deflection, or any other indications of structural distress were observed in the buildings. Minor settling was observed in Unit 155 and patching was observed at the doorway and at the concrete patio at the entrance. We note that this appears to be a minor issue and should be monitored by the maintenance team.

79 – It appears that minor settling is occurring and has been patched

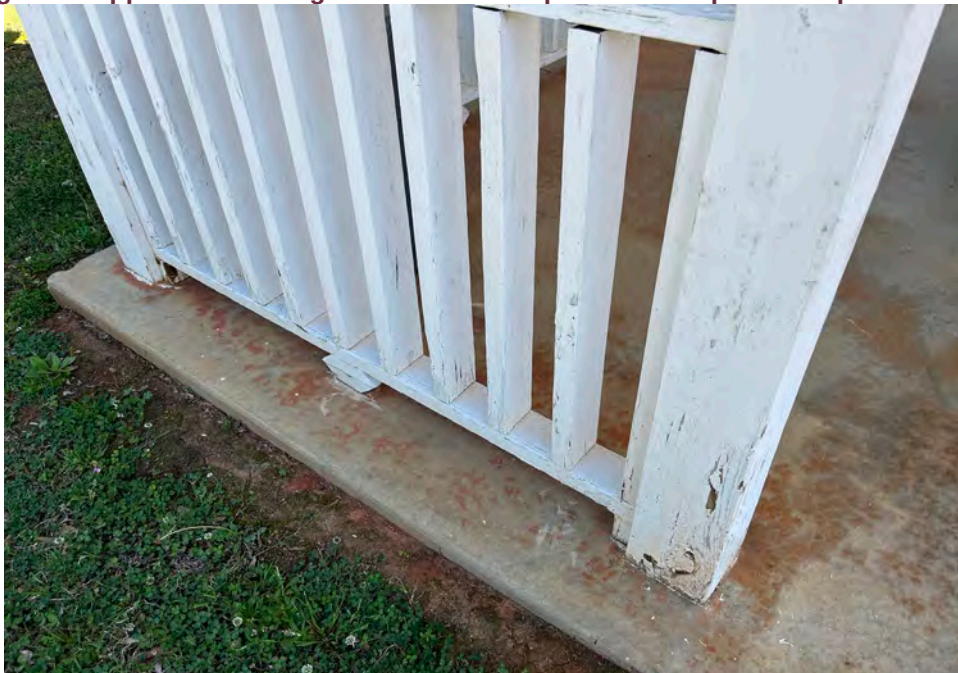
88 – The gazebo appears to be original to the development and repairs and paint are necessary

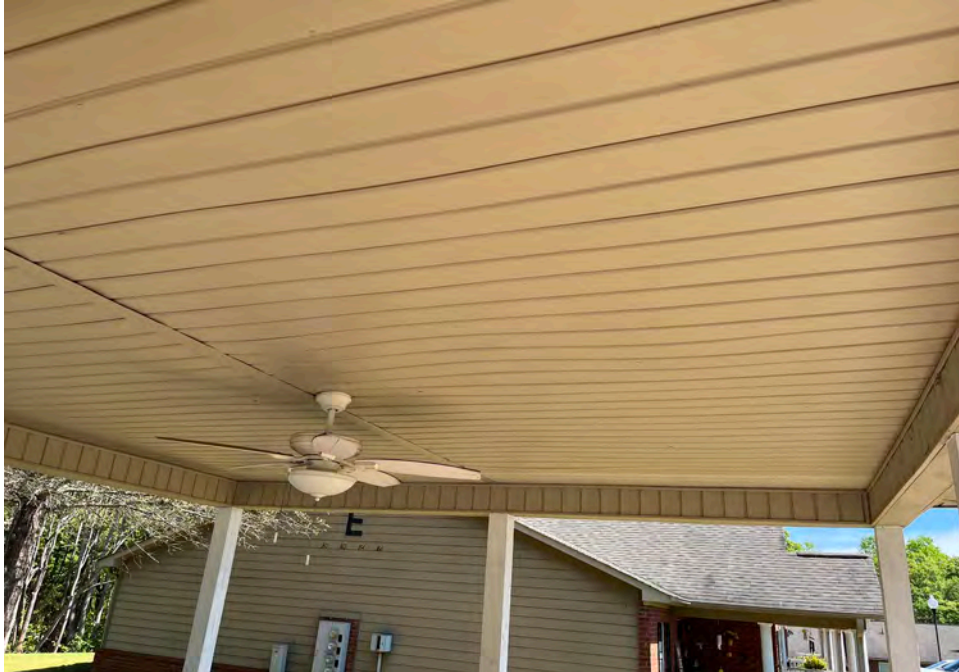
89 – The vinyl ceiling material in the gazebo appears to be failing and should be replaced

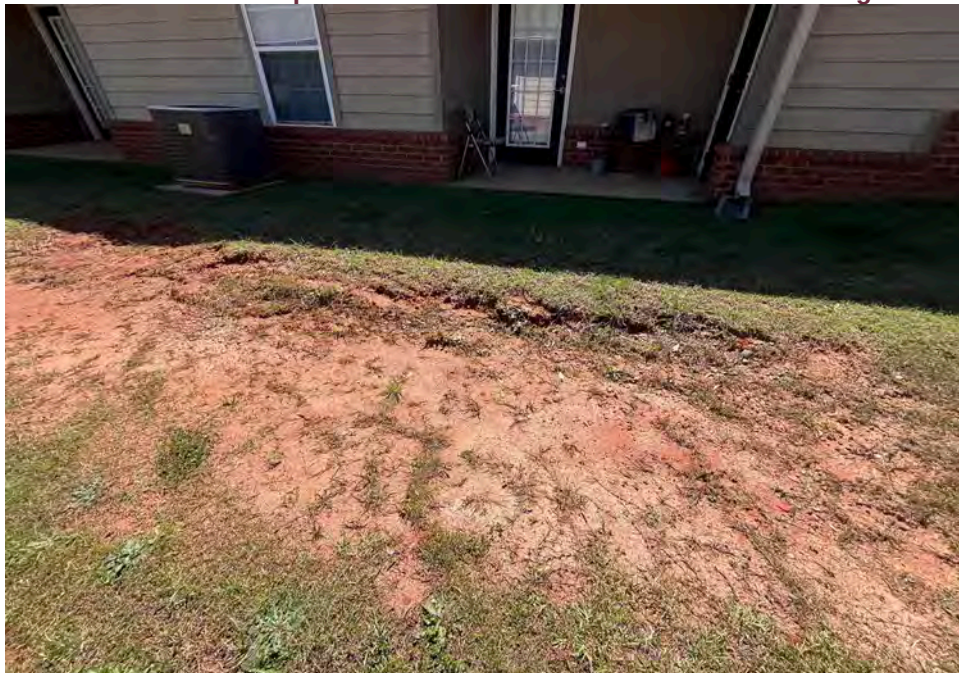
114 – Erosion is present in various areas between the buildings

6. Regrade the areas at the rear of the buildings where stormwater is causing erosion (Estimated Cost = \$2,000.00)
7. Repair or patch asphalt areas where subbase is failing at the northwest corner of the site. (Estimated Cost = \$2,750.00)

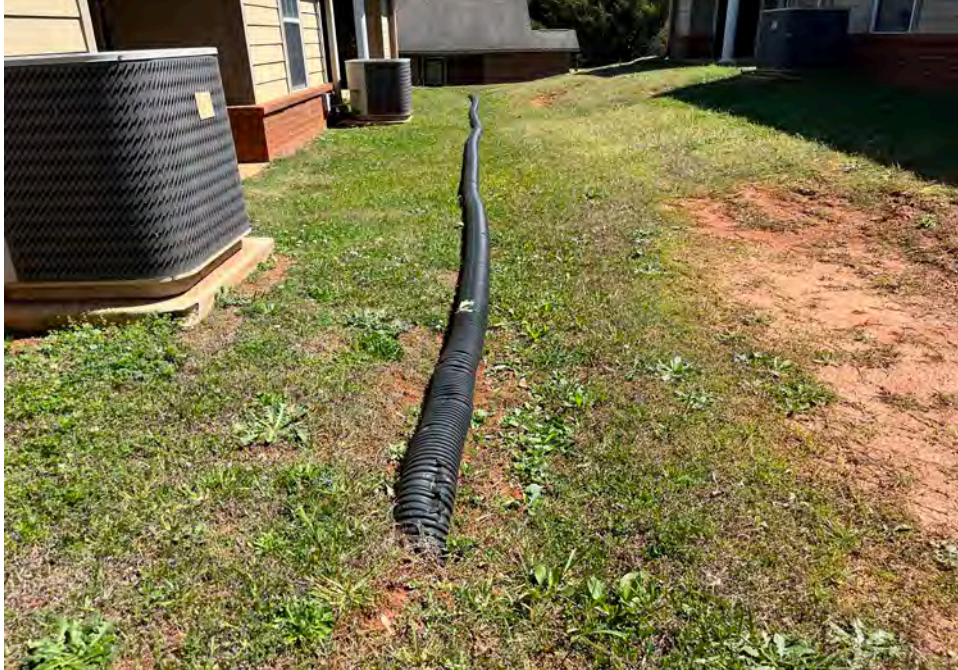
115 – The downspout drains are exposed and damaged between the buildings

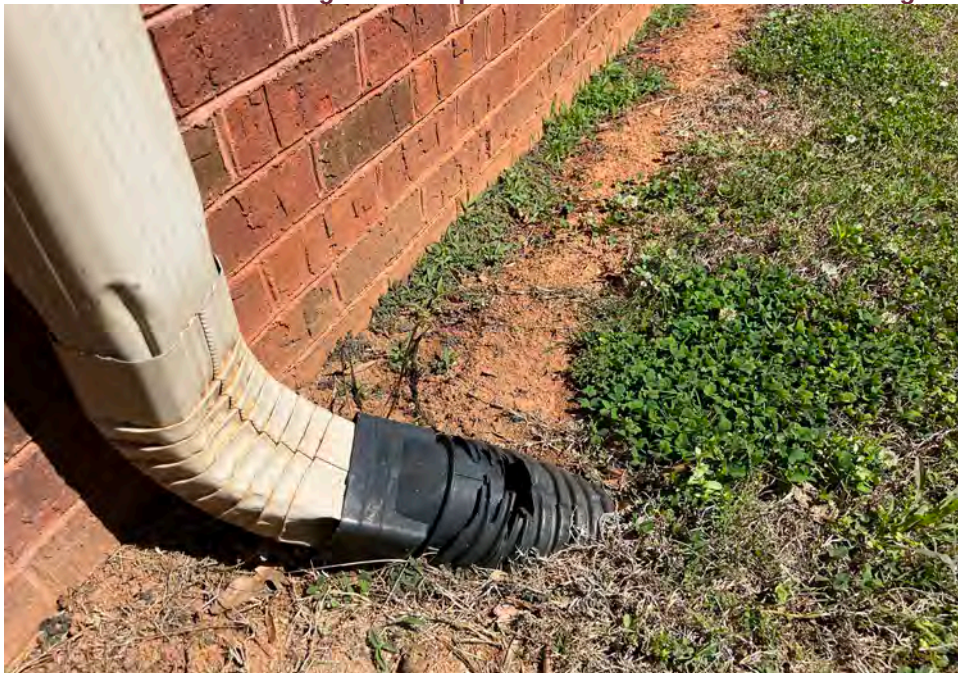
116 – View of a damaged downspout drain at the rear of the building

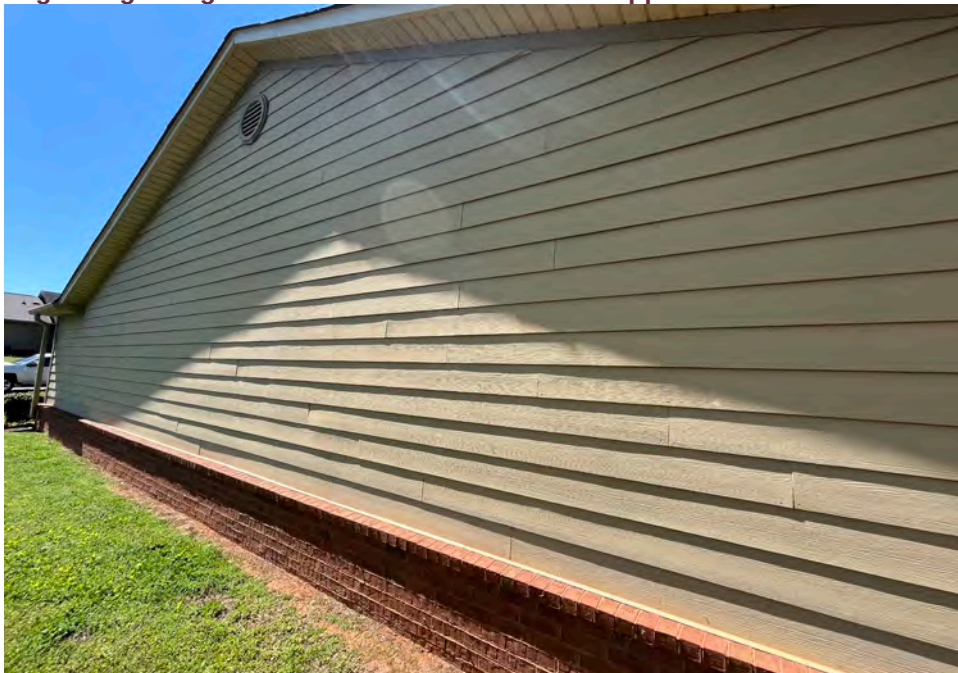
The appearance and condition of the cementitious siding and trims were generally fair. These types of materials do require occasional cleaning and if not pre-painted or pre-finished they should require re-painting every 15-20 years (approximately). We note that minor gaps and warping are present at the exterior of the building and replacement of damaged pieces, caulking, and painting of the siding will be required in the next two to four years.

120 – The siding is beginning to buckle in various areas and appears to be at the end of its useful life

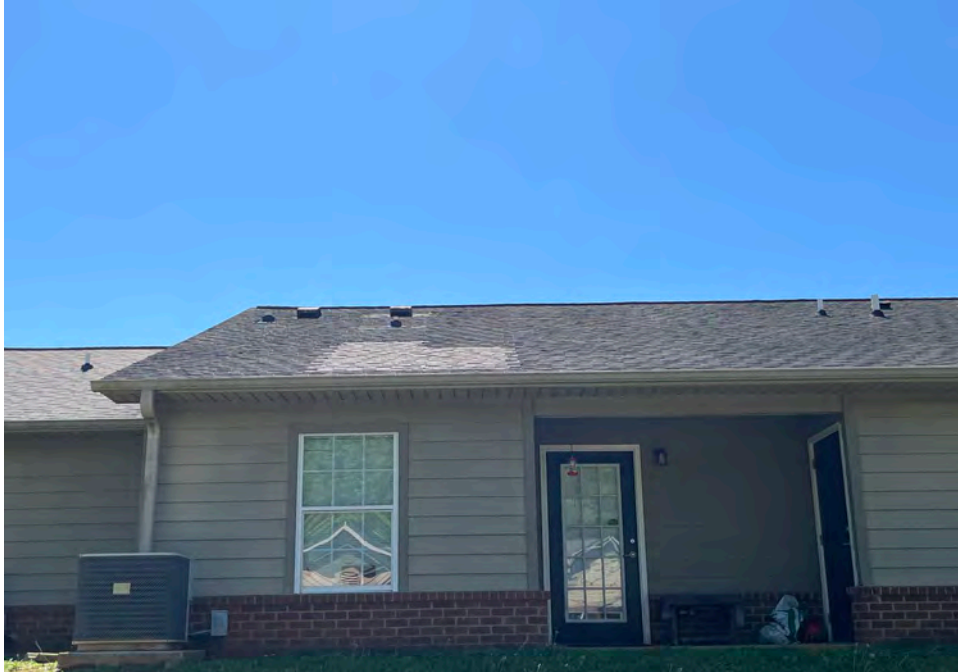
The appearance and condition of the roofing systems were fair with some significant wear visible on the shingles. On April 7, 2026, we consulted with Ms. Jamiya Martin from The Vantage Group, who informed us that the roofing systems were original to the development making them approximately 21 years old. Consequently, we expect these roofing systems to remain effective for an additional three to five years, although they will likely require some targeted repairs and routine maintenance in the one to three-year period. We observed patches in various locations throughout the buildings on the roof areas and interiors where leaks have previously occurred.

121 – Several roof patches were observed throughout the development

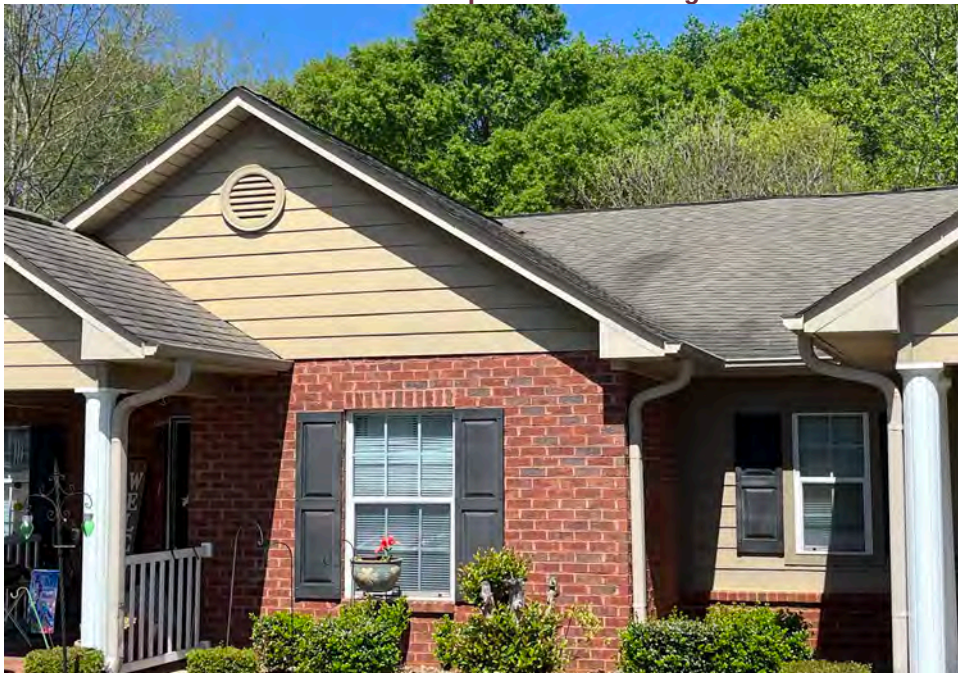
122 – View of wear areas present at the original roofs

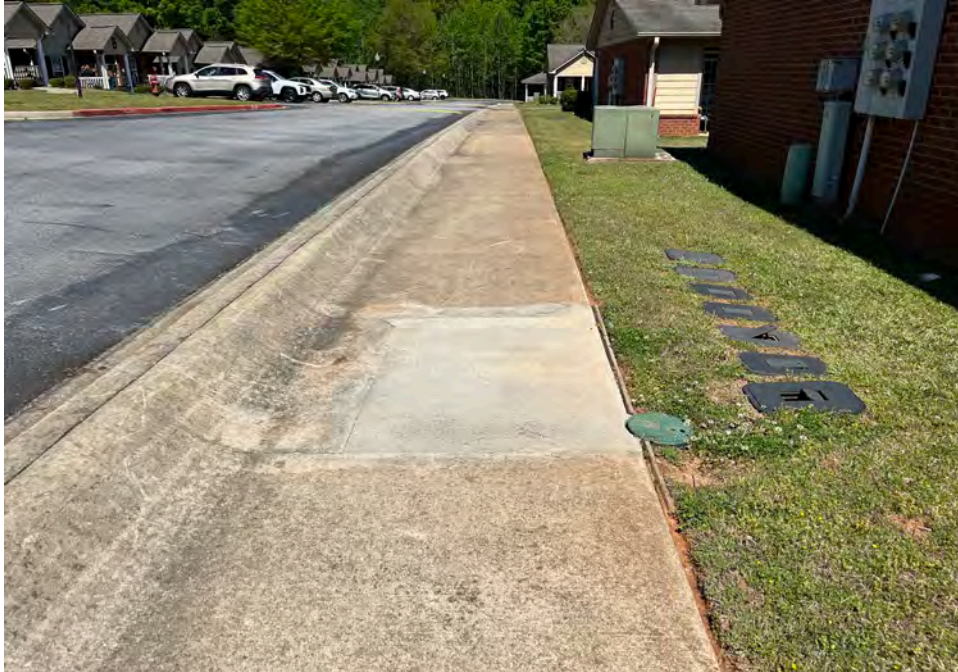
127 – Several areas of the concrete sidewalk are patched and should be replaced

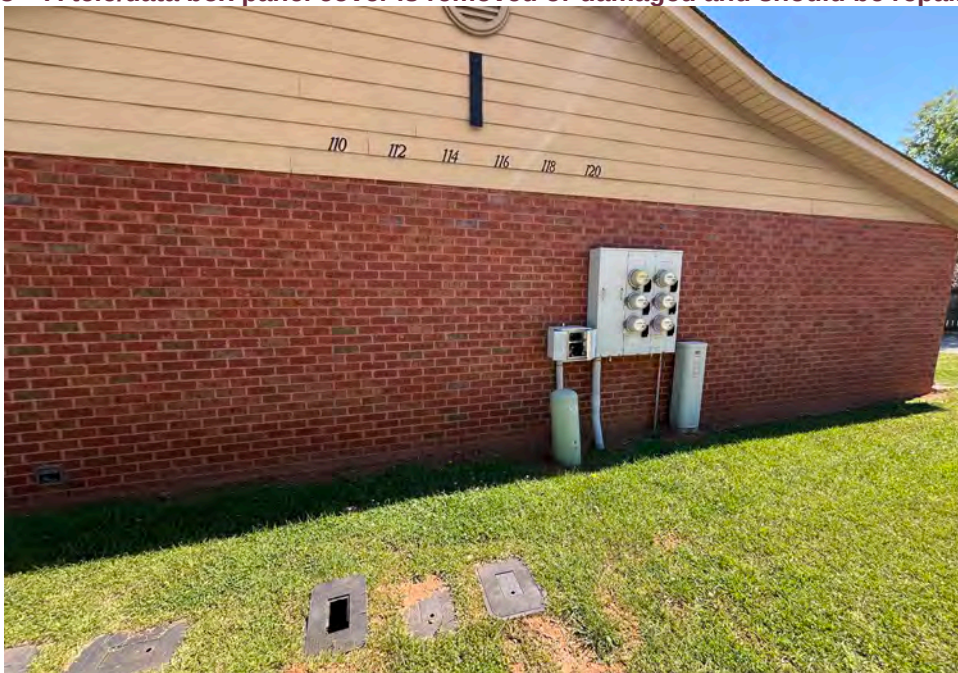
128 – A tele/data box panel cover is removed or damaged and should be repaired

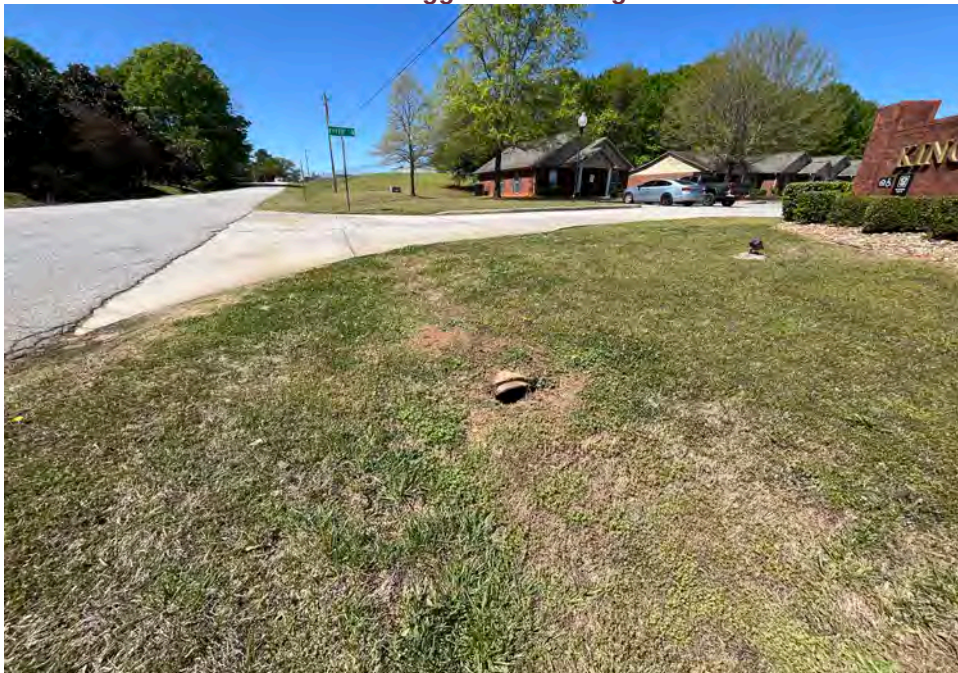
132 – The stormwater culvert is clogged with overgrowth and should be cleared

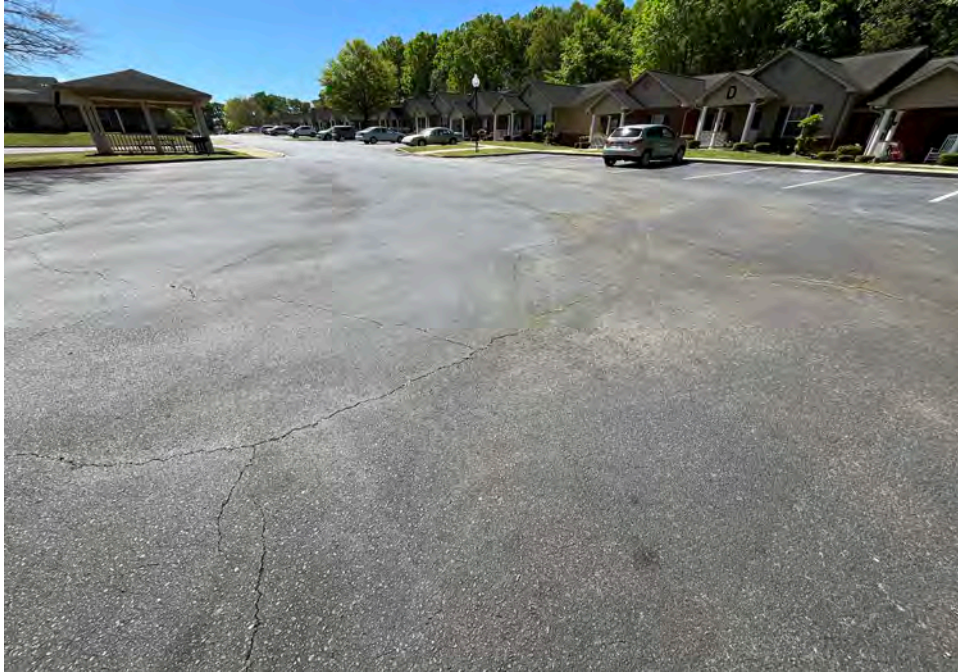
133 – View of the cracking and spalling present at the cul-de-sac area at the north side of the site
