## ZEFFERT & ASSOCIATES

### Accessibility Site Visit (Master)

| <b>Project Name</b> | Sample Property |
| <b>Date of Inspection</b> | 01-15-2020 |

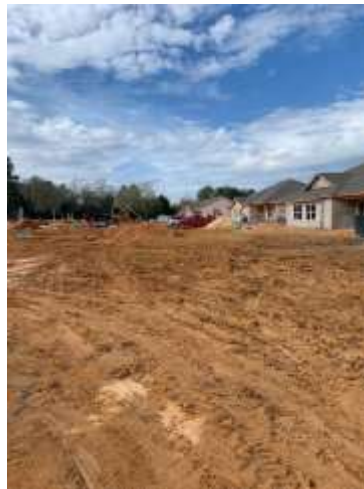
| Accessible Parking Photos | |

| Location of Parking | Throughout Property |
| HC Parking Status | Under Construction |

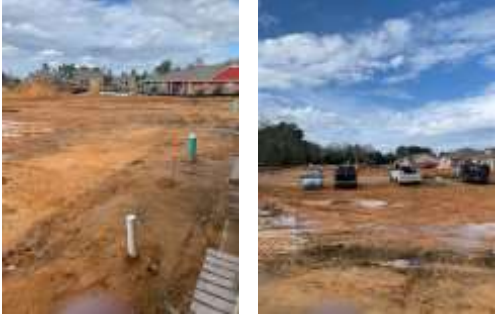
| <b>Add Photos of Accessible Route</b> | |

| <b>Accessible Route Location</b> | Throughout Property |
| <b>Status of accessible route</b> | Under Construction |

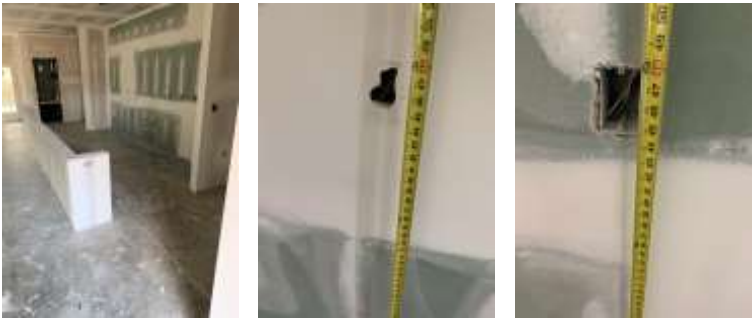
| <b>Common Kitchen Photos</b> | |

| <b>Status of this area</b> | Drywall stage |
| <b>Doorway has a clear opening width 32" min. (ADA 404.2.3)</b> | Yes |

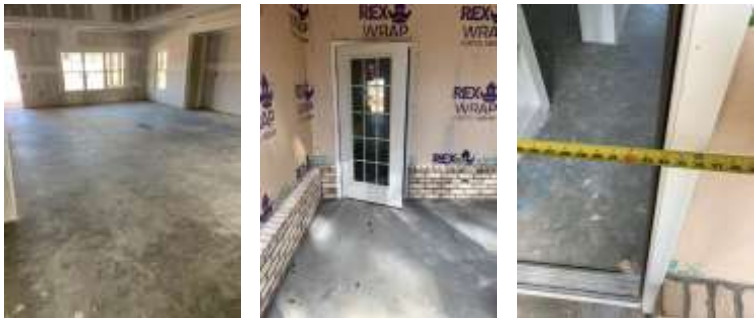
| <b>Community Room Photos</b> | |

| <b>Status of this area</b> | Drywall stage |
| <b>Doorway has a clear opening width 32" min. (ADA 404.2.3)</b> | Yes |
| <b>Electric switches 48" max. AFF and outlets 15" min. (unobstructed) (ADA 308.2.1)</b> | Yes |

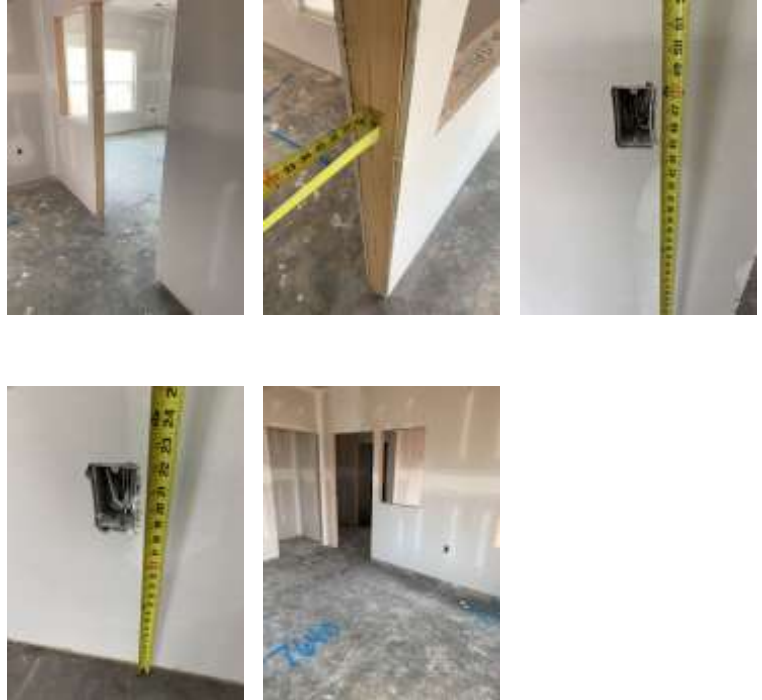
### Leasing Office Photos

| <b>Status of this area</b> | Drywall stage |
| <b>Doorway has a clear opening width 32" min. (ADA 404.2.3)</b> | Yes |
| <b>Electric switches 48" max. AFF and outlets 15" min. (unobstructed) (ADA 308.2.1)</b> | Yes |

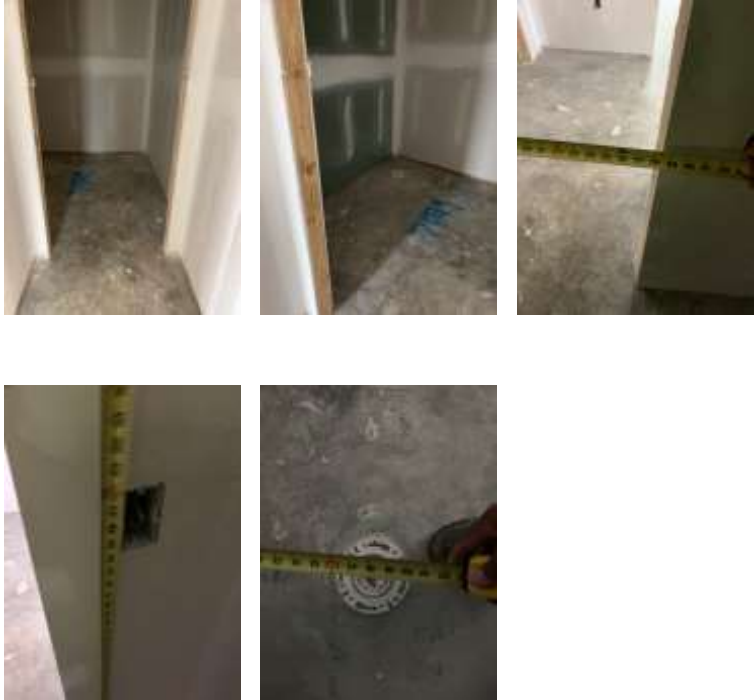
| <b>Restroom Photos</b> | |

| <b>Public Restroom Description</b> | Community Building Women's |
| <b>Status of this area</b> | Drywall stage |
| <b>Doorway has a clear opening width 32" min. (ADA 404.2.3)</b> | Yes |

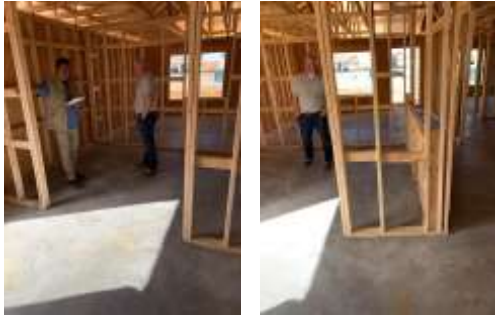
| <b>HC Unit Kitchen Photos</b> | |

| <b>Entry and/or door 32" min. (UFAS 4.13.5)</b> | Yes |
| <b>Additional Comments for HC Unit Kitchen</b> | No electrical installed at the time of inspection |

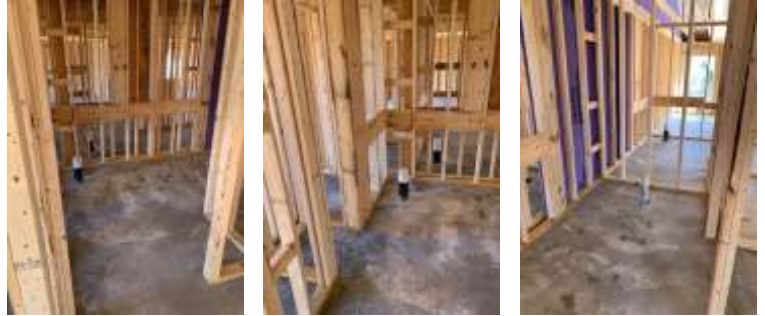
### Bathroom Blocking Photos

| <b>Status of Blocking</b> | Framing stage |
| <b>FHA &amp; HC Units - All bathrooms required to have blocking. (UFAS 4.26, FHA 6.3)</b> | In FHA & HC Units ALL bathrooms required to have blocking. |

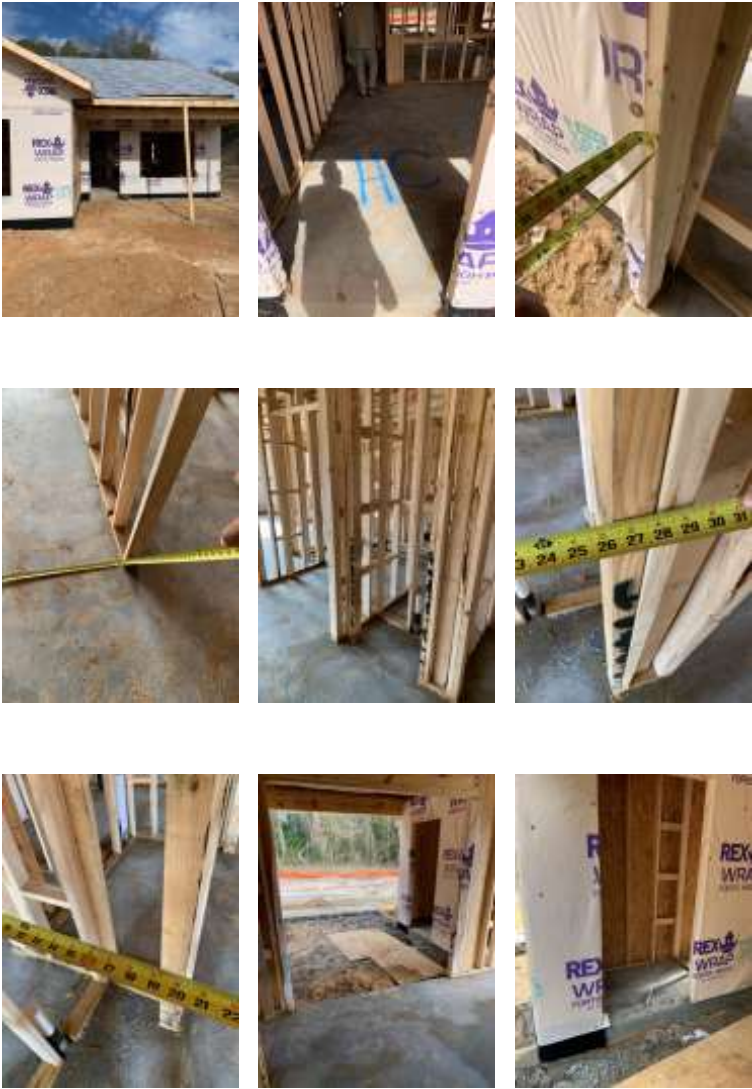
| <b>36" min width accessible route through dwelling unit (UFAS 4.34.2 (3), 4.3)</b> | Yes |
| <b>Comments for HC Unit Misc.</b> | No electrical installed at the time of inspection |

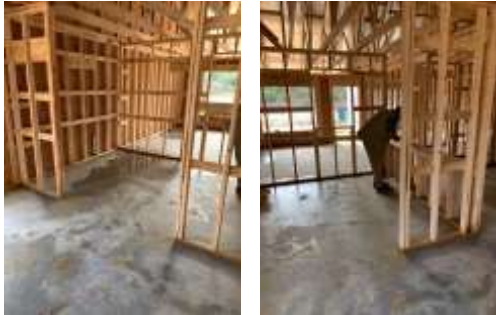
| <b>HC Unit Kitchen Photos</b> | |

| <b>Status of this area</b> | Framing stage |
| <b>Additional Comments for HC Unit Kitchen</b> | No electrical installed at the time of inspection |

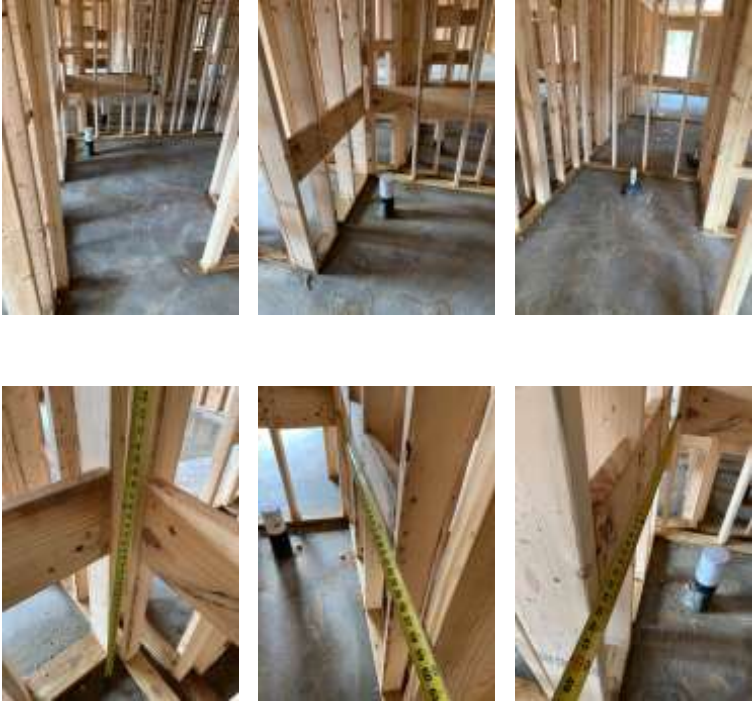
| <p>Bathroom Blocking Photos</p> | |

| <b>Status of Blocking</b> | Framing stage |
| <b>FHA &amp; HC Units - All bathrooms required to have blocking. (UFAS 4.26 FHA 6.3)</b> | In FHA & HC Units ALL bathrooms required to have blocking. |
| <b>2" x 8" blocking installed 32" - 38" AFF for length of 42" for 36" grab bar (UFAS Fig. 47)</b> | Yes |

| <p>2" x 8" blocking installed 32" - 38" AFF for length of 54" for 42" grab bar (UFAS Fig. 47)</p> | <p>No</p> |
| <p>Bathtub or shower enclosure has 2" x 8" blocking installed 32" - 38" AFF on three walls (UFAS Fig. 48)</p> | <p>No</p> |
