May 4, 2026

**Subject:       Lead-Based Paint Testing Data Report  
                  TMS #0152-16-18-001.000 (Shady Grove)  
                  1505 Broughton Street & 164 Broad Street  
                  Orangeburg, South Carolina  
                  JPEG Project #3615-26**

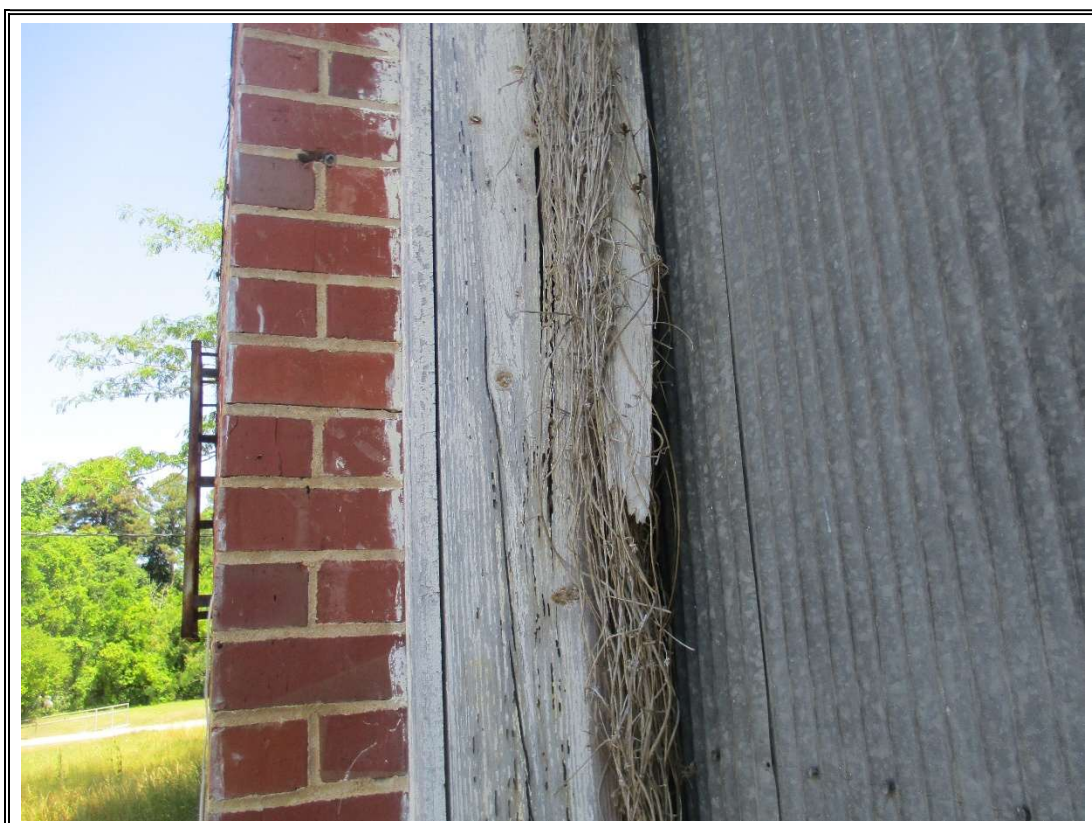
Photo 2: Positive XRF reading on framing of warehouse bay door (Side C).

| Reading # | Concentration<br>(mg/cm <sup>2</sup> ) | Result | Room | Wall/<br>Side | Component | Color | Substrate |
|---|---|---|---|---|---|---|---|
| 25 | 1.4 | Positive | Exterior | C | Bay Door, frame | White | Wood |

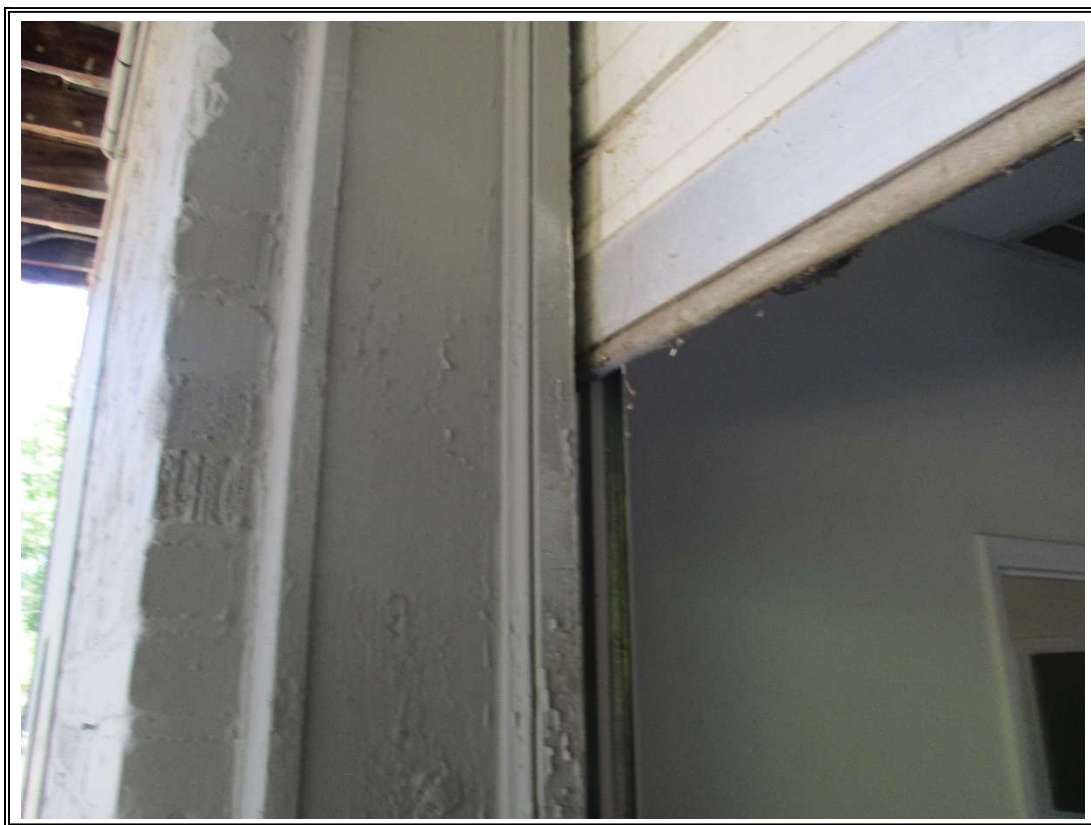
Photo 3: Positive XRF reading on framing of bay door to office/tenant suite (Side C).

| Reading # | Concentration<br>(mg/cm <sup>2</sup> ) | Result | Room | Wall/<br>Side | Component | Color | Substrate |
|---|---|---|---|---|---|---|---|
| 63 | 6.6 | Positive | Interior (1553) | C | Exterior Bay door, casing/frame | White | Wood |

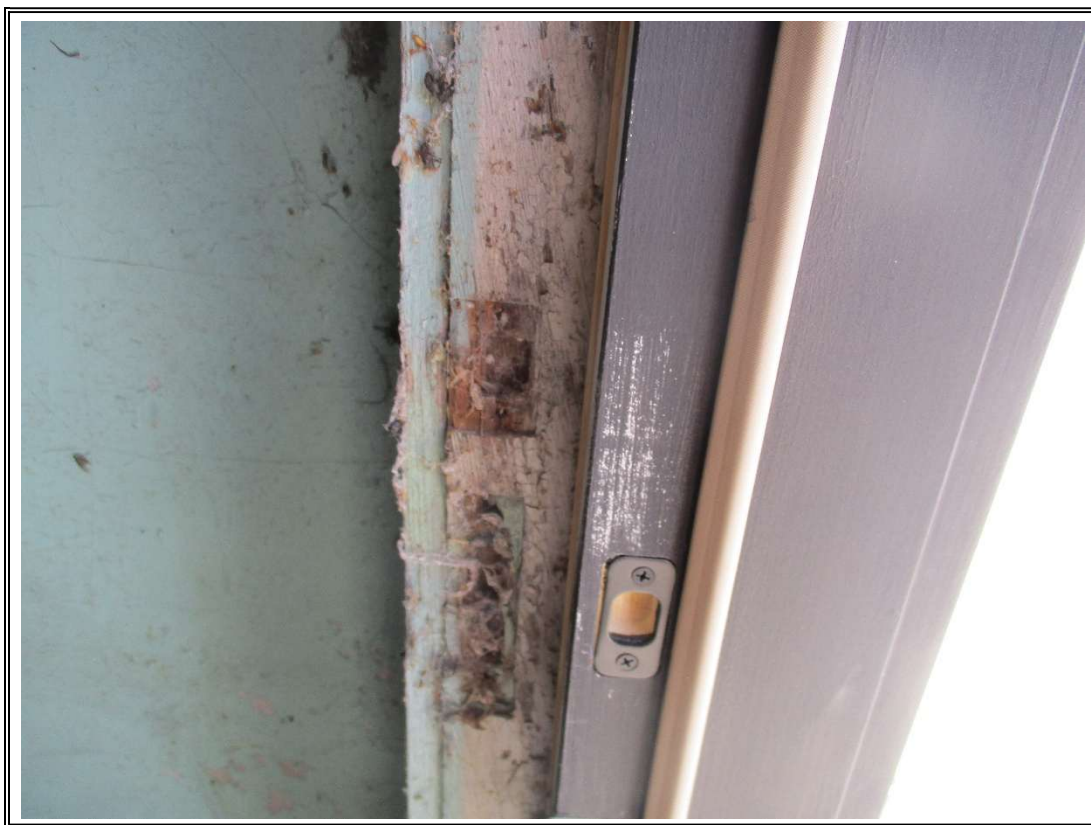
Photo 4: Positive XRF reading on white-painted door frame of storage room (Side A).

| Reading # | Concentration<br>(mg/cm <sup>2</sup> ) | Result | Room | Wall/<br>Side | Component | Color | Substrate |
|---|---|---|---|---|---|---|---|
| 14 | 1.3 | Positive | Storage Room | A | Inner door frame | White | Wood |

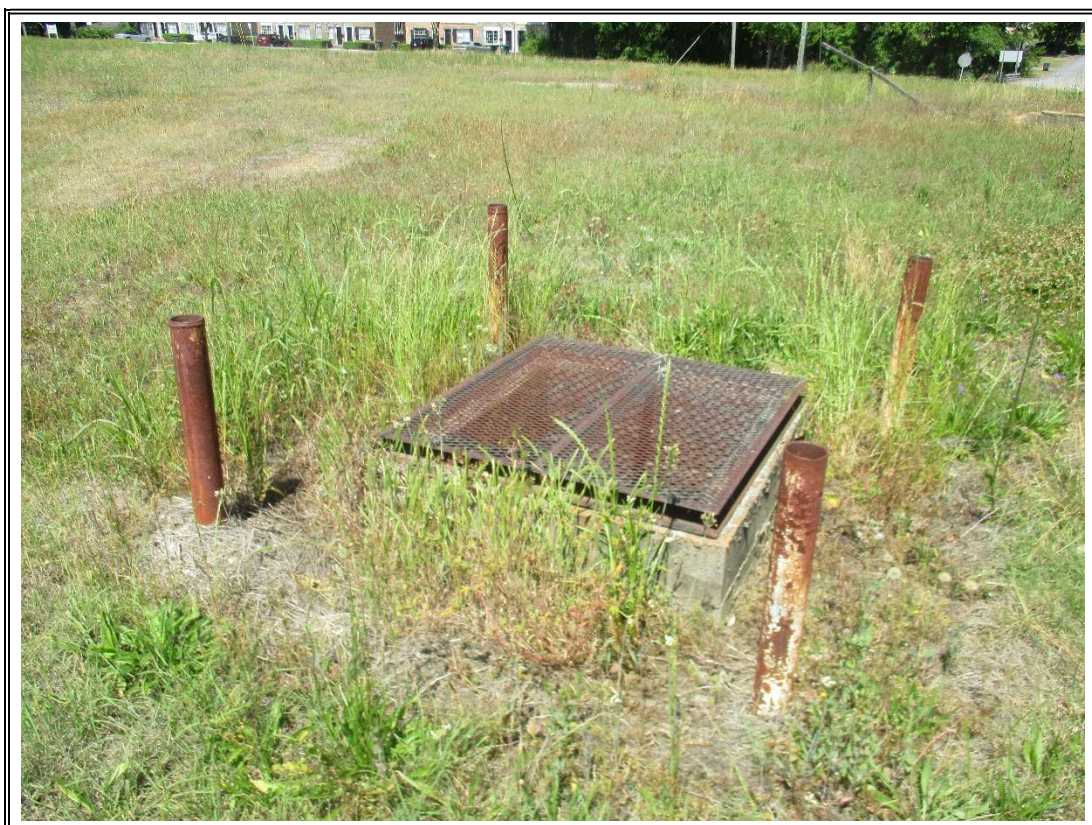
Photo 5: Positive XRF reading front right traffic post (Side B).

| Reading # | Concentration<br>(mg/cm <sup>2</sup> ) | Result | Room | Wall/<br>Side | Component | Color | Substrate |
|---|---|---|---|---|---|---|---|
| 23 | 1.2 | Positive | Exterior | B | Traffic Post (1 of 4) | White | Metal |

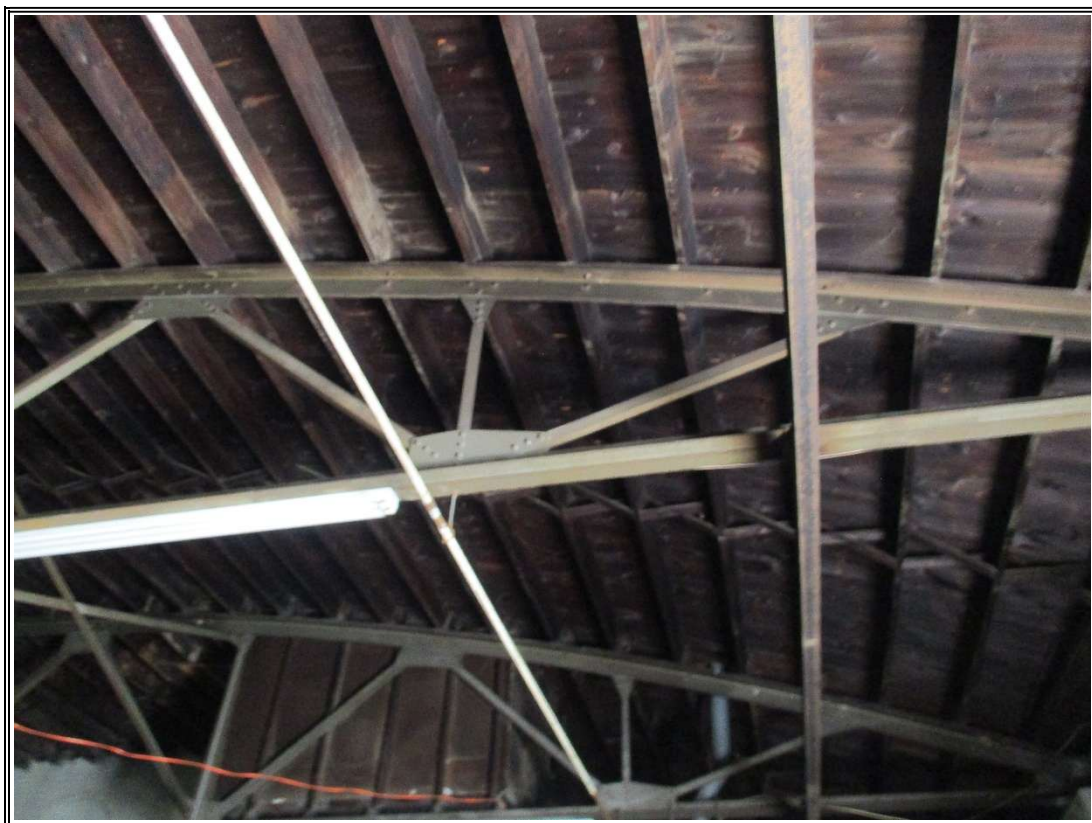
Painted roof components of both buildings and ceiling trusses within the warehouse were not safely accessible without the use of mechanical lift equipment. These components should be presumed positive for lead until such time as XRF or paint chip testing is performed.

Photo 6: View of example steel trusses within warehouse (portions painted).

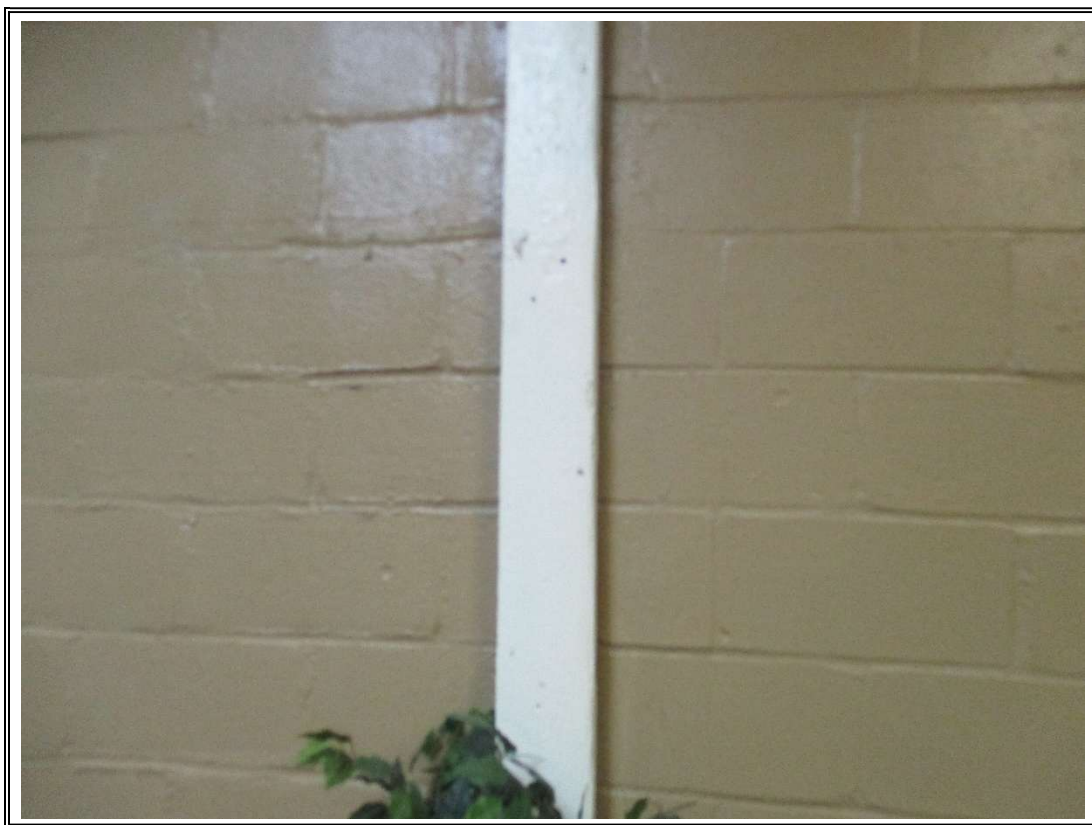
Twenty-three (23) XRF readings were recorded during the testing activities at the church building. A tabular summary of the XRF results with corresponding testing locations is provided in **Appendix B**. One (1) positive XRF reading was detected at the church building on a relic wooden furring strip located on Side A of the church foyer (Photograph 9, Appendix A).

Photo 8: Positive XRF reading on white-painted furring strip (Side A).

| Reading # | Concentration<br>(mg/cm <sup>2</sup> ) | Result | Room | Wall/<br>Side | Component | Color | Substrate |
|---|---|---|---|---|---|---|---|
| 90 | 1.9 | Positive | Foyer | A | Relic furring strip | White | Wood |
