## ZEFFERT & ASSOCIATES

### Accessibility Site Visit (Master)

| <b>Project Name</b> | Sample Property |
| <b>Date of Inspection</b> | 01-15-2020 |

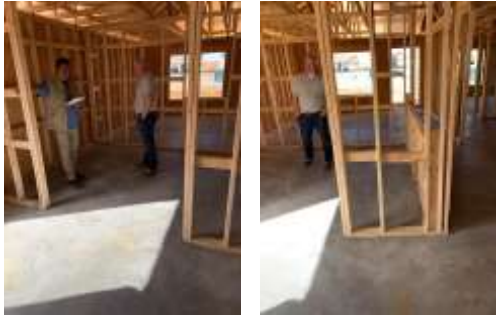
| <b>Entry and/or door 32" min. (UFAS 4.13.5)</b> | Yes |
| <b>Additional Comments for HC Unit Kitchen</b> | No electrical installed at the time of inspection |

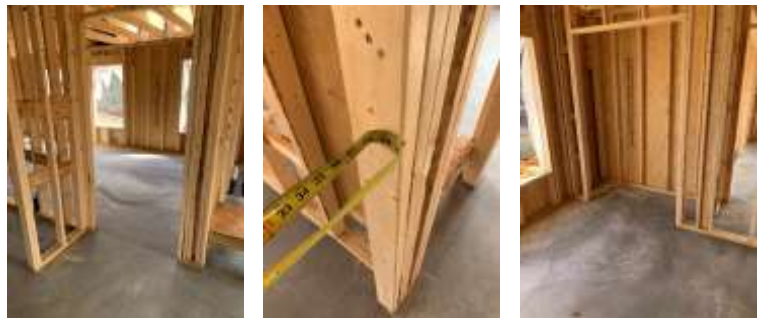
| <b>Bedroom Description</b> | Bedrooms 1-2 |
| <b>Status of this area</b> | Framing stage |
| <b>Doorway has a clear opening width 32" min. (UFAS 4.13.5)</b> | Yes |
| <b>Closet - depth and door opening compliant (UFAS 4.13.5)</b> | Yes |
| <b>Additional Comments for HC Bedroom</b> | No electrical installed at the time of inspection |

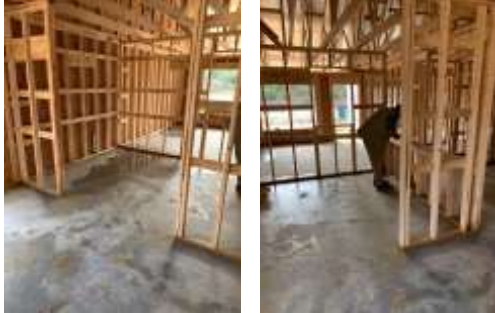
| <b>Status of this area</b> | Framing stage |
| <b>Additional Comments for HC Unit Kitchen</b> | No electrical installed at the time of inspection |
