Subject: Asbestos Operation and Maintenance Plan of:

Manning Gardens  
214 Alfred Henry Street  
Manning, South Carolina 29102  
ET928O2860

# Asbestos Operations & Maintenance Plan

## GG PROJECT NO.: ET928O2860

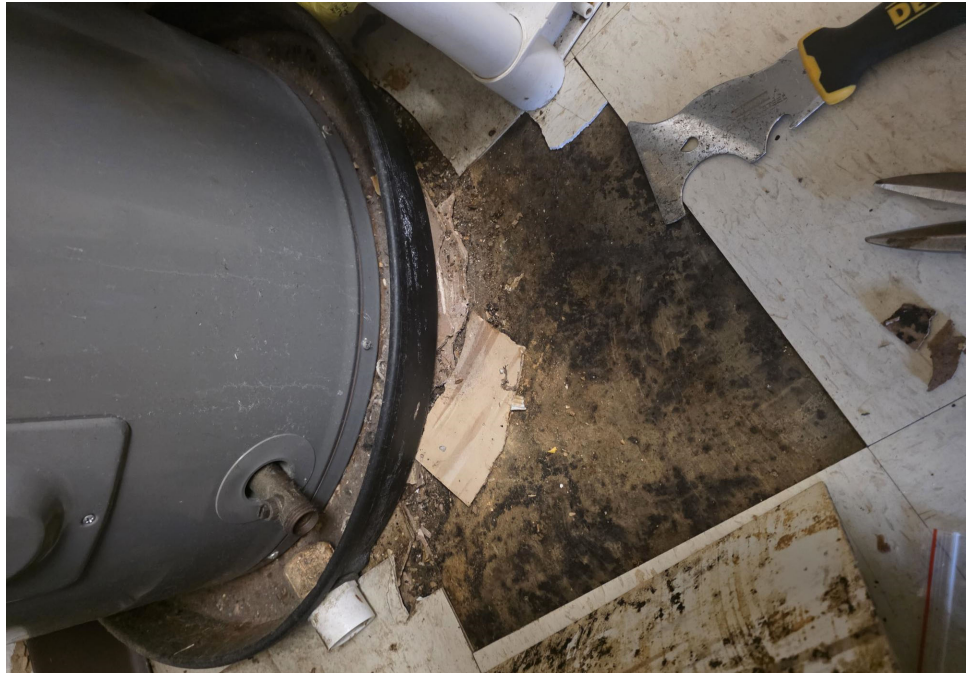
SM16 - tile under hot water heater

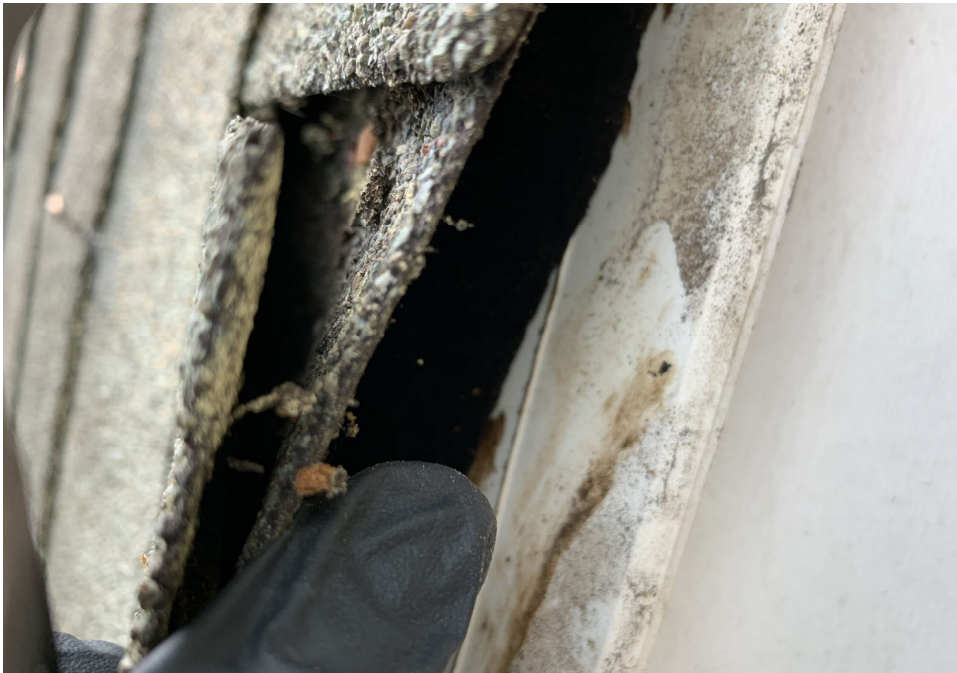
Roofing shingles and felt (SM22 and SM23)

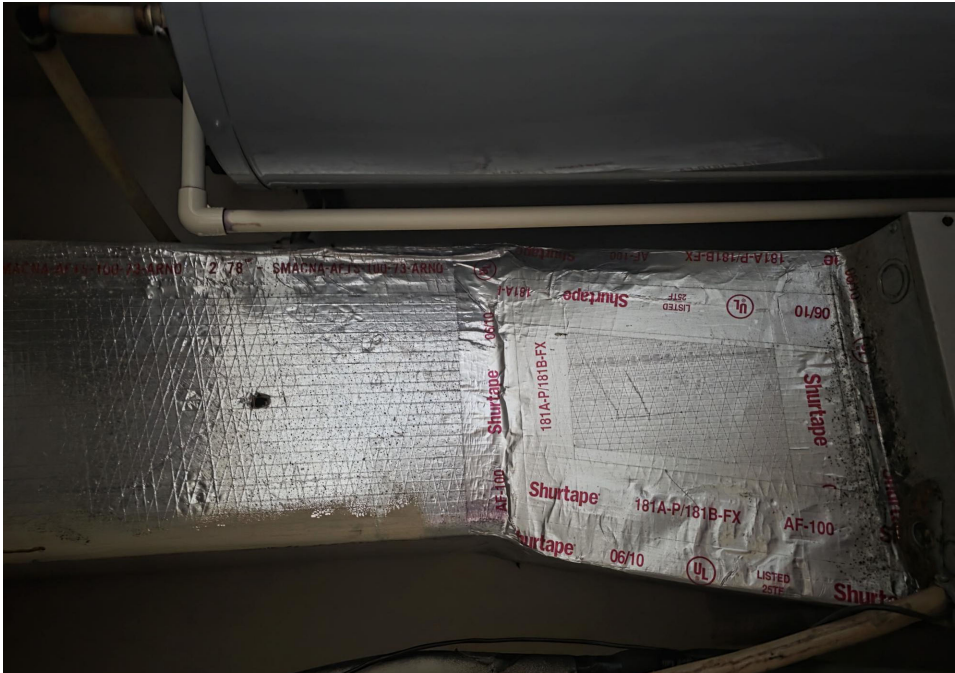
Foil over fiberglass on HVAC duct

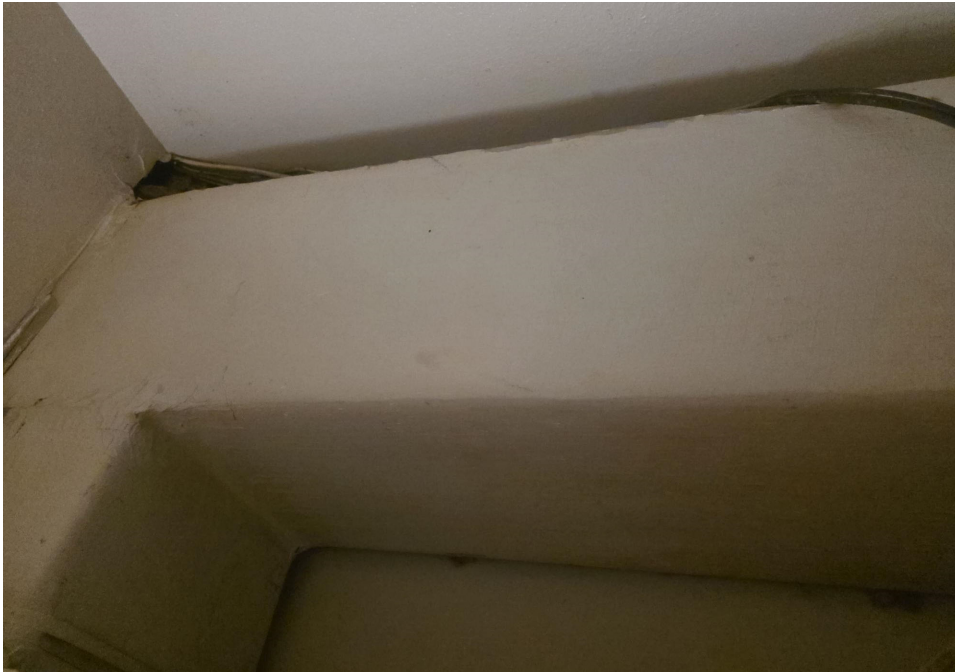
SM18 in unit 20F

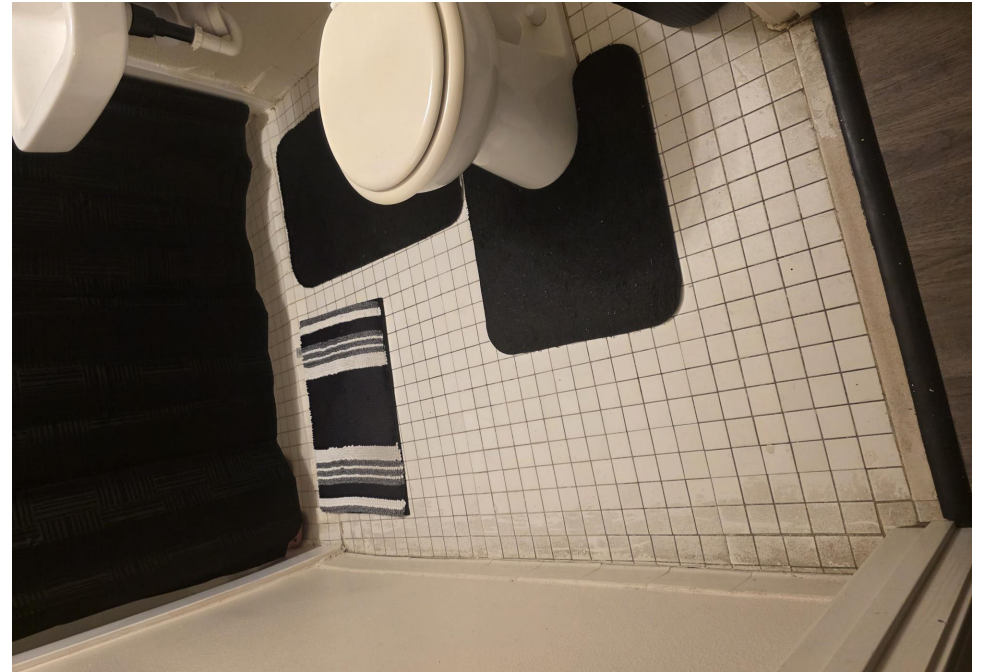
Ceramic tile in bathroom in unit 1A

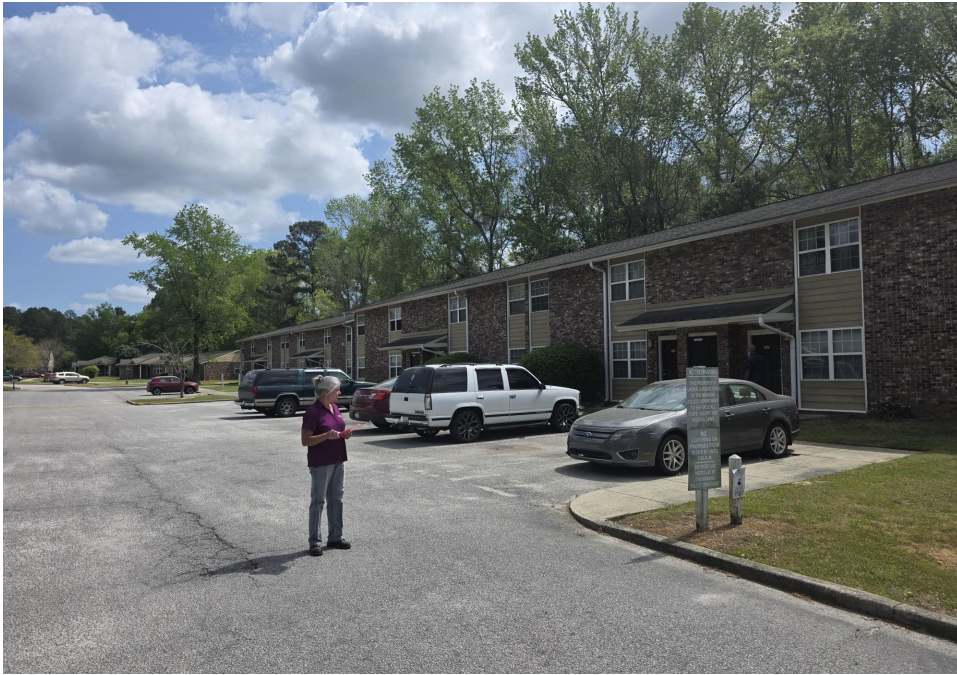
Exterior - brick mortar (SM22) and shingles (SM23)

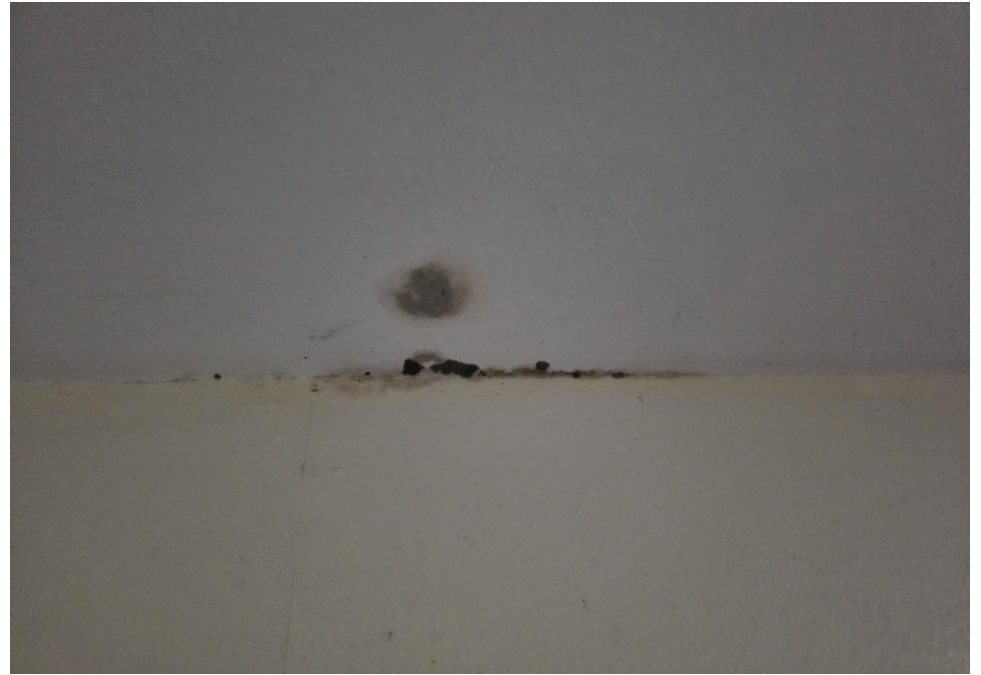
Sheetrock ceiling (SM1) and sheetrock wall (SM2)

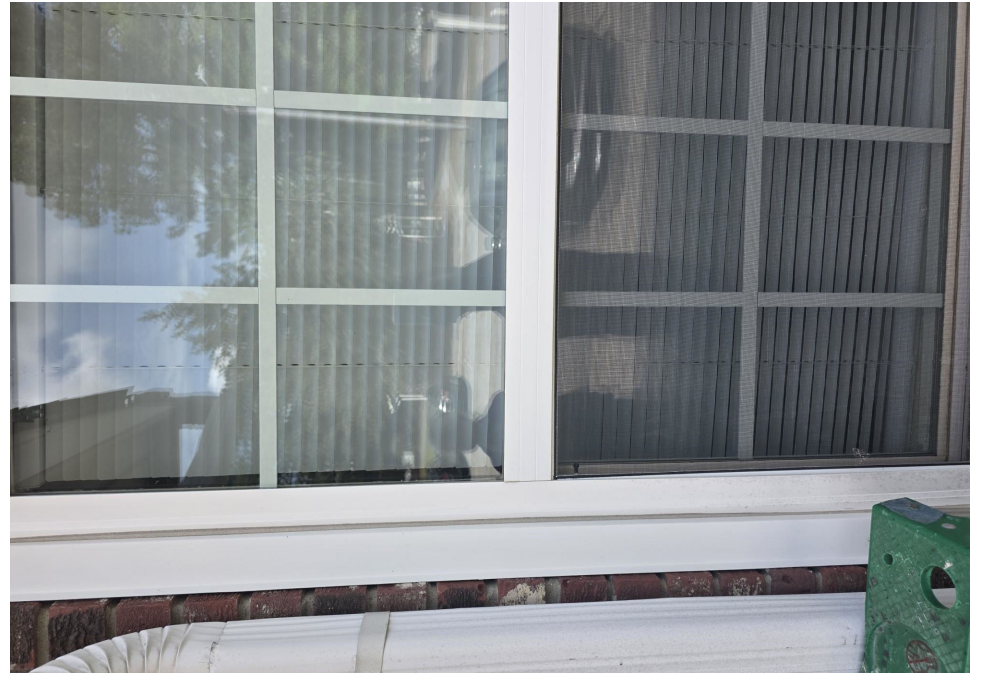
Vinyl windows - no caulking

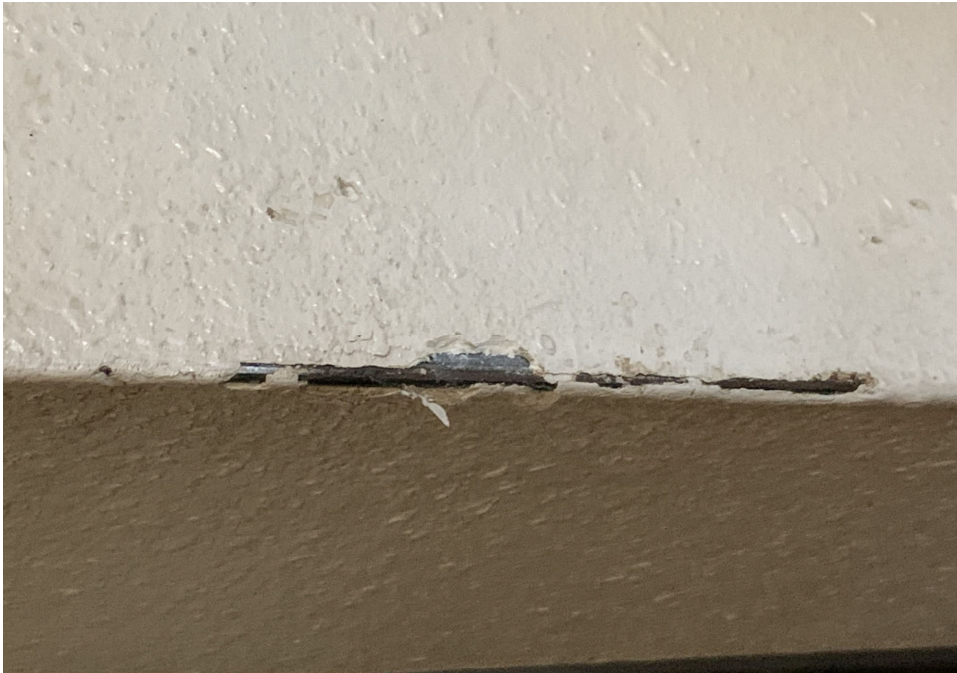
Sheetrock ceilings and walls (SM1 and SM2)

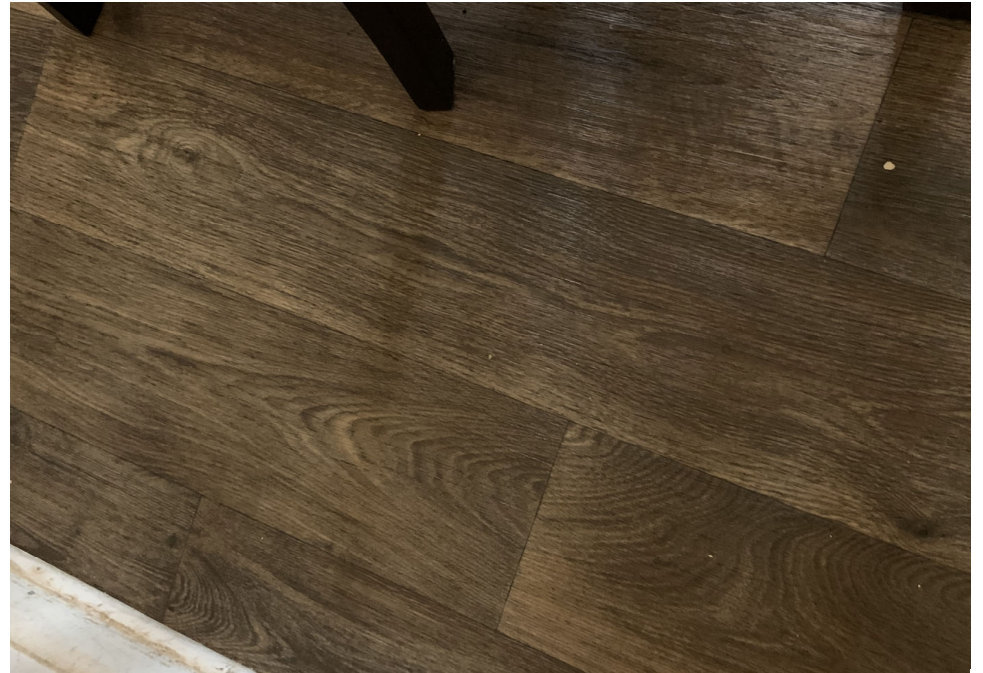
Brown vinyl plank flooring

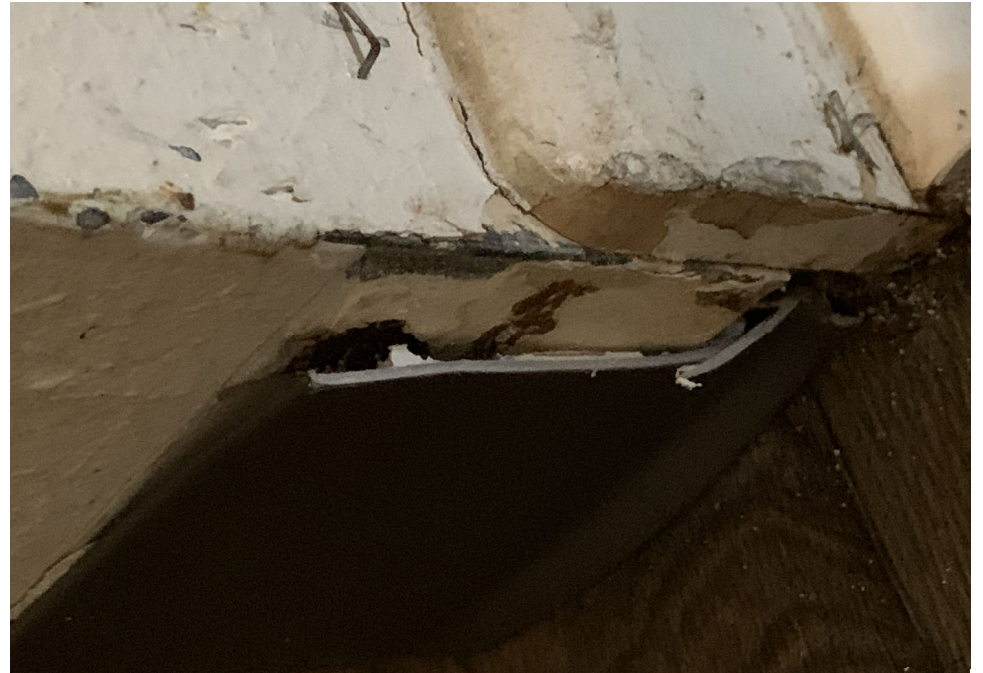
Black covebase (SM6)

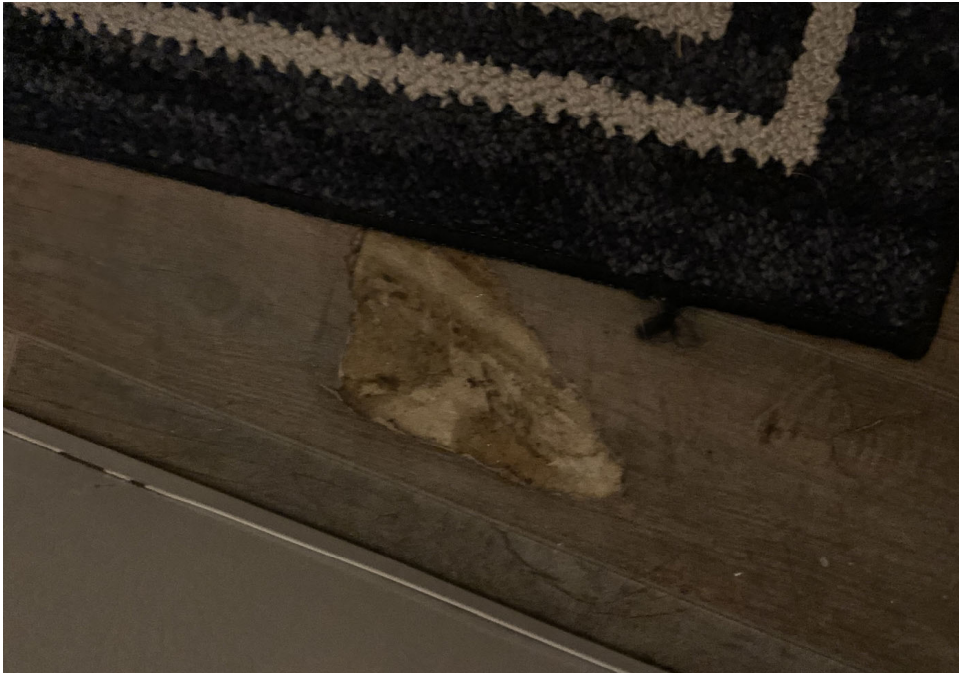
Grey LVP (SM5)

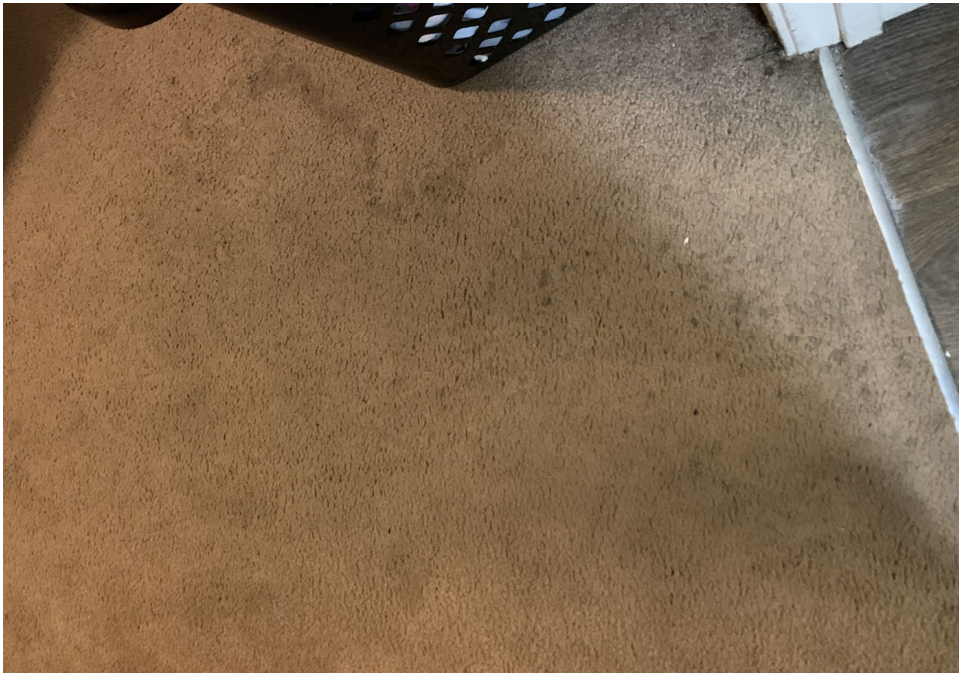
Carpet on pad (no glue)

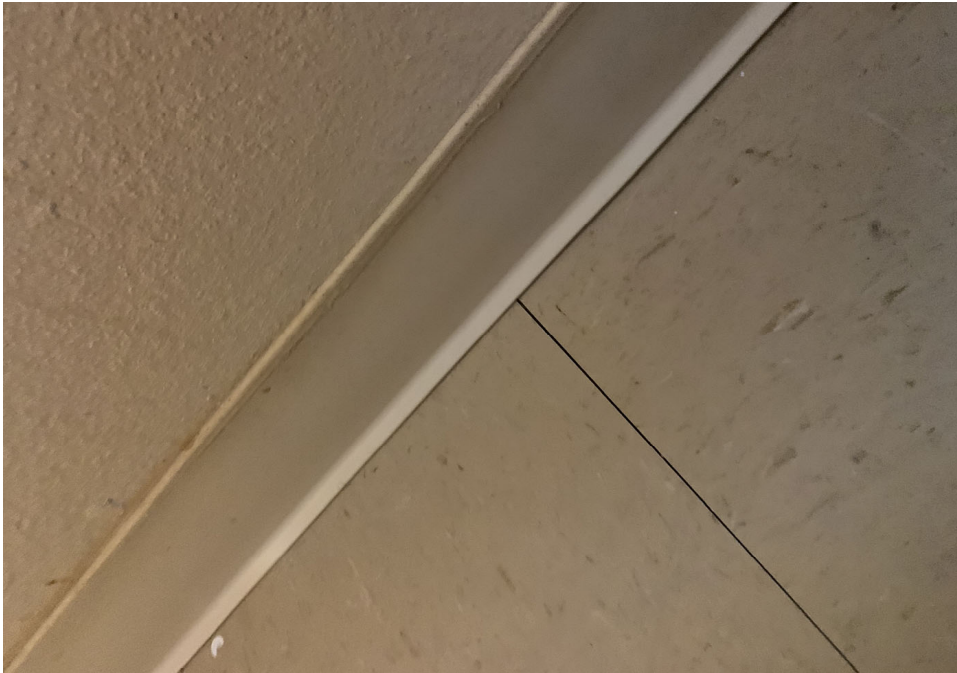
SM7 - 12x12 VCT

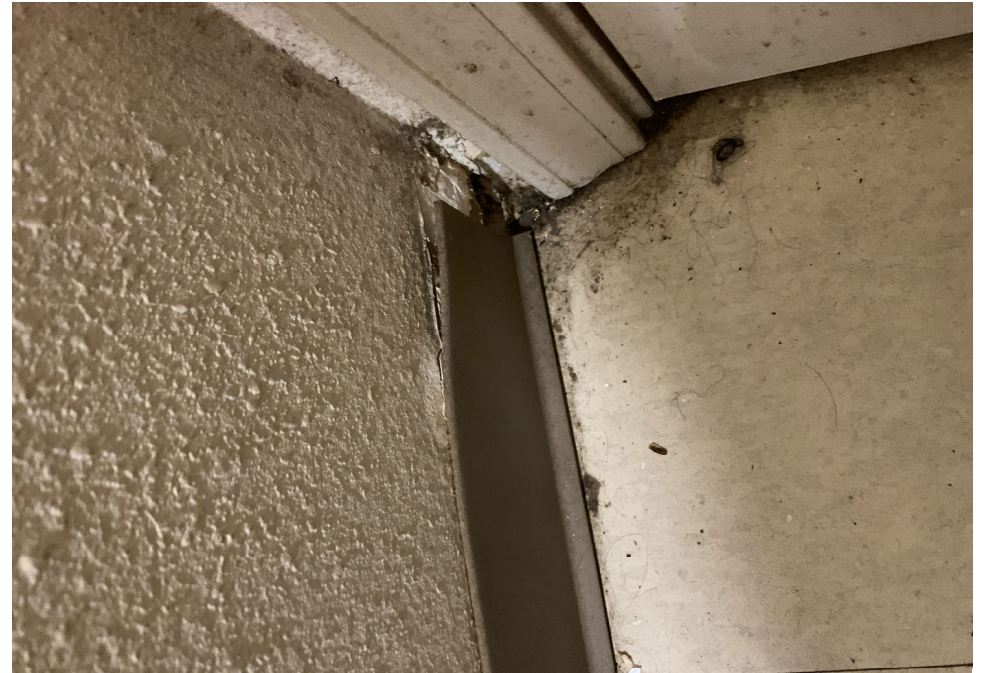
Sheetrock wall (SM2) and brown covebase (SM3)

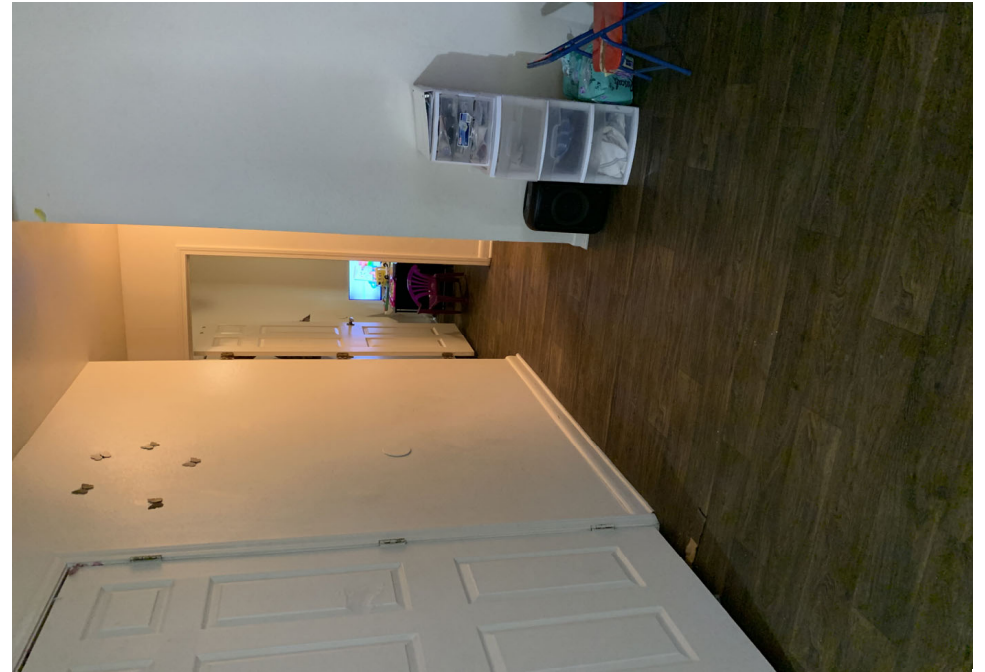
Grey LVP (SM5)

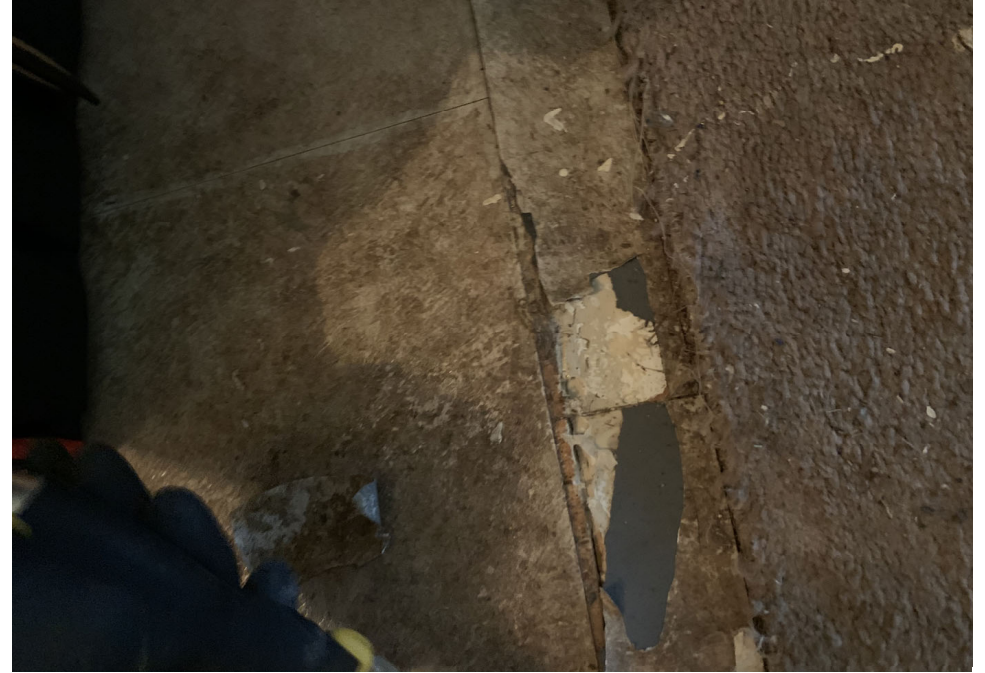
Bottom layer VCT (SM19)

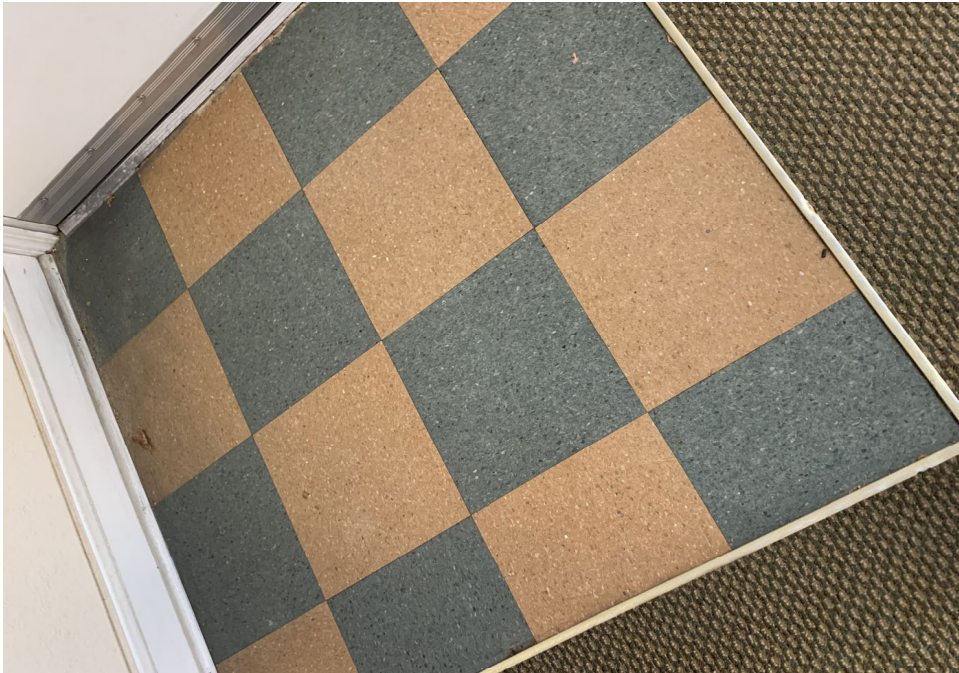
Blue VCT (SM11) and orange VCT (SM12)

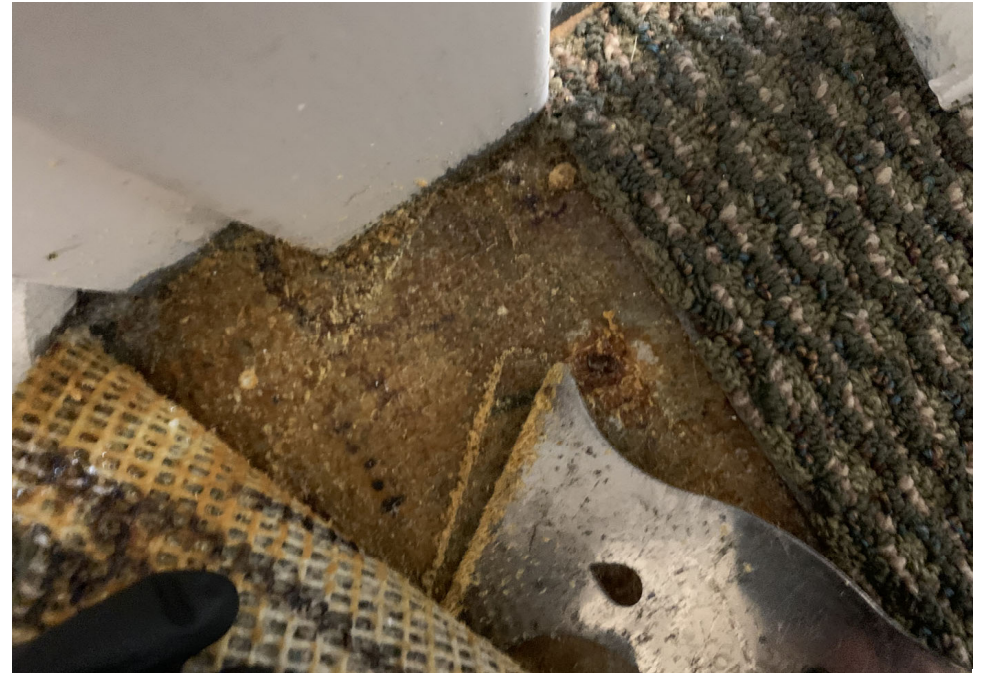
Carpet glue (SM13)

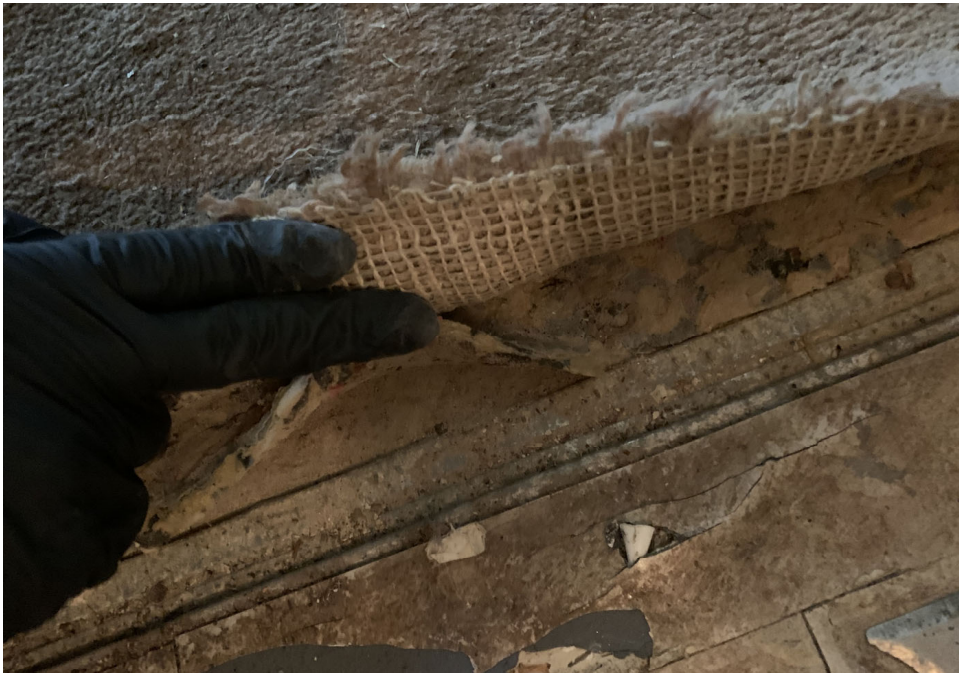
Carpet and pad (no glue)

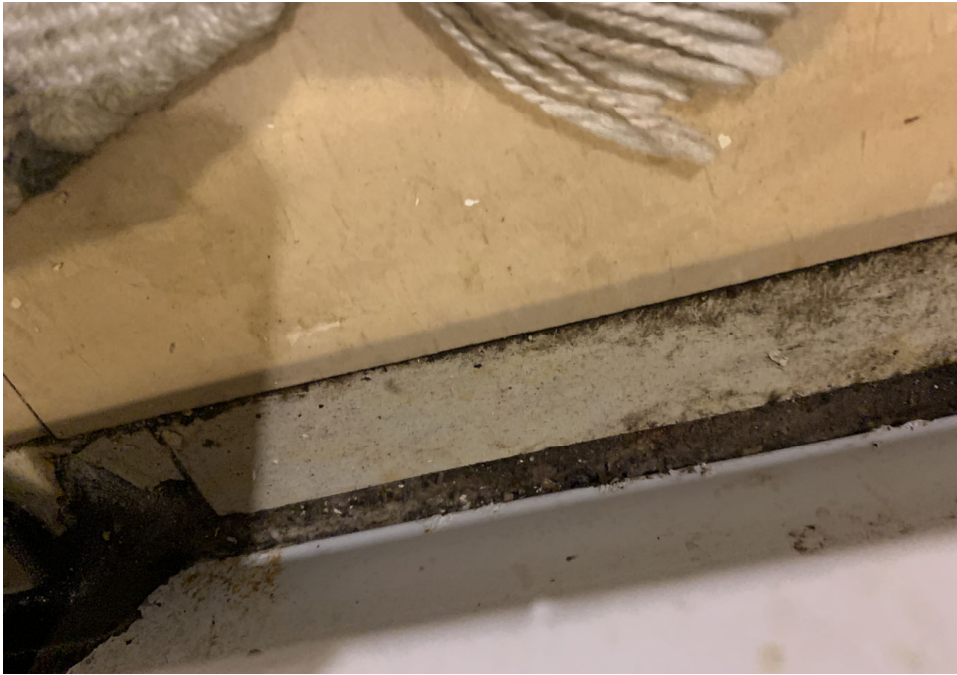
Bottom layer tile (3A, 3C, 3D)

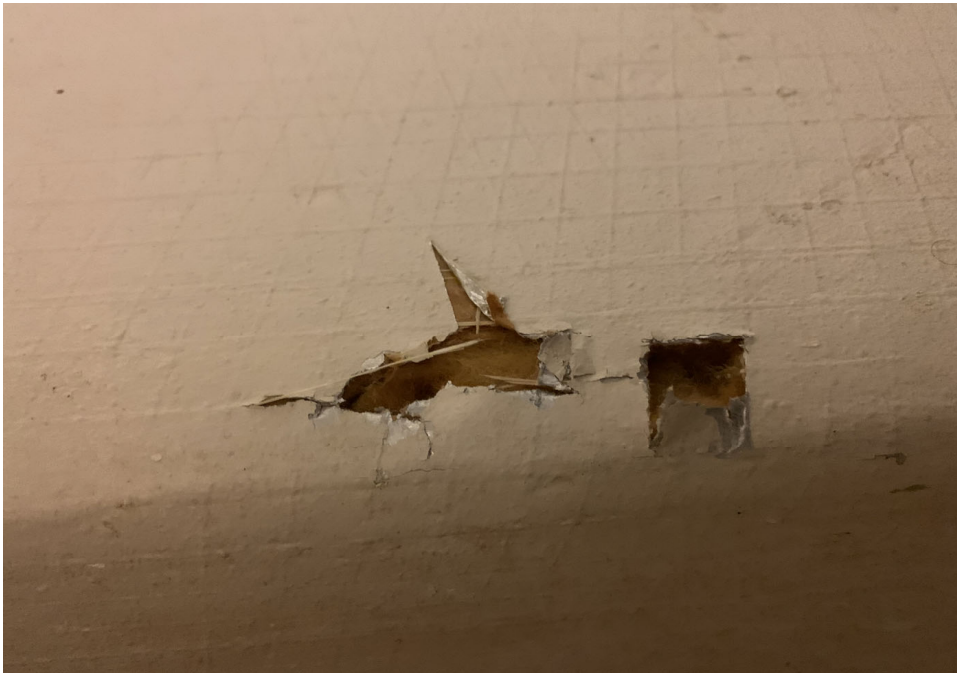
SM18 - HVAC duct wrap in unit 20F

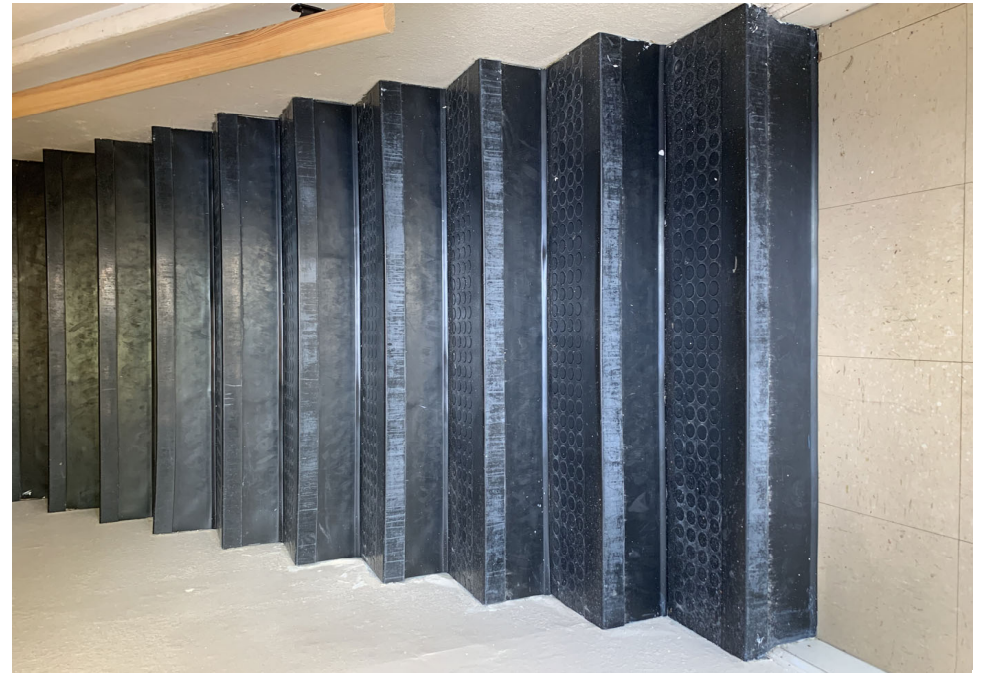
Rubberized flooring in stairwell (non suspect)

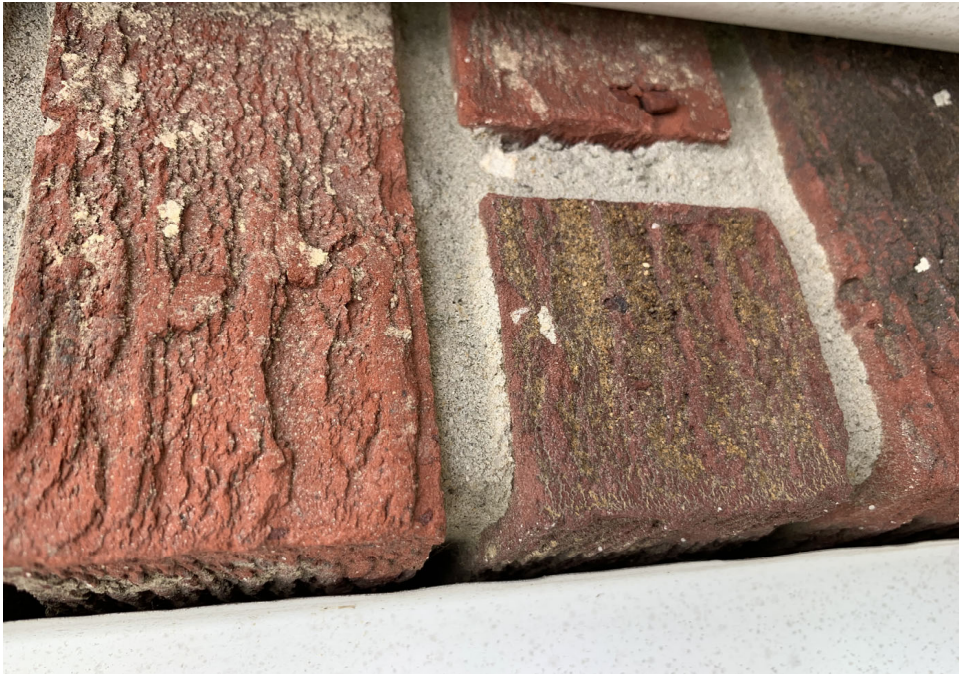
Brick mortar (SM22)

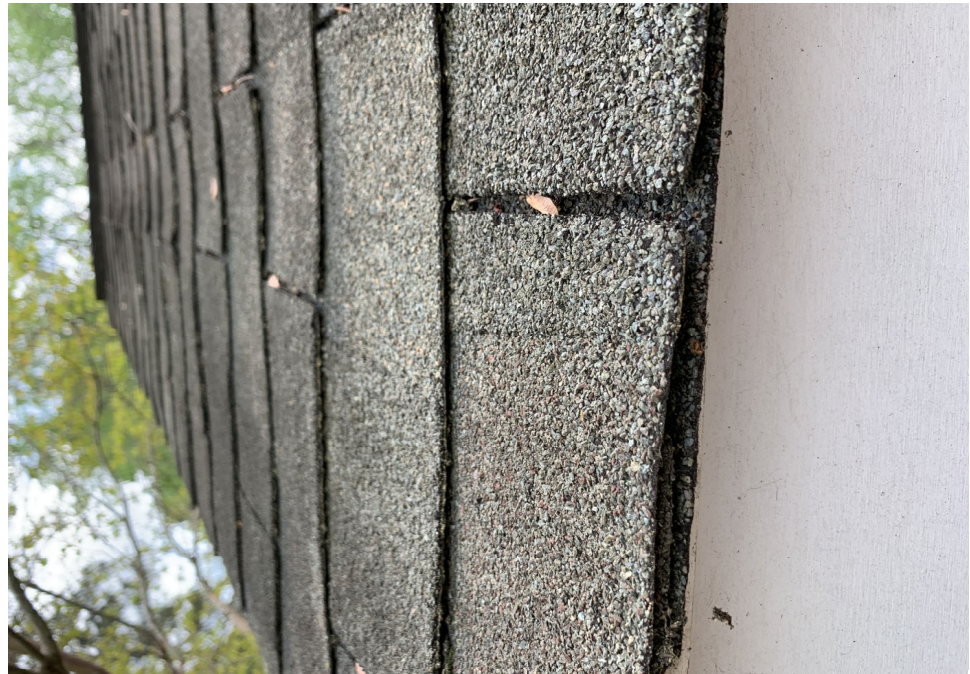
Shingles (SM23)
