## Property Needs Assessment Project Summary

Project: Timberlake Apartments

Date: 5/7/2026

### Inspection Report

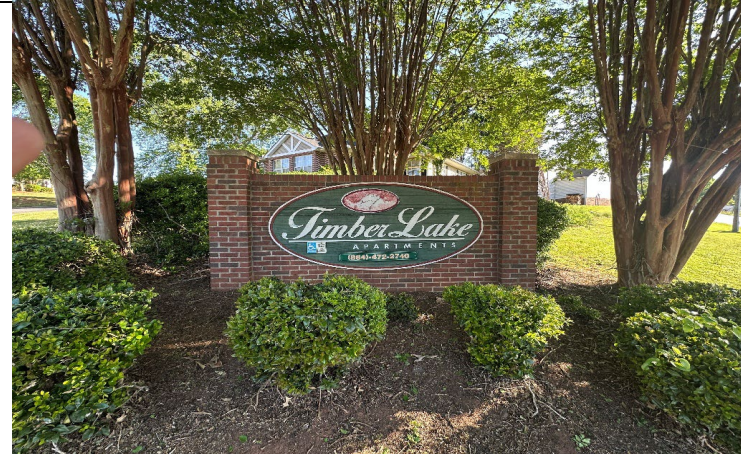
The playground on site is in good condition and should be replaced as needed or at the end of its RUL and the same standards go with the ground cover surrounding the playground. The entrance sign to the property is a brick monument and is in fair condition and should be replaced as needed.

Entrance sign.

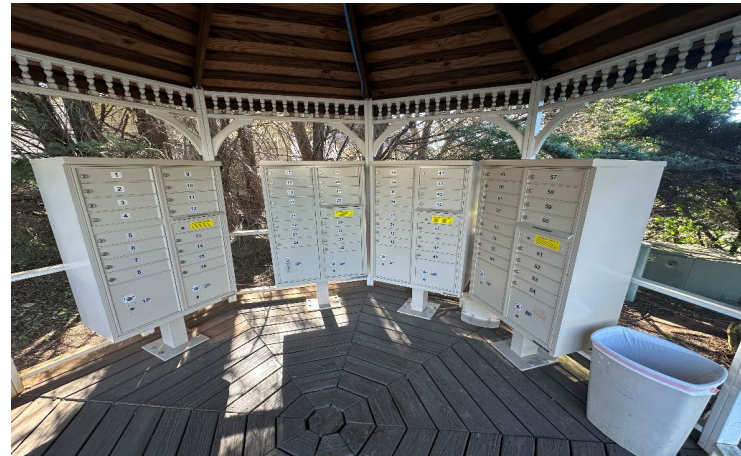
| Project: Timberlake Apartments | | | | | | | | | | Date: 5/7/2026 | | Project: Timberlake Apartments | | | | | | | | | | Date: 5/7/2026 | | | | | | | | | | | | | | | | | | | |
|---|---|---|---|---|---|---|---|---|---|---|---|---|---|---|---|---|---|---|---|---|---|---|---|---|---|---|---|---|---|---|---|---|---|---|---|--|--|--|--|--|--|
| Mail Kiosk | 15 | 3 | 12 | Good | Replace | 1 | 76 | ea | 78.99 | 6003.24 | The mail kiosks are in good condition and should be replaced as needed. | Mail Kiosk | 0 | 0 | 0 | 0 | 0 | 0 | 0 | 0 | 0 | 0 | 0 | 0 | 6003 | 0 | 0 | 0 | 0 | 0 | 0 | 0 | 0 | 6003 | | | | | | | |

Mail Kiosk.

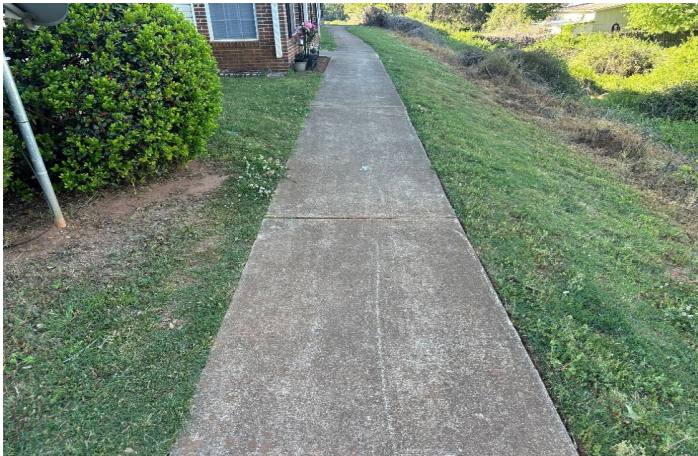
The concrete curbing and concrete pavement are in fair condition and will outlast the term of this report though some spots repairs could have to be to both. The asphalt parking lot on site is in fair condition with some signs of age and should be replaced as needed

Concrete pavement.

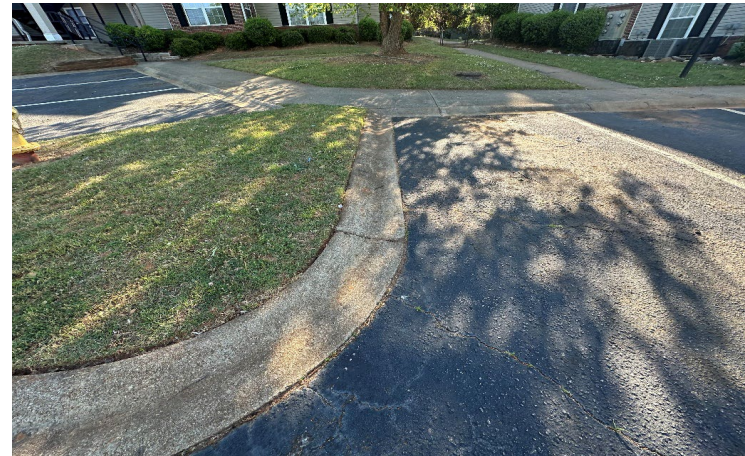
Concrete curbing.

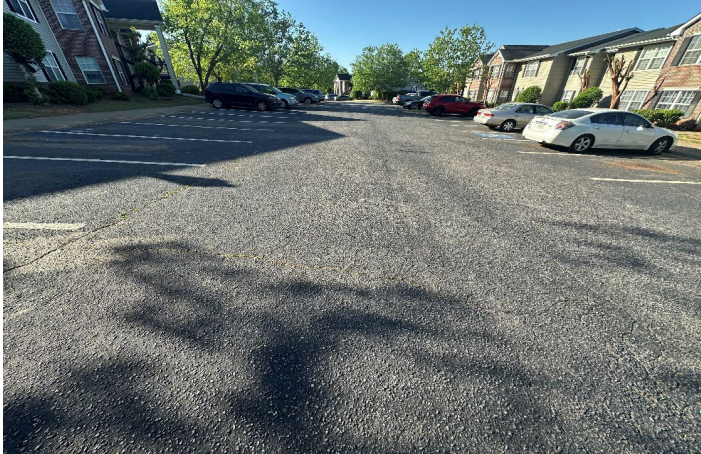
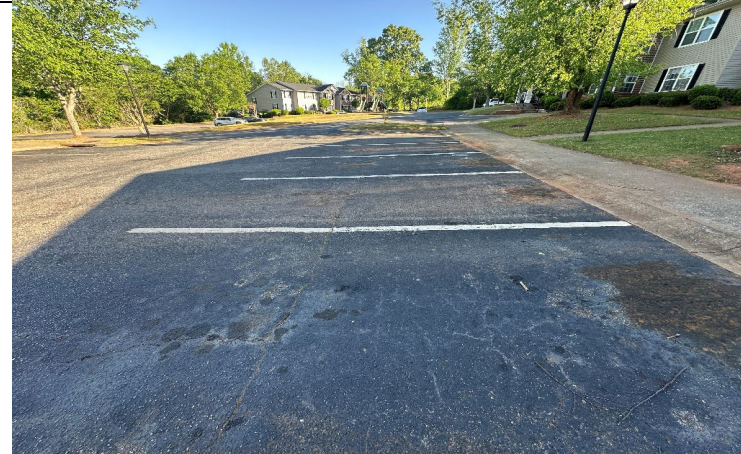
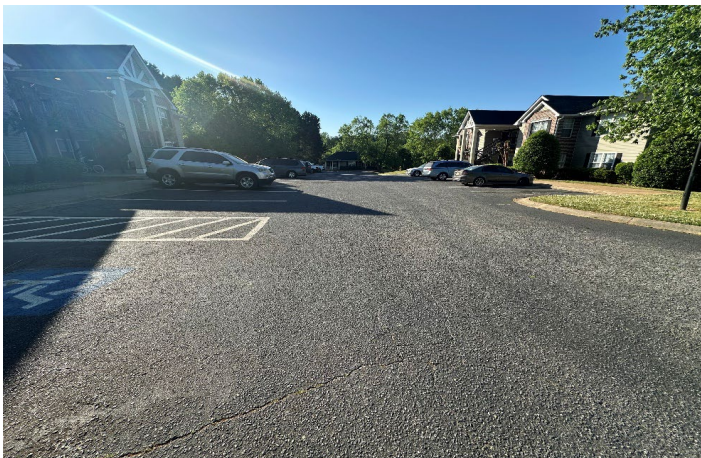
| Project: Timberlake Apartments | | | | | | | | | | Date: 5/7/2026 | | Project: Timberlake Apartments | | | | | | | | | | Date: 5/7/2026 | | | | | | | | | | | | | | | | | | | |
|---|---|---|---|---|---|---|---|---|---|---|---|---|---|---|---|---|---|---|---|---|---|---|---|---|---|---|---|---|---|---|---|---|---|---|---|--|--|--|--|--|--|
| Paving vehicular: asphalt pavement | 25 | 20 | 5 | Fair | Replace | 2 | 6667 | SQ YD | 23.63 | 157541 | The paving vehicular asphalt pavement is in fair condition and should be replaced as needed or at the end of its RUL. | Paving vehicular: asphalt pavement | 0 | 0 | 0 | 0 | 0 | 78771 | 78771 | 0 | 0 | 0 | 0 | 0 | 0 | 0 | 0 | 0 | 0 | 0 | 0 | 0 | 0 | 157541 | | | | | | | |

Asphalt pavement.

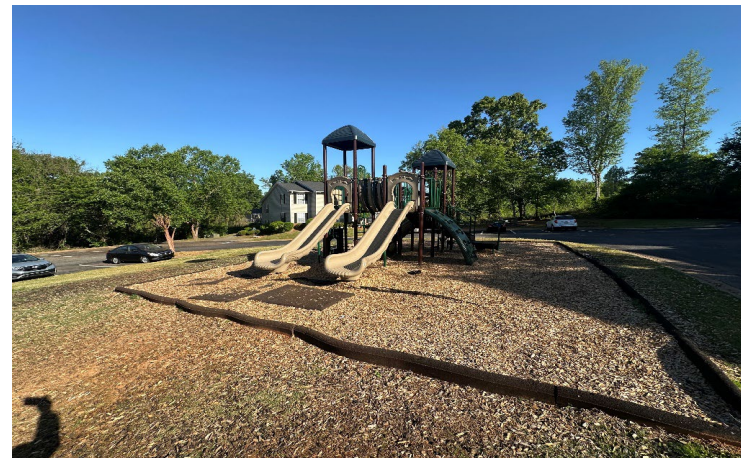
| Project: Timberlake Apartments | | | | | | | | | | Date: 5/7/2026 | | Project: Timberlake Apartments | | | | | | | | | | Date: 5/7/2026 | | | | | | | | | | | | | | | | | | | |
|---|---|---|---|---|---|---|---|---|---|---|---|---|---|---|---|---|---|---|---|---|---|---|---|---|---|---|---|---|---|---|---|---|---|---|---|--|--|--|--|--|--|
| Tot Lot: ground cover loose bark | 3 | 3 | 0 | Poor | Replace | 1 | 1500 | SQ FT | 1 | 1500 | The cover / loose bark for the playground is in poor condition and should be replaced in year 1. | Tot Lot: ground cover loose bark | 1500 | 0 | 0 | 1500 | 0 | 0 | 1500 | 0 | 0 | 1500 | 0 | 0 | 1500 | 0 | 1500 | 0 | 1500 | 0 | 1500 | 0 | 0 | 10500 | | | | | | | |

Playground and loose bark.

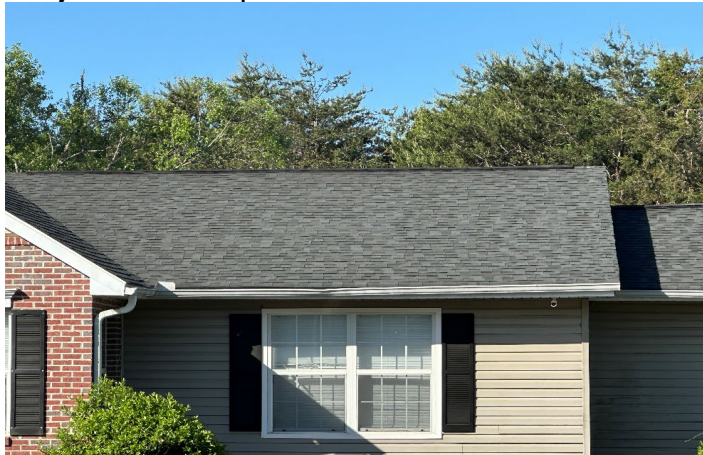
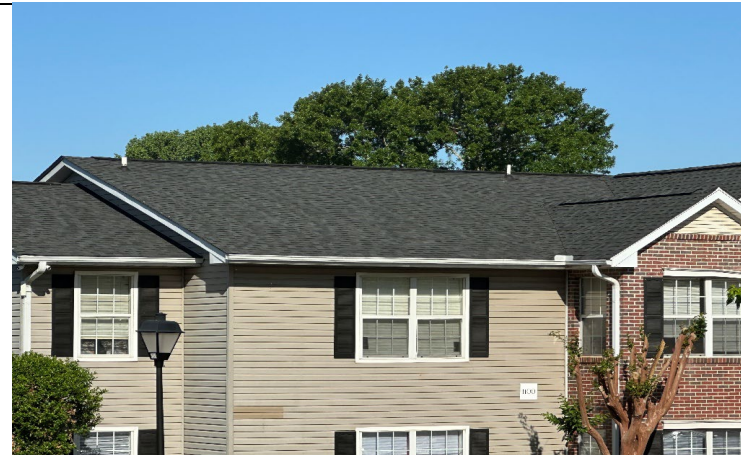
The roofing is original asphalt shingle from 2000; the roofing is in fair condition due to age but seems to be in good condition from appearance. The roofing should be replaced as needed or at the end of its RUL. The fascia and soffits on site are in fair condition and should be replaced as needed or at the of their RUL as well they should be replaced at the same time to avoid unneeded labor costs. The gutters and downspouts on site are also in fair condition and should be replaced as needed or at the of their RUL.

Roofing.

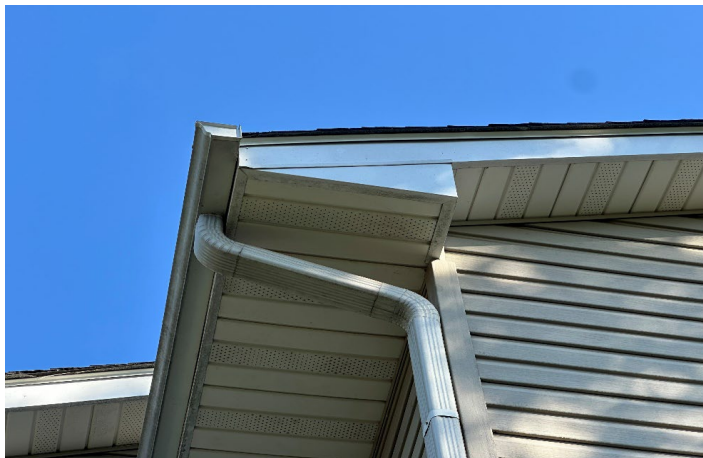
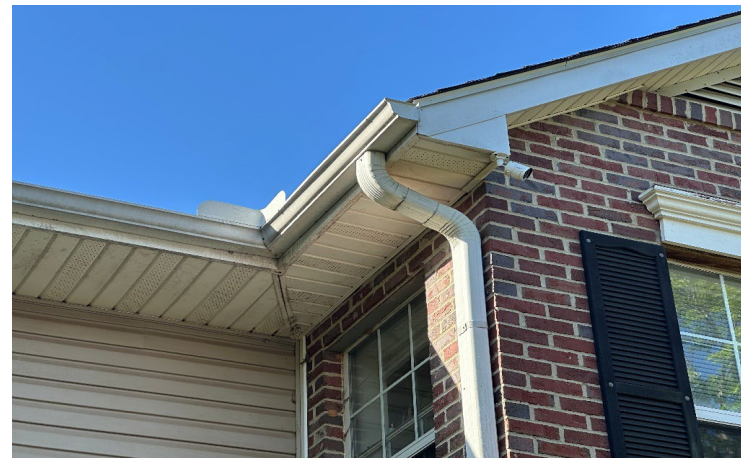
Fascia, soffits and gutters.

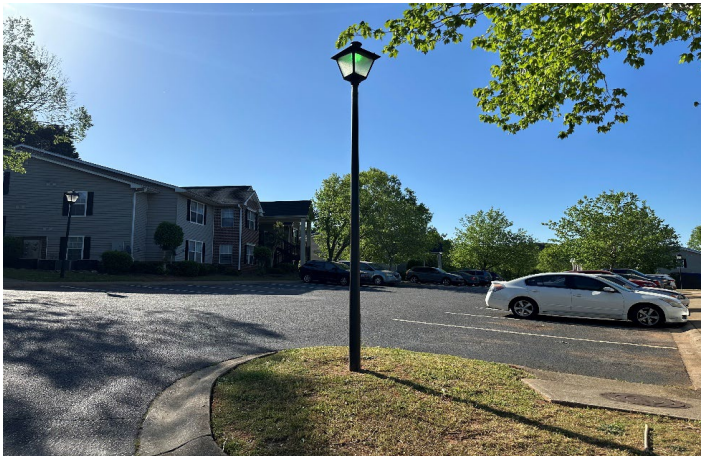
| Project: Timberlake Apartments | | | | | | | | | | Date: 5/7/2026 | | Project: Timberlake Apartments | | | | | | | | | | Date: 5/7/2026 | | | | | | | | | | | | | | | | | | | |
|---|---|---|---|---|---|---|---|---|---|---|---|---|---|---|---|---|---|---|---|---|---|---|---|---|---|---|---|---|---|---|---|---|---|---|---|--|--|--|--|--|--|
| Lighting: pole mounted lights | 25 | 15 | 10 | Fair | Replace | 3 | 15 | ea | 1368 | 20520 | The pole mounted lighting around the property are in fair condition and should be replaced as needed or at the end of their RUL. | Lighting: pole mounted lights | 0 | 0 | 0 | 0 | 0 | 0 | 0 | 0 | 0 | 0 | 6840 | 6840 | 6840 | 0 | 0 | 0 | 0 | 0 | 0 | 0 | 0 | 20520 | | | | | | | |

Pole mounted lighting.

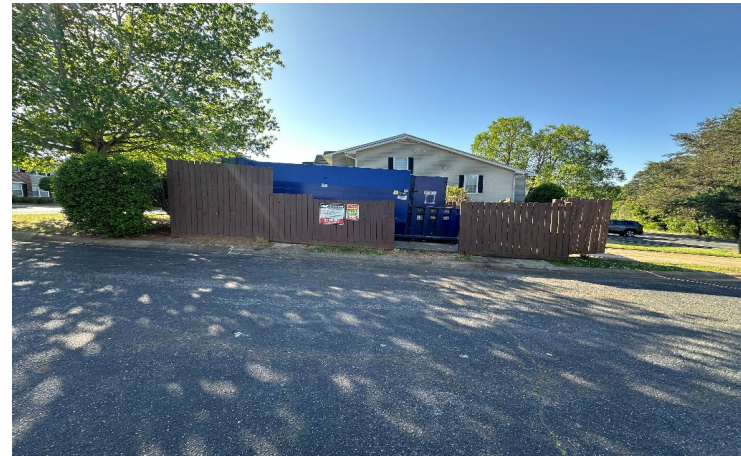
| Project: Timberlake Apartments | | | | | | | | | | Date: 5/7/2026 | | Project: Timberlake Apartments | | | | | | | | | | Date: 5/7/2026 | | | | | | | | | | | | | | | | | | | |
|---|---|---|---|---|---|---|---|---|---|---|---|---|---|---|---|---|---|---|---|---|---|---|---|---|---|---|---|---|---|---|---|---|---|---|---|--|--|--|--|--|--|
| Trash: compactor | 20 | 10 | 10 | Fair | No Action | 0 | 0 | 0 | 0 | 0 | The trash compactor on site will not be replaced. | Trash: compactor | 0 | 0 | 0 | 0 | 0 | 0 | 0 | 0 | 0 | 0 | 0 | 0 | 0 | 0 | 0 | 0 | 0 | 0 | 0 | 0 | 0 | 0 | 0 | | | | | | |

Trash compactor (will not be replaced.)

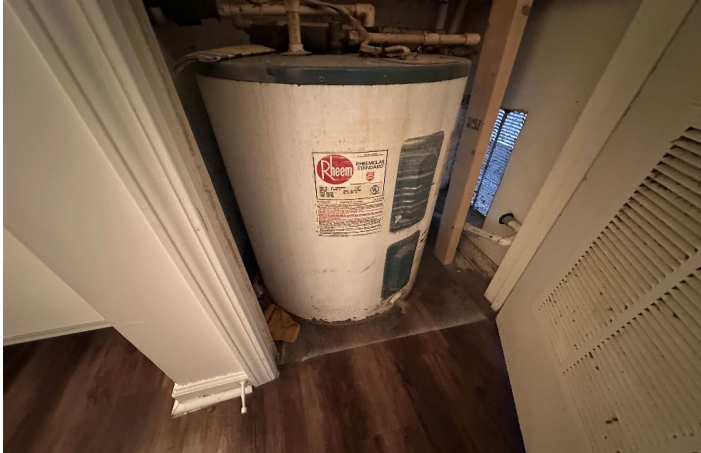
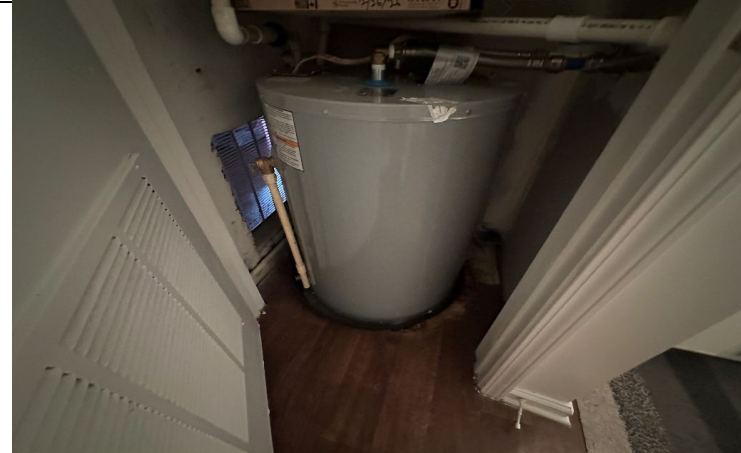
The hot water heaters on the property are in good to poor condition (due to age not function) ranging on a unit per unit basis, most units have models from either Rheem or AO Smith and are 40-gallon electric units. The HVAC systems on site like hot water heaters range in age and condition as seen in photos. Some units have brands whose logos have worn off while some units have Goodman and Interec systems. These HVAC systems should be replaced as needed depending on age or in year one if past their RUL. The smoke and CO detectors on site are in fair condition and should be inspected bi-annually and replaced or maintained as needed or at the end of their RUL. The tenant lighting is in fair condition with the units being well lit. There are also a vast number of security cameras on site that are in fair condition and should be replaced as needed.

Hot water heater

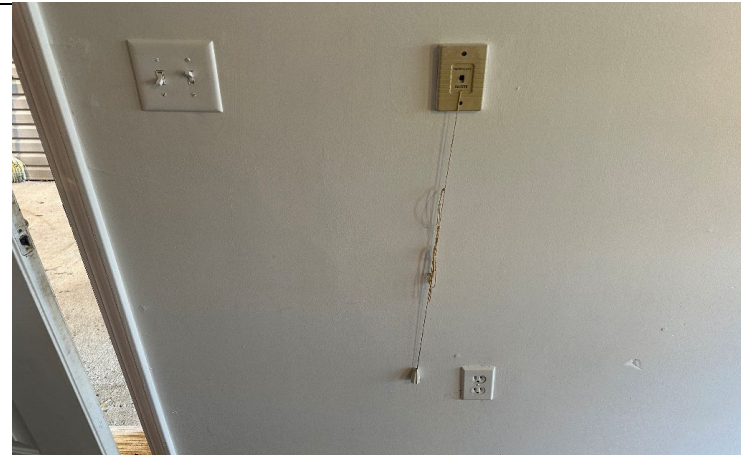
the property to add a level of security. Pullcords are installed in the units to signal flashing lights if a tenant is in need of help, these pullcords should be regularly tested and replaced or repaired as needed.

Pullcord.

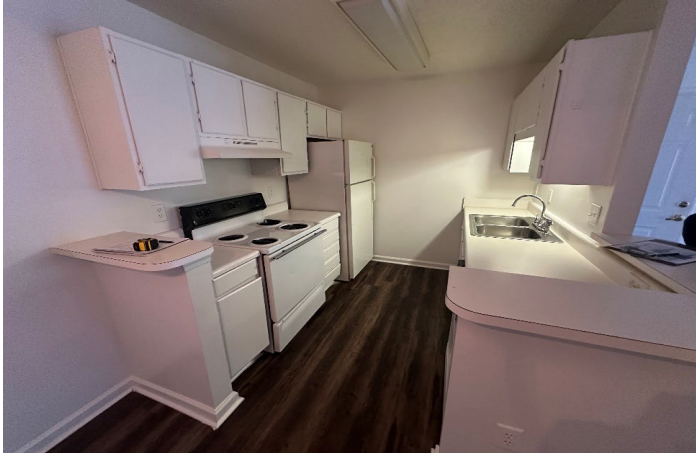
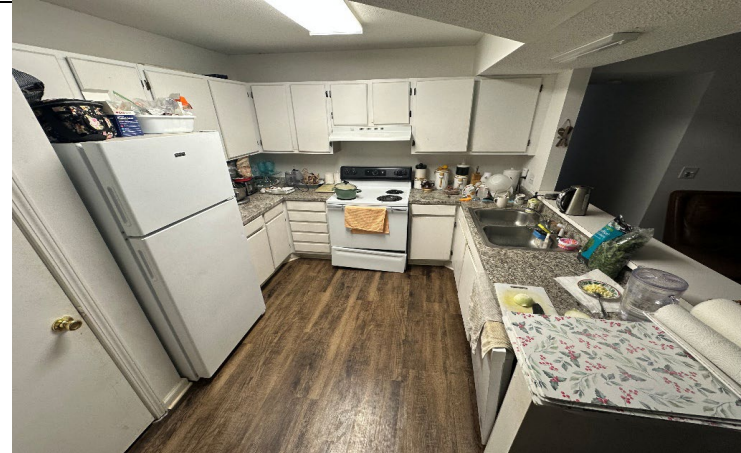
The kitchens are equipped with wooded cabinets that are in poor condition due to age and should be replaced when possible.

Laminate wood countertops are installed in the units and are in poor condition due to age and should be replaced when possible.

Kitchen (2br)

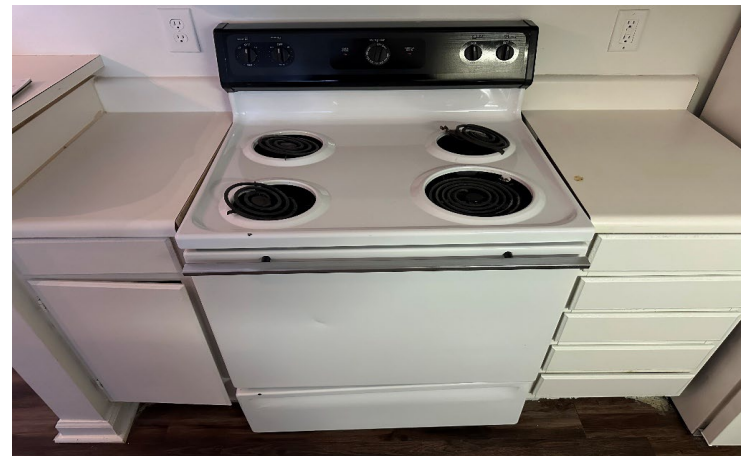
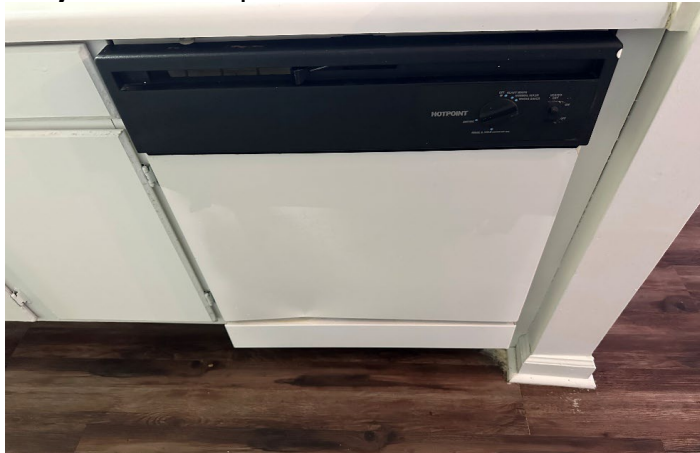
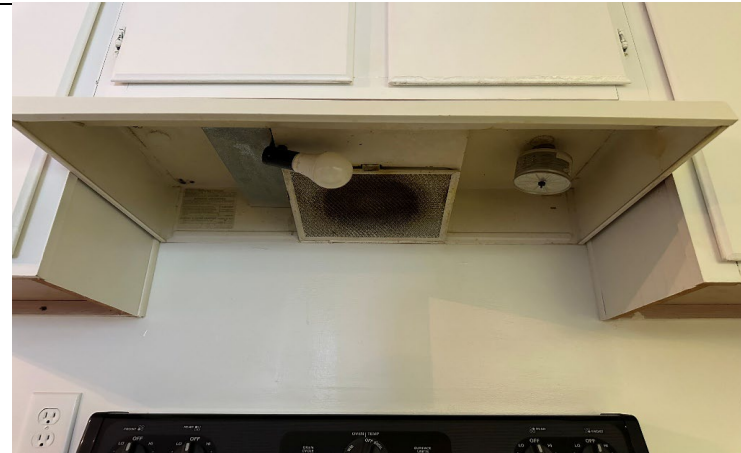
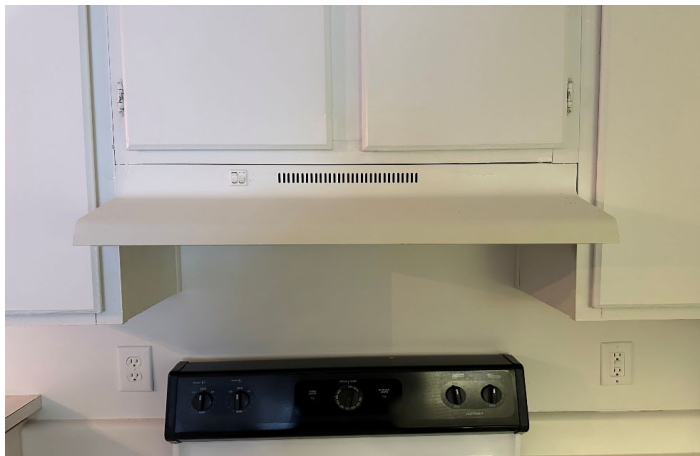
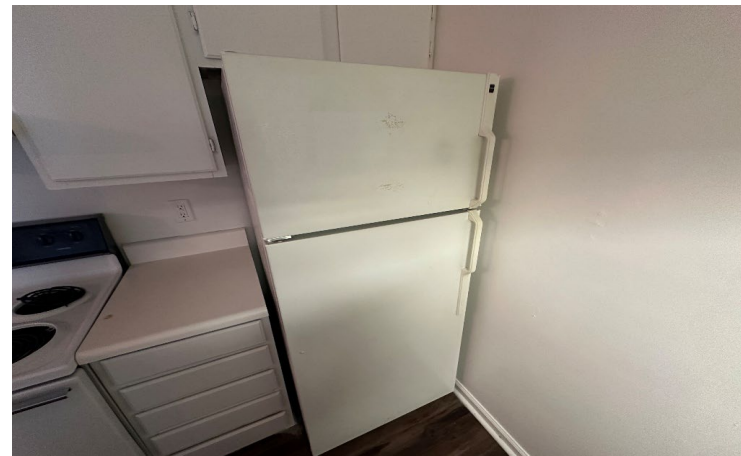
The appliances in the dwelling units are dish washers, electric range, refrigerator, range hood with light, and stainless-steel sink. The appliances are varying ages, makes and models while the vast majority of these appliances are in poor condition due to age and should be replaced when possible.

Range.
