Limited Lead-Based Paint Survey  
Peaks of Manning II  
Kennedy Lane  
Manning, Clarendon County, South  
Carolina

RE: Report of Limited Lead-Based Paint Survey  
**Peaks of Manning II**  
Kennedy Lane  
Manning, Clarendon County, South Carolina  
Project No. RESHG-26-SC-10302-01

Vacant Residential House  
Kennedy Lane, Manning, South Carolina (Behind CVS)  
Limited Lead-Based Paint Survey Report  
ARM Project Number 09-7030-26

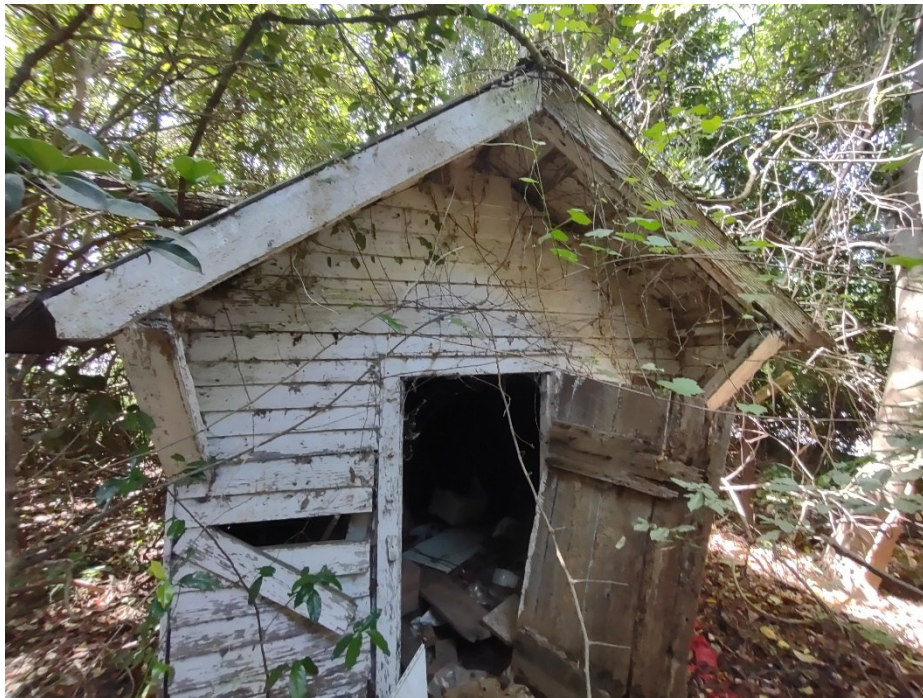
**Photo 2:** This photo shows an out-building at the rear of the subject building.

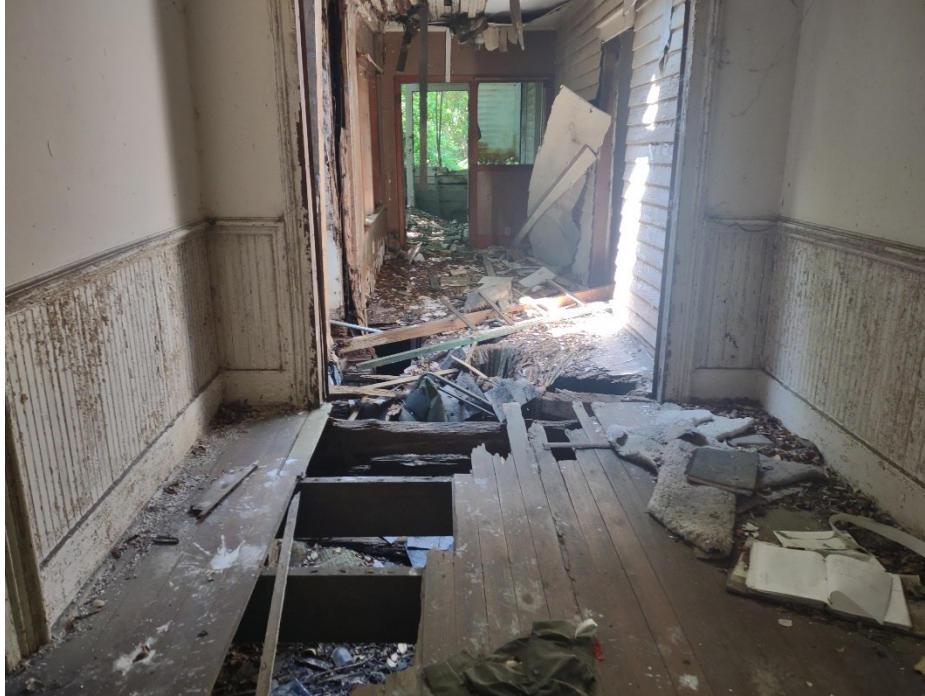
**Photo 3:** The rear portion of the hallway and several rooms were inaccessible due to structural damage.

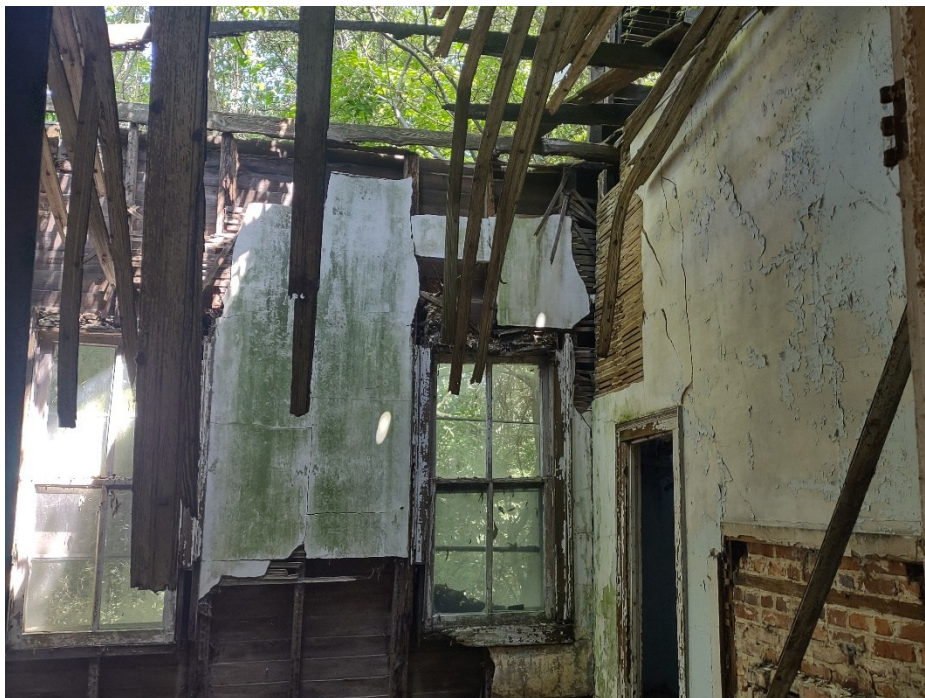
**Photo 4:** Portions of the roof at the rear of the building had significant structural damage.

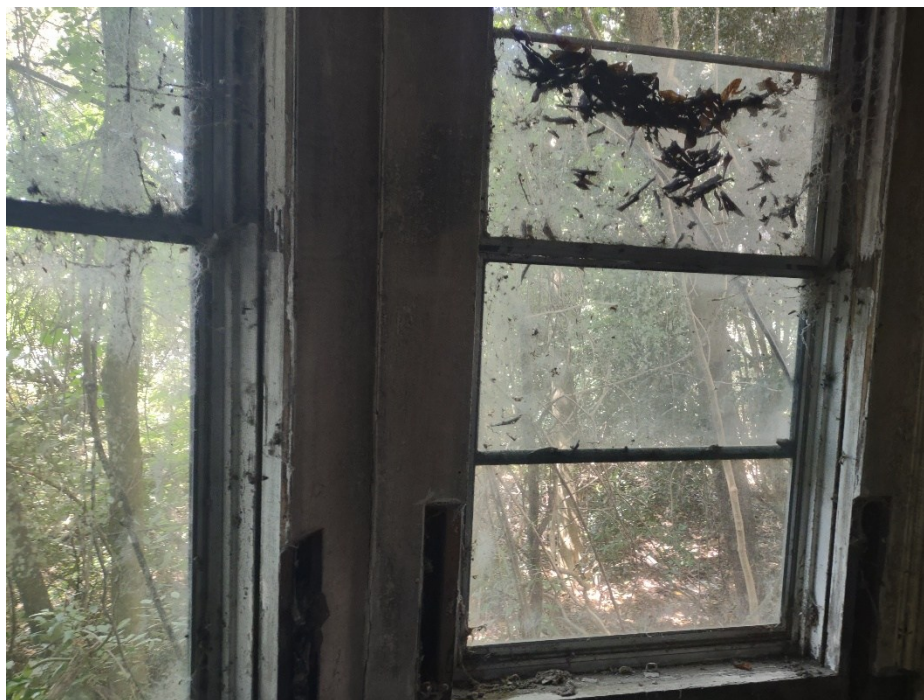
| Material Description | Material Location | Color | Material Condition | XRF Results<br>mg/cm <sup>2</sup> |
|---|---|---|---|---|
| Wood Window-Interior | Room 1, Side B | White | Intact | 4.9 |
| Wood Window-Interior | Room 1, Side B | White | Intact | 3.9 |
| Wood Window-Interior | Room 5, Side B | White | Deteriorated | 2.6 |
| Wood Window-Interior | Room 5, Side B | White | Deteriorated | 2.4 |

**Photo 5:** The wood white windows shown here are located throughout the building and contain lead-based paint.

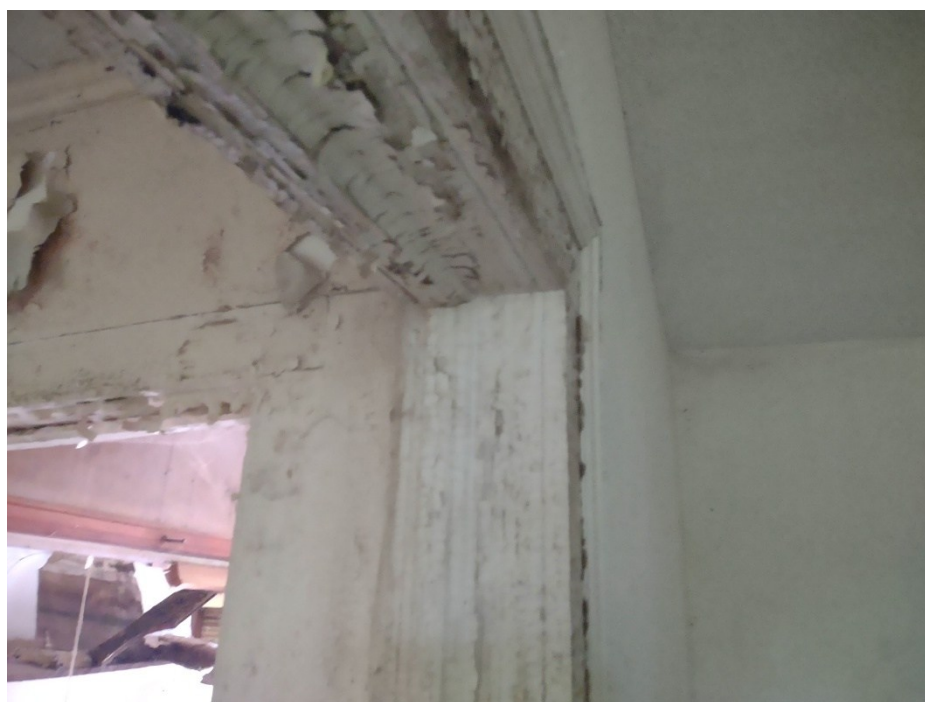
| Material Description | Material Location | Color | Material Condition | XRF Results<br>mg/cm <sup>2</sup> |
|---|---|---|---|---|
| Wood Door Jamb- Interior | Room 2, Side C | White | Deteriorated | 1.4 |
| Wood Door Jamb- Interior | Room 2, Side C | White | Deteriorated | 1.1 |

**Photo 6:** The wood white door jambs inside the subject building contain lead-based paint.

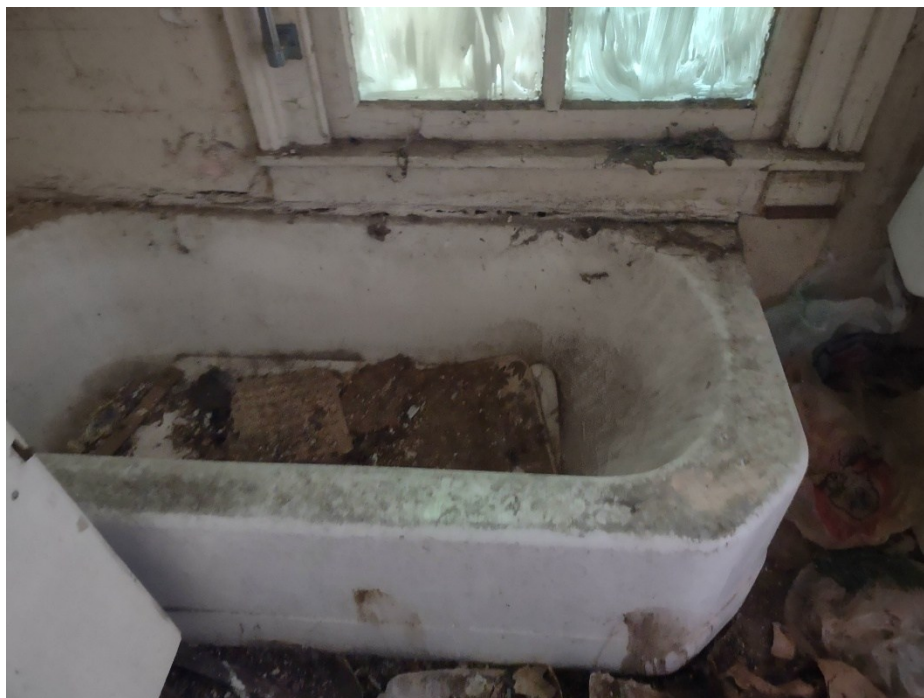
| Material Description | Material Location | Color | Material Condition | XRF Results<br>mg/cm <sup>2</sup> |
|---|---|---|---|---|
| Porcelain Bath Tub- Interior | Room 3, Side B | White | Intact | 0.80 |

**Photo 7:** The white porcelain tub shown here contains lead-based paint.

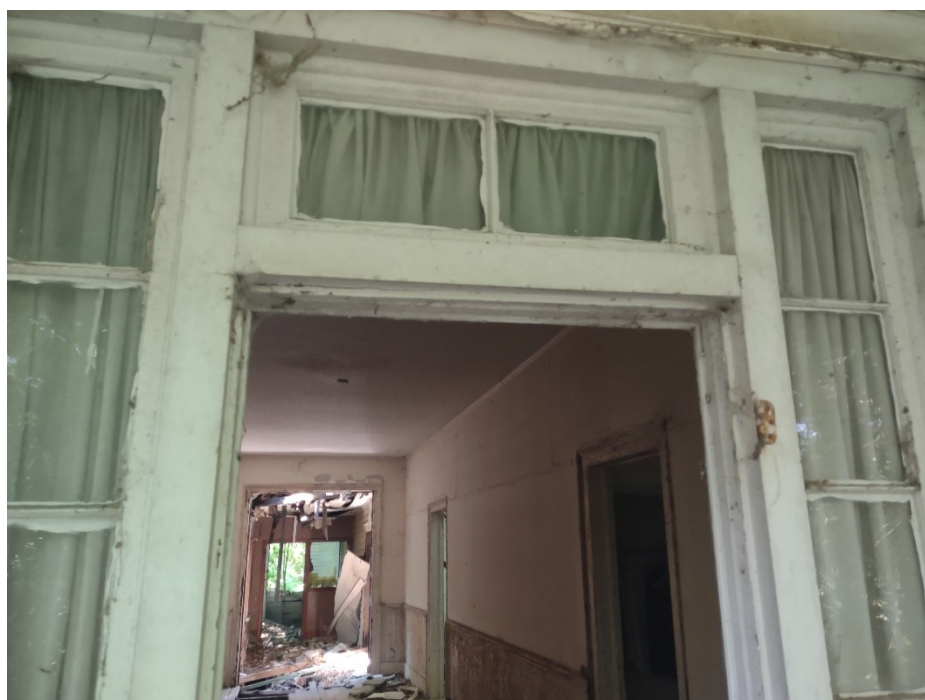
| Material Description | Material Location | Color | Material Condition | XRF Results<br>mg/cm <sup>2</sup> |
|---|---|---|---|---|
| Wood Door- Exterior | Front Entry, Side A | White | Deteriorated | 1.4 |
| Wood Door- Exterior | Front Entry, Side A | White | Deteriorated | 2.4 |

**Photo 8:** The white wood entry door along with the sidelights and transom contain lead-based paint.

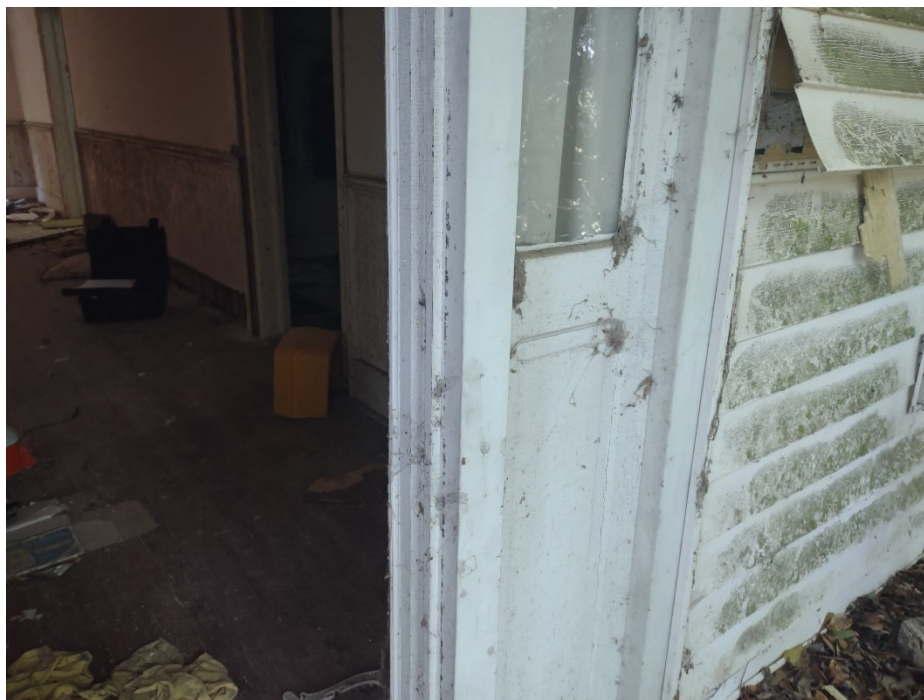
**Photo 9:** The wood siding beneath the vinyl siding on the exterior of the house contains lead-based paint.

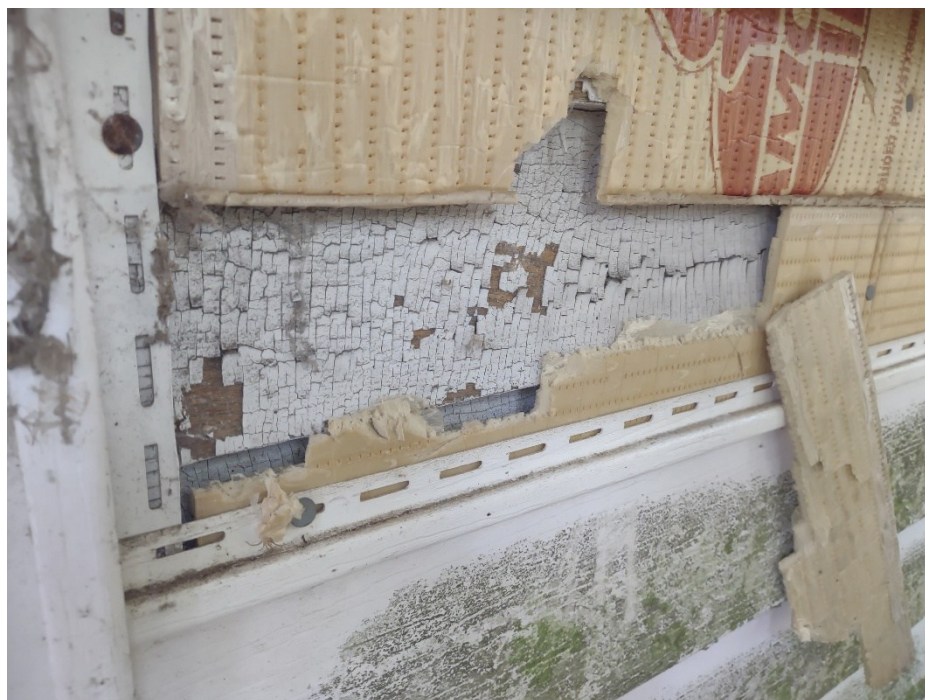
**Photo 10:** A closer view of the wood siding that contains lead-based paint.
