Asbestos and Lead-Based Paint Assessment  
Proposed Parkside Commons  
901 South 9<sup>th</sup> Avenue  
Dillon, Dillon County, South Carolina  
S&ME Project No. 26630033

Reference: **Asbestos and Lead-Based Paint Assessment  
Proposed Parkside Commons**  
901 S. 9<sup>th</sup> Avenue  
Dillon, Dillon County, South Carolina  
S&ME Project No. 26630033

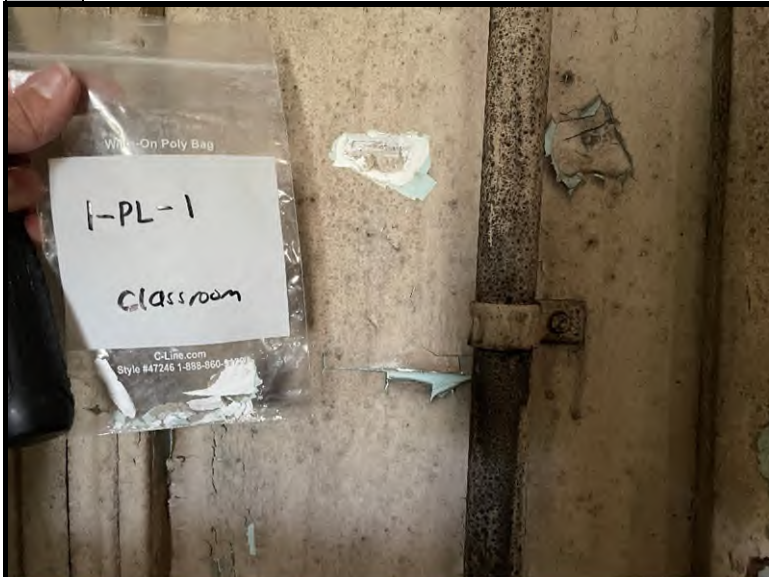
3 View of plaster (interior walls). No asbestos detected.

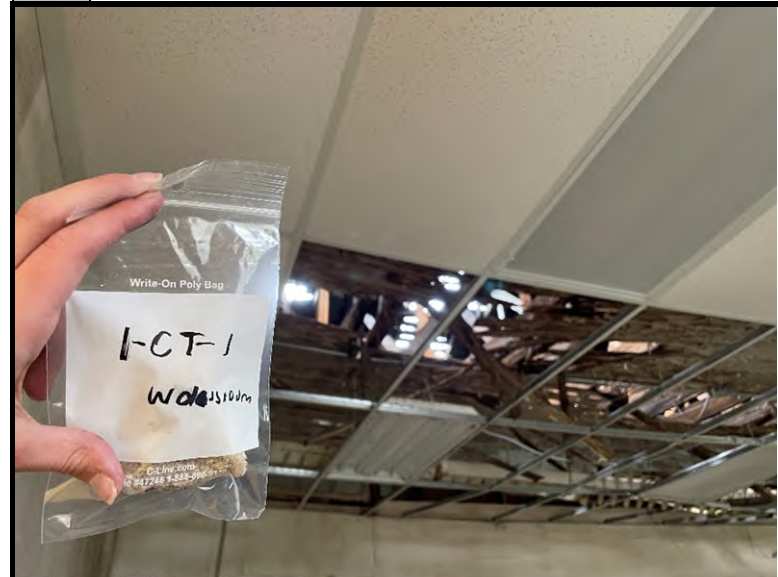
4 View of ceiling tile (throughout interior). No asbestos detected.

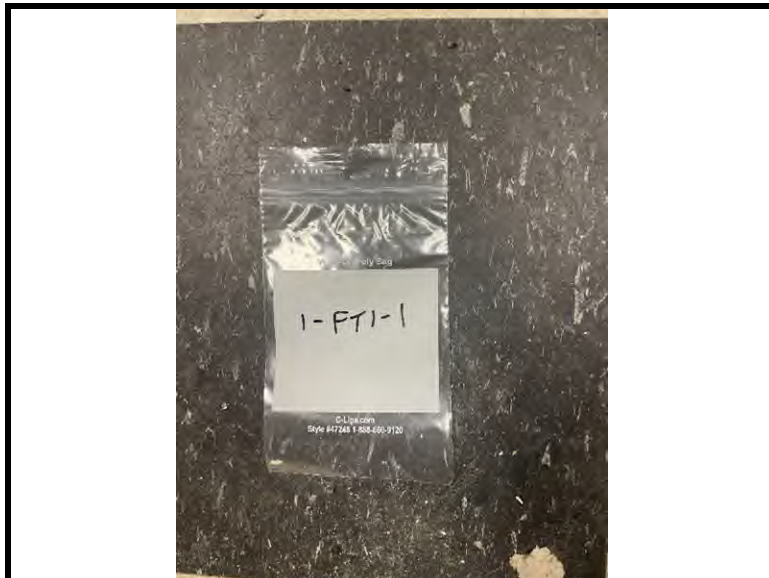
**5** View of floor tile (Main Entrance Office). No asbestos detected.

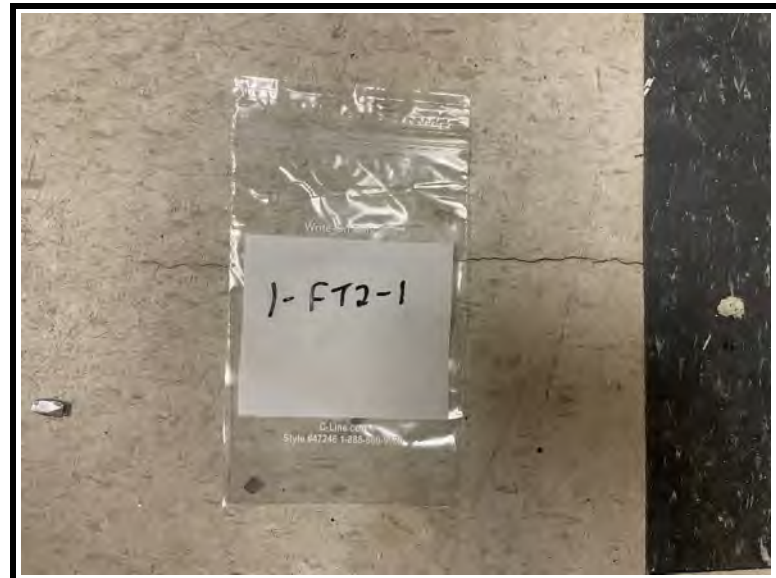
**6** View of floor tile (Main Entrance Office). No asbestos detected.

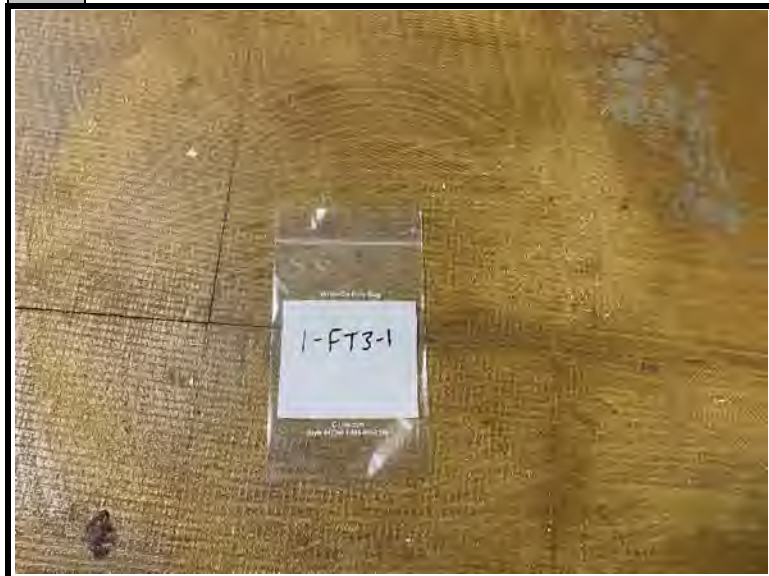
**7** View of floor tile, 9"x9" (Attendance Office) with **3% Chrysotile asbestos floor tile.**

SCDES requires proper removal and disposal of ACMs which will be disturbed by demolition or renovation activities. We recommend proper removal and disposal of the identified ACMs by a contractor licensed by SCDES, Asbestos Section, prior to the planned demolition activities. A copy of this assessment report must be submitted to SCDES, along with an application for asbestos removal and building demolition or renovation at least 10 working days prior to asbestos abatement activities. The required notification for asbestos removal may vary from four to 10 days depending on the quantity or type of ACM to be abated.

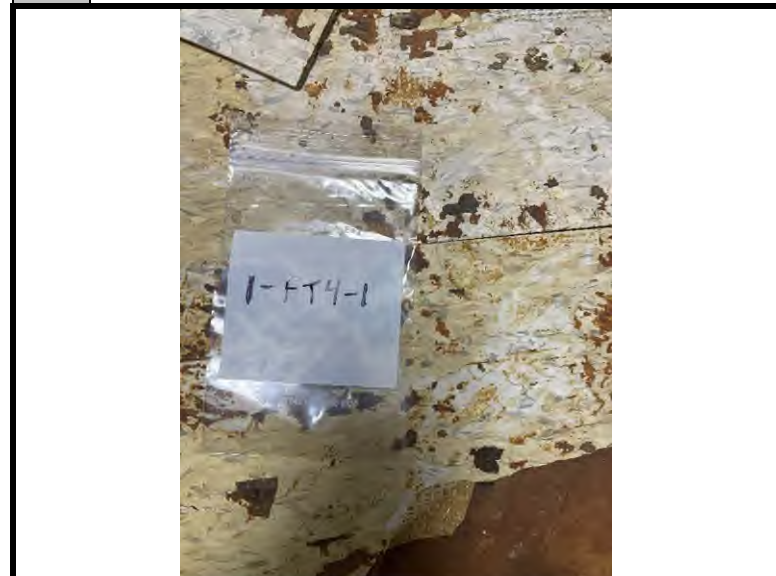
**8** View of floor tile (Attendance Office). No asbestos detected.

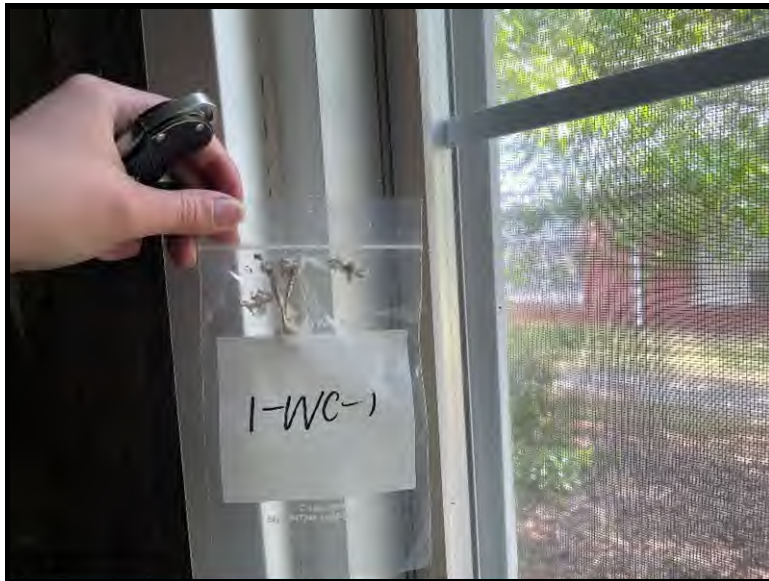
**9** View of caulk (interior windows). No asbestos detected.

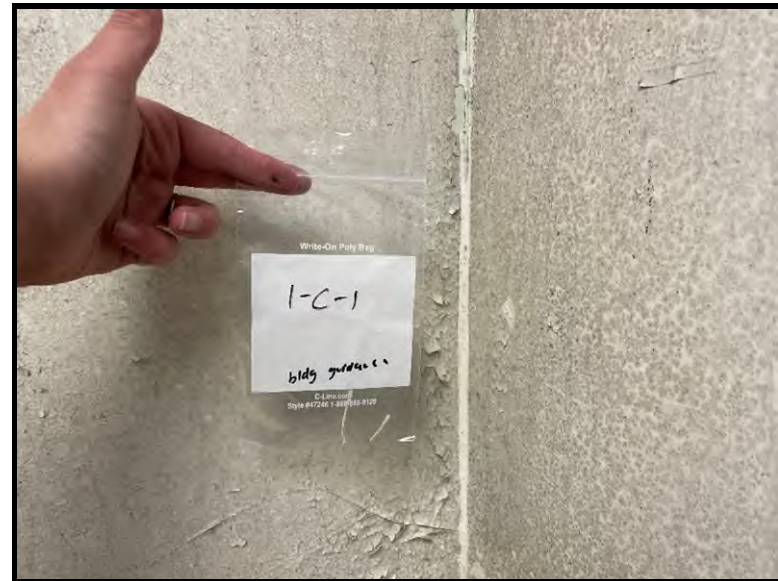
**10** View of caulk (interior wall corners). No asbestos detected.

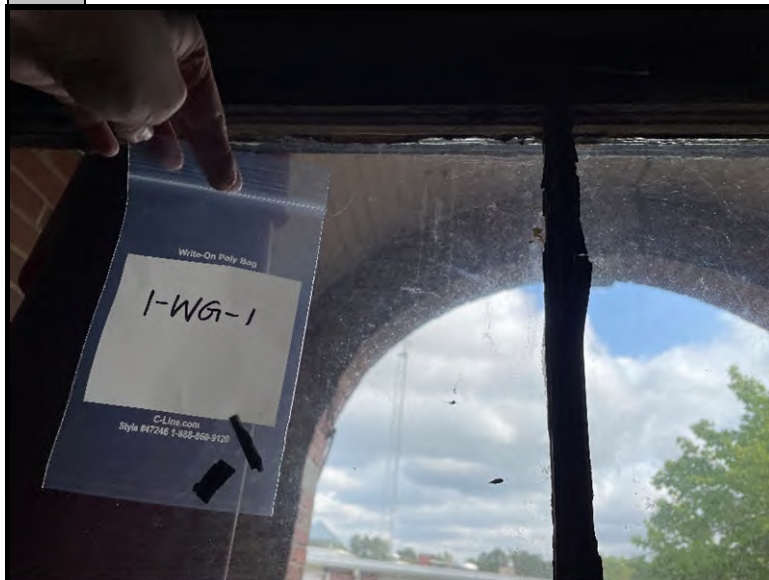
**11** View of window glazing (interior windows). No asbestos detected.

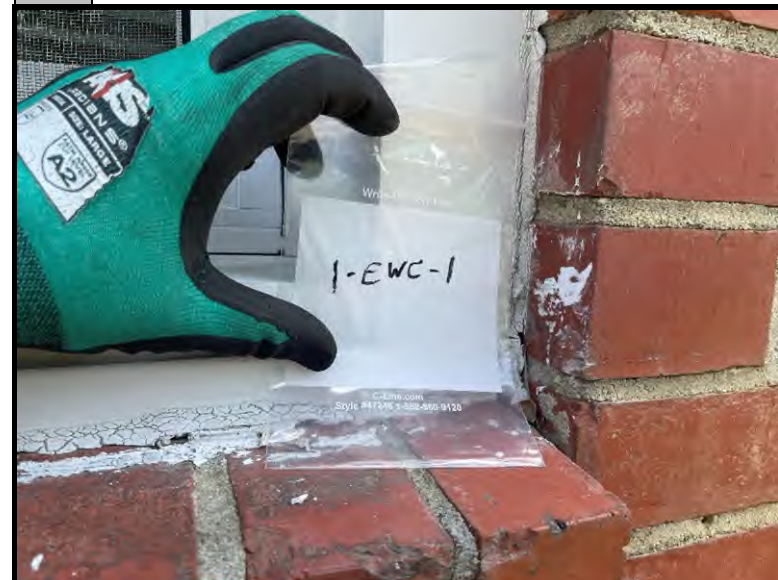
**12** View of caulk (exterior windows). No asbestos detected.

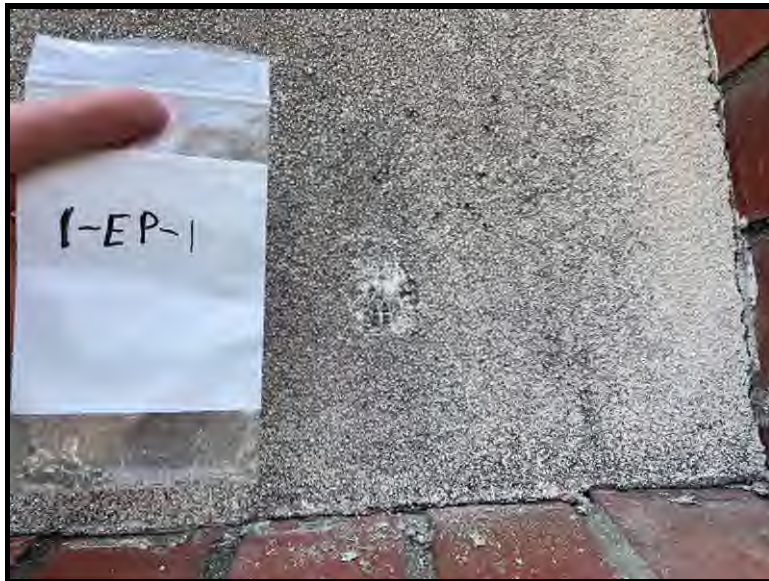
**13** View of plaster (exterior walls). No asbestos detected.

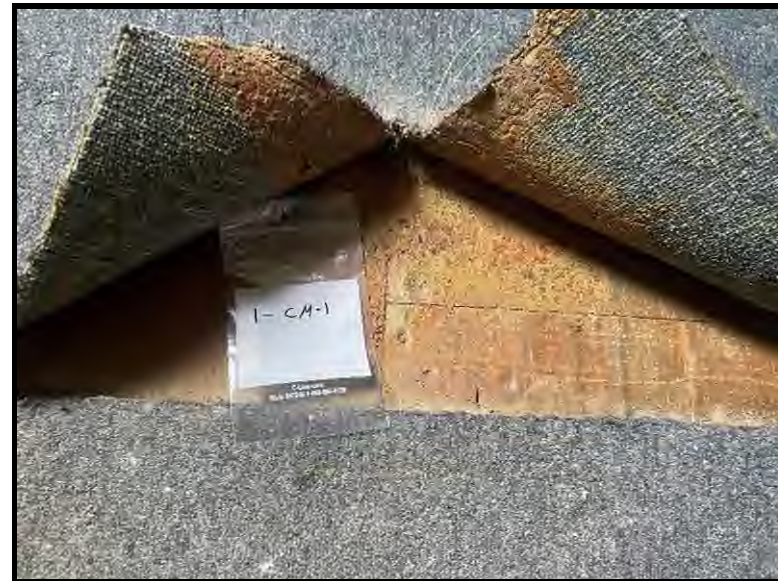
**14** View of carpet mastic (throughout interior). No asbestos detected.

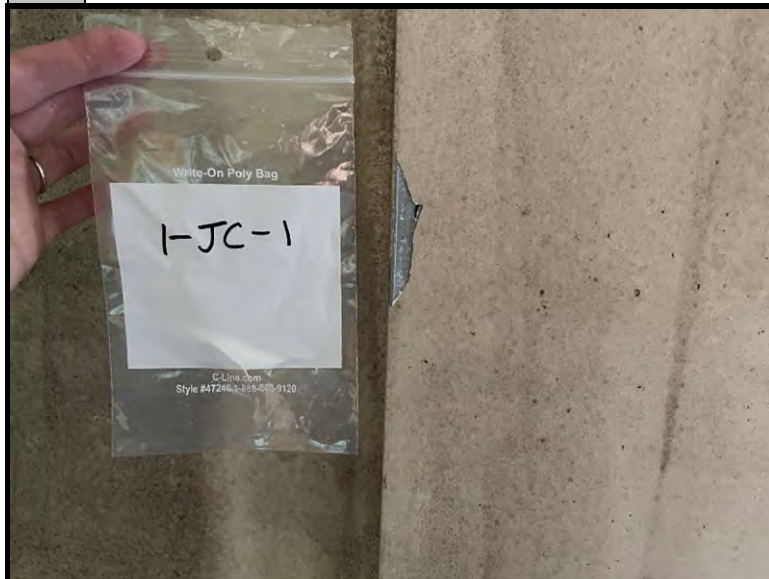
**15** View of joint compound (throughout interior). No asbestos detected.

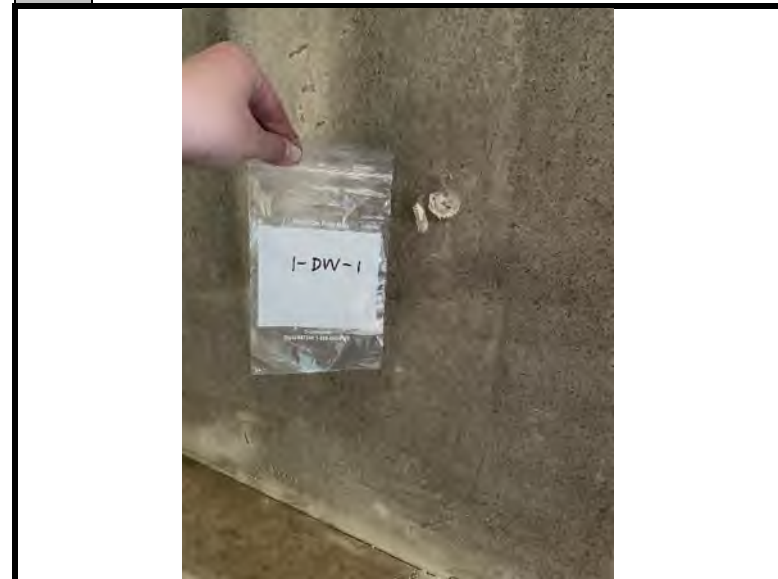
**16** View of drywall (throughout interior). No asbestos detected.

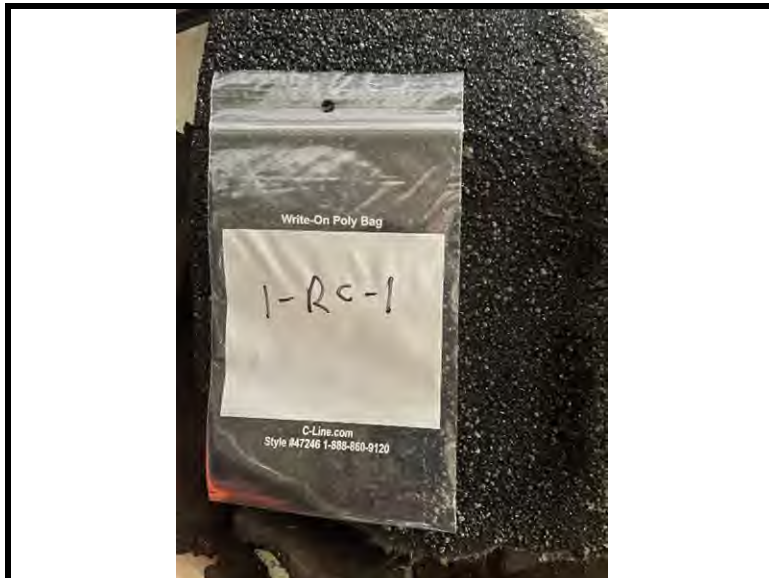
**17** View of roof core. No asbestos detected.

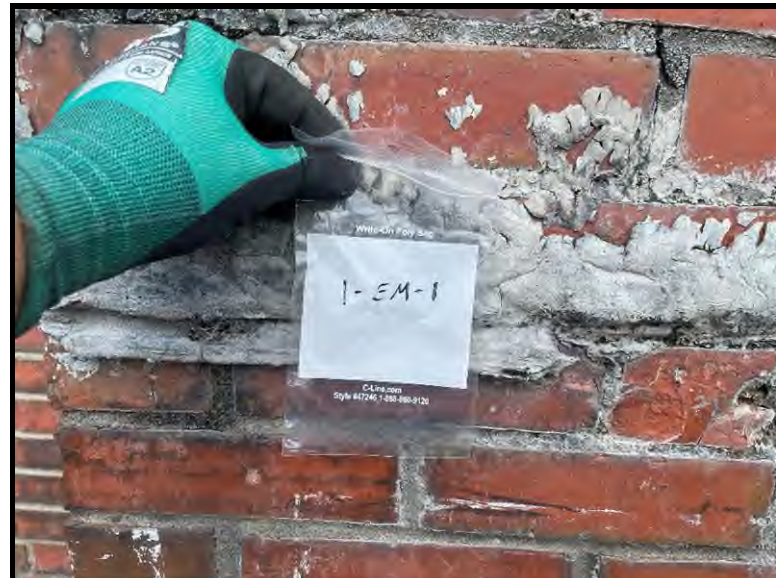
**18** View of mastic (south side of chimney) with **3% Chrysotile asbestos mastic.**

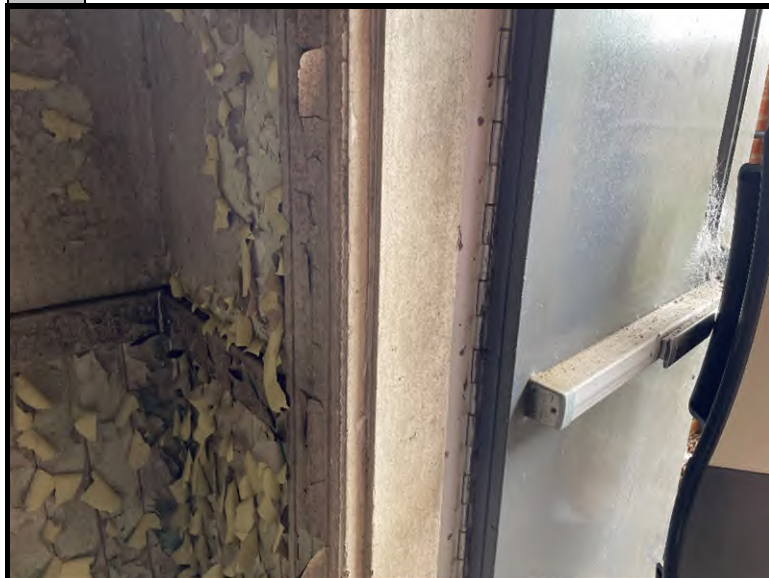
| Reading Number | Floor/Area | Room | Feature | Substrate | Condition | Color | Result | XRF Reading (mg/cm²) |
|---|---|---|---|---|---|---|---|---|
| 7 | Interior | Entry | Door Frame | Wood | Deteriorated | White | Positive | 0.90 |

**19** View of **lead positive interior entry wood door frame.**

Destructive actions (sanding, burning, demolition, component removal, paint preparation) to the painted surfaces will require the contractor to comply with the standards of OSHA, including but not limited to initial exposure monitoring, the use of personal protective equipment, and medical surveillance. Components painted with lead-based paint ( $> 0.7$  mg/cm<sup>2</sup>) must be disposed in a SCDES permitted Class II (C&D) or Class III (Subtitle D, Municipal Solid Waste) landfill.

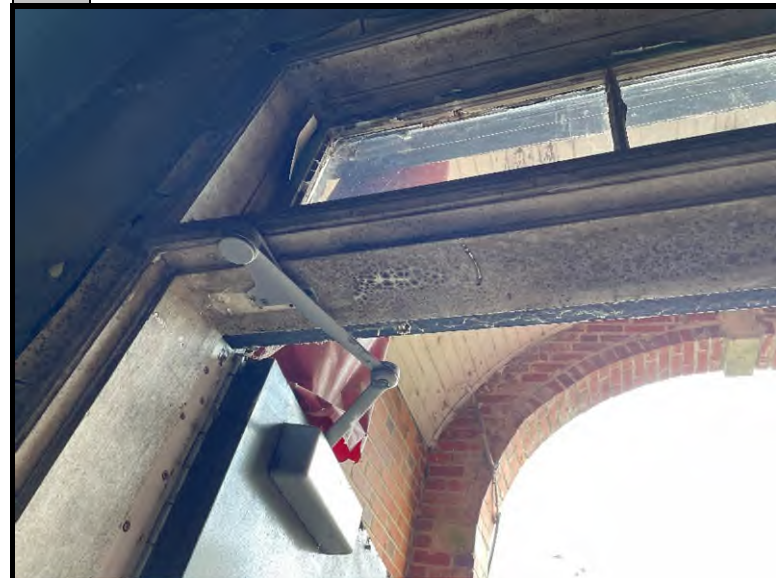
| Reading Number | Floor/Area | Room | Feature | Substrate | Condition | Color | Result | XRF Reading (mg/cm²) |
|---|---|---|---|---|---|---|---|---|
| 8 | Interior | Entry | Door Lintel | Wood | Deteriorated | White | Positive | 0.70 |

**20** View of **lead positive interior entry wood door beam.**

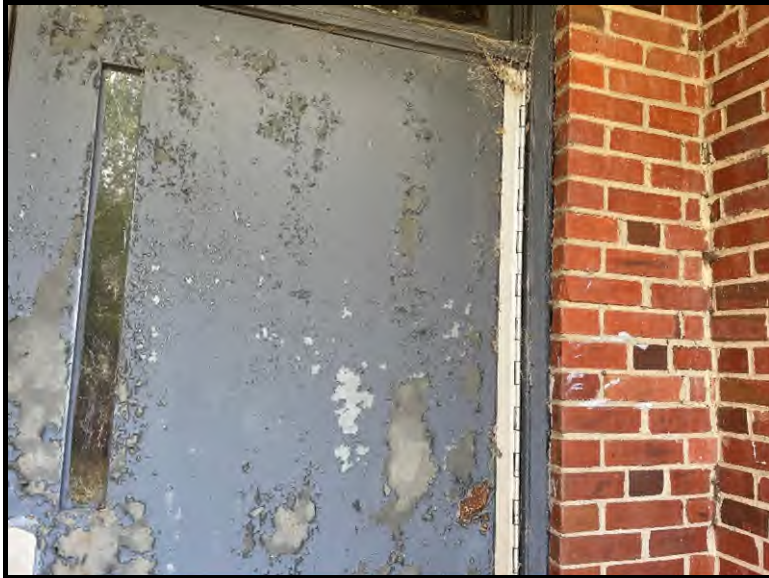
| Reading Number | Floor/Area | Room | Feature | Substrate | Condition | Color | Result | XRF Reading (mg/cm²) |
|---|---|---|---|---|---|---|---|---|
| 46 | Exterior | Exterior | Door | Wood | Deteriorated | Blue | Positive | 1.90 |

**21** View of **lead positive exterior wood door.**

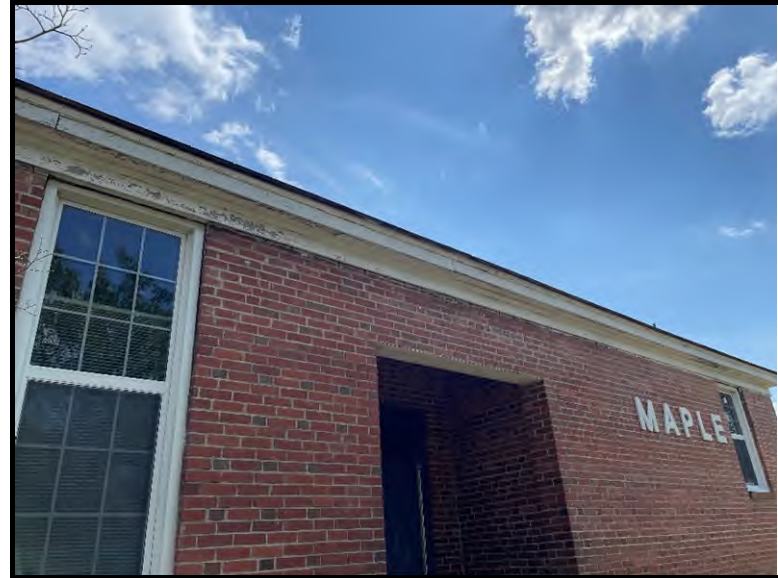
| Reading Number | Floor/Area | Room | Feature | Substrate | Condition | Color | Result | XRF Reading (mg/cm²) |
|---|---|---|---|---|---|---|---|---|
| 47 | Exterior | Exterior | Fascia | Wood | Deteriorated | White | Positive | 0.70 |

**22** View of **lead positive exterior wood fascia.**

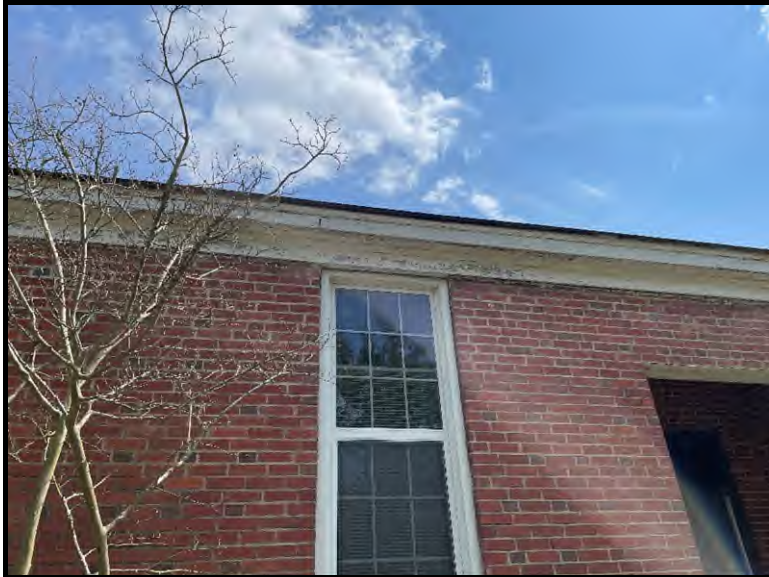
| Reading Number | Floor/Area | Room | Feature | Substrate | Condition | Color | Result | XRF Reading (mg/cm²) |
|---|---|---|---|---|---|---|---|---|
| 48 | Exterior | Exterior | Soffit | Wood | Deteriorated | White | Positive | 2.40 |

**23** View of **lead positive exterior wood soffit.**

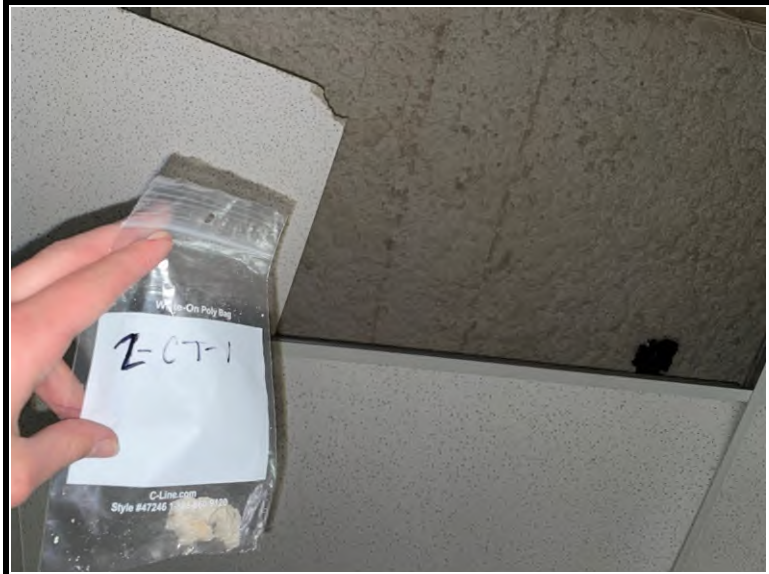
**27** View of ceiling tile (Southeast and Middle Sections). No asbestos detected.

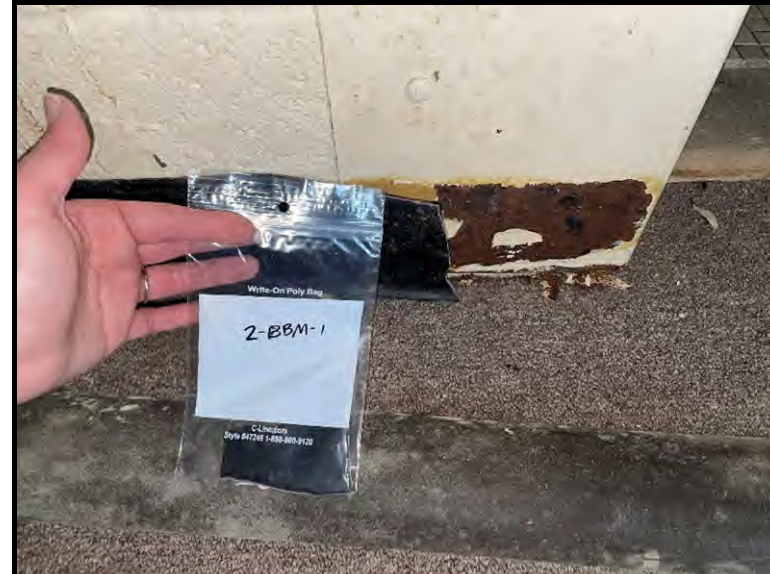
**28** View of baseboard mastic (Southeast and Middle Sections). No asbestos detected.

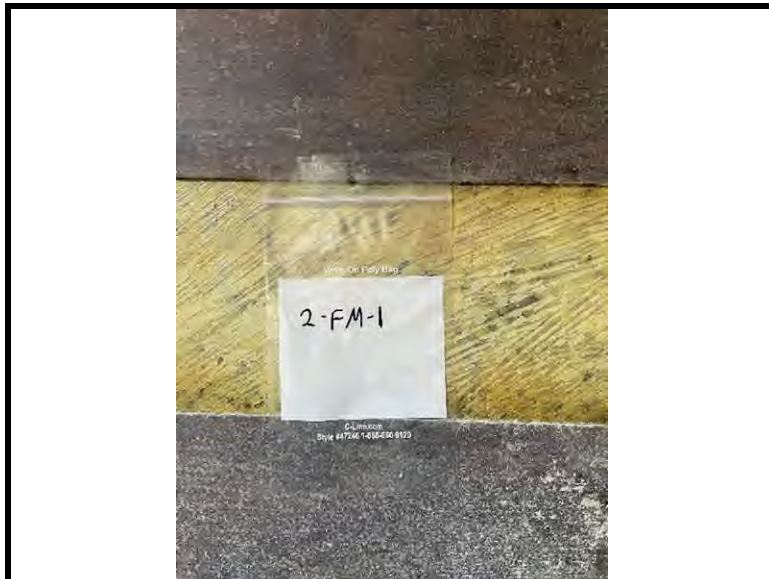
**29** View of floor mastic (Media and Tech. Center). No asbestos detected.

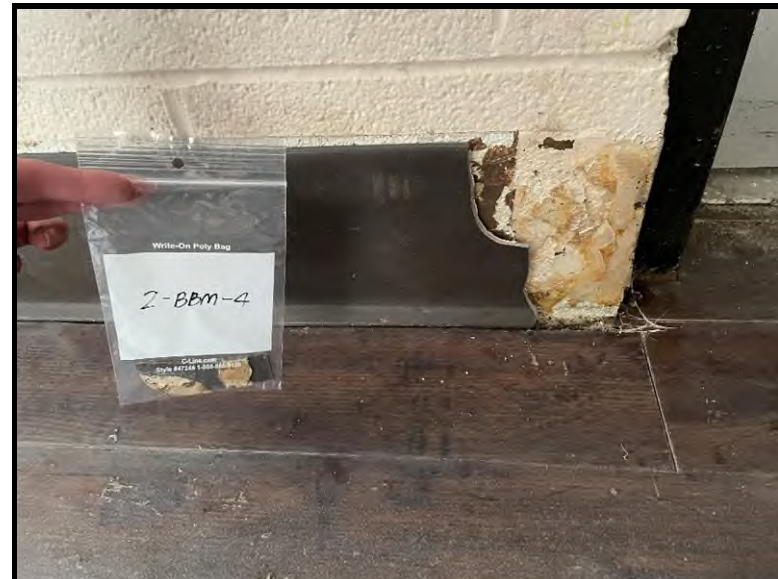
**30** View of baseboard mastic (Tech. Center). No asbestos detected.

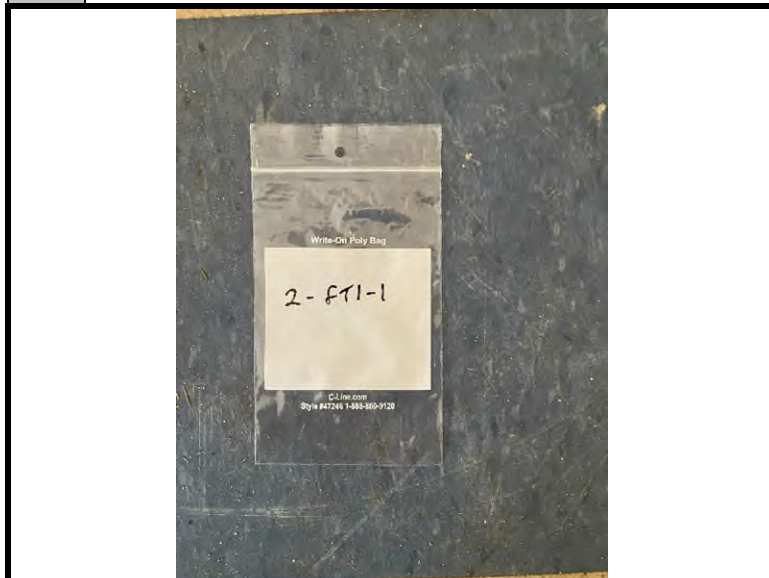
**31** View of floor tile (Staff Development). No asbestos detected.

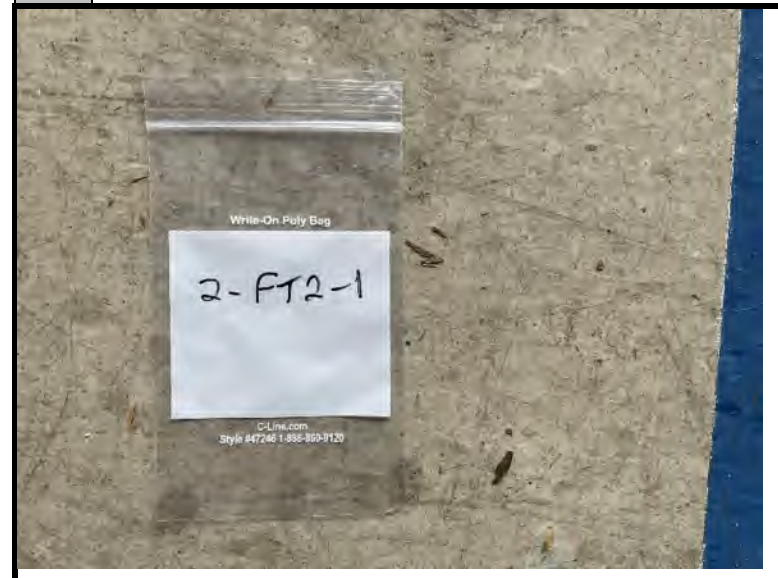
**32** View of floor tile (Staff Development). No asbestos detected.

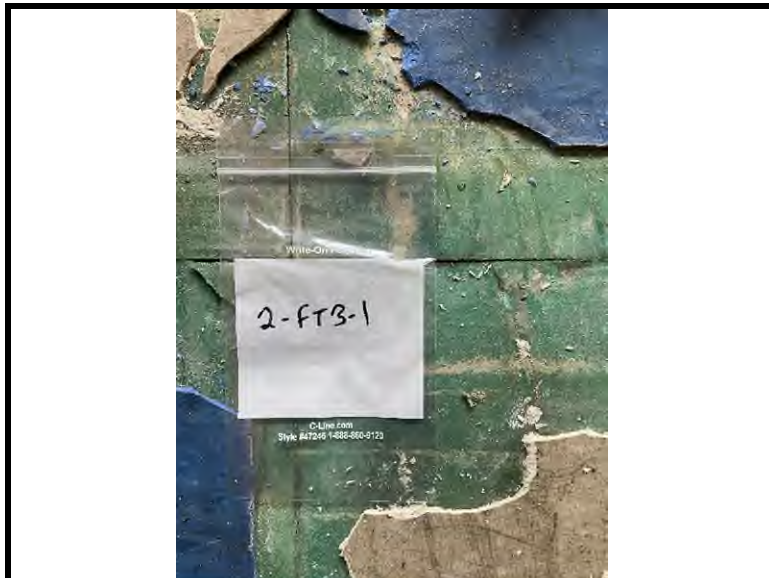
**33** View of floor tile (Staff Development) with **5% Chrysotile asbestos floor tile and 9.9% Chrysotile asbestos mastic.**

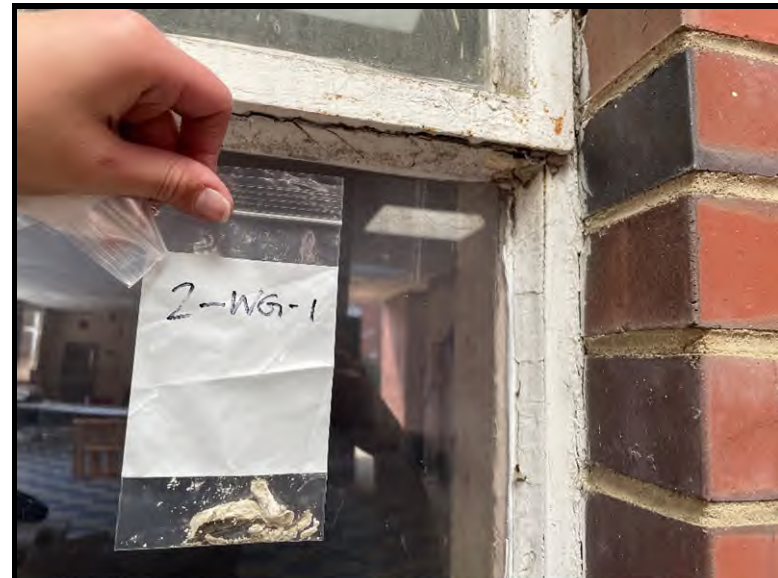
**34** View of window glazing (exterior windows). No asbestos detected.

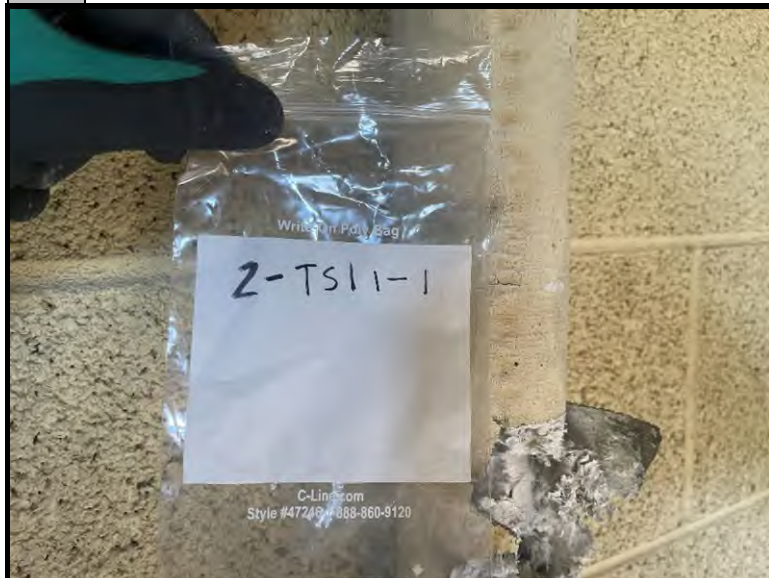
**35** View of 2" pipe insulation (East Boiler Room) with **65% Chrysotile asbestos TSI insulation.**

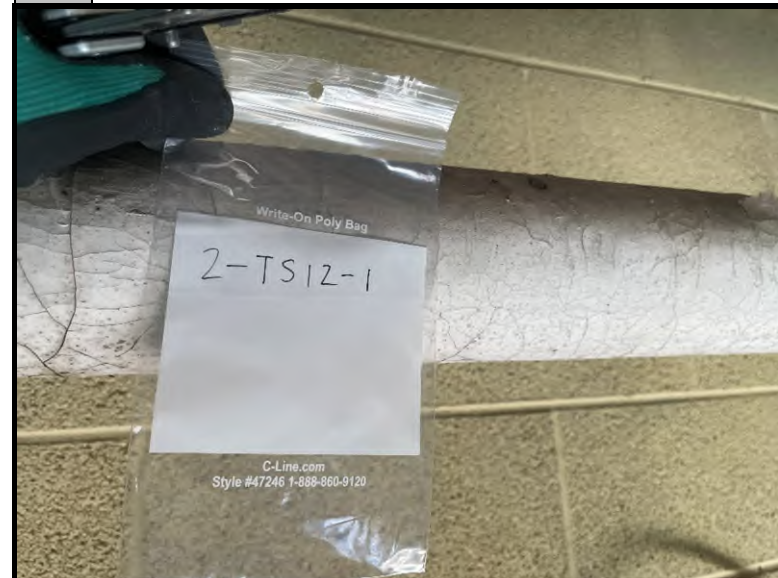
**36** View of 3" pipe insulation (East Boiler Room) with **2% Chrysotile/10% Amosite asbestos TSI insulation.**

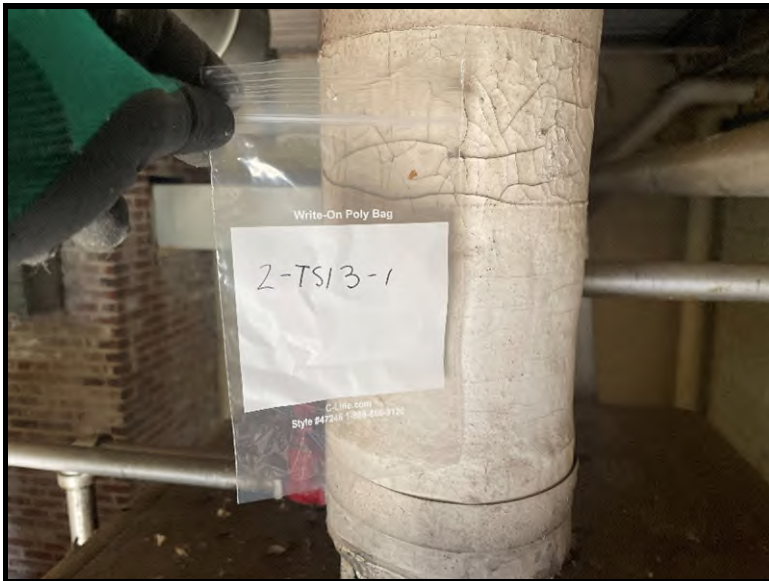
**37** View of 6" pipe insulation (East Boiler Room) with **65% Chrysotile/10% Amosite asbestos TSI insulation.**

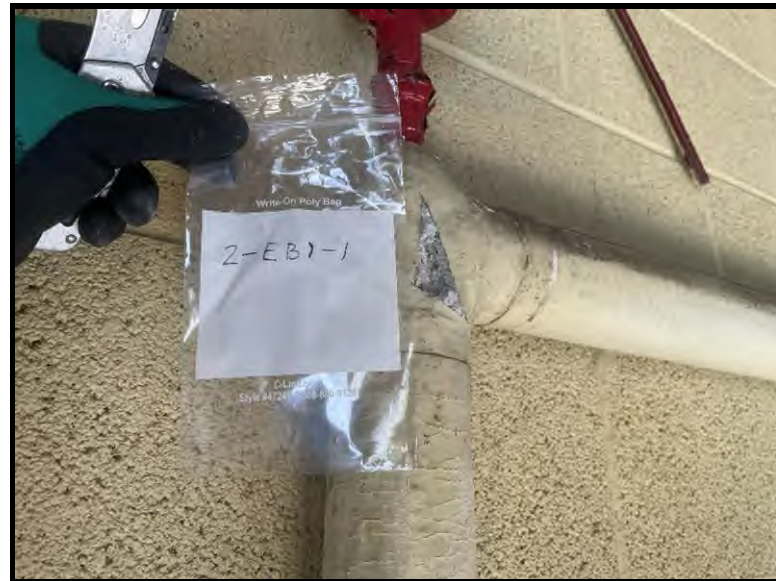
**38** View of 2" elbow insulation (East Boiler Room) with **65% Chrysotile/2% Amosite asbestos TSI insulation.**

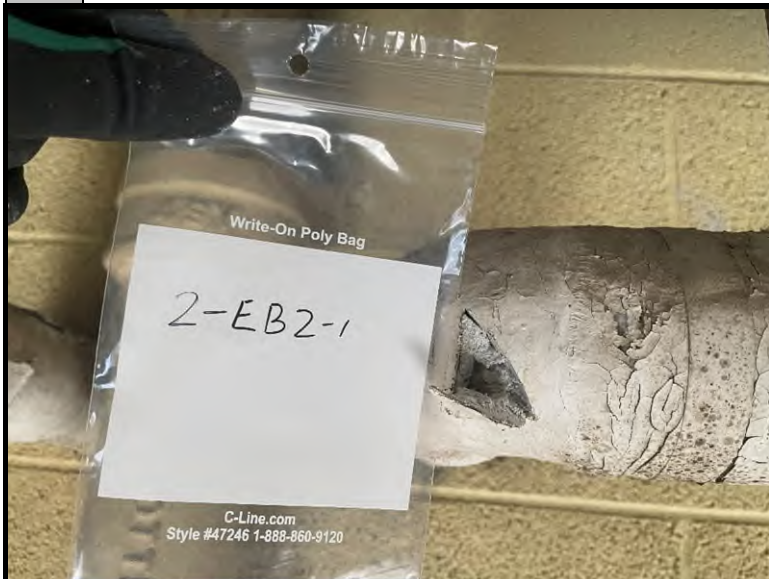
**39** View of 3" elbow insulation (East Boiler Room) with **65% Chrysotile/2% Amosite asbestos TSI insulation.**

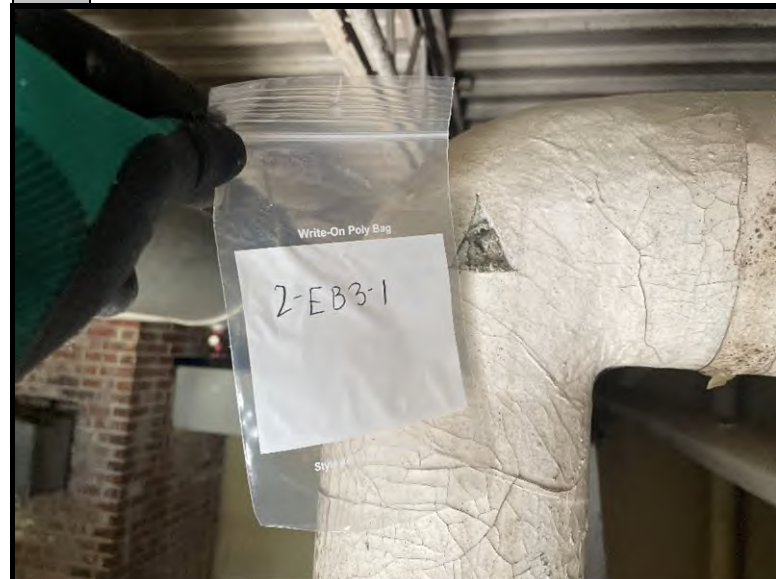
**40** View of 6" elbow insulation (East Boiler Room) with **65% Chrysotile/2% Amosite asbestos TSI insulation.**

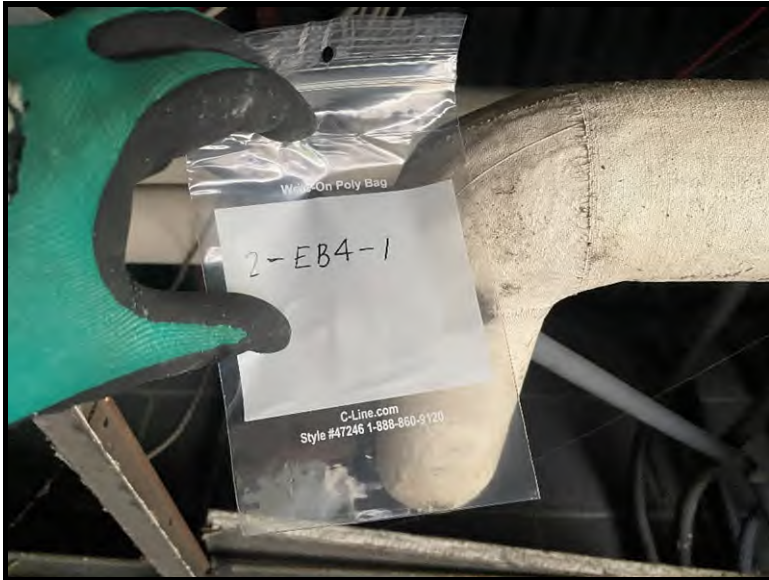
**41** View of 2" elbow insulation (South Boiler Room) with **10% Chrysotile asbestos TSI insulation.**

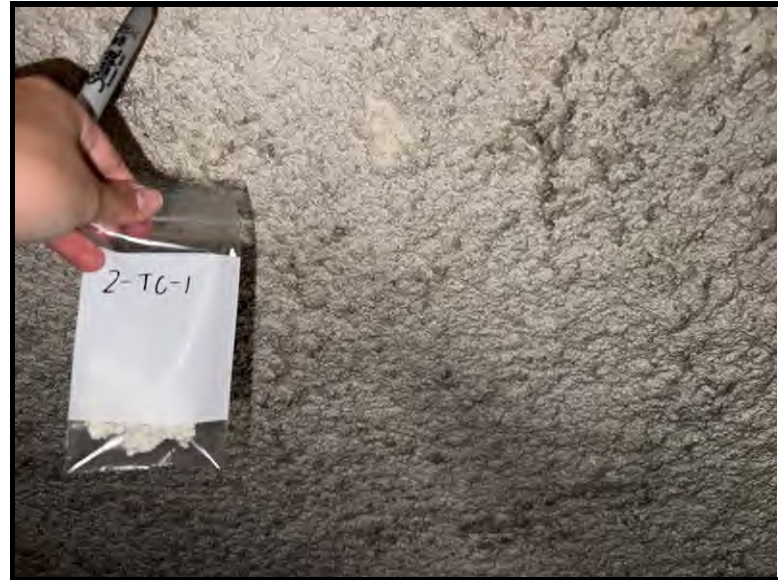
**42** View of textured ceiling (Training Lab, Media and Tech. Center). No asbestos detected.

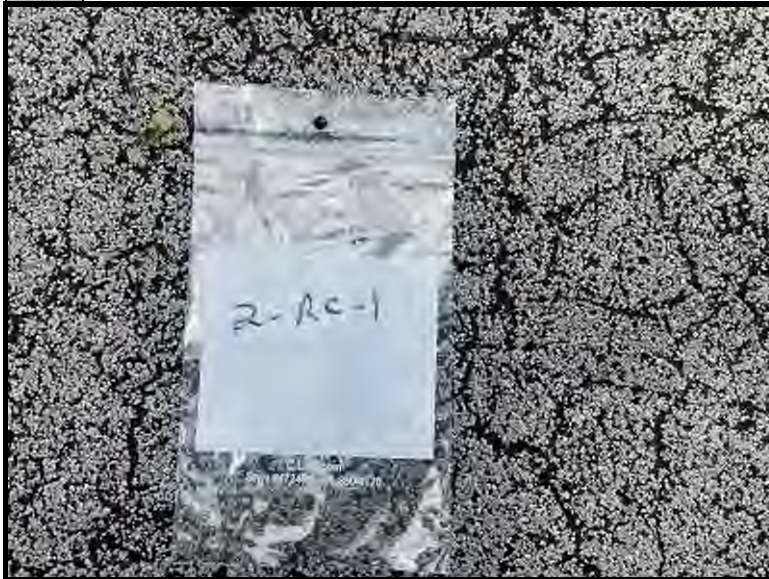
**43** View of roof core. No asbestos detected.

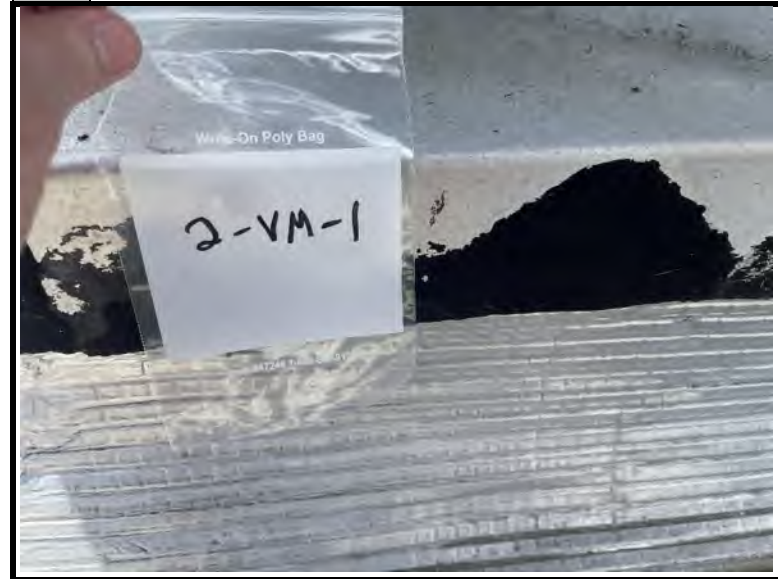
**44** View of vent mastic. No asbestos detected.

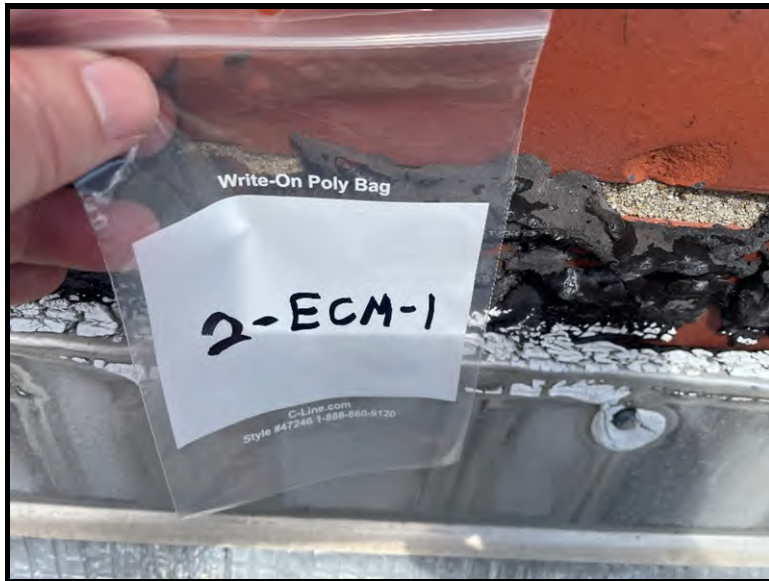
**45** View of chimney mastic. No asbestos detected.

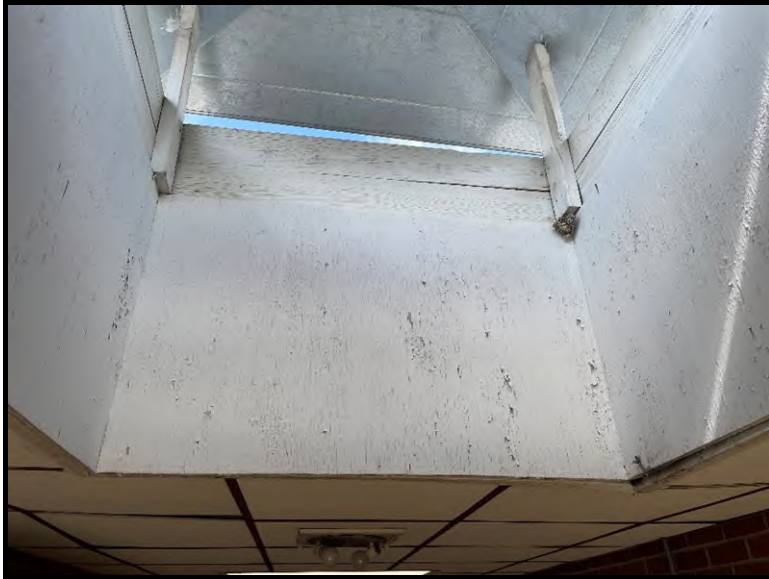
| Reading Number | Floor/Area | Room | Feature | Substrate | Condition | Color | Result | XRF Reading (mg/cm²) |
|---|---|---|---|---|---|---|---|---|
| 23 | Exterior | Breezeway | Vent Area Ceiling | Wood | Deteriorated | White | Positive | 1.30 |

**47** View of **lead positive exterior wood vent area ceiling (Breezeway).**

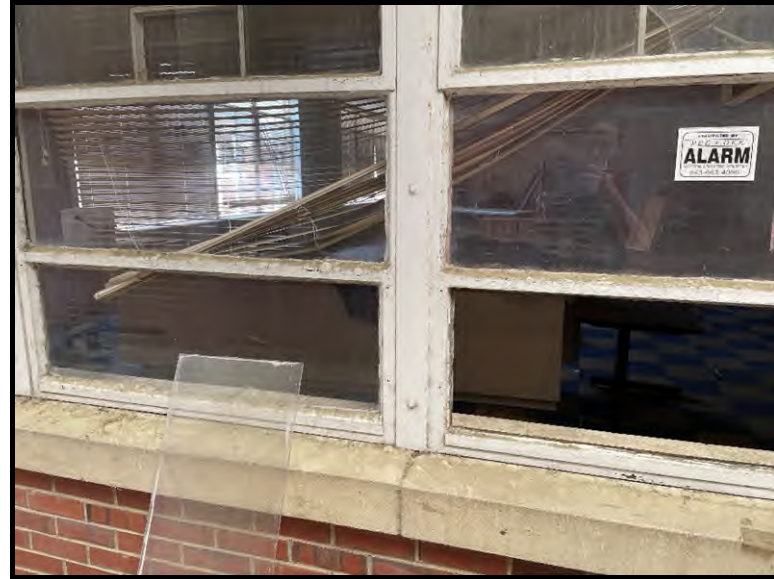
**48** View of **lead positive exterior metal window frame (Staff Development).**

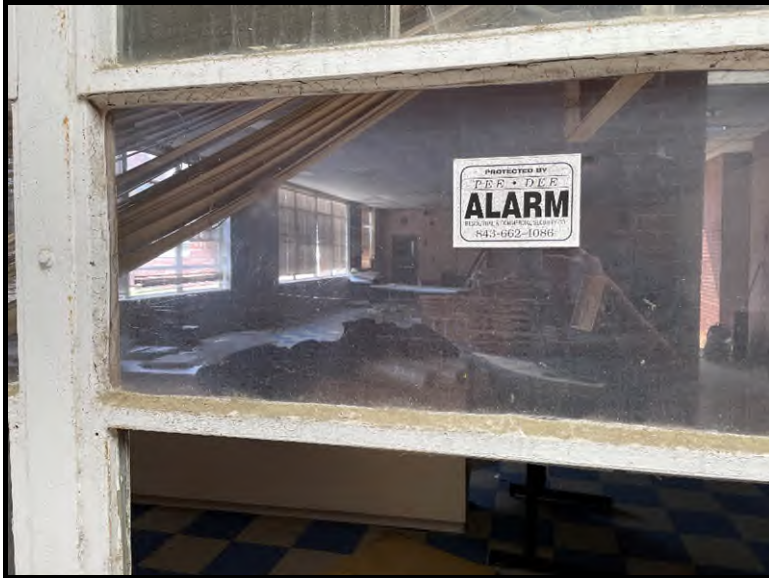
**49** View of lead positive exterior wood windowpane (Staff Development).

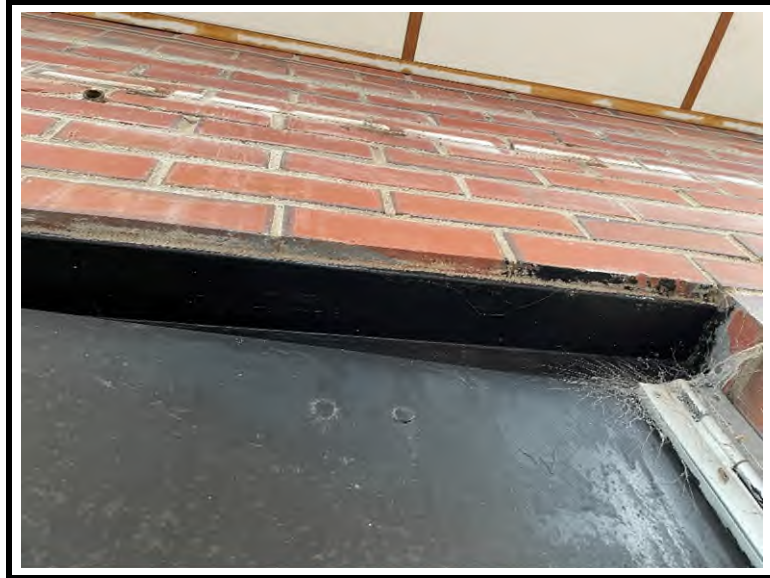
**50** View of lead positive exterior metal door beam (Staff Development).

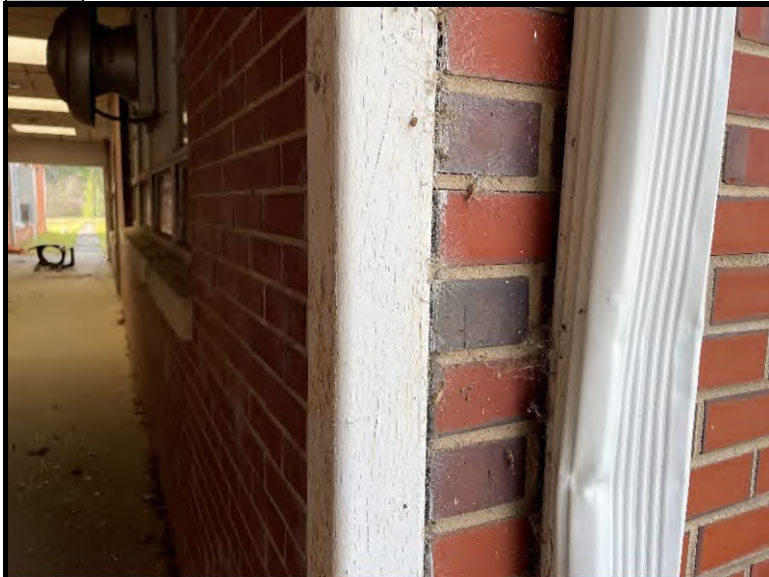
**51** View of lead positive exterior metal support (Staff Development).

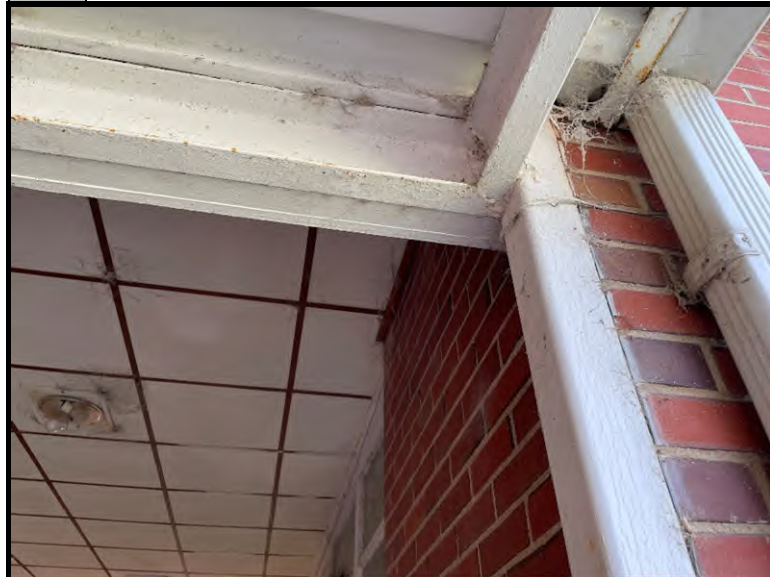
**52** View of lead positive exterior metal beam (Staff Development).

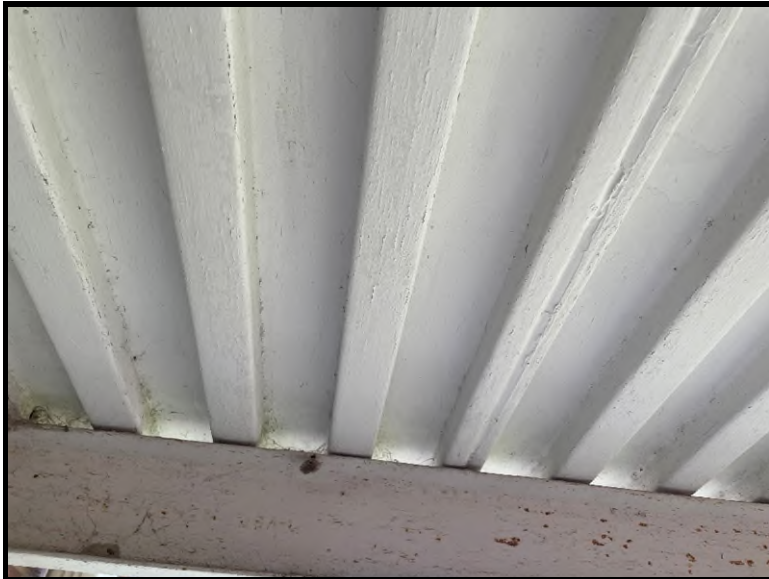
**53** View of **lead positive exterior concrete portico ceiling (Staff Development)**.
