Asbestos and Lead-Based Paint Assessment  
Proposed Parkside Commons  
901 South 9<sup>th</sup> Avenue  
Dillon, Dillon County, South Carolina  
S&ME Project No. 26630033

Reference: **Asbestos and Lead-Based Paint Assessment  
Proposed Parkside Commons**  
901 S. 9<sup>th</sup> Avenue  
Dillon, Dillon County, South Carolina  
S&ME Project No. 26630033

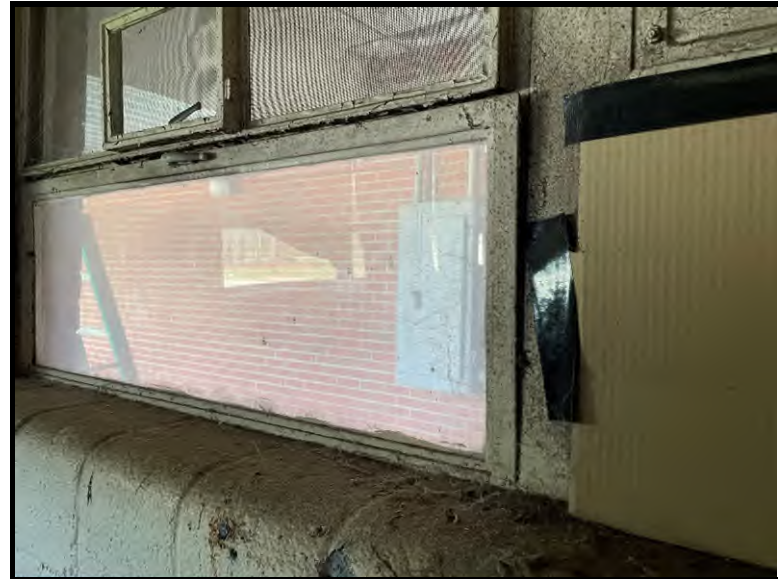
**54** View of **lead positive interior metal windowpane (Staff Development - Kitchen)**.

Destructive actions (sanding, burning, demolition, component removal, paint preparation) to the painted surfaces will require the contractor to comply with the standards of OSHA, including but not limited to initial exposure monitoring, the use of personal protective equipment, and medical surveillance. Components painted with lead-based paint ( $> 0.7$  mg/cm<sup>2</sup>) must be disposed in a SCDES permitted Class II (C&D) or Class III (Subtitle D, Municipal Solid Waste) landfill.

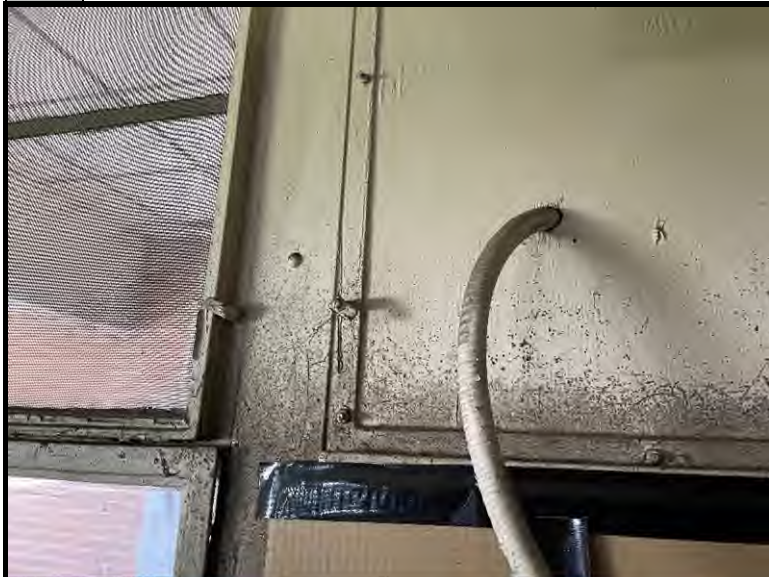
**55** View of **lead positive interior metal window frame (Staff Development - Kitchen)**.

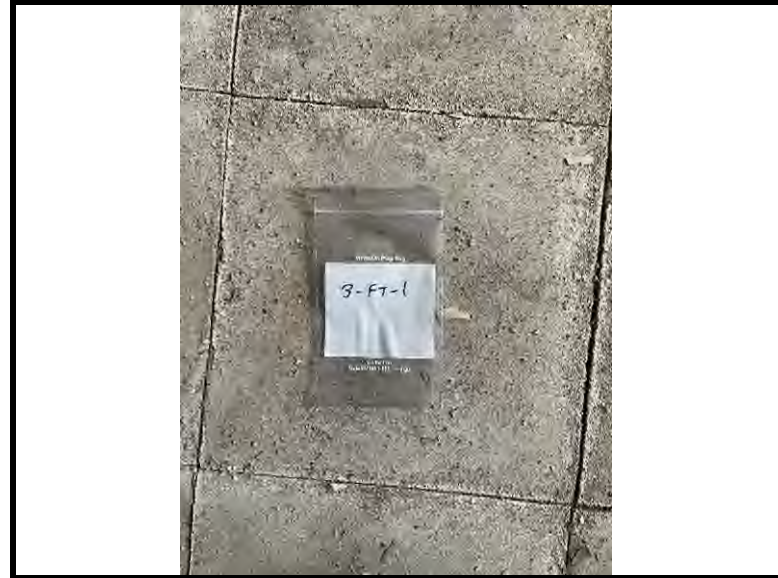
**58** View of floor tile (west classroom). No asbestos detected.

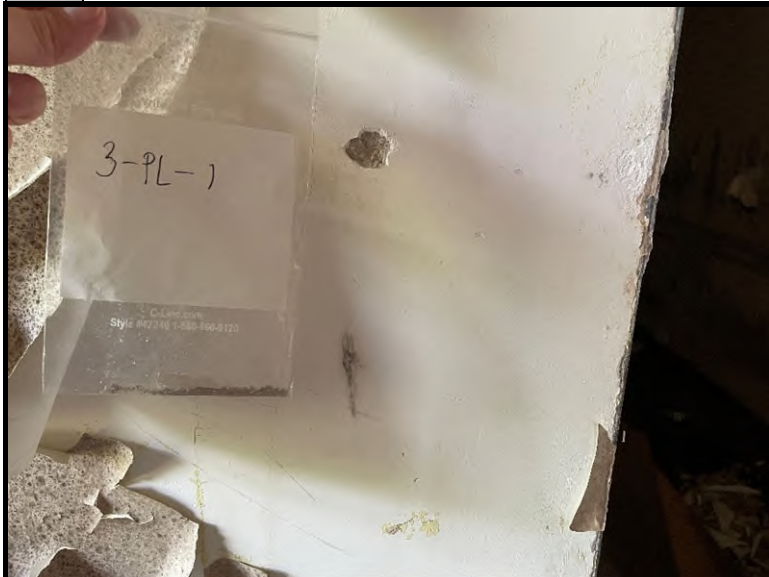
**59** View of plaster (throughout interior). No asbestos detected.

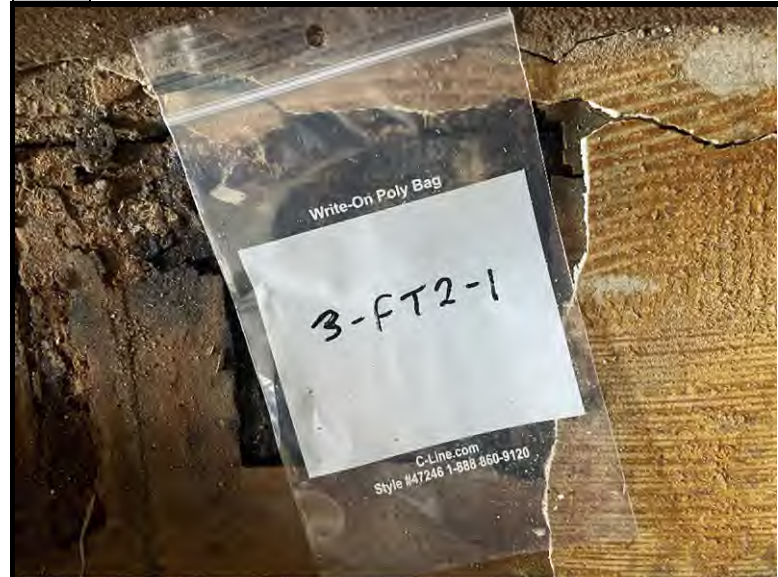
**60** View of floor tile, 9"x9" (throughout interior) with **7% Chrysotile asbestos floor tile.**

SCDES requires proper removal and disposal of ACMs which will be disturbed by demolition or renovation activities. We recommend proper removal and disposal of the identified ACMs by a contractor licensed by SCDES, Asbestos Section, prior to the planned demolition activities. A copy of this assessment report must be submitted to SCDES, along with an application for asbestos removal and building demolition or renovation at least 10 working days prior to asbestos abatement activities. The required notification for asbestos removal may vary from four to 10 days depending on the quantity or type of ACM to be abated.

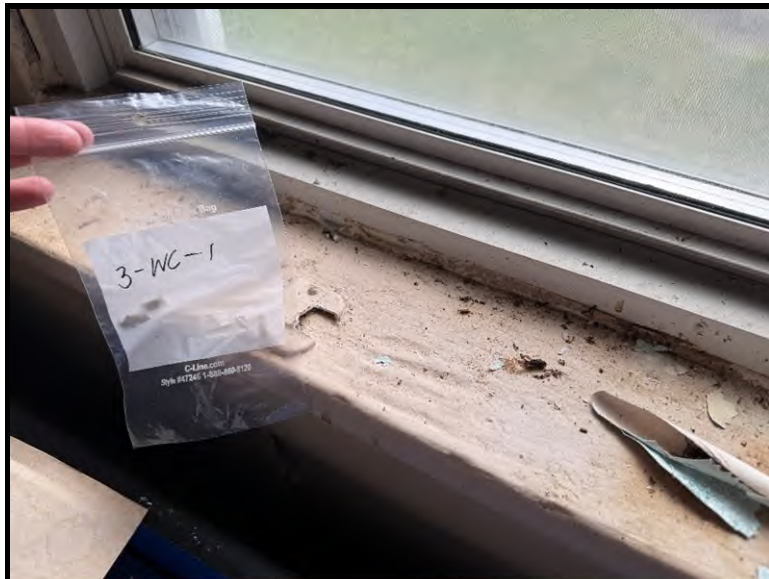
**61** View of caulk (interior windows). No asbestos detected.

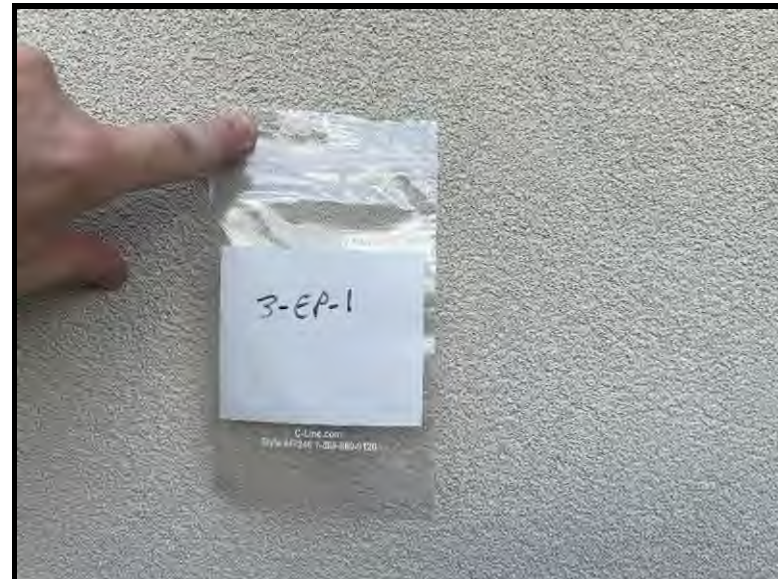
**62** View of plaster (exterior walls). No asbestos detected.

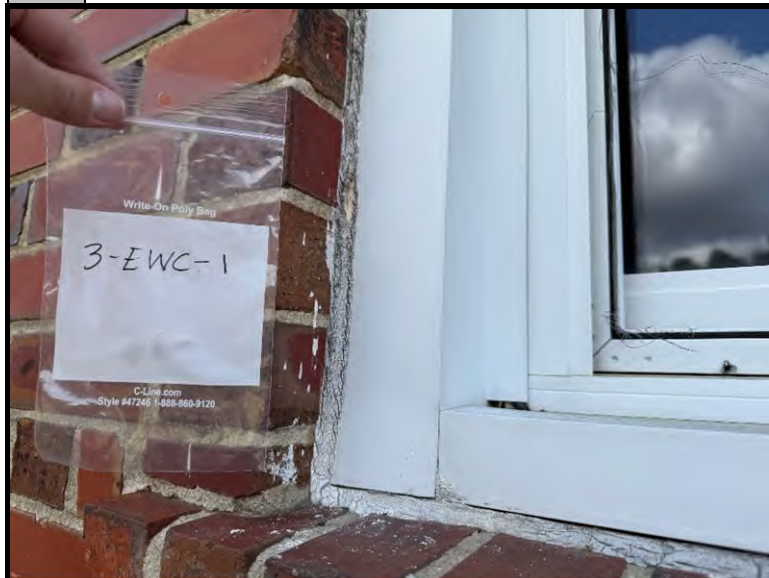
**63** View of caulk (exterior windows). No asbestos detected.

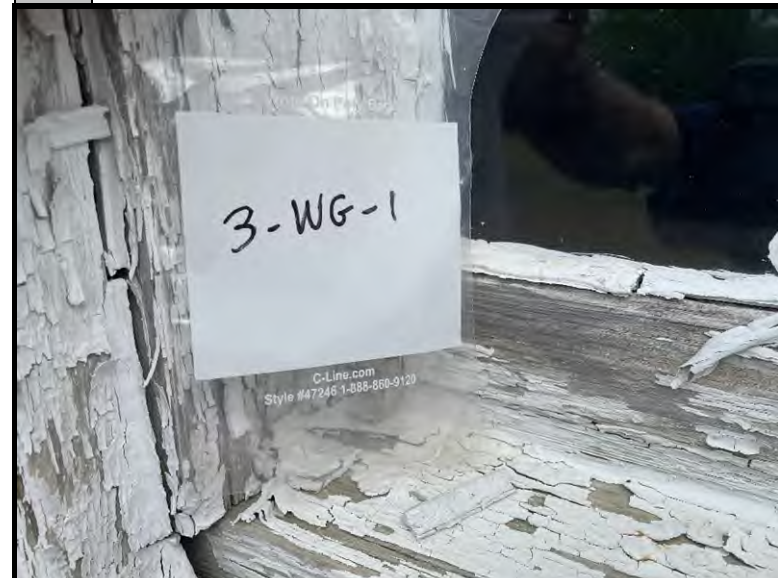
**64** View of window glazing (exterior windows). No asbestos detected.

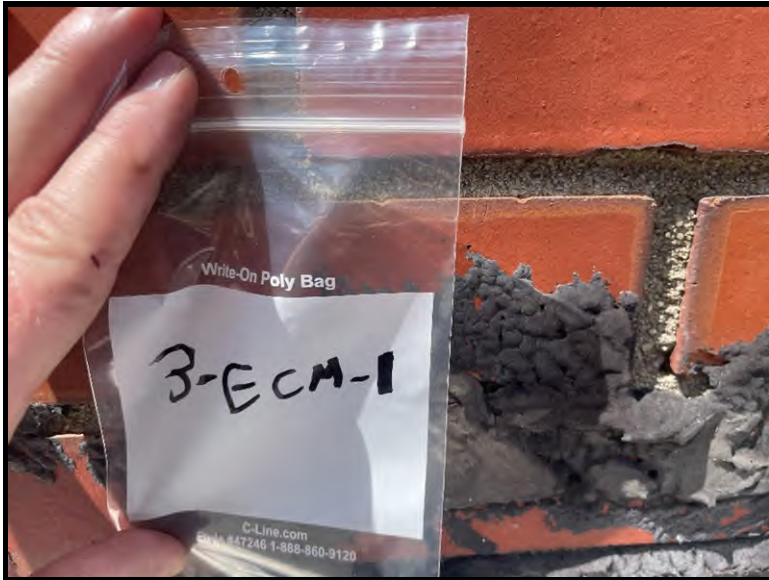
**65** View of chimney mastic. No asbestos detected.

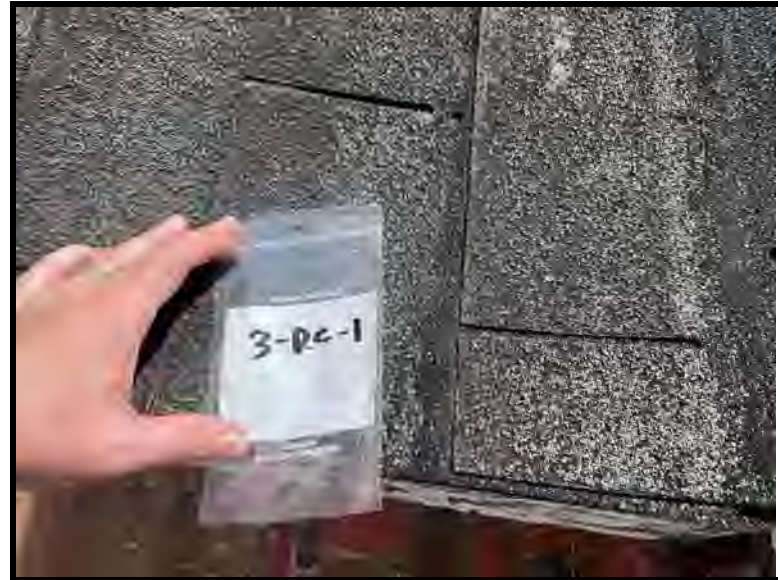
**66** View of roof core. No asbestos detected.

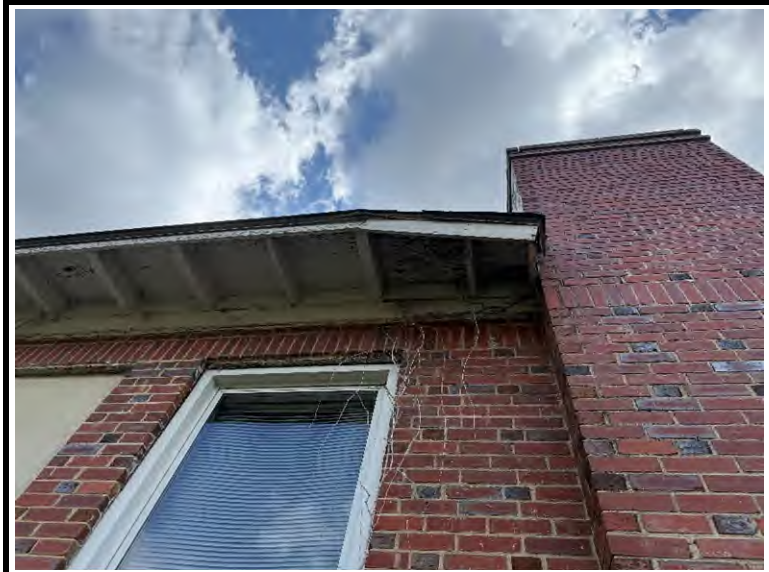
**67** View of **lead positive exterior wood soffit.**

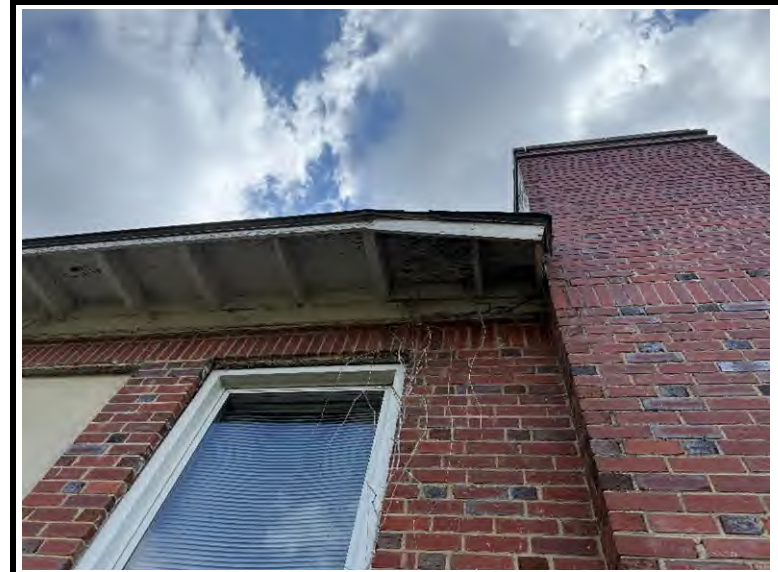
**68** View of **lead positive exterior wood fascia.**
