***Physical Inspection Report  
of***

***Knollwood Apartments  
822 Archie Street  
Fort Mill, South Carolina 29715***

***April 28-29, 2026***

JPS & Associates, Inc.  
319 North Main Ave, Suite 100  
Springfield, Missouri 65806  
(417) 882-4208 Fax (417) 886-7173  
e-mail: [jps@jps-associates.com](mailto:jps@jps-associates.com)

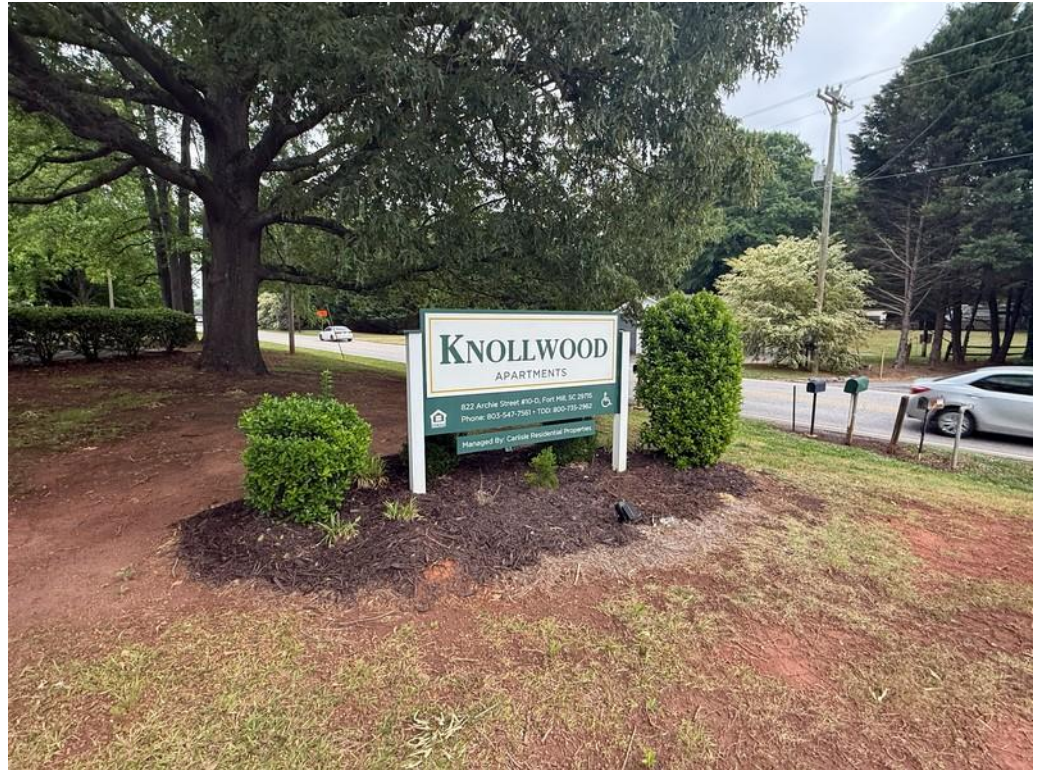
There is a wood sign with painted lettering mounted between two wood posts located on the southeast corner of the site. The sign is in average condition.

1. View of the property identification sign.

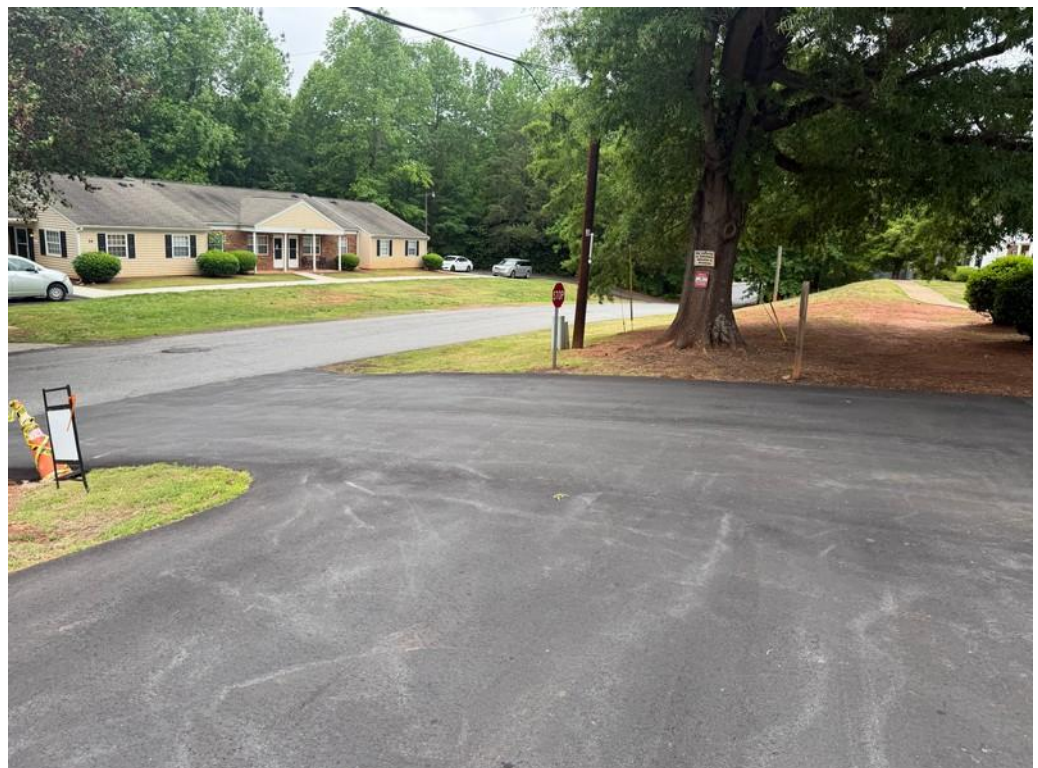
Paving on the property consists of 40,140 square feet of asphalt paving and 1,700 square feet of concrete paving that is in average to fair condition.

2. View of typical asphalt drive.

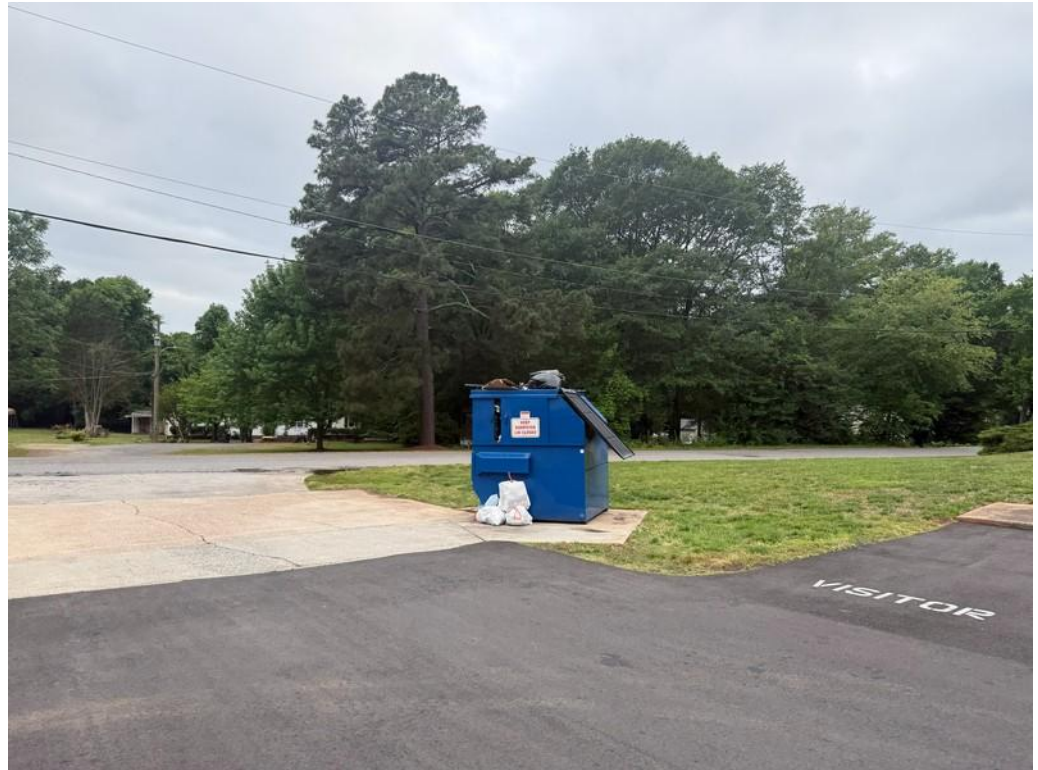
There are two trash dumpsters located on the site. The dumpsters sit on a concrete pad and are not enclosed. One dumpster is located north of Building 1 and the other is located south of Building 9. The dumpsters and concrete pads are in average to fair condition.

9. View of a typical trash dumpster.

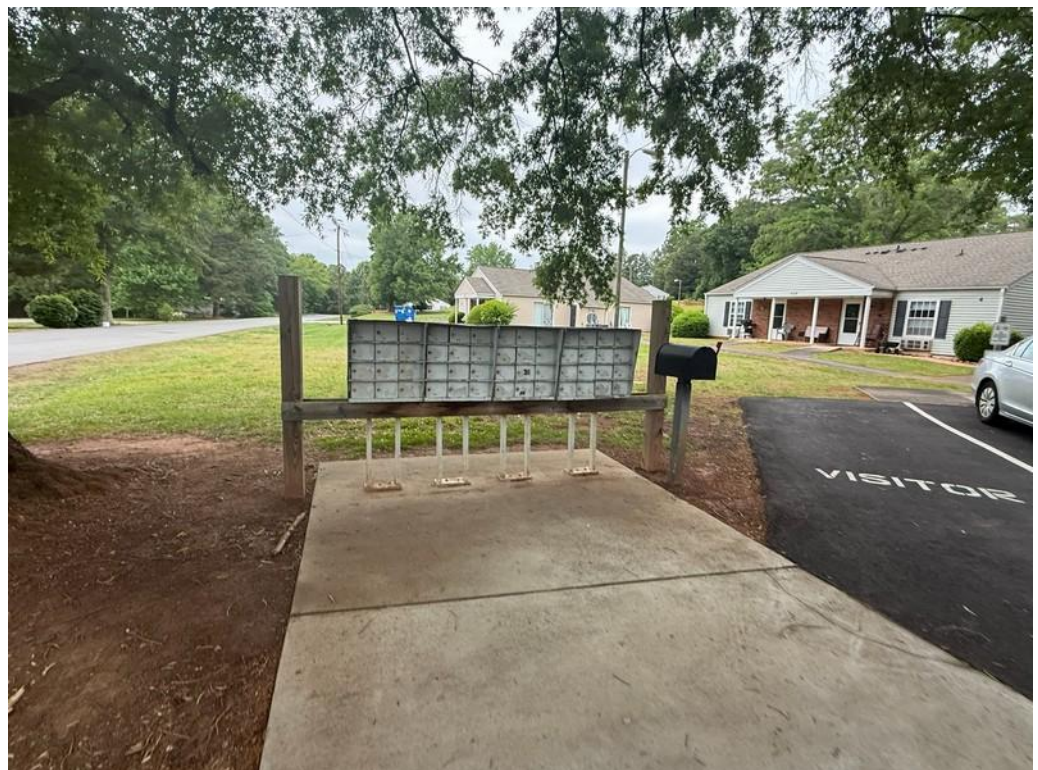
There are a total of 52 front loading, free-standing gang style mailboxes located on the southeast corner of the site. The mailboxes are owned by the property and are in fair condition.

10. View of free-standing mailboxes.

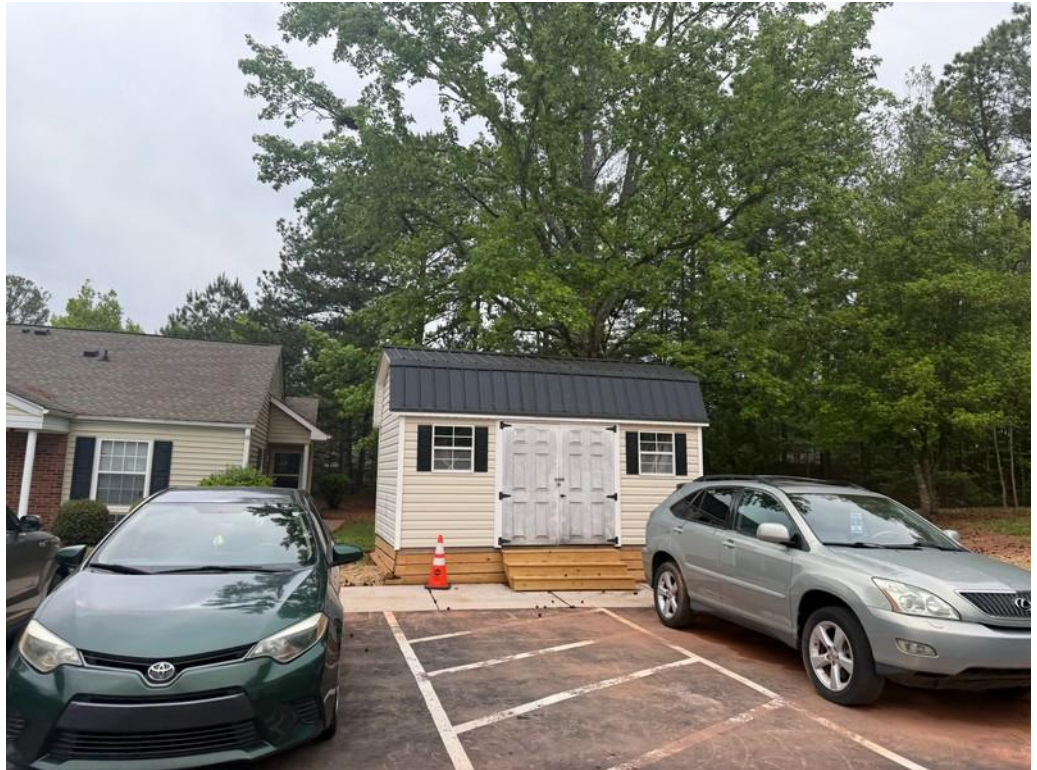
There is a 10' x 12' wood framed shed with vinyl siding and a metal roof located to the northeast of Building 12. The shed is in average condition.

11. View of the shed.

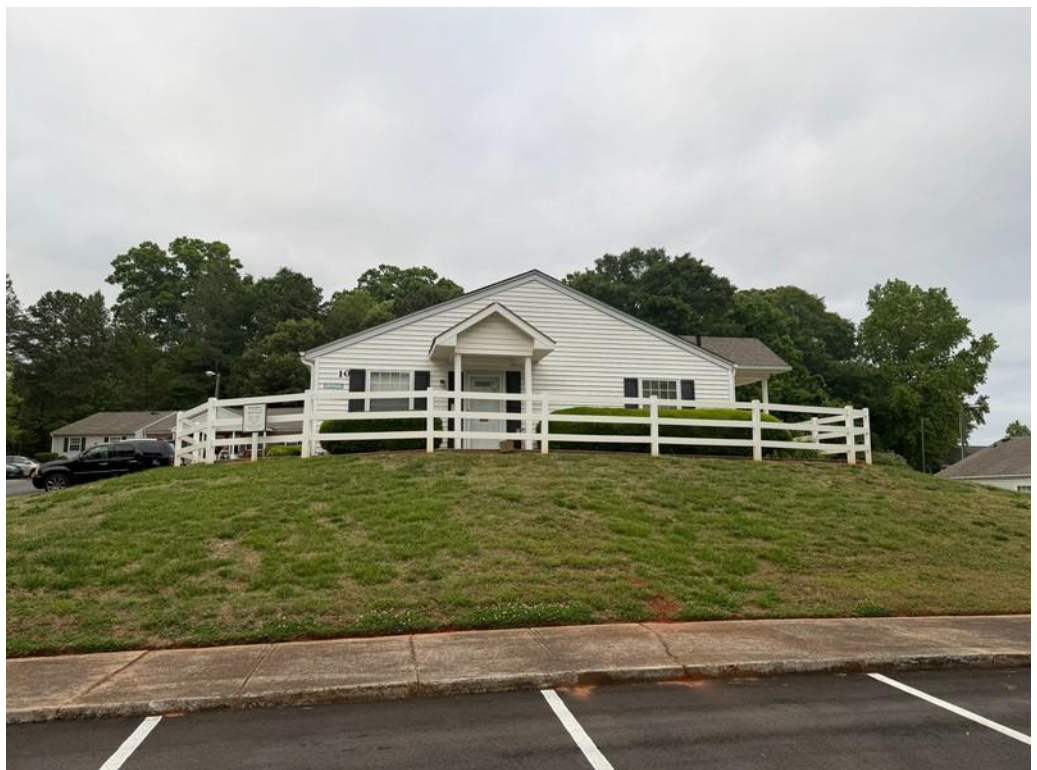
There is 90 linear feet of 4' high vinyl post and rail fencing on the south side of Building 10. The fencing is in average to fair condition.

The exterior walls for the buildings are 23,365 square feet of vinyl siding and 5,110 square feet of brick veneer. The exteriors walls are in average to fair condition.

12. View of typical  
building exteriors.  
Note the fencing.

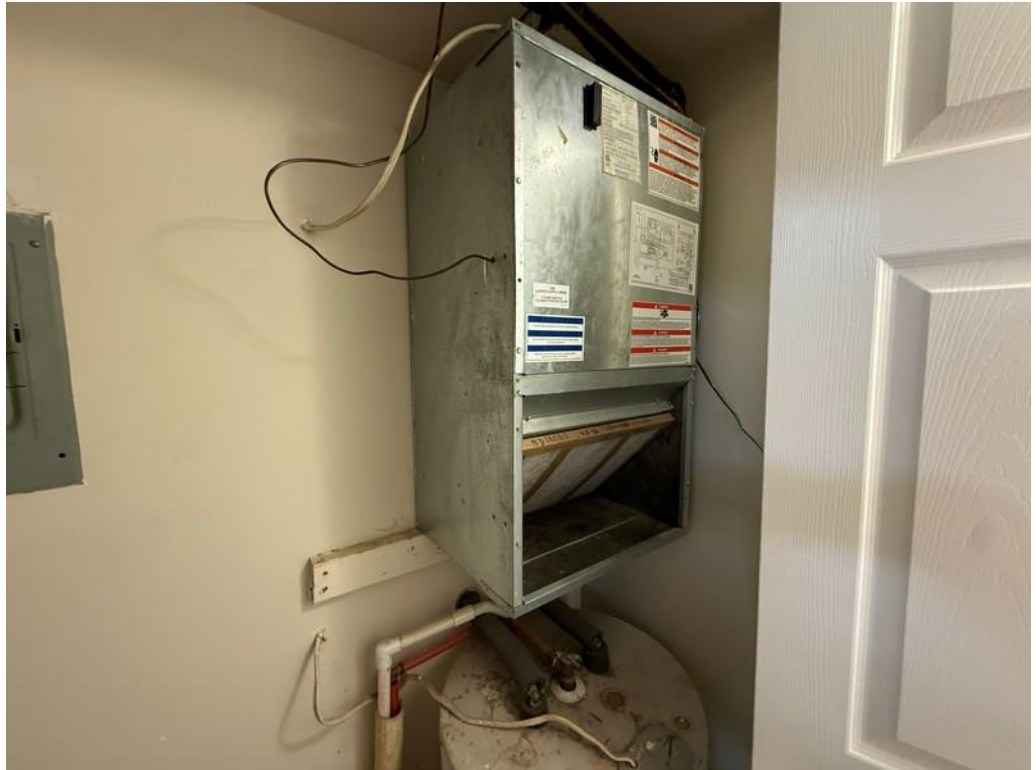
Heat is supplied to the office by an electric air handler located in the maintenance closet. The air handler is in average to fair condition.

23. View of office fan coil unit in the mechanical closet.

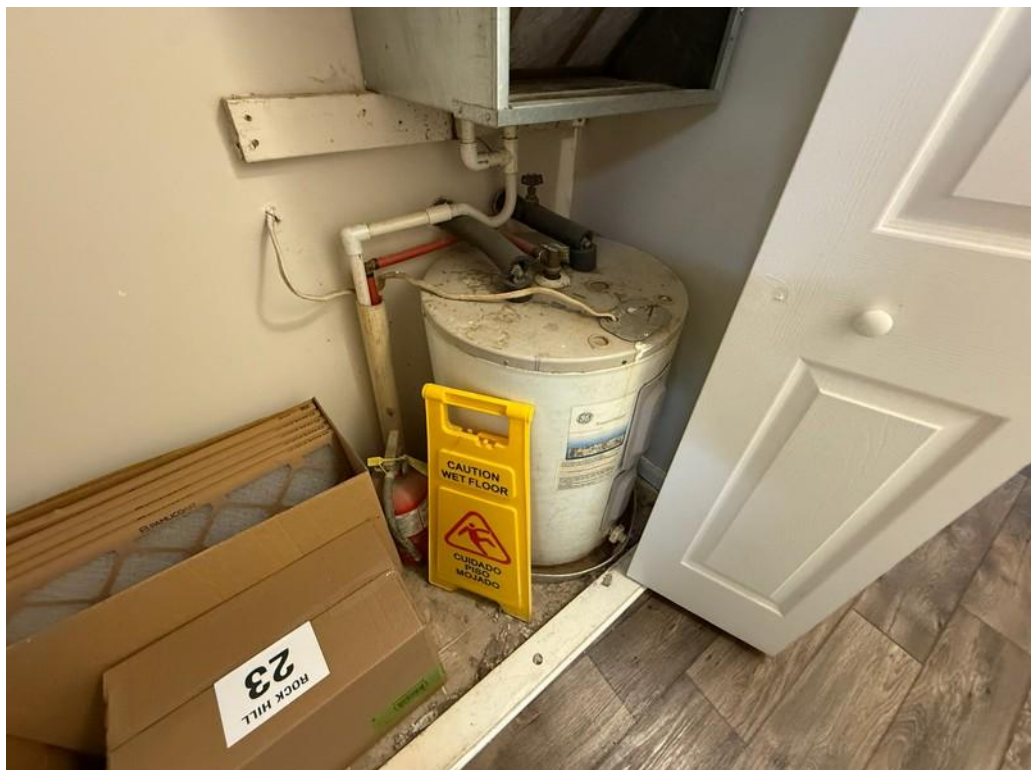
Domestic hot water is supplied to the office common areas by a 40-gallon electric water heater located in the maintenance closet. Domestic hot water is supplied to the laundry facilities of the office by a 50-gallon gas-fired water heater located behind the walls of the office. The common area water heater is in average to fair condition.

24. View of the office water heater in the mechanical closet.

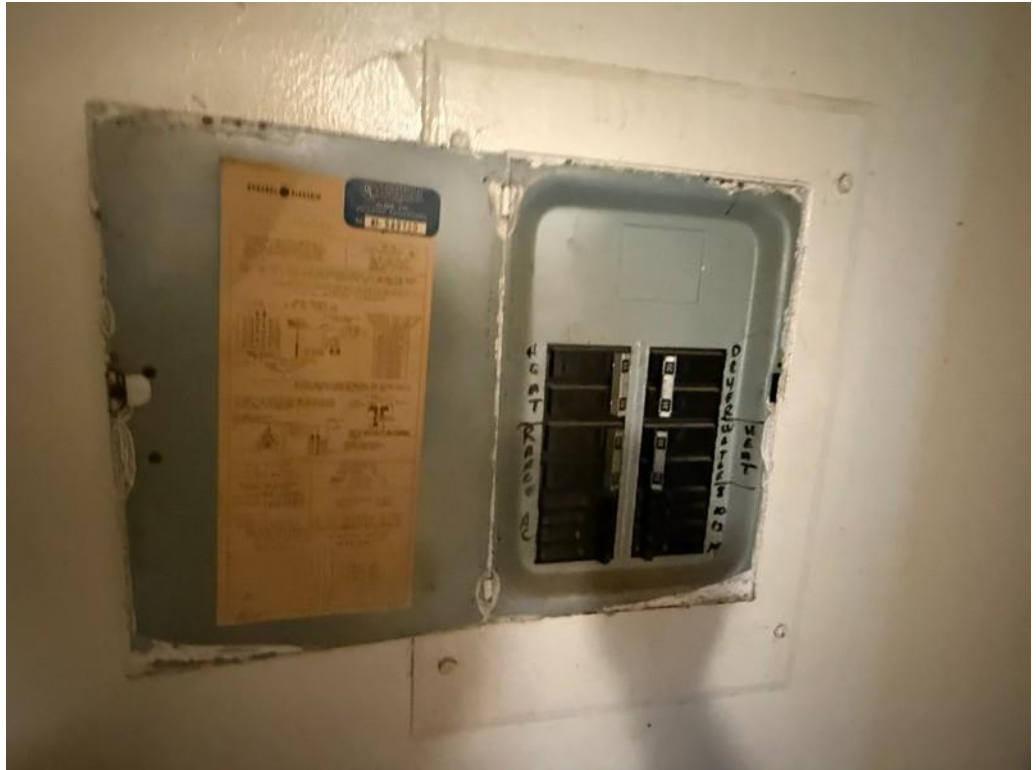
The pad-mounted electrical service transformers on the property are owned by the utility company and showed no visible signs of leaking. The electrical meters are located on the exteriors of the building. The apartment electrical service panels are GE, 125-amp, 16 space electrical service panels located in each apartment. The electrical service panels are in average to fair condition.

61. View of a typical unit electrical panel.

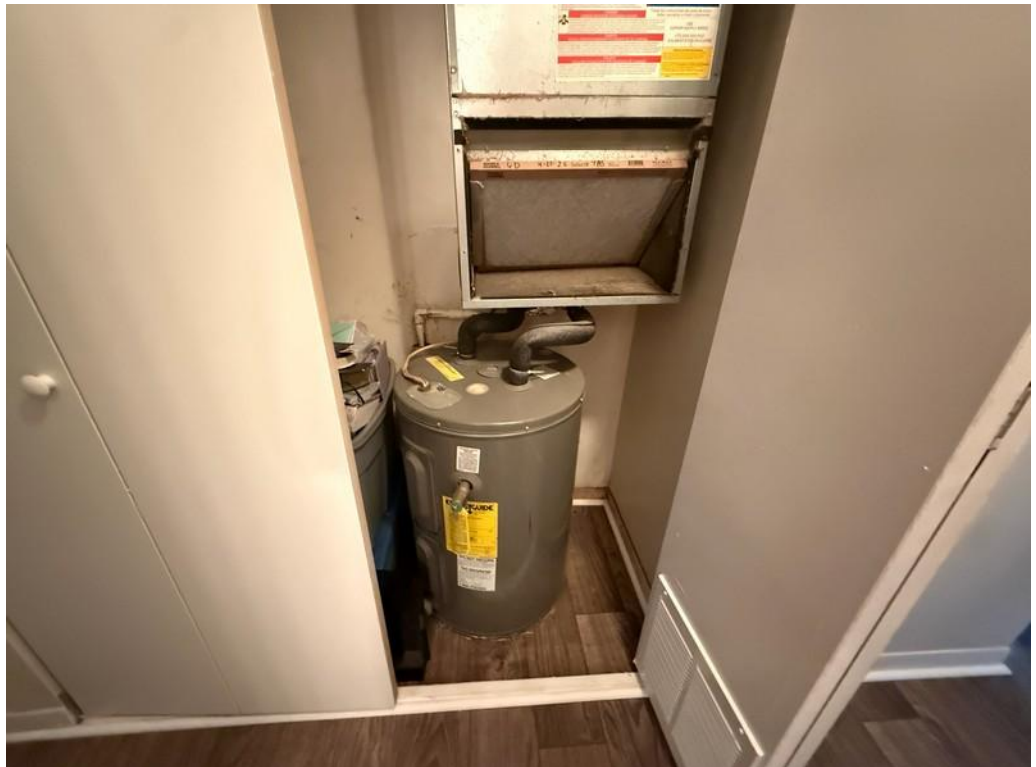
Domestic hot water is supplied to the apartments by a 40-gallon, water heaters located in the mechanical closets. The apartment water heaters are in average to fair condition.

Heat is supplied to the studio apartments by a PTAC unit. Heat is supplied to the remaining apartments by an electric fan coil unit located in the mechanical closets. The PTAC and fan coil units are in average to fair condition.

62. View of typical unit water heater and fan coil unit.
