PROPERTY CONDITION ASSESSMENT

Highland Square Apartments

200 Pine Creek Court Extension
Greenville, South Carolina 29605

October 1, 2024

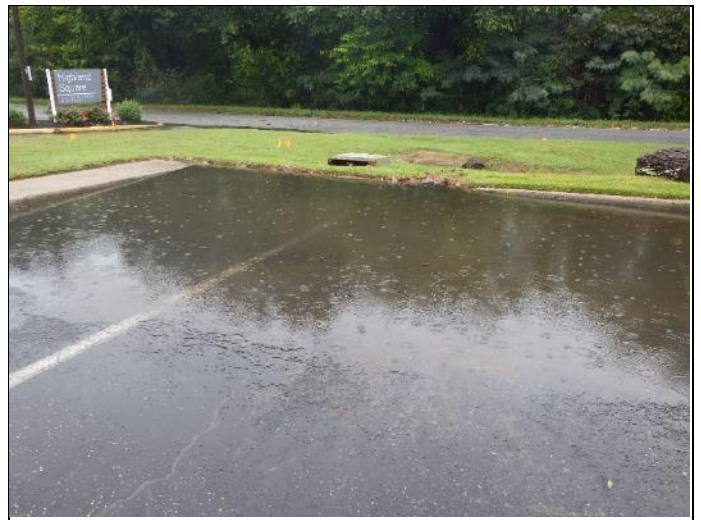
4. Ponding of water near F building.

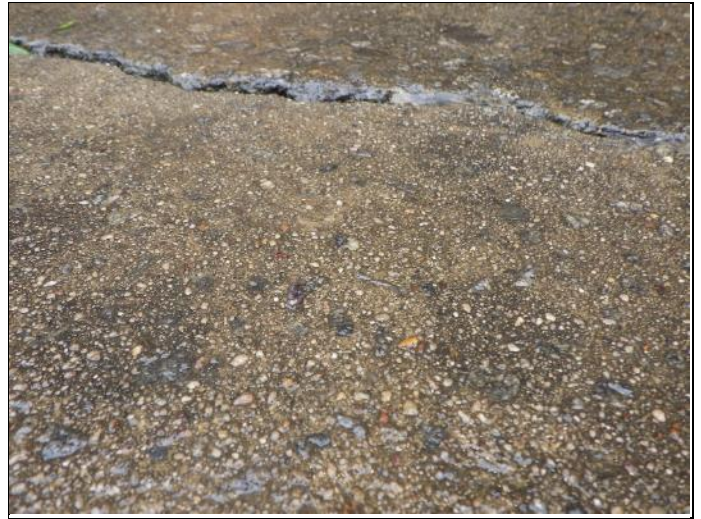
8. Trip hazards found at most building walkways.

| Sect. No. | Deficiency or Repair Item | Quantity | Unit | Unit Cost | Immediate Repair | Short-Term Cost | Total Cost |
|---|--|---|---|---|---|---|---|
| 3.2.3 | <p>The pedestrian concrete walkways appear to be in good to fair overall condition. Cracking and displacement were observed throughout the property's sidewalks particularly along the building frontage. Repair of the noted areas are recommended.</p> | 580 | SF | \$8.50 | \$4,930 | | \$4,930 |

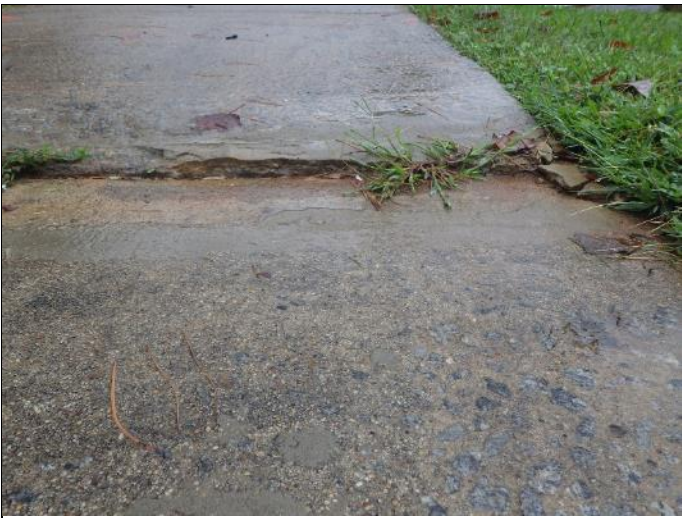
9. Typical displaced sidewalks throughout the site.

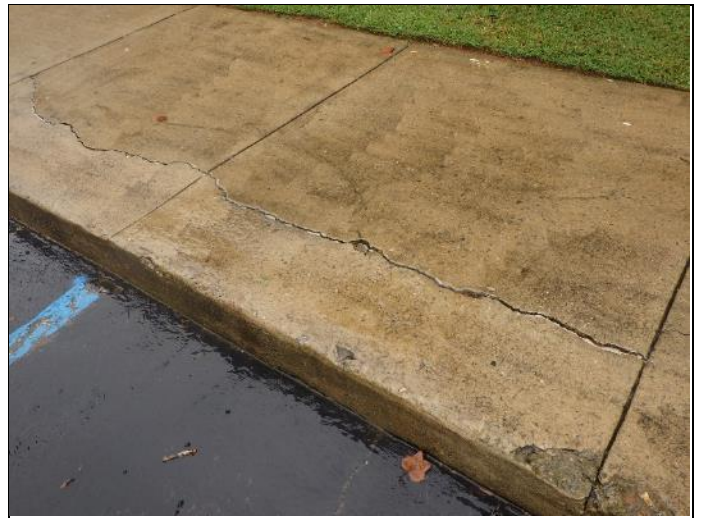
10. Cracked sidewalk by G building and trip hazard.

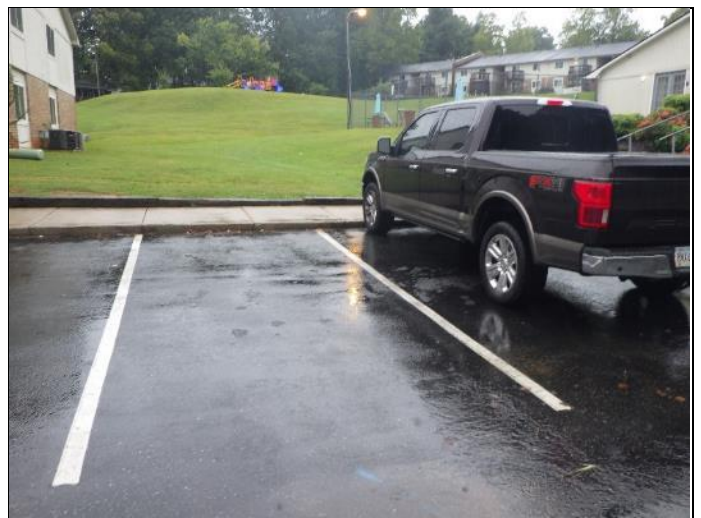
12. Parking near leasing office; note lack of Van-Accessible stall.

| Sect. No. | Deficiency or Repair Item | Quantity | Unit | Unit Cost | Immediate Repair | Short-Term Cost | Total Cost |
|---|--|---|---|---|---|---|---|
| 7.1 | Partner noted a designated accessible parking space is not provided in close proximity to the leasing office. On of the existing parking spaces near the leasing office should be modified for "Van Accessibility" (i.e., signage placard, 96" stall, 96" aisle with access to curb cut). | 1 | EA | \$2,500 | \$2,500 | | \$2,500 |

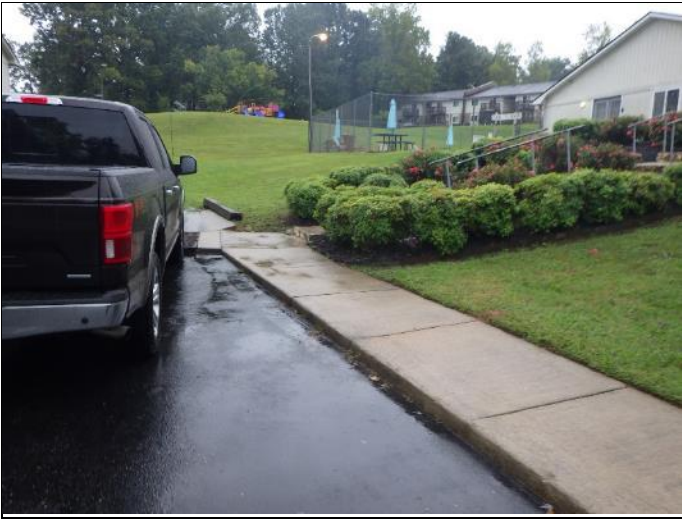
13. A curb cut is needed for accessible route to the leasing office.

| Sect. No. | Deficiency or Repair Item | Quantity | Unit | Unit Cost | Immediate Repair | Short-Term Cost | Total Cost |
|---|--|---|---|---|---|---|---|
| 7.1 | An accessible route is present from the parking areas to the leasing office entrance. However, handrails along the ramp and a single step make the route inaccessible. An accessible route (i.e., compliant walkway/path of travel) should be provided to the leasing office. Partner recommends installing a concrete walkway, curb ramps, and/or crosswalk pavement markings as necessary. | 1 | EA | \$6,500 | \$6,500 | | \$6,500 |

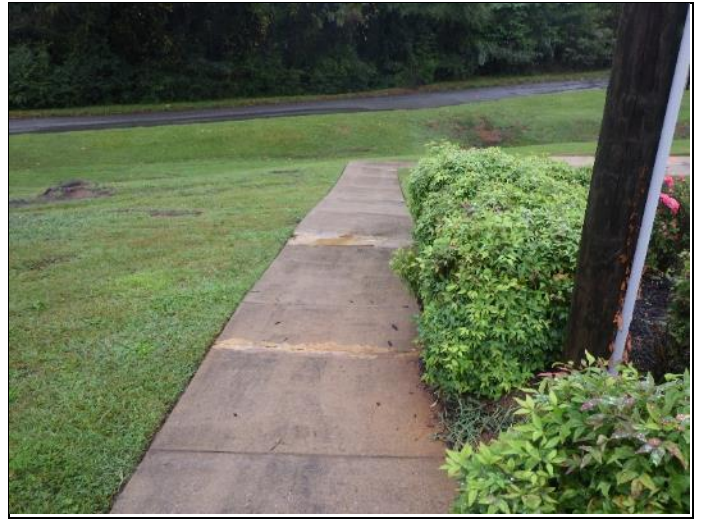
14. Ramp to the leasing office.

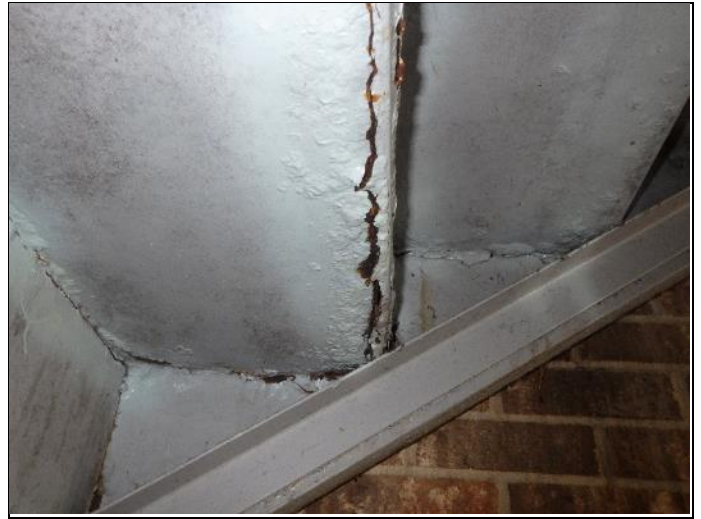
32. Cracked steel treads need repairing.

| Sect. No. | Deficiency or Repair Item | Quantity | Unit | Unit Cost | Immediate Repair | Short-Term Cost | Total Cost |
|---|--|---|---|---|---|---|---|
| 4.5 | Stairs and balconies appeared to be in good to fair condition. Corrosion of the steel framing and pans supporting the treads was observed on many of the stair systems. To avoid future failure of the steel components an investigation of all stairs is needed to quantify the number of treads that need replacement. Repair all corroding stair components at each building. | 10 | Bldgs | \$1,500 | | \$15,000 | \$15,000 |

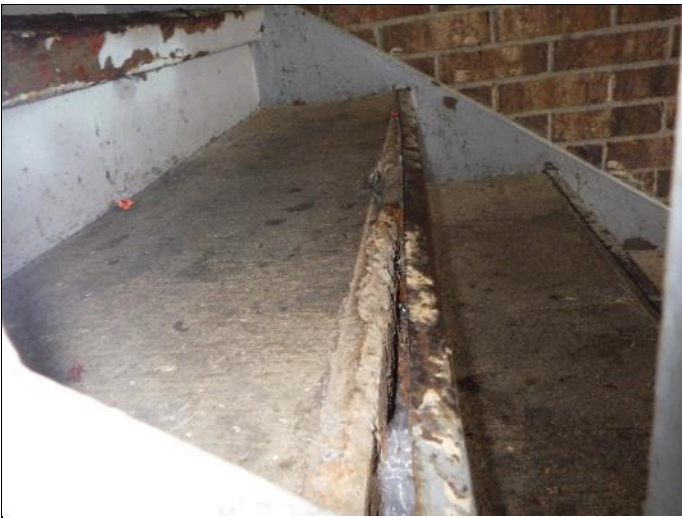
33. Corroding stair system needs repairs.

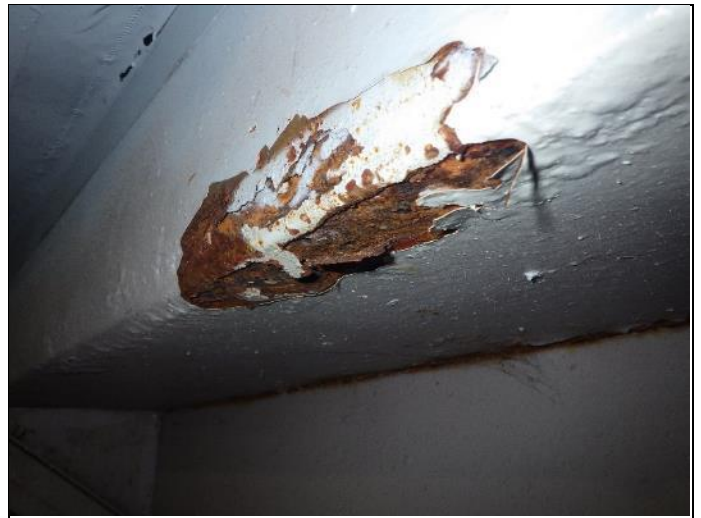
34. Corroding stairs need repairs.

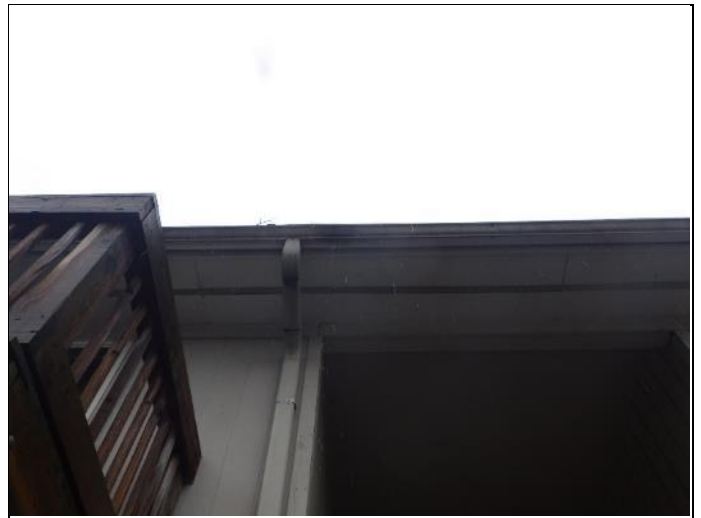
40. Roof drainage; note gutters in poor condition and need to be replaced on each building.

| Sect. No. | Deficiency or Repair Item | Quantity | Unit | Unit Cost | Immediate Repair | Short-Term Cost | Total Cost |
|---|--|---|---|---|---|---|---|
| 4.4.2 | The gutters and downspouts appeared to be in fair to poor overall condition. Many of the gutters were observed to be falling off the building. Holes in the gutters were seen dropping water. Based on age, condition and EUL, gutters and downspouts should be replaced immediately. | 11 | Bldgs | \$0.00 | | \$0 | \$0 |

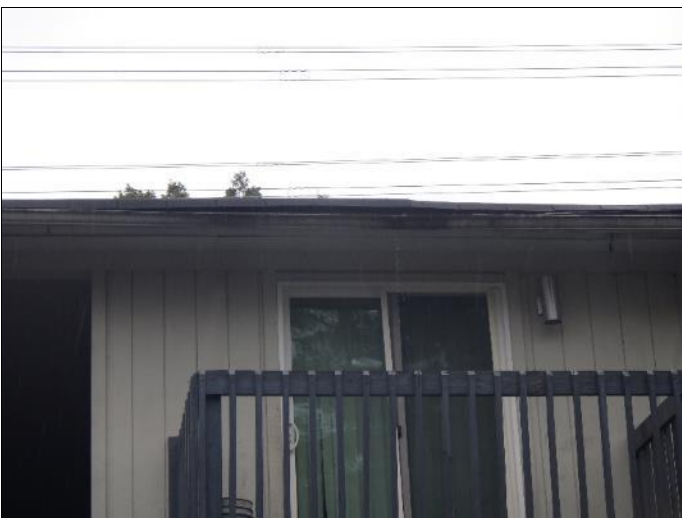
41. Roof drainage; note gutters in poor condition and need to be replaced on each building.

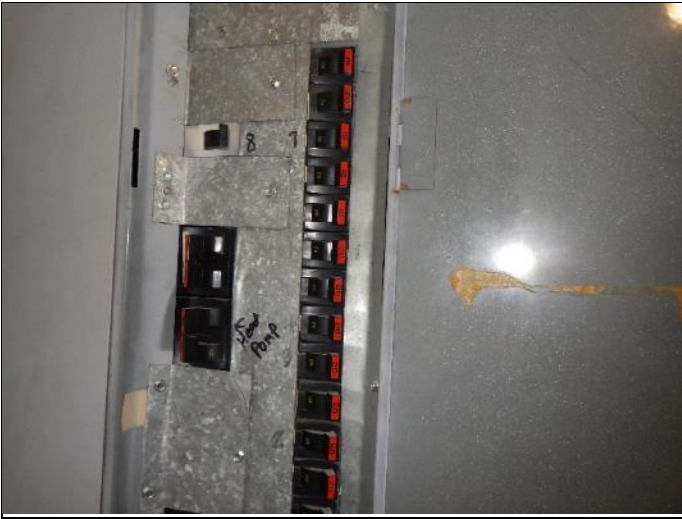
49. Federal Pacific panel in leasing office.

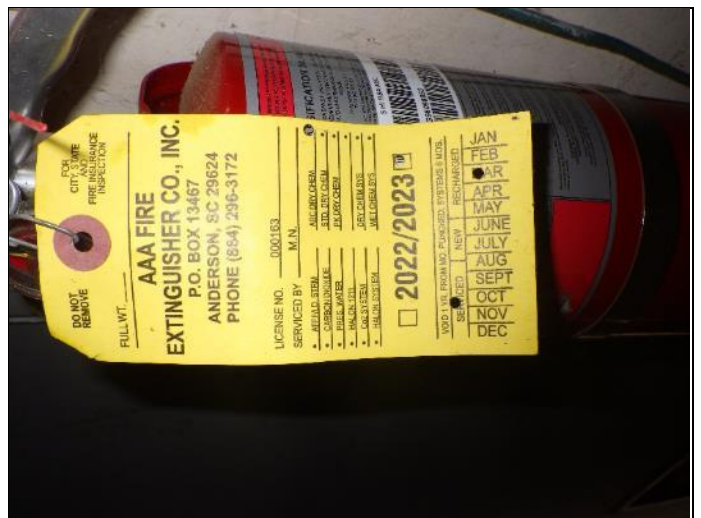
54. Extinguisher with expired tags; in common areas only.

| Sect. No. | Deficiency or Repair Item | Quantity | Unit | Unit Cost | Immediate Repair | Short-Term Cost | Total Cost |
|---|--|---|---|---|---|---|---|
| 5.5 | The fire extinguisher appeared to be in good to fair overall condition. The system is reportedly tested on an annual basis. Current inspection tags were observed on the fire extinguishers in each unit dated March 2024. However, fire extinguishers in common areas had expired tags (March 2023) and require immediate inspections. | 6 | EA | \$50 | \$300 | | \$300 |

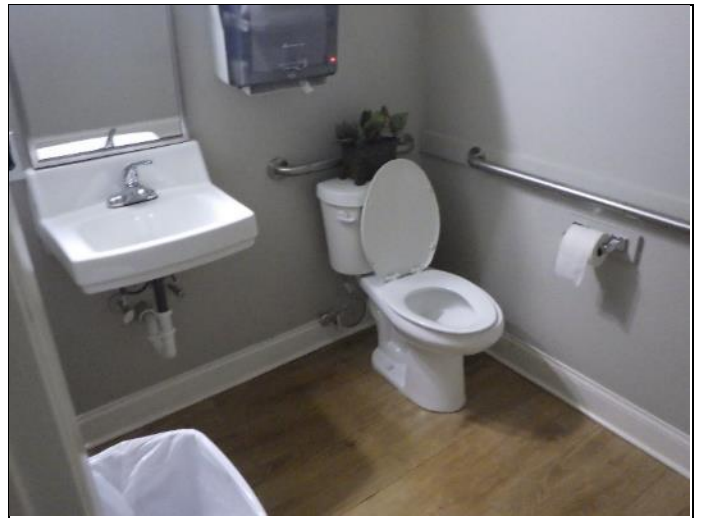
58. Restroom in leasing office needs pipe protection.

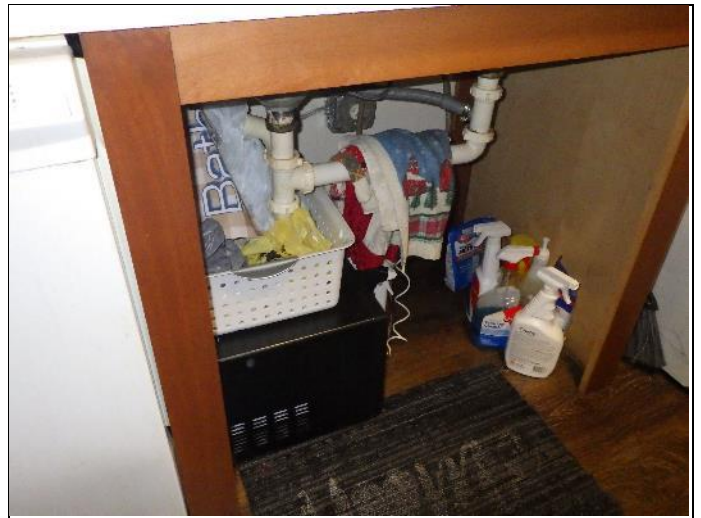
64. Designated accessible unit kitchen; note lack of pipe cover.

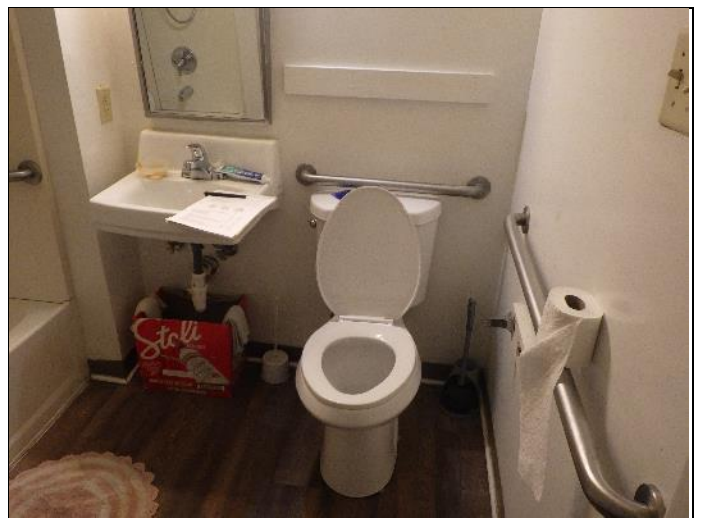
66. Designated accessible unit bathroom; note missing ptrap cover.

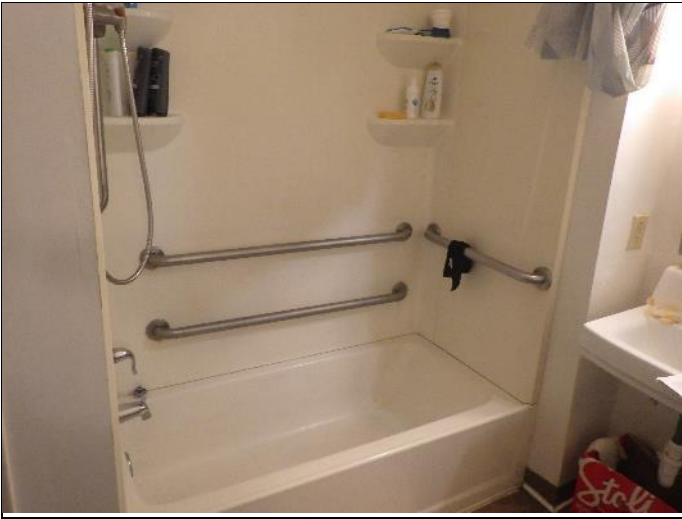
67. Designated accessible unit bathroom; note lack of shower seat.
