**CAPITAL NEEDS ASSESSMENT
NORTHGATE MANOR
220 BIBLEBROOK DRIVE
GREER, SOUTH CAROLINA 29651**

**D3G PROJECT NUMBER:
2024-1708**

**REPORT ISSUE DATE:
SEPTEMBER 27, 2024**

**INSPECTION DATE:
JULY 15 - 17, 2024**

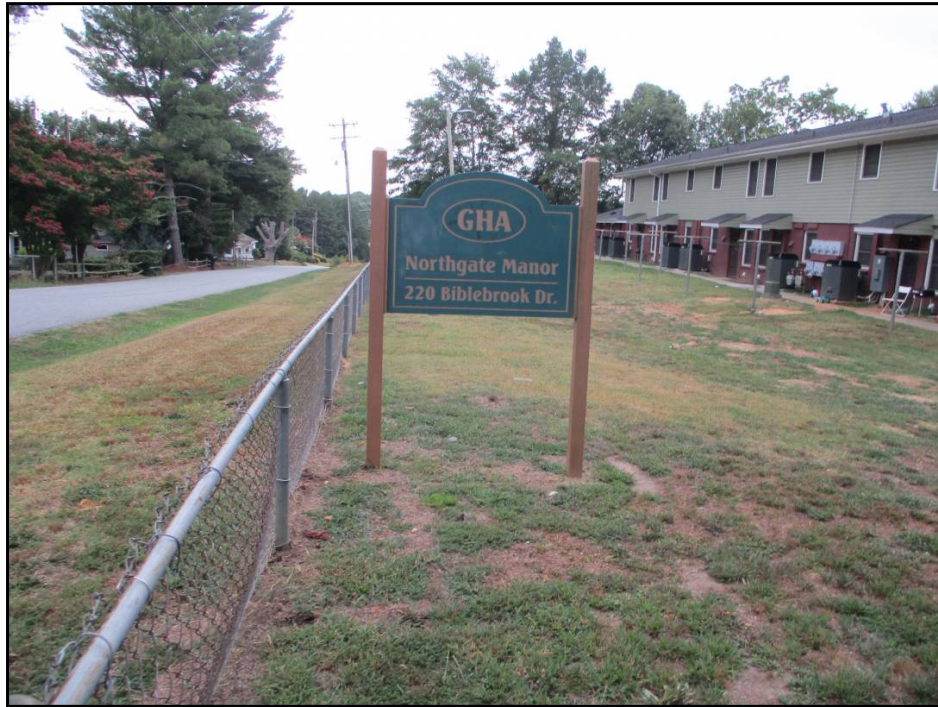
A wooden sign identifying the property as Northgate Manor is situated adjacent to the main driveway entrance to the site. The sign was observed to be in fair physical condition; however, it is nearing the end of its EUL and its replacement has been recommended (Non-Critical Repair).

1: Property Identification Sign

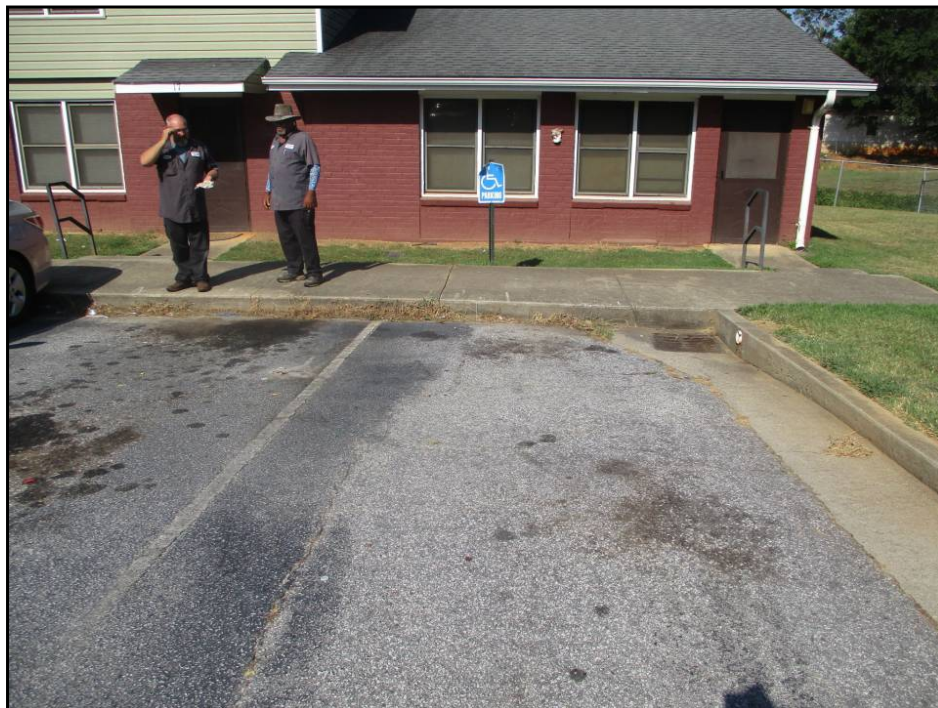
34: Non-Compliant Handicapped Parking Missing Access Aisle, Pavement Markings and Curb Access (Critical Repair)

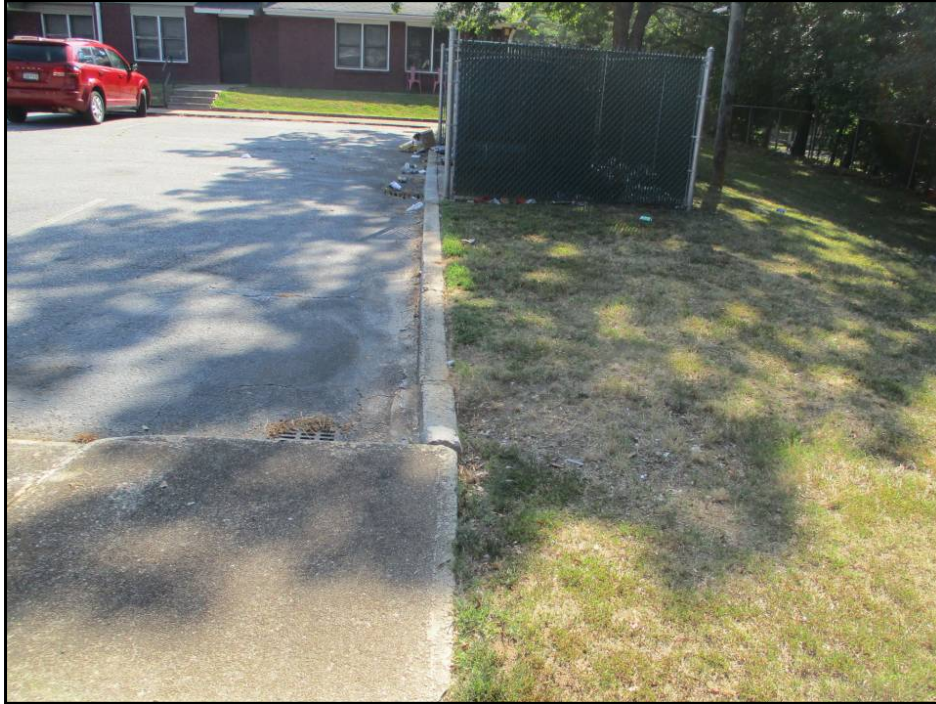
35: Non-Compliant Site Amenity (Dumpster) Missing Accessible Route (Critical Repair)

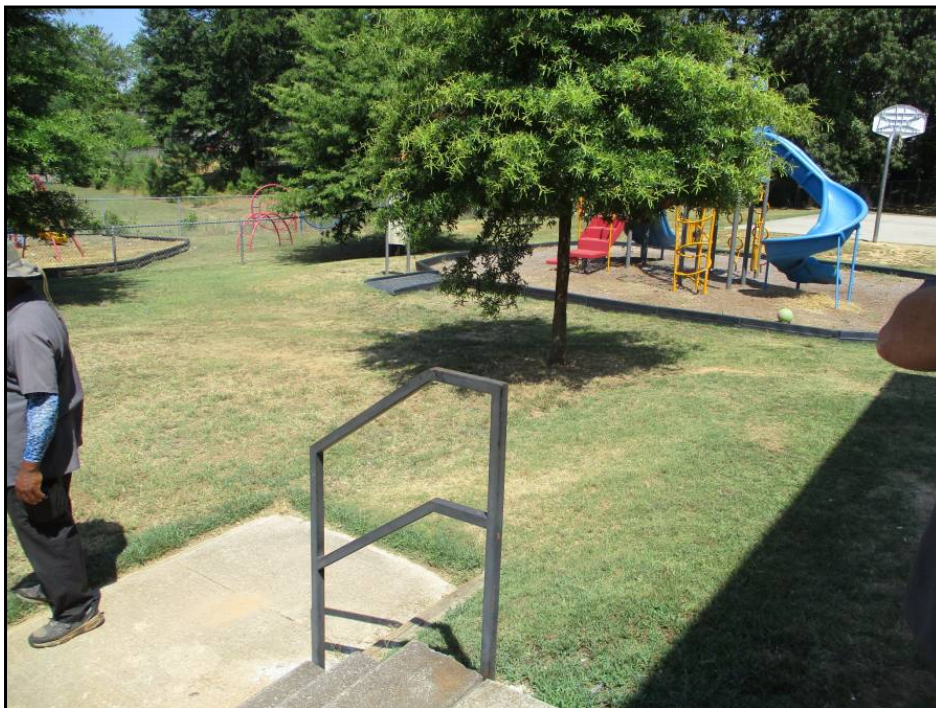
36: Non-Compliant Site Amenity (Playground, Gazebo) Missing Accessible Route (Critical Repair)

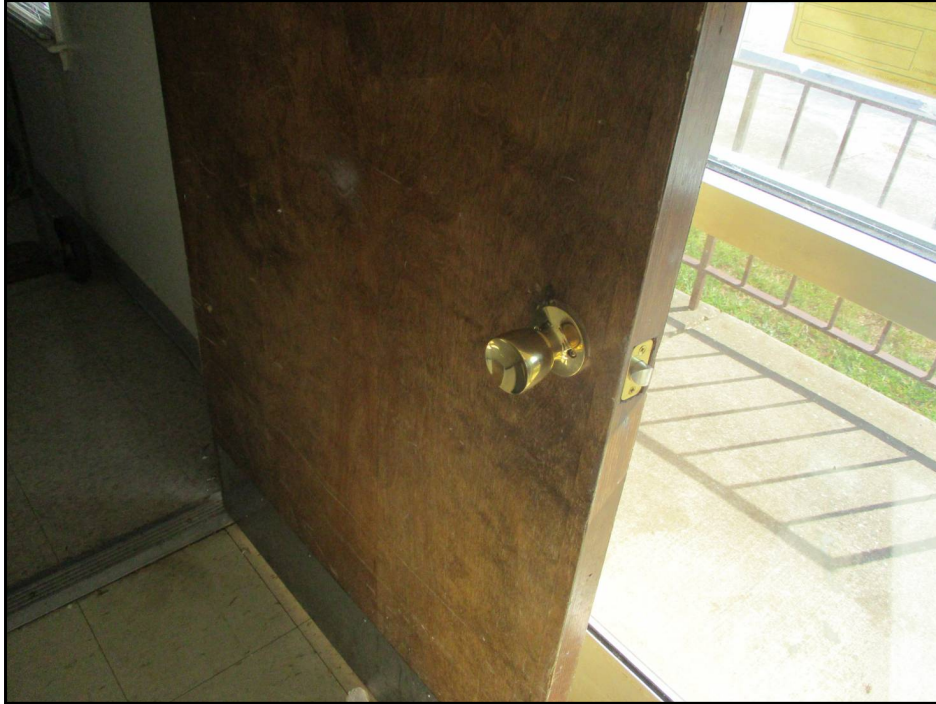
37: Non-Compliant Community Room Door Missing Levered Hardware (Critical Repair)

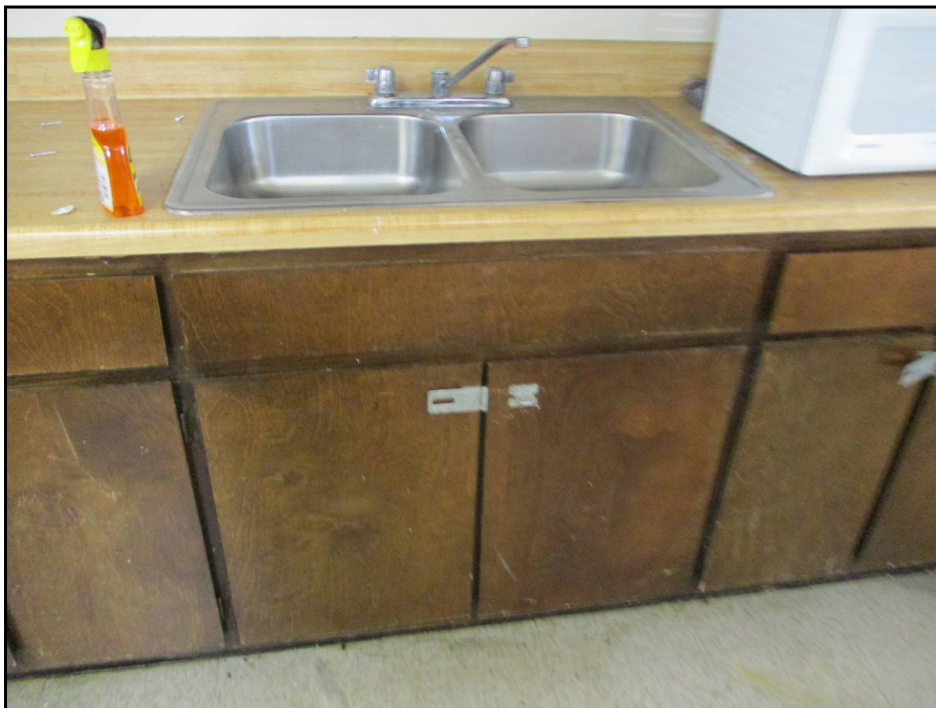
38: Non-Compliant Common Area Kitchen Sink Missing Roll-Under Access (Critical Repair)

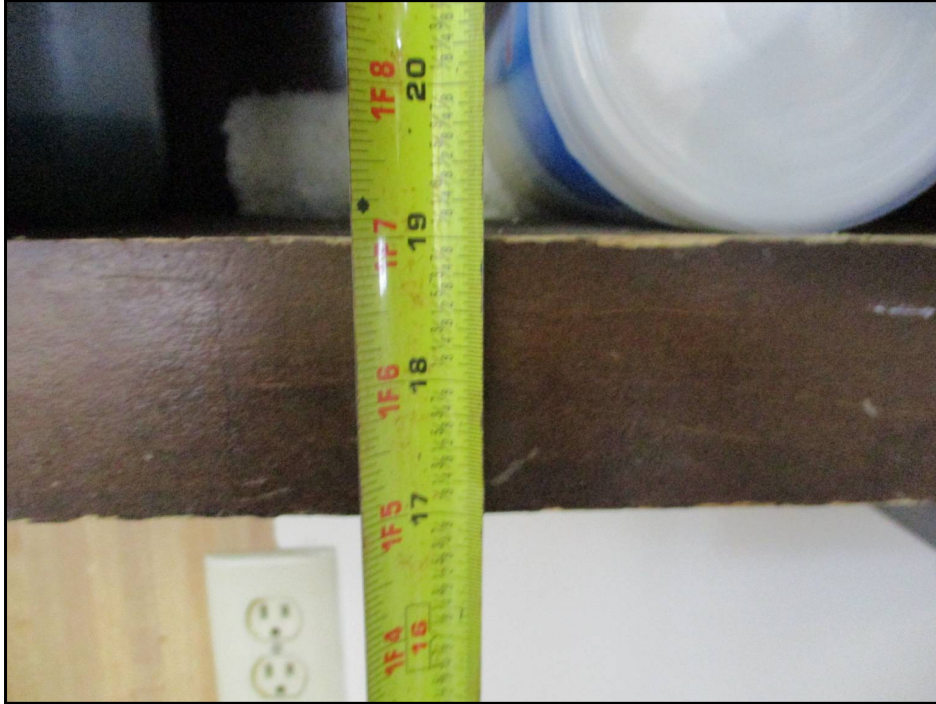
39: Non-Compliant Common Area Kitchen Wall Cabinet Height (Critical Repair)

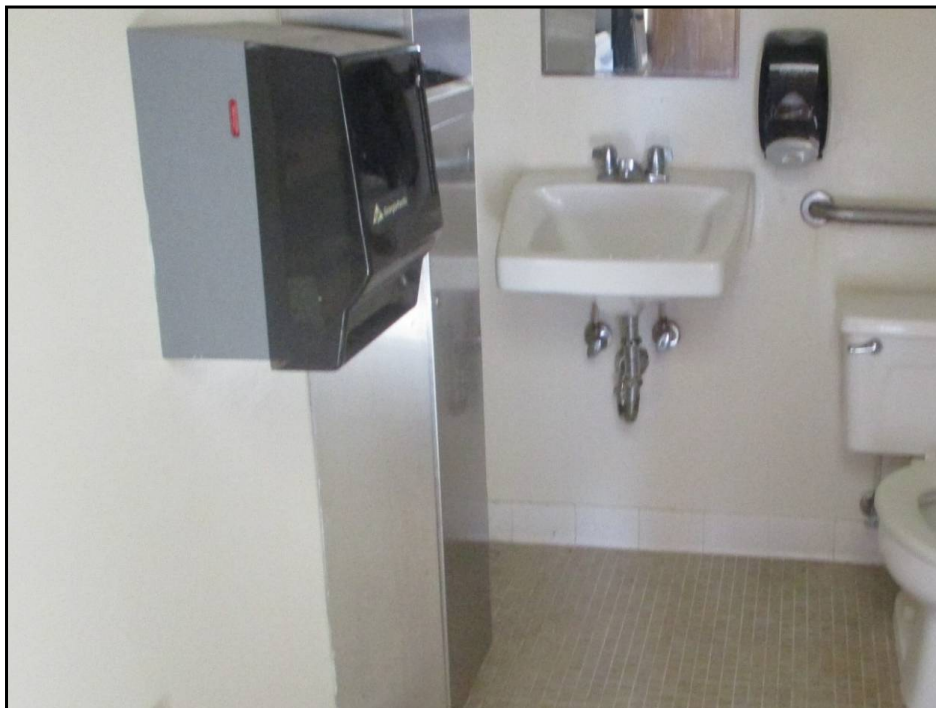
40: Non-Compliant Common Area Restroom Roll-Under Sink Missing Scald/Abrasion Protection (Critical Repair)

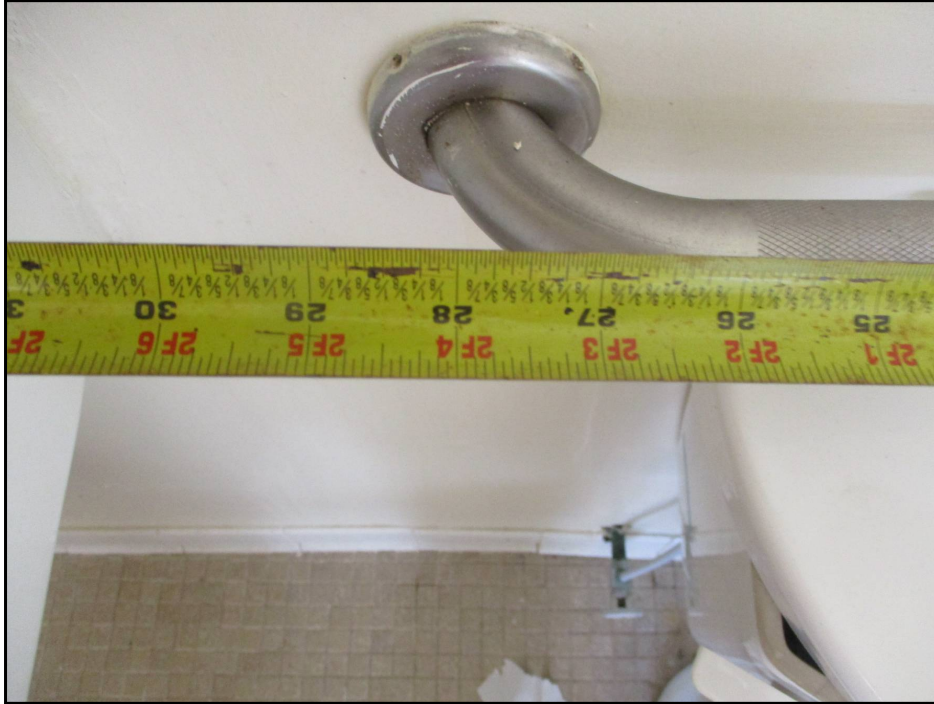
41: Non-Compliant Common Area Restroom Rear Toilet Grab Bar Length (Critical Repair)

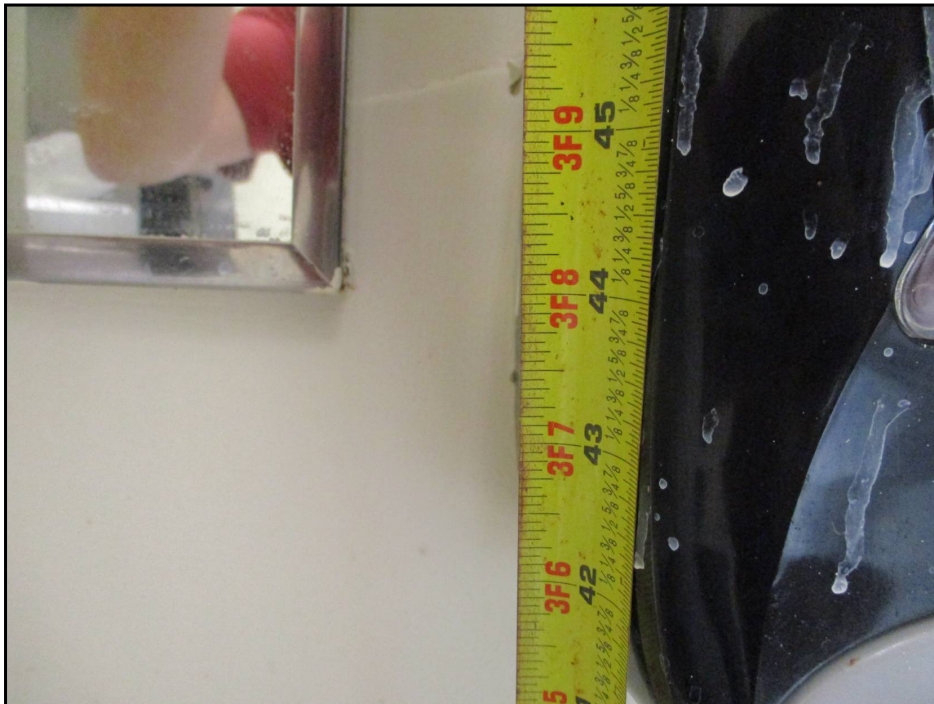
42: Non-Compliant Common Area Restroom Mirror Height (Critical Repair)

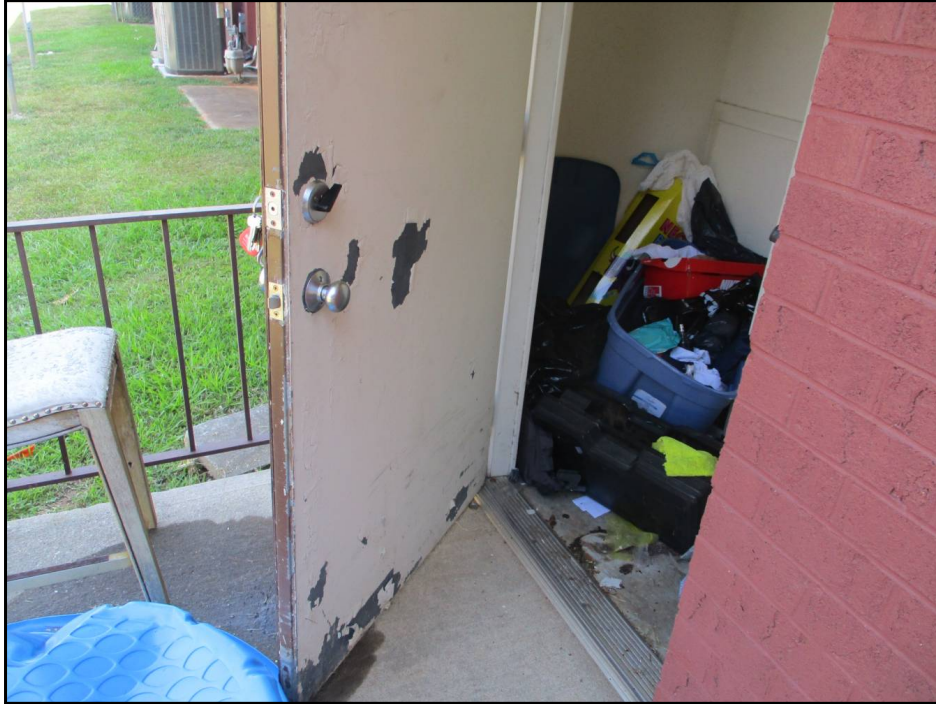
43: Non-Compliant Handicapped Dwelling Unit Exterior Storage Room Door Missing Levered Hardware (Critical Repair)

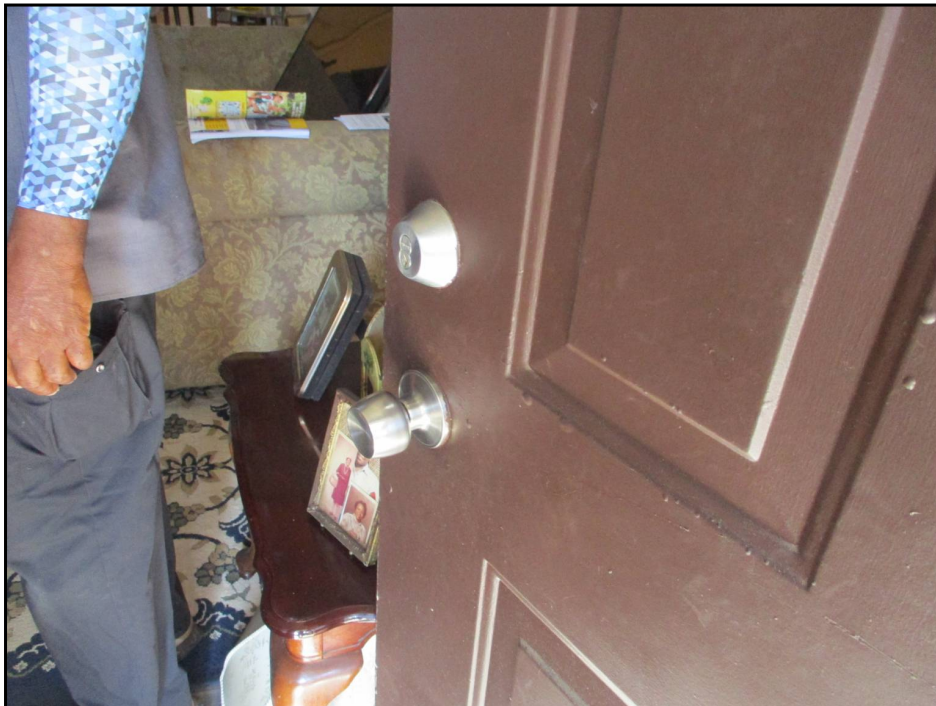
44: Non-Compliant Handicapped Dwelling Unit Entry Door Missing Levered Hardware (Critical Repair)

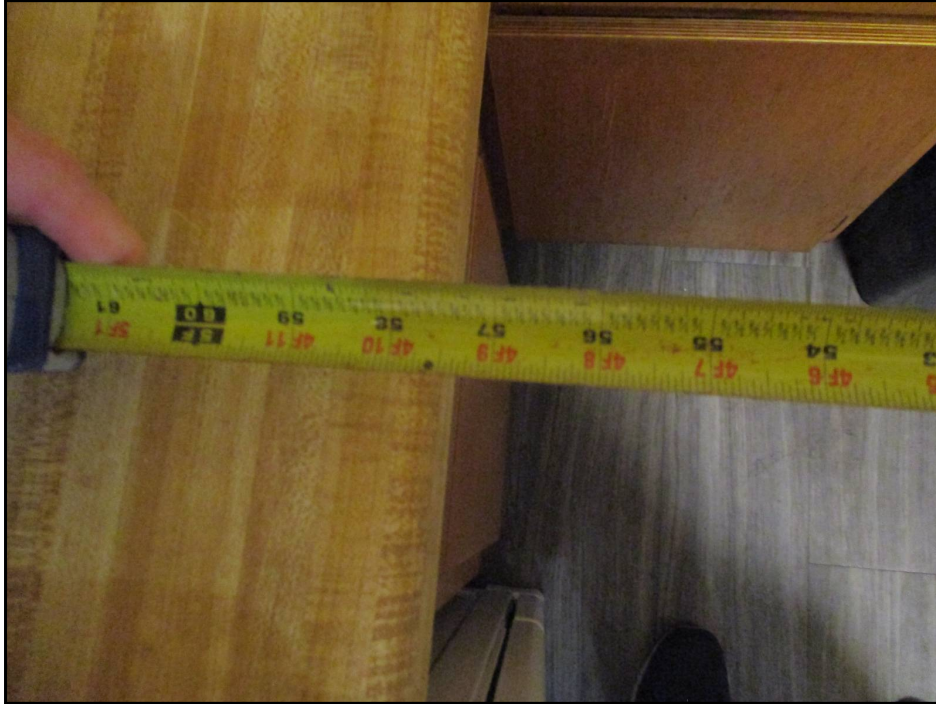
45: Non-Compliant Handicapped Dwelling Unit U-Shaped Kitchen Clear Floor Space (Critical Repair)

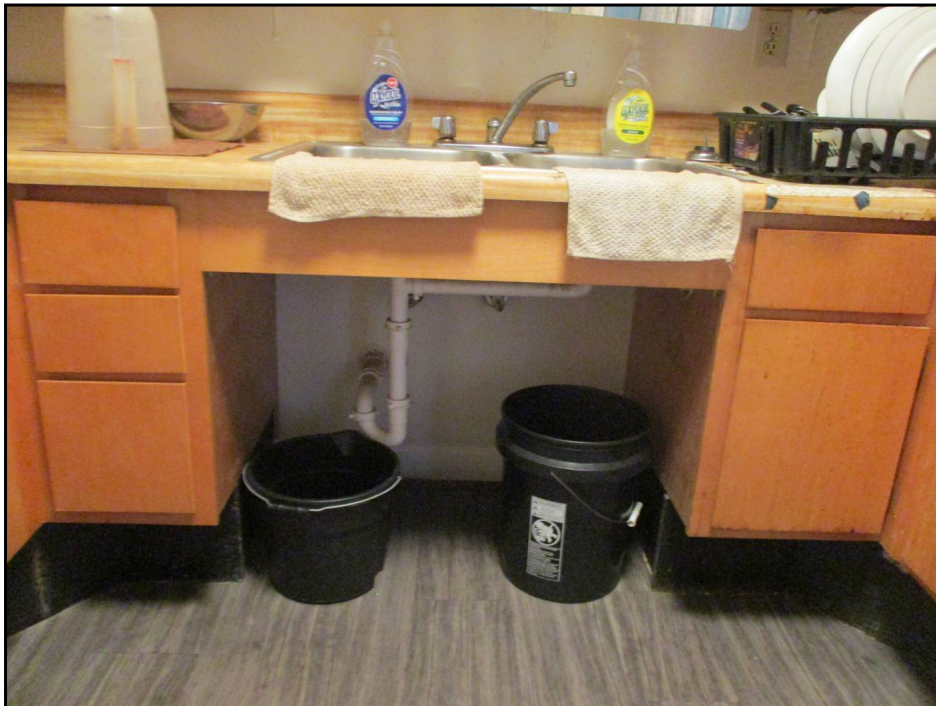
46: Non-Compliant Handicapped Dwelling Unit Kitchen Roll-Under Sink Missing Scald/Abrasion Protection and Levered Hardware (Critical Repair)

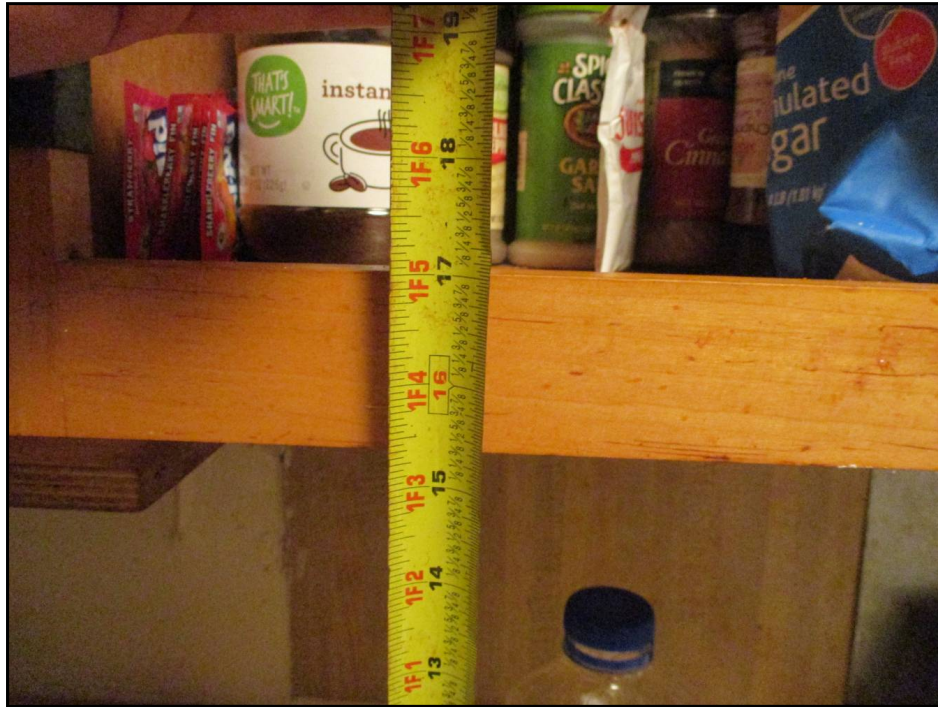
47: Non-Compliant Handicapped Dwelling Unit Kitchen Wall Cabinet Height (Critical Repair)

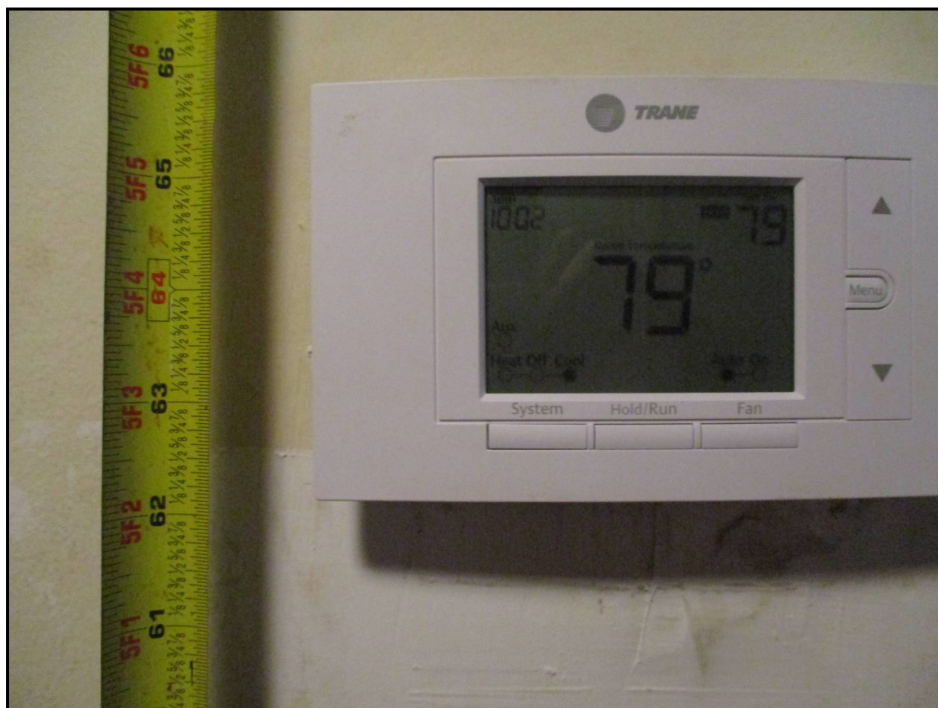
48: Non-Compliant Handicapped Dwelling Unit Thermostat Height (Critical Repair)

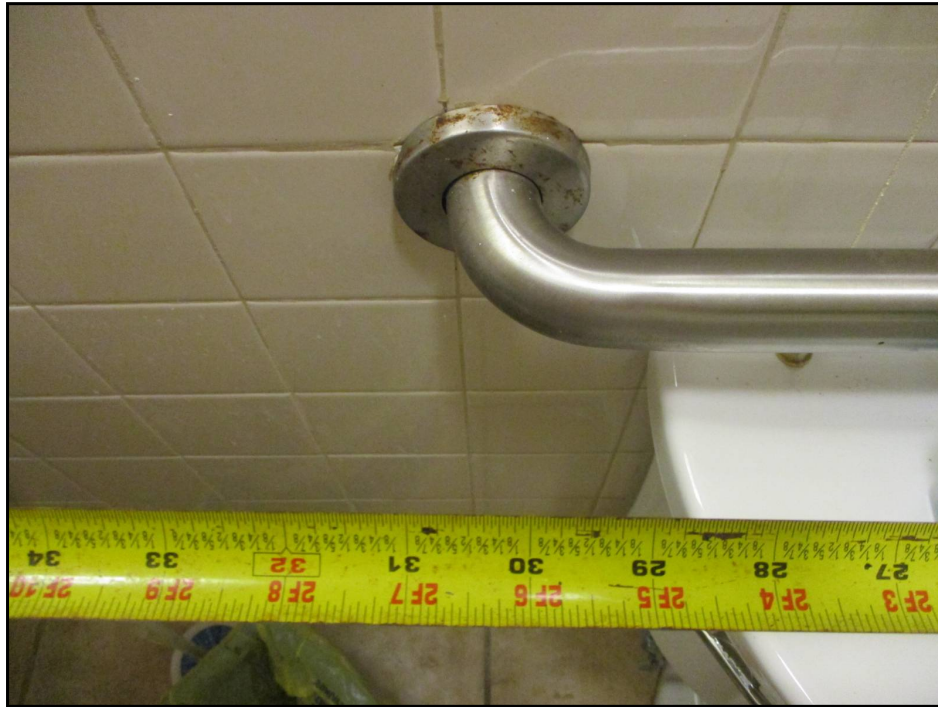
49: Non-Compliant Handicapped Dwelling Unit Bathroom Rear Toilet Grab Bar Length (Critical Repair)

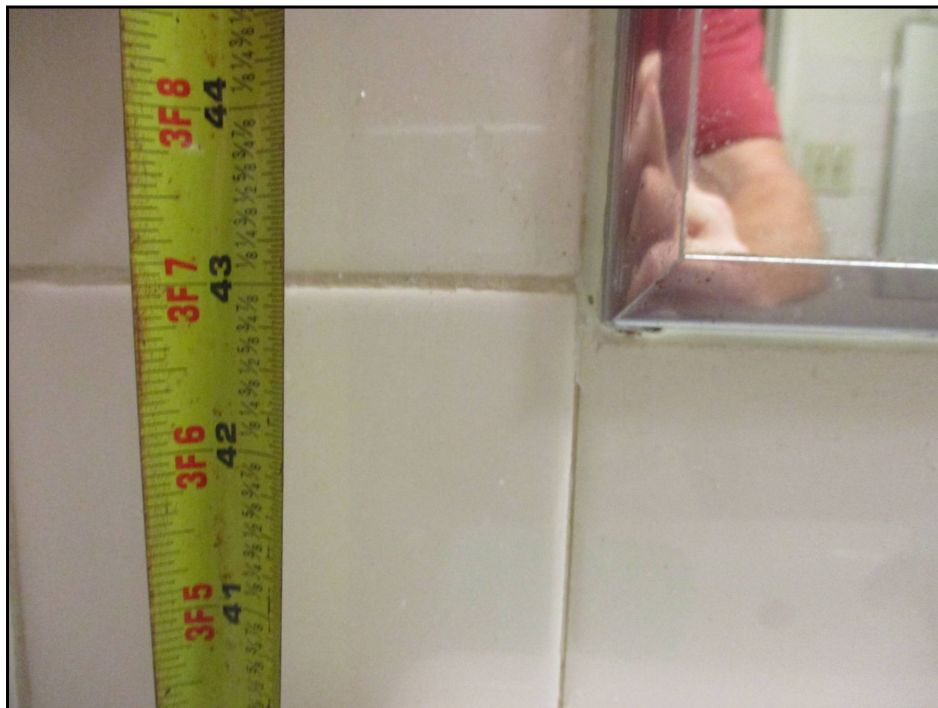
50: Non-Compliant Handicapped Dwelling Unit Bathroom Mirror Height (Critical Repair)

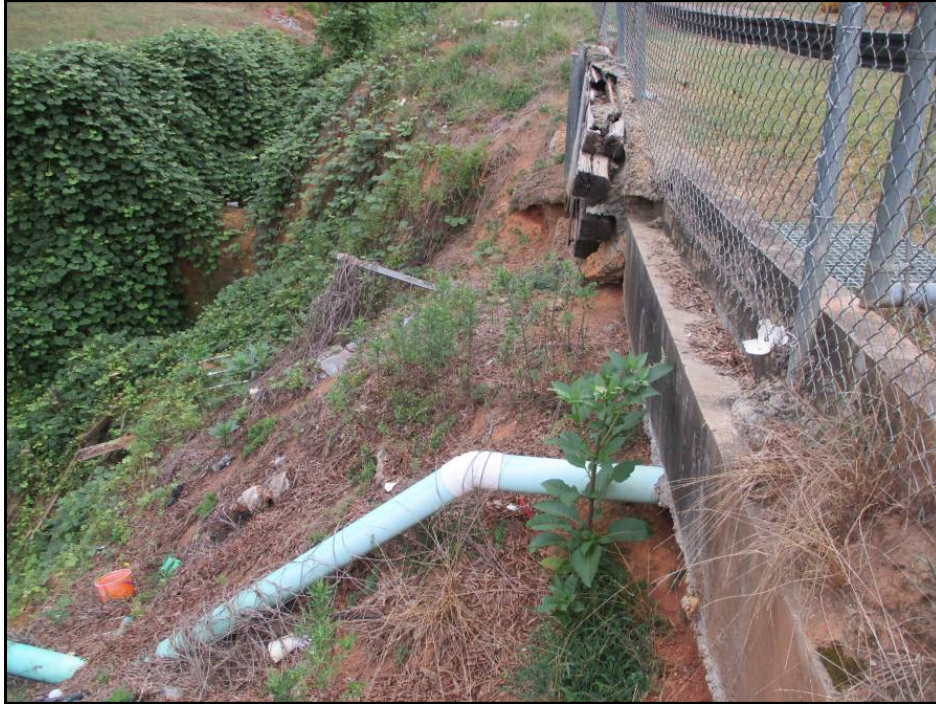
The topography of the property varies slightly across the site. The site has been graded to provide positive drainage away from the structures. However, the slope along the creek on the west perimeter of the site was observed with heavy erosion and retaining wall failure (Critical Repair). Storm-water drainage consists of surface percolation and storm sewer drains/catch basins.

The property features chain link fencing along the perimeter of the site and at the maintenance yard. The fencing was observed to be in fair to good physical condition, with the exception of the damaged sections caused by the erosion at the drainage creek. Additionally, the fencing is beyond its EUL and replacement has been recommended (Non-Critical Repairs).

1: Correct Erosion Issues and Repair Retaining Walls and Fencing (Critical Repair)

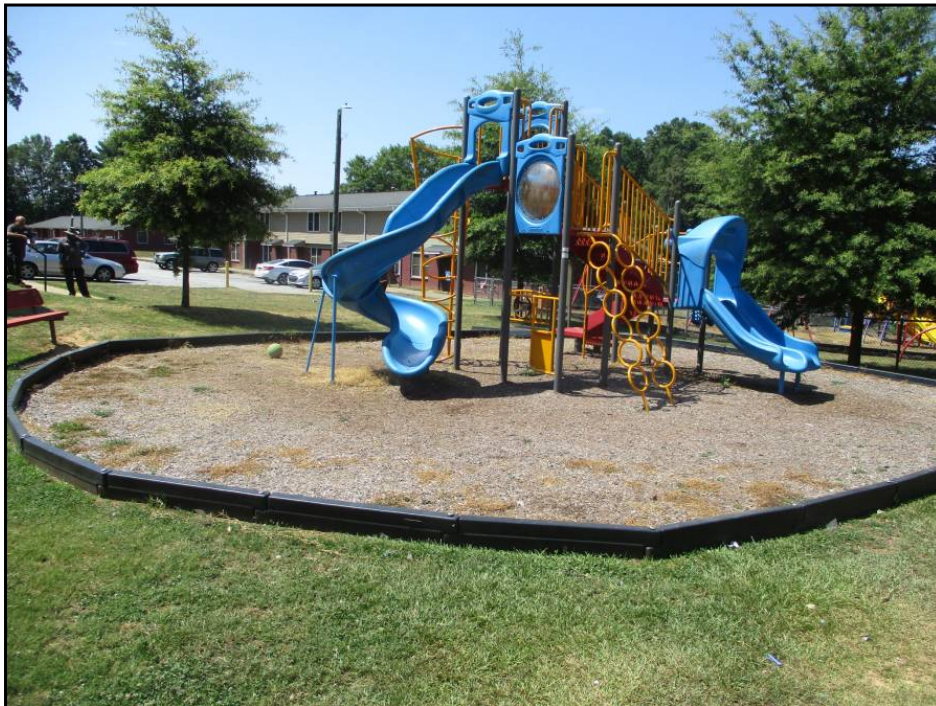
The property features a children's playground surrounded by chain link fencing that was reported and observed to be in poor physical condition and was closed for resident use due to safety concerns from the erosion issue along the west side of the site (Critical Repair). In addition, the site features a wooden gazebo and an additional children's playground that were reportedly installed in 2020 and were observed to be in good physical condition. However, the replacement of the playground equipment has been recommended (Non-Critical Repair).

2: Install Impact Absorbent Ground Cover at Playground- (Critical Repair)

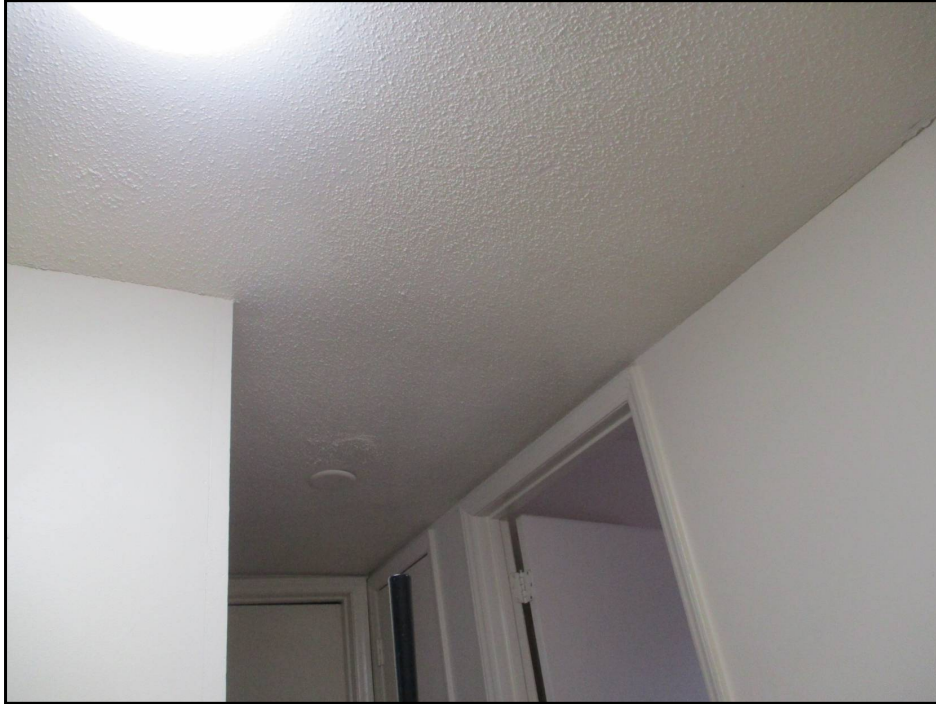
The dwelling units contain tamper-proof 10-year battery operated smoke detectors located on the 1st level of the townhome dwelling units, as well as within the bedrooms. However, the upstairs hallways do not feature any smoke detectors (Critical Repair). Per HUD MAP Guidelines; according to Life Safety Code (NFPA 101), paragraph 31.3.4.5.1, smoke alarms must be installed outside every sleeping area in the immediate vicinity of the bedrooms and on all levels of the dwelling unit, including basements. In addition to the NFPA requirements, the regulation in 24 CFR 200.76 requires that smoke detectors must also be installed inside each sleeping area. The smoke detectors can be either hard wired or battery powered. Battery powered smoke detectors must have the following features: the cell must be tamper-resistant; the cells cannot be used in any other toy or appliance; the cells must have a ten-year life (i.e. lithium battery); the smoke detector may have a manual silencing device to clear unwanted alarms such as cooking smoke. For the purpose of this report we have budgeted battery powered smoke detectors, allowable by the HUD MAP Guidelines. It is recommended to contact the local municipality to determine if battery powered smoke detectors are allowable.

3: Install Smoke Detectors in Townhome Dwelling Unit Upstairs Hallway- (Critical Repair)

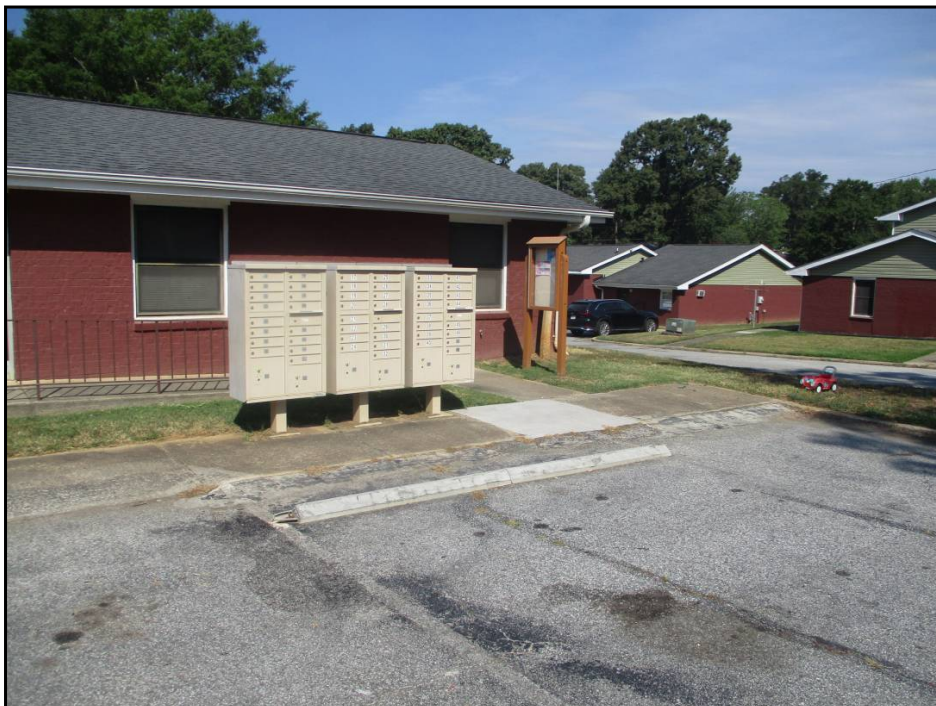
Additionally, the site features a metal framed smoking area shelter and wooden school bus shelter. Both structures were observed to be in fair physical condition; however, their replacement has been recommended (Non-Critical Repairs). Additionally, per SCSHFDA 2024 QAP requirements, the installation of a structure covering the mailbox kiosks is also required (Non-Critical Repair).

4: Install Overhead Cover at Exterior Mailbox Kiosks- (Non-Critical Repair)

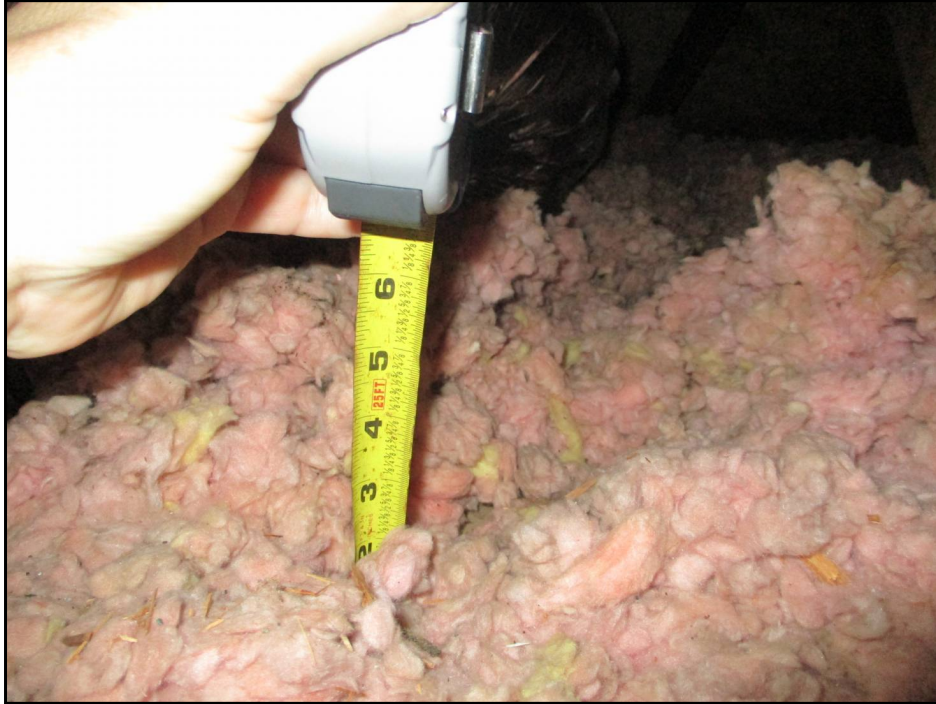
Select attics within the apartment buildings were inspected and no evidence of moisture was observed. Penetrations and attic air bypasses are properly sealed. Attics feature approximately 6-inches of loose-fill blown cellulose insulation. Based on depth and type of insulation, it is estimated that there is approximately R-18 of insulation within the attics; however, per SCSHFDA 2024 QAP requirements, the installation of additional insulation to achieve a minimum R-value of 30 is required (Non-Critical Repair).

5: Install Code Compliant Attic Insulation- (Non-Critical Repair)

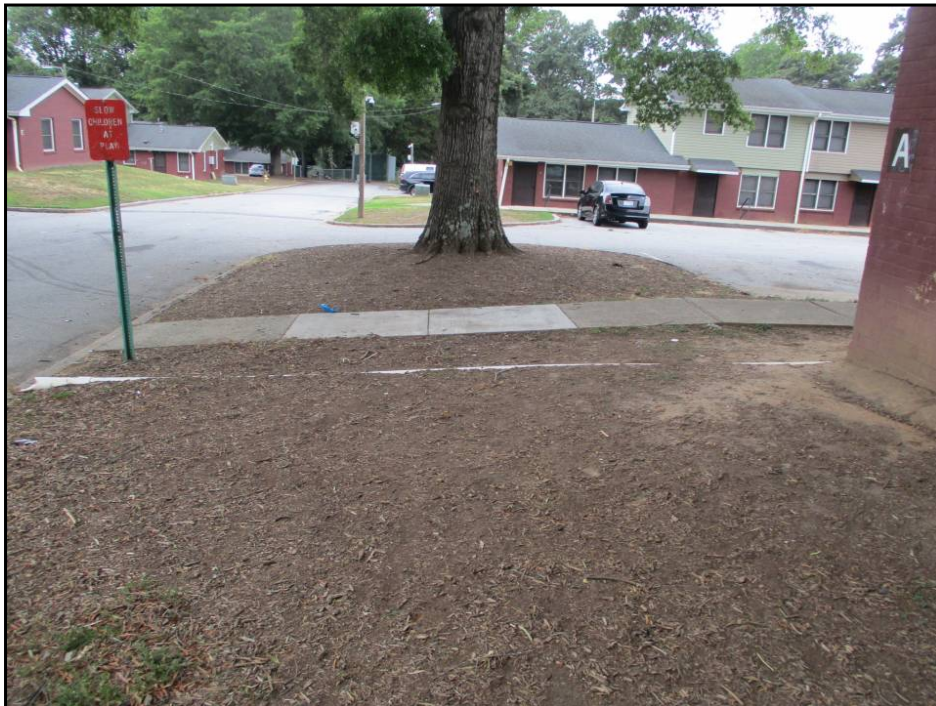
The property landscaping consists of trees, shrubs, and grasses situated throughout the site. The existing landscaping was observed to be in fair physical condition, with the exception of areas of bare ground and erosion noted (Non-Critical Repairs). The site does not feature an irrigation system.

6: Overseed / Landscape Bare Landscaping Areas- (Non-Critical Repair)
