**PHASE I ENVIRONMENTAL SITE ASSESSMENT  
NORTHGATE MANOR  
220 BIBLEBROOK DRIVE  
CITY OF GREER, SPARTANBURG COUNTY, SOUTH CAROLINA  
29651**

**D3G PROJECT NUMBER:**  
**2024-001708**

**REPORT ISSUE DATE:**  
**OCTOBER 17, 2024**

**PREPARED FOR:**  
**GREENVILLE HOUSING FUND  
1615-A WADE HAMPTON BOULEVARD  
GREENVILLE, SOUTH CAROLINA 29609**

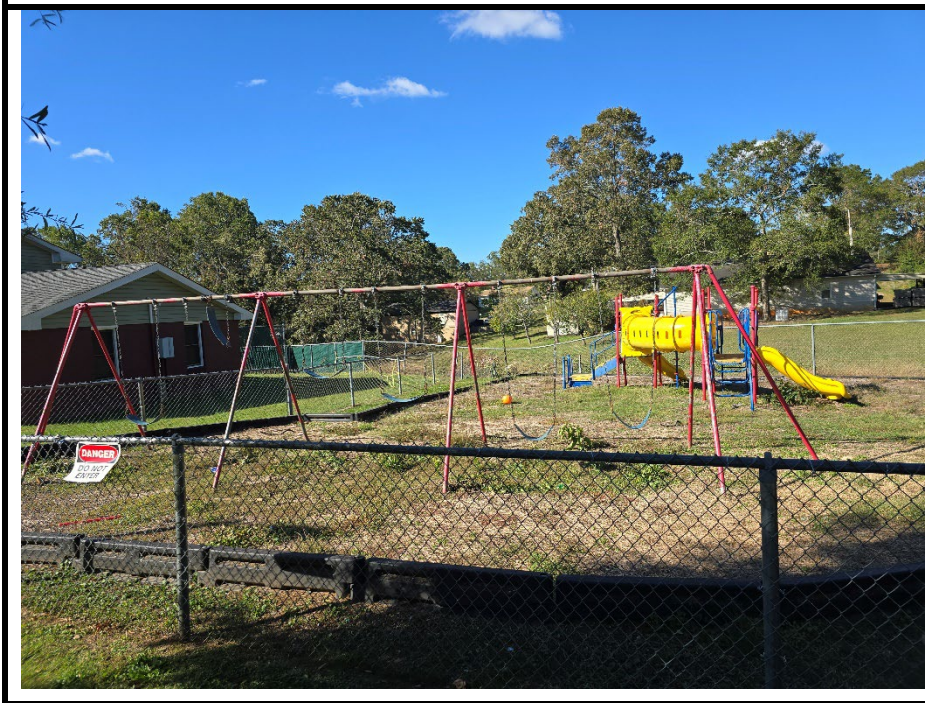
4. Playground 2 – not in use, to be demolished

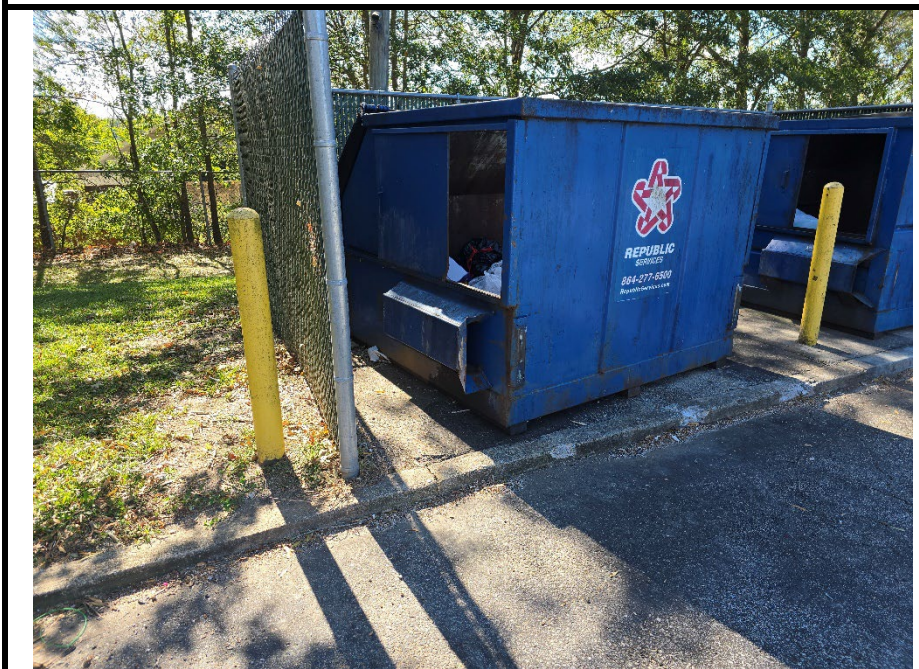
The exterior bollards (both metal and concrete) were identified to be deteriorated. Component removal and replacement or paint stabilization is warranted. The remainder of the identified LBP was noted to be in an intact condition.

10. LBP Hazards for  
Bollards at Dumpster  
in Bldgs E/F Parking  
Lot

(1) D3G recommends utilizing interim controls (i.e. paint stabilization) to address the identified paint-dust hazards or removing the components. If the components are removed, no further evaluations for LBP would be warranted. If the LBP components are not removed, they will be required to be managed under a site-specific Operations and Maintenance (O&M) Program. In addition, all renovation and maintenance workers who may impact LBP are also required to have a one-day EPA renovator class when working in residential facilities constructed prior to 1978 that contain LBP and any impacts to LBP must be conducted in accordance with EPA regulations.

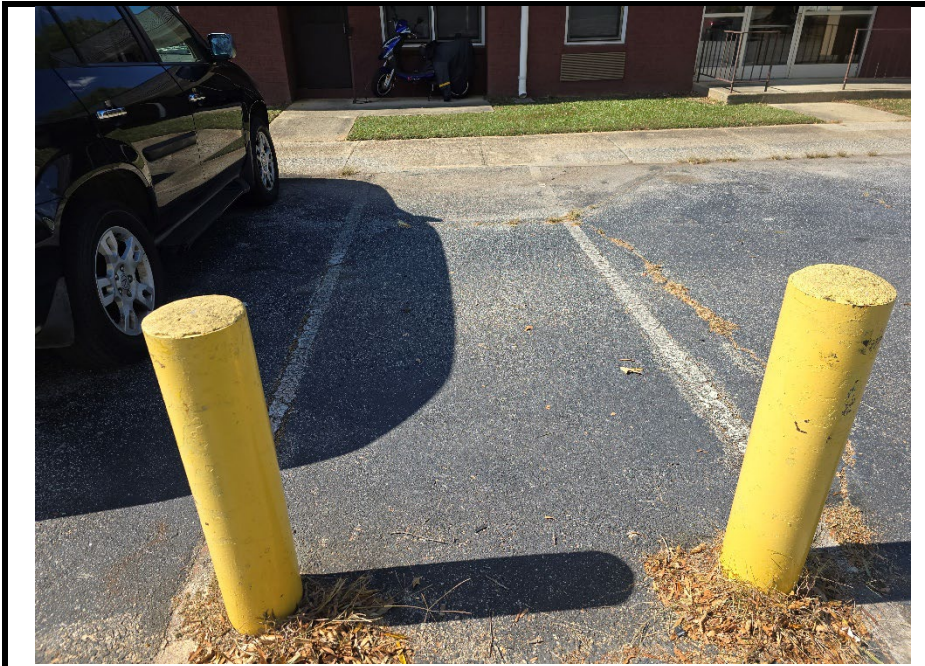
11. LBP Hazards at  
Bollards in Parking Lot  
of Bldg E

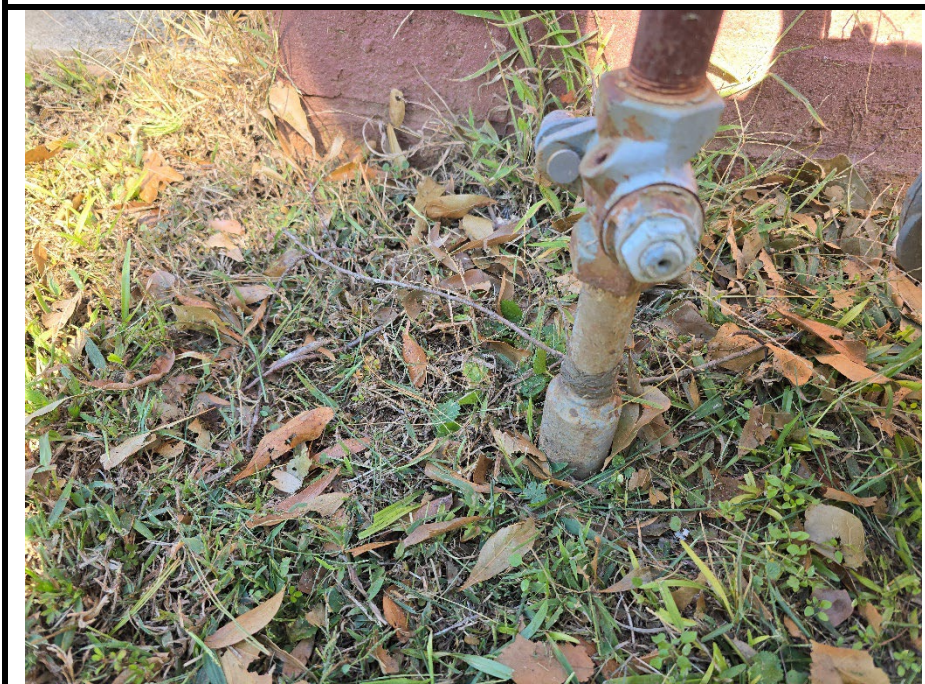
12. LBP on Gas Pipe Nut
