**Physical Needs Assessment  
As Is  
West Yards Lofts Apartments**  
2375 Noisette Blvd.  
North Charleston, SC 29405

**Report Date- 06/16/2025  
ID# 05162025-1-FINAL**

Unit Count: 60  
Bld Count: 1  
Family  
2010

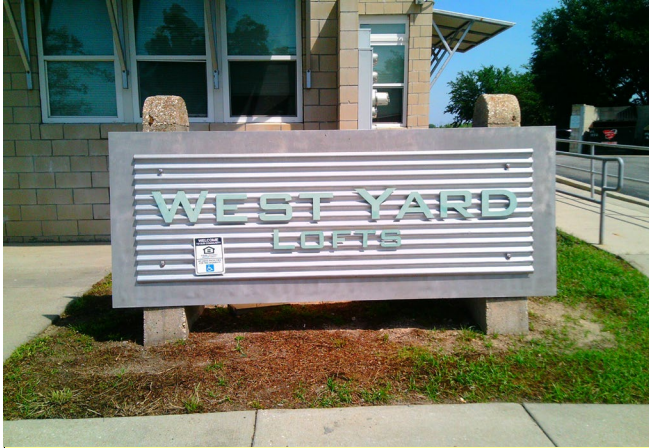
Site Sign

| <b>Signage</b> | <p>Site identification is provided by one monument sign at the site entrance. The sign is an unknown age but assumed to be original to the date of construction. The sign did not show any sign of damage or deterioration and based on the age and effective useful life replacement of the sign is not anticipated thus a cost has not been included in the Capital Needs Over the Term Spreadsheets.</p> |

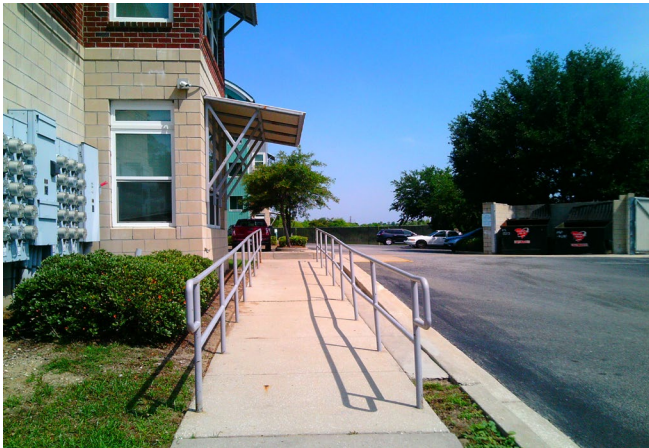
Sidewalk

| Sidewalks | Sidewalks are constructed of cast-in-place concrete assumed to be 4" in thickness. The sidewalks seem to be in good condition and have had repairs and replacement at various areas around the property. Based on the effective remaining life of the sidewalks and the needs observed repairs are anticipated during the term thus a cost has been included in the Capital Needs Over the Term Table. |

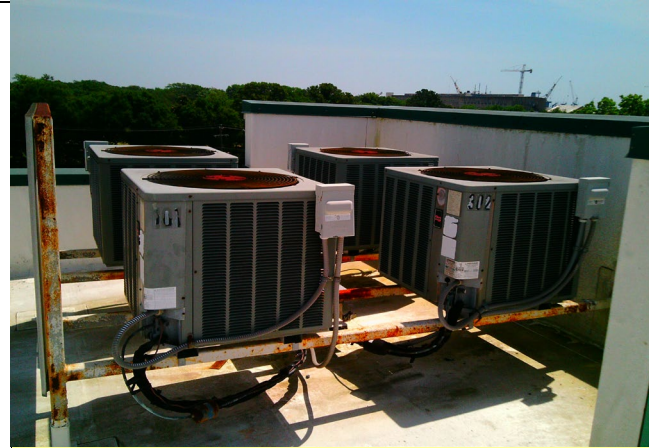
HVAC Units

| Item | Observations/Comments |
|---|--|
| HVAC | <p>The common area is equipped with two 14 SEER electric central HVAC systems of an unknown age. A replacement cost has been included in the Capital Needs Over the Term Table.</p> <p>HVAC within the dwelling units is discussed in Section D, below.</p> |

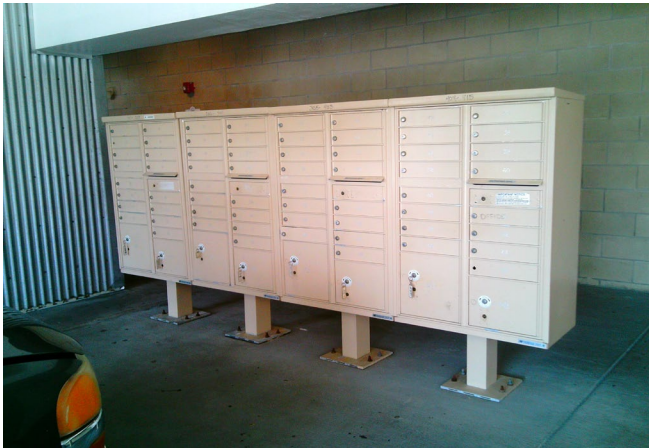
Mailboxes

| <b>Mail Facilities</b> | <p>The post mounted mailboxes are centrally located at the site and appeared to be in good condition. The mail boxes are an unknown age but it is reasonable to assume they are original to the date of construction. Based on the estimated age of the mailboxes and the remaining useful life, replacement over the term is not anticipated thus a cost to complete this work is not included in the Capital Needs Over the Term Table.</p> |

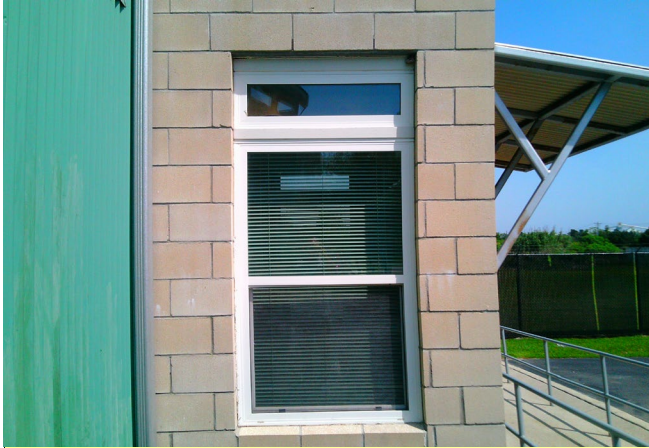
Exterior Window

| Item | Observations/Comment |
|---|--|
| <b>Windows/Doors</b> | <p>The front exterior doors that access each dwelling unit and common area doors are insulated metal doors set in a wood door frame. The front and rear doors seemed to be original to the date of construction. The dwelling unit windows are original vinyl framed single hung windows. The interior access and closet doors are standard hollow core hinged doors that were well maintained and original to the date of construction.</p> <p>The interior and exterior doors appeared to be well maintained and in good condition. Based on the effective remaining life of the exterior and interior doors and windows replacement is anticipated during the term, thus a cost has been included in the Capital Needs Over the Term Table. The staff replaces the window glass when necessary.</p> |

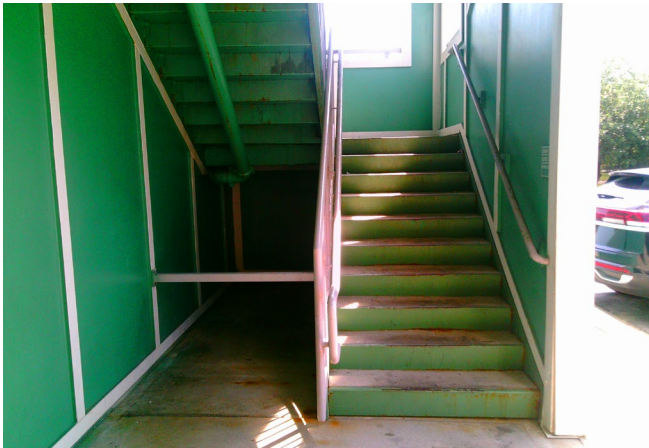
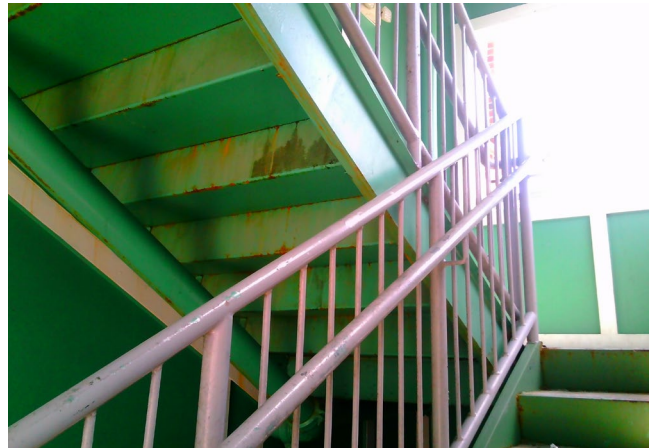
| Item | EUL | AGE | RUL | Cond | Action | DUR | QTY | Unit | Unit Cost | Total Cost | Comments |
|---|---|---|---|---|---|---|---|---|---|---|---|
| Stair, Exterior: tread - metal, concrete filled | 40 | 15 | 1 | Fair | Maintain | 1 | 2 | ea | 90000 | 180000 | significant repairs are needed |

Exterior Stairs

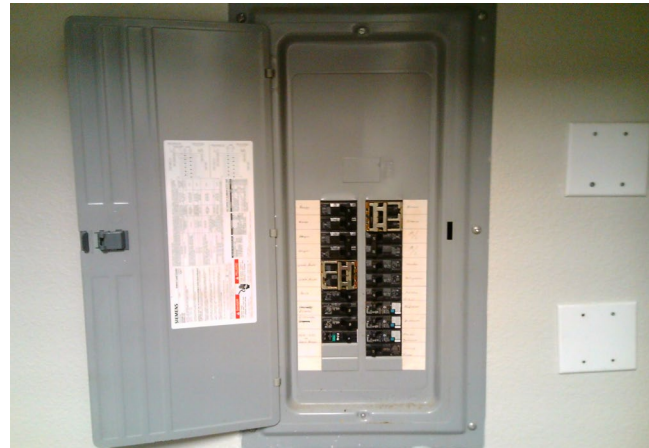
Electrical Panel Box

| Item | Observations/Comments |
|---|--|
| Electrical | <p>The electrical service is provided underground from pad-mounted transformers that feed electrical meter mounted with main disconnect panels on the exterior of the buildings.</p> <p>The electrical service to each unit is rated at 150 amps, 2 pole, 240 volt rating. The branch circuit distribution wiring is reportedly copper. A GFI outlet is provided in the bathrooms and in some of the kitchens. Some of the units that were tested were not functional. Management was aware of the deficient GFCI outlets and in the process of making the necessary repairs.</p> <p>No problems with system capacity or the circuit breakers were reported. The equipment appears to be in generally good condition. Based on the effective remaining life, routine maintenance is anticipated during the term.</p> |

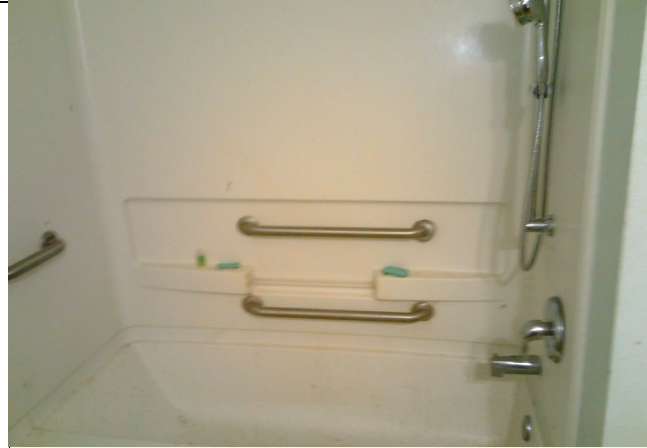
ADA Shower/Tub

The tubs and surrounds are fiberglass tubs and surrounds and are in good condition and estimated to be original to the date of construction. Based on the effective remaining life, replacement of the bathtubs and surrounds in the dwelling units is anticipated over the term thus a cost is included in the Capital Needs Over the Term Table.

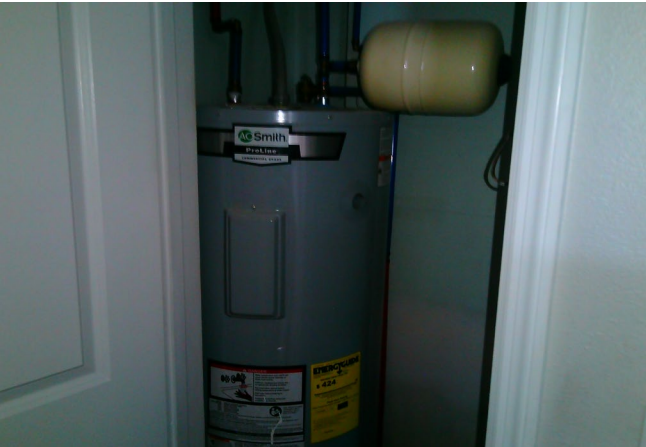
Hot Water Heater

The property is equipped with a 40 gallon electric hot water heater in each of the units. All of the inspected units are of mixed age but appeared to be in serviceable condition. Replacement of the hot water heaters is anticipated thus a cost has been included in the Capital Needs Over the Term Table.

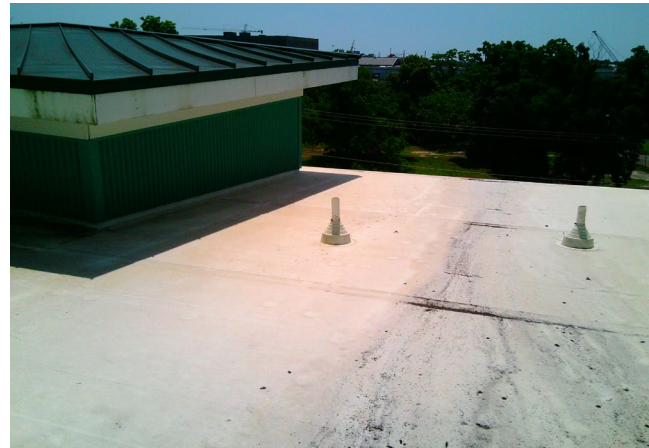
Roof

| Item | Observations/Comment |
|---|--|
| <b>Roof</b> | The building has a flat membrane roof system that is original to the date of construction. Venting of the attic spaces is achieved by ridge vents. Roof drainage is provided by metal gutters and downspouts that empty to splash blocks. There was no information as to the age of the roofing material thus for the purposed of this report it is assumed that it is original. Based on the effective useful life replacement is anticipated over the term, a cost for this item has been included on the Capital Needs Over the Term. |
