PROPERTY CONDITION ASSESSMENT

Palms on Ashley River

4370 Ladson Road
Summerville, South Carolina 29456

June 3, 2025

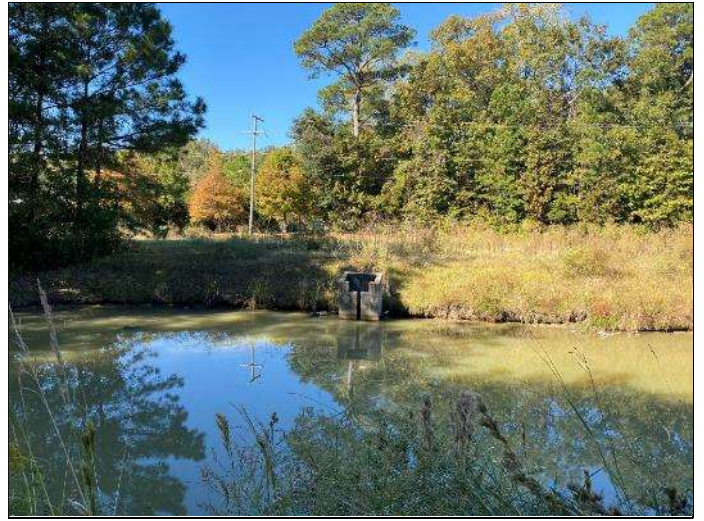
14. Retention pond; note tilted standpipe

3.0	Site Improvements						
3.2.1	Precipitation was not present during the site assessment; consequently, direct observation of the operation of the storm water drainage system was not possible. Evidence of improper operation was not readily apparent. The detention pond was observed littered with rubbish. Additionally, the concrete standpipe serving the pond appeared to be tilted. Therefore, clearing of all rubbish from the pond and repair to the standpipe to maintain adequate drainage of the pond is recommended.	1	LS	\$5,000		\$5,000	\$5,000

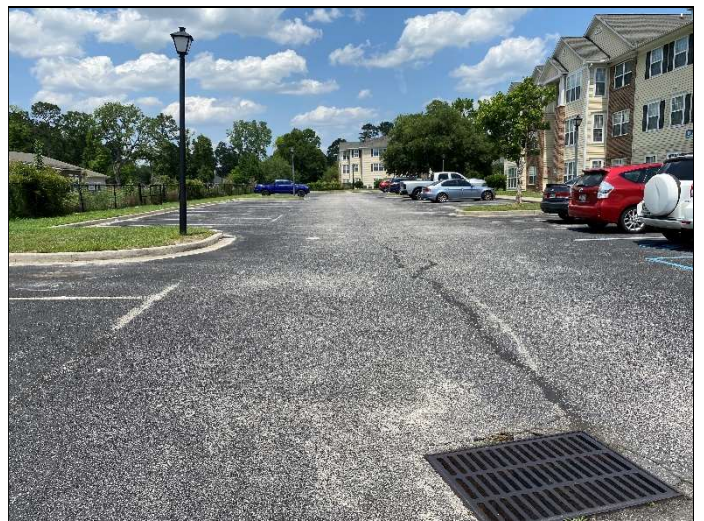
18. Asphalt pavement near Building D; note map cracking

3.2.2	Pavement appeared to be in good to fair structural condition. Map cracking was observed along the driving lane located to the west of Building D. Replacement of the noted area is recommended.	7,000	SF	\$3.00		\$21,000	\$21,000

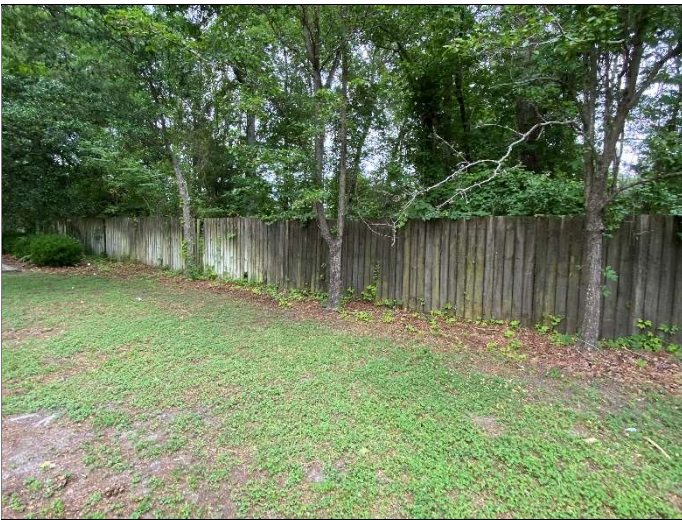
21. Wood plank fencing; note condition

3.2.7	Wood privacy fencing appeared to be in fair overall condition. Several wood boards were missing or damaged and a majority were observed with mildew and/or ivy growth. Based on age, condition, and EUL, replacement of the fencing system is recommended.	775	LF	\$25		\$19,375	\$19,375

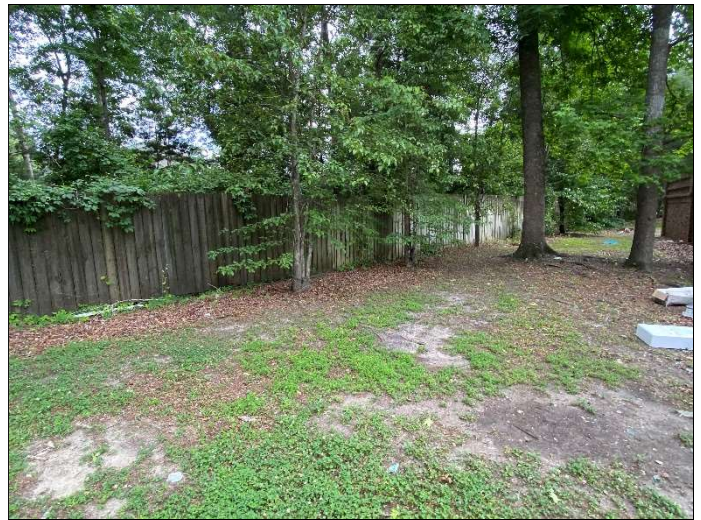
22. Wood plank fencing; note condition

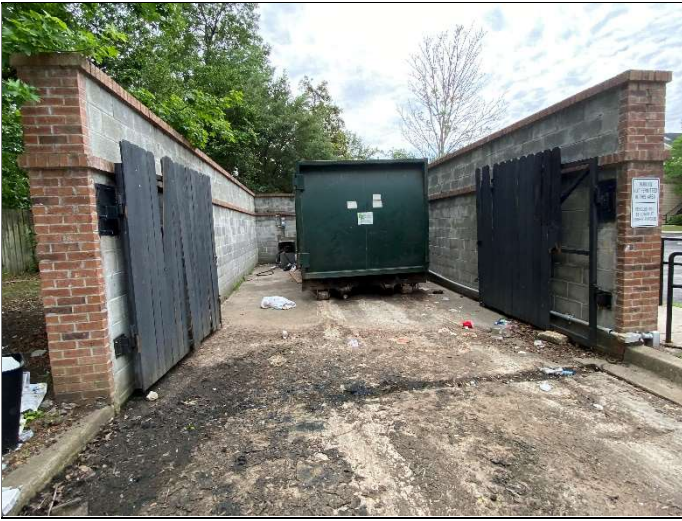
25. Trash compactor. Note: Damaged compactor gate.

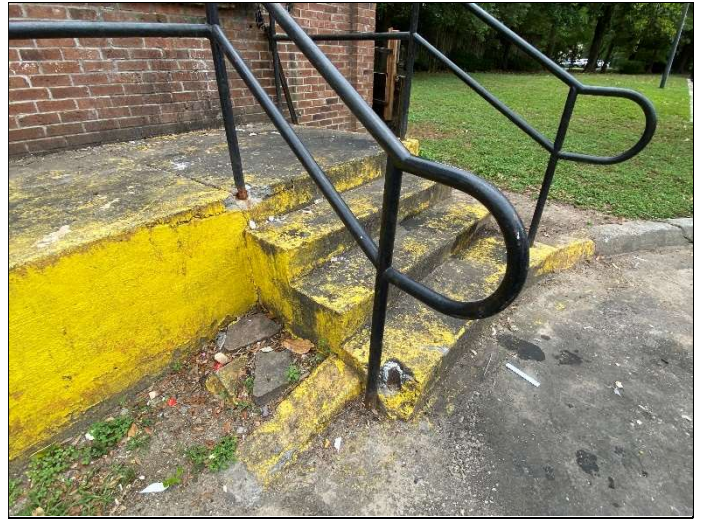
26. Reattach compactor stair railing

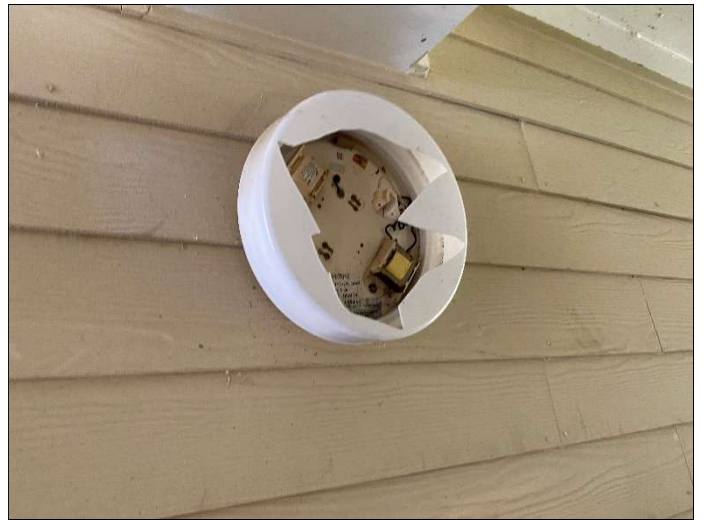
28. Breezeway lighting; note condition

3.2.9	The light fixtures were reported and appeared to be in fair to poor overall condition. Several fixtures were observed with cracked or shattered lenses and a majority were stained or filled with insects. Based on age, condition, and EUL, replacement of the breezeway fixtures is recommended.	144	EA	\$150		\$21,600	\$21,600

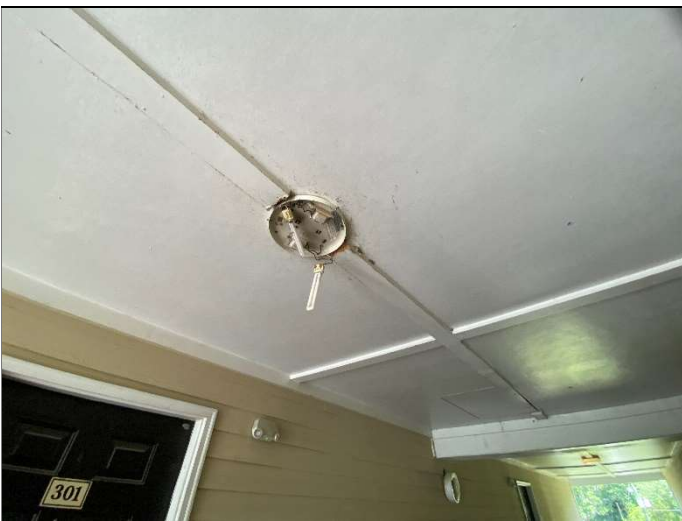
29. Breezeway lighting; note condition

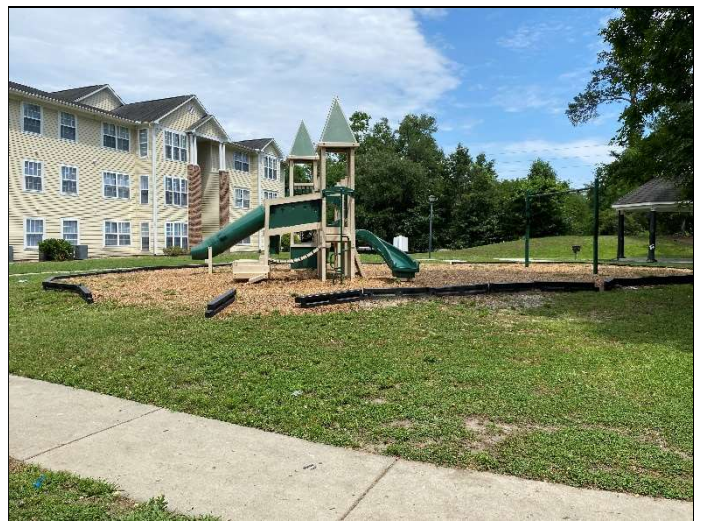
30. Playground; note condition

3.2.10	The playground appeared to be in fair overall condition. The play surface was somewhat barren, and equipment appeared worn, outdated, and had graffiti. Additionally, the swing set was missing all swings. Based on age, condition, and EUL, replacement of the play surface and playground equipment is recommended.	1	LS	\$25,000		\$25,000	\$25,000

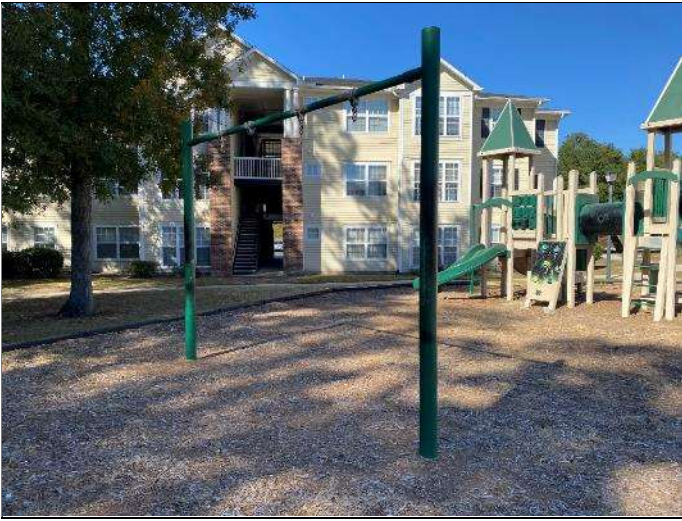
31. Playground; note condition and missing swings

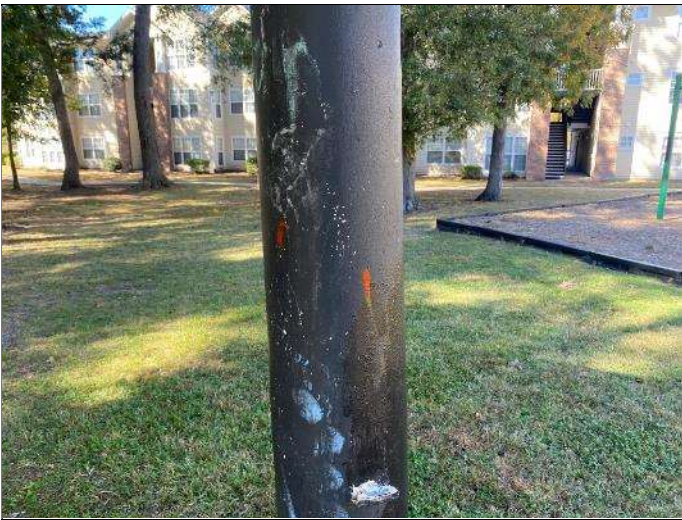
33. Gazebo finishes; note condition

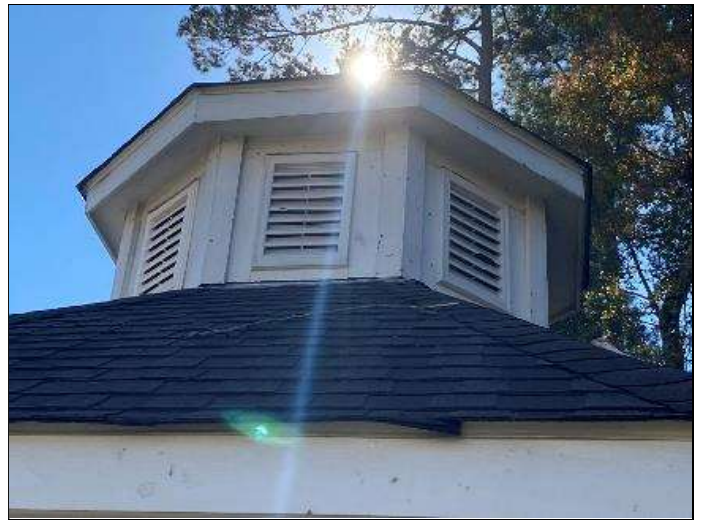
34. Gazebo finishes; note condition

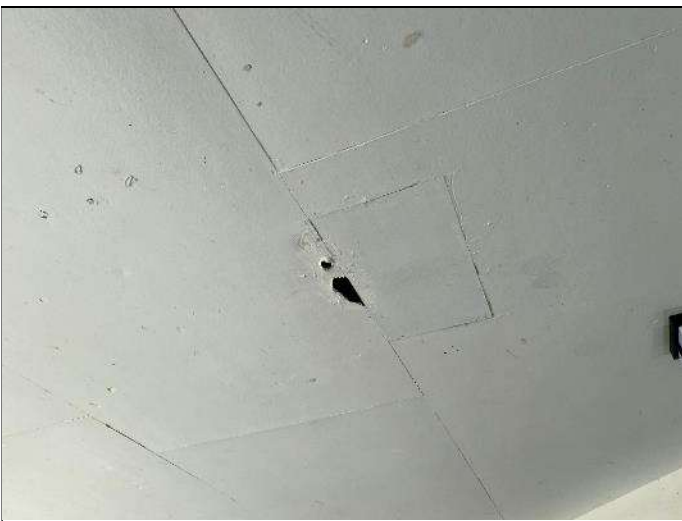
35. Gazebo soffit; note condition

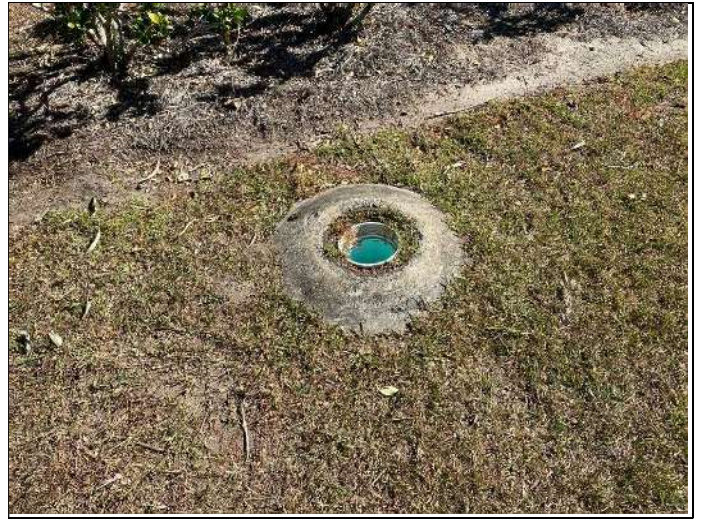
44. Sanitary sewer cleanout missing a cap

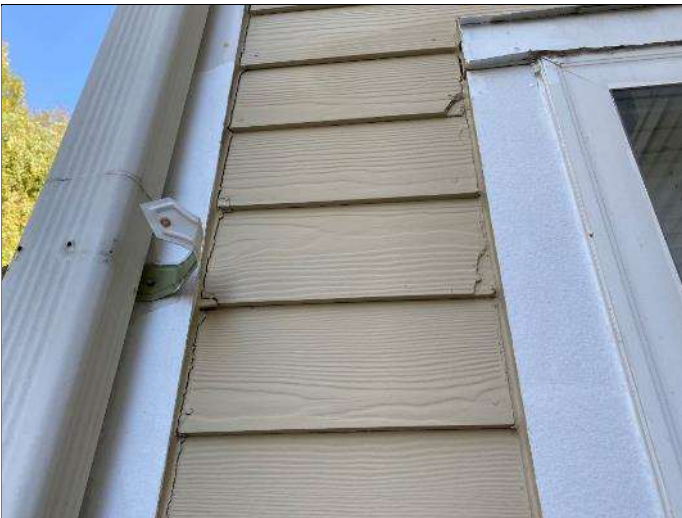
51. Deteriorated sealants and fasteners

4.0	Structural Frame and Building Envelope						
4.3.1	Fiber cement siding and soffits appeared to be in good to fair overall condition. Minor deficiencies, including missing fasteners, boards with chipped edges or small blunt trauma, deteriorated sealants, and soffit cracking were observed amongst a portion of wall and ceilings areas. Additionally, several locations of graffiti and mismatched, missing, and or faded paint finish were noted throughout. paint. Repair to the siding and soffits followed by replication of paints and sealants is recommended.	100,000	SF	\$0.75		\$75,000	\$75,000

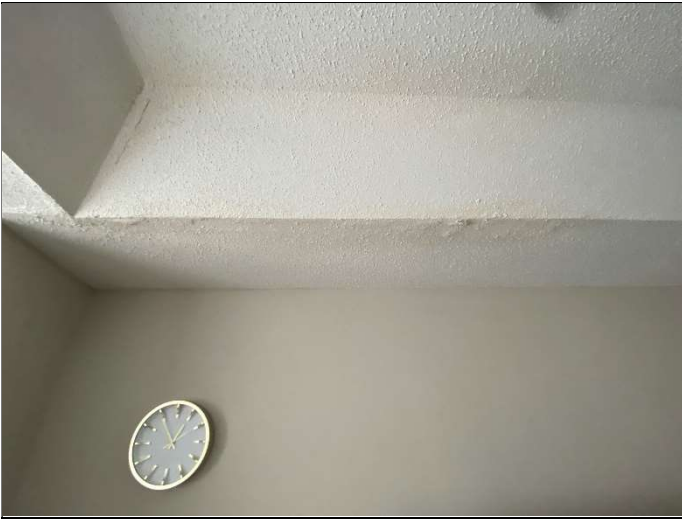
55. Stained ceiling in unit C307 due to active/former roof leak

4.4.1	The roofing systems appeared to be in good to fair overall condition. According to property management, the shingles are the originally installed systems. Based on our observations, the reported age appeared to be reasonable. Active roof leaks were not reported by management however evidence of former or active leaks were observed within units A304, B302, C307, and H201. Repair to the active leaks is recommended.	3	EA	\$1,500	\$4,500		\$4,500

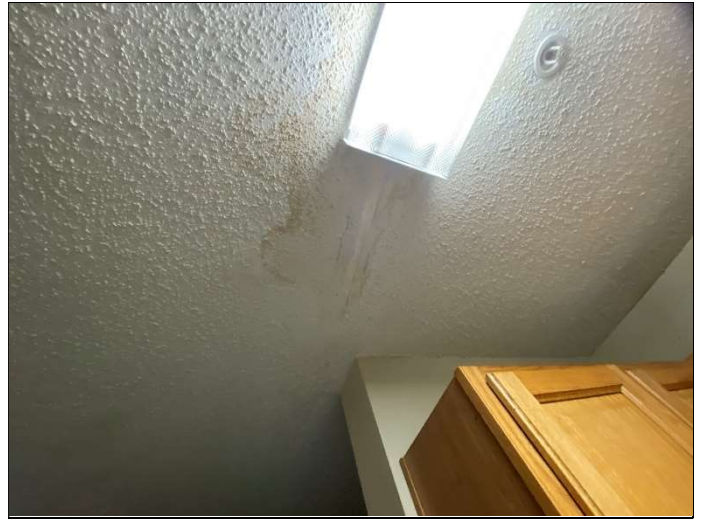
56. Stained ceiling and wall in unit H201 due to active/former roof leak

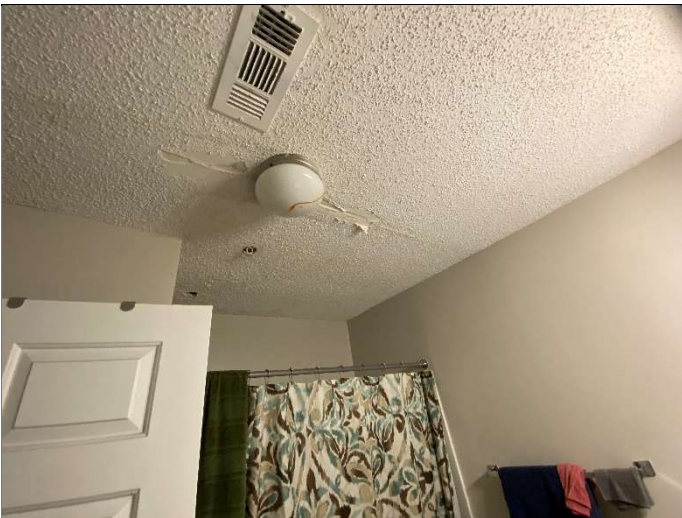
57. Stained ceiling in unit H102 due to active/former plumbing leak

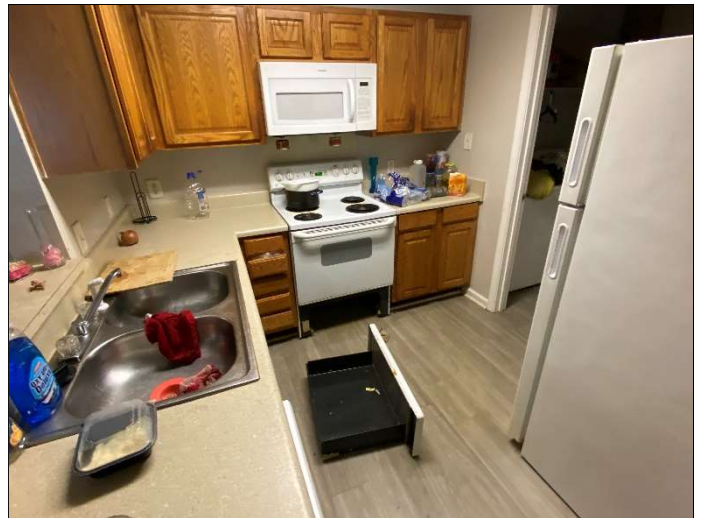
58. Water standing in floor from leak in B201.

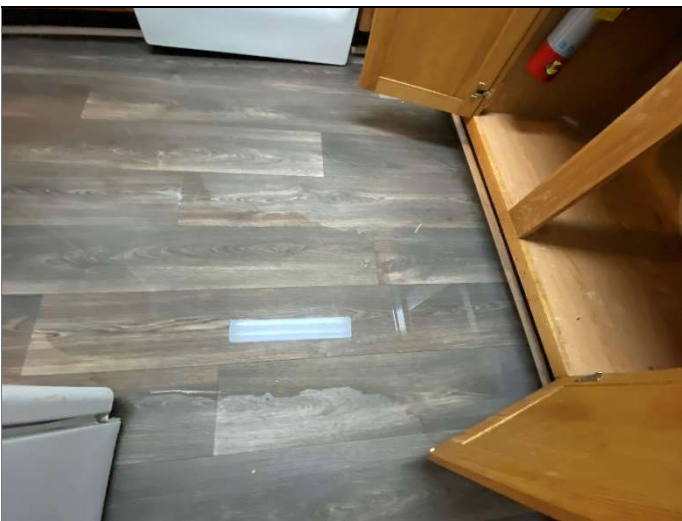
59. Water standing in floor from leak in C308.

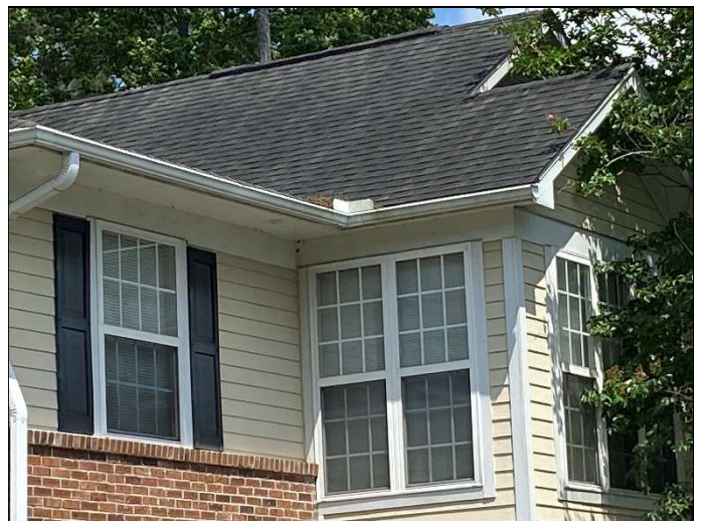
60. Gutters clogged with debris

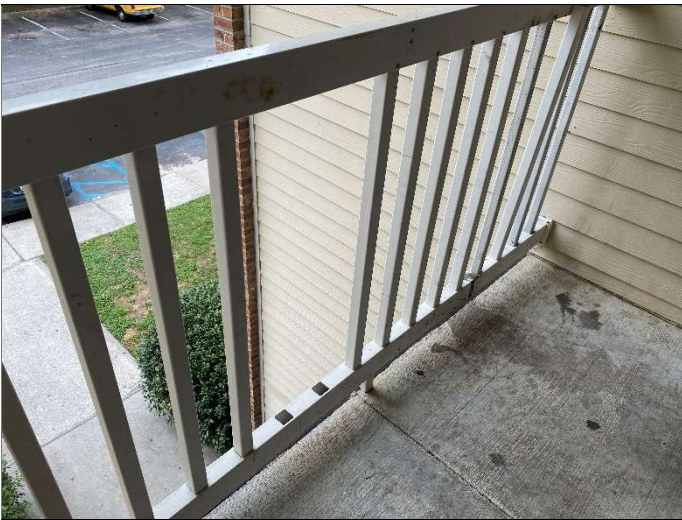
63. Breezeway stairs intermediary landing. Note missing guardrails Building 300

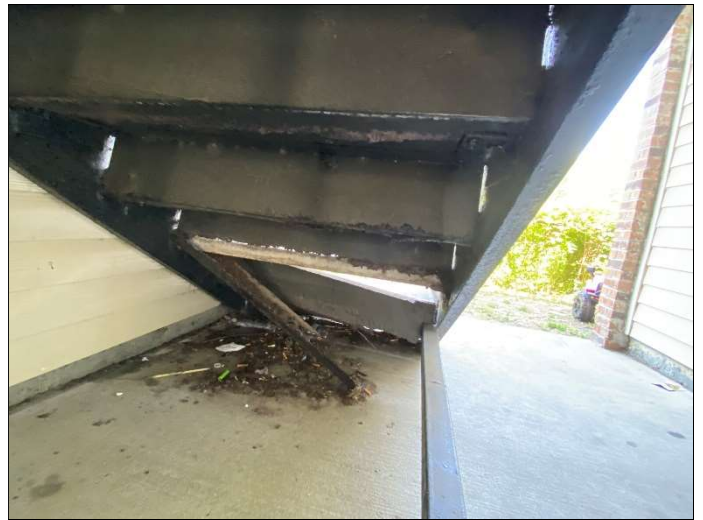
64. Corroded riser at a first flight of stairs

4.5	Stairs appeared to be in good to fair condition. Excessive corrosion appears to be exhausting the EUL of the metal structural components of the first flight of stairs. A sister property corrected this deficiency by removing the risers on the first flight and installed new treads, which appeared to restrain the corrosion by allowing better drainage and drying off water on the systems. Overhaul of the of the stairs in a similar scope is recommended. Damaged treads amongst remaining flights should also be addressed at this time.	17	EA	\$5,000		\$85,000	\$85,000

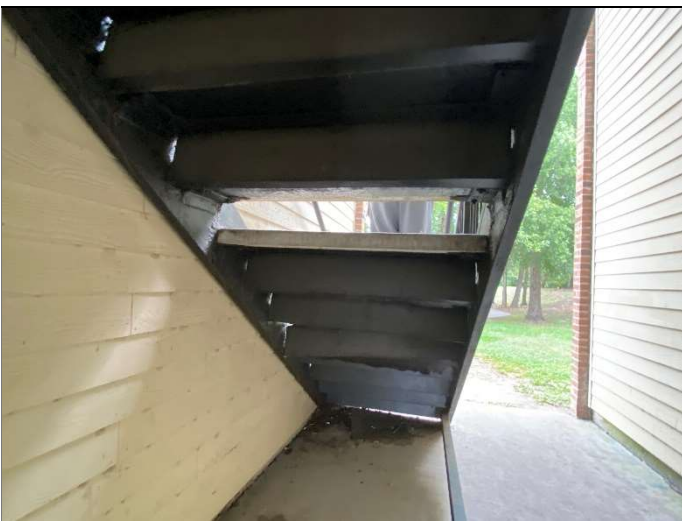
65. Supports at the underside of first flight of stairs

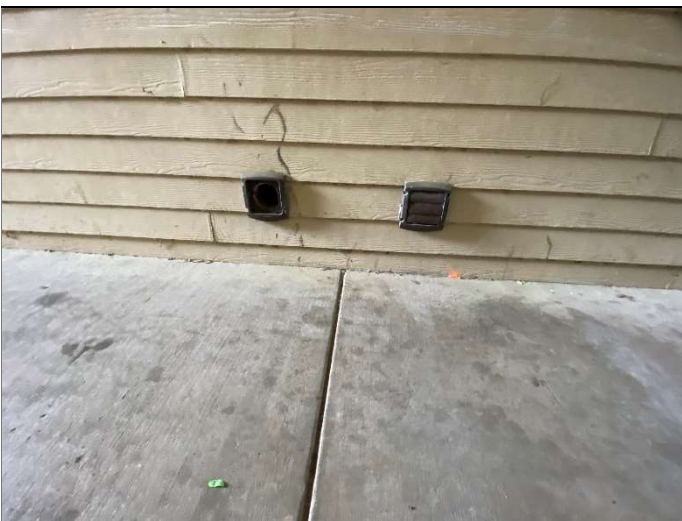
71. Dryer vents; note condition

5.0	Mechanical and Electrical Systems						
5.2	Dryer vents discharge hoods at the breezeways appeared to be in fair to poor condition. Several were missing or damaged. Additionally, substantial dryer lint was observed within the breezeways. Based on the observed condition, replacement of most vent hoods and cleaning of the vent is recommended. Similarly, excessive debris was observed within air handler closets and at HVAC intakes/registers. Cleaning of all HVAC ductwork is recommended in coordination with cleaning and replacement of the dryer vents.	192	UNIT	\$100	\$19,200		\$19,200

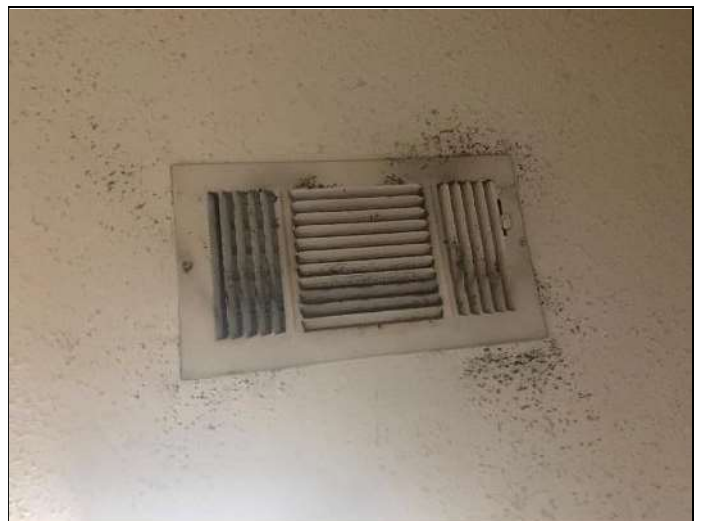
72. Dust accumulation indicative of dirty filters/ducts

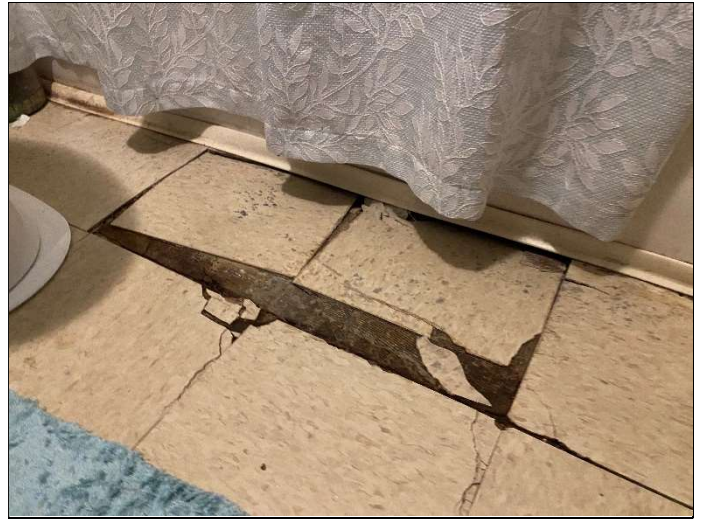
104. Bathroom with VCT flooring. Unit 307 leaking.

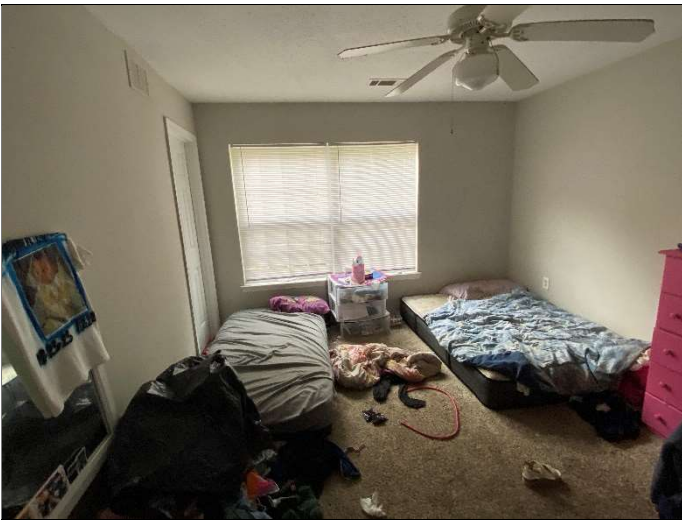
105. Carpet stains

6.5.1	Carpeting appeared to be in good to fair overall condition. Approximately 44 dwellings were observed with blistering, stained, ripped, and/or pilling carpet. Refer to the unit printout for specific unit locations. Based on age, condition, and EUL, resetting, cleaning, and/or replacement of the aged carpeting as applicable is recommended.	44	UNIT	\$750		\$33,000	\$33,000

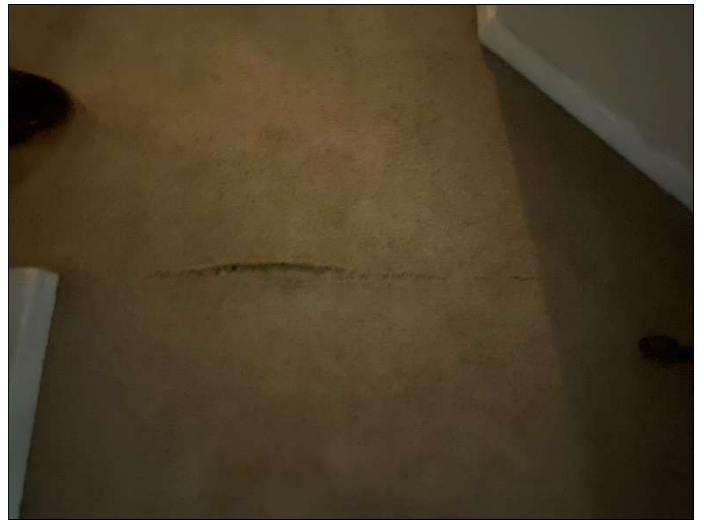
106. Ripped carpet

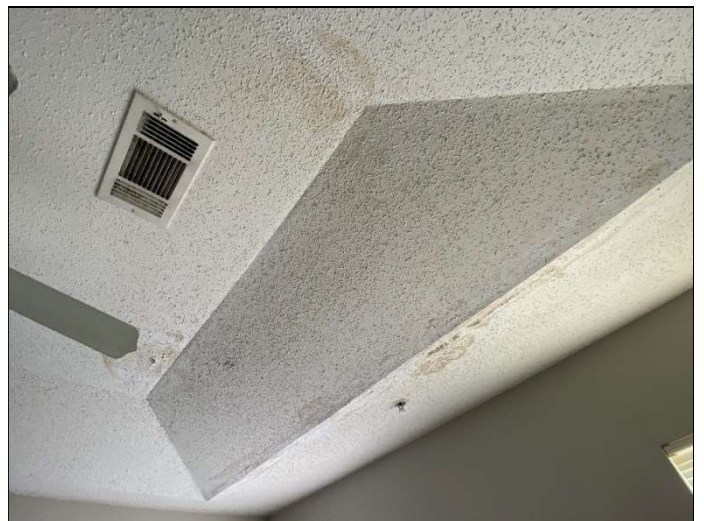
108. Roof leak in Unit 304

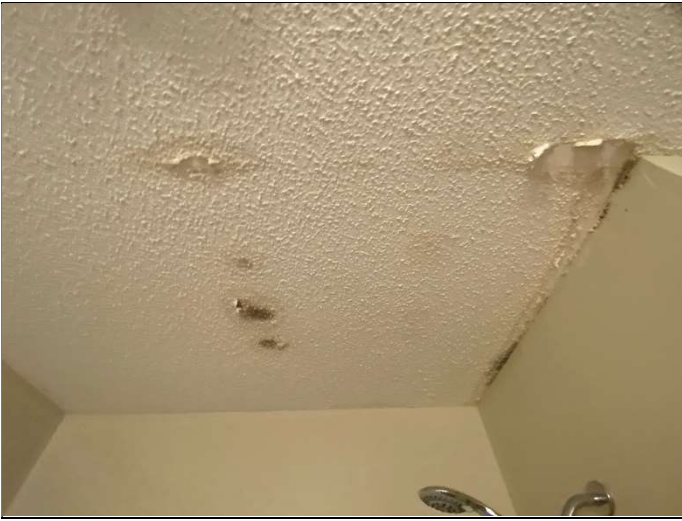
109. Aged water staining and growth on a ceiling. Unit 201.

6.5.1	Wall and ceiling finishes appeared to be in good to fair overall condition. Minor deficiencies were observed, including, but not limited to, 20 locations of patched, peeling, and/or stained ceilings above select kitchens, bathrooms, and hallways due to former plumbing or roof leaks; and five units had light suspect microbial growth on walls surrounding the bathtub. Refer to the unit printout for specific unit locations. Based on age, condition, and EUL, addressal of the deficiencies is recommended.	25	EA	\$200		\$5,000	\$5,000

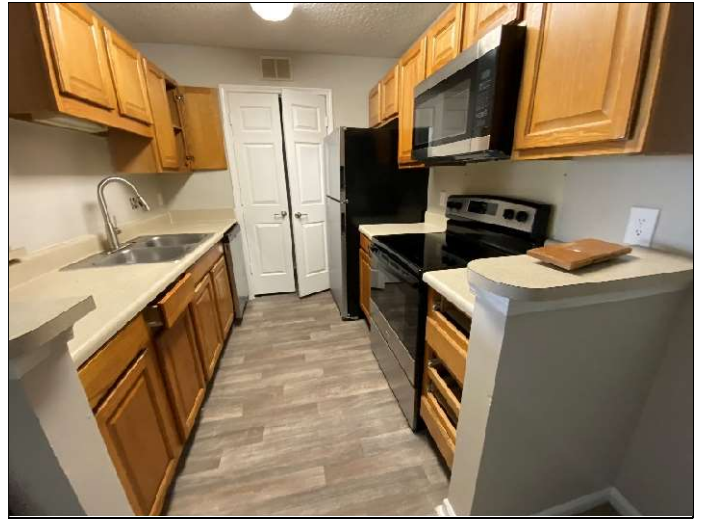
110. Deficient kitchen casework

6.5.2	Cabinets and vanities appeared to be in good to fair overall condition. Approximately 18 units had casework with missing/damaged drawers and doors. Refer to the unit printout for specific unit locations. Based on age, condition, and EUL, repair to the areas of damaged casework is recommended.	18	EA	\$250		\$4,500	\$4,500

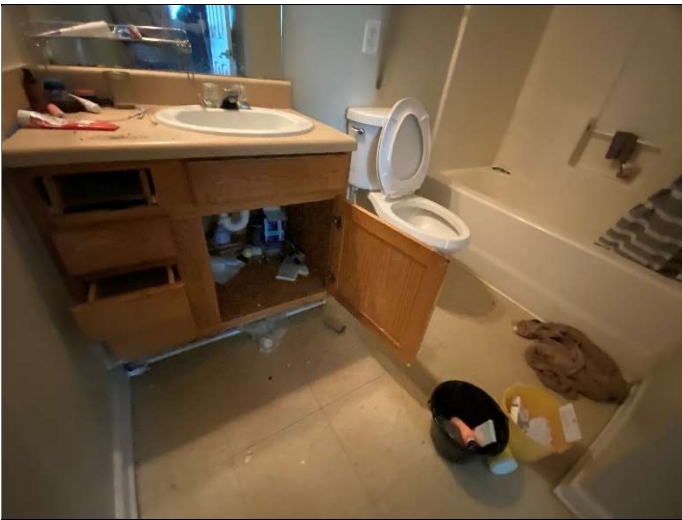
111. Deficient vanity casework

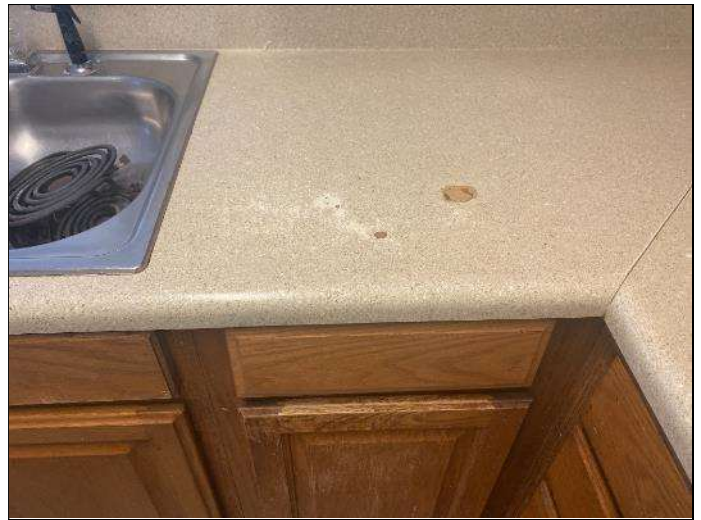
112. Deficient countertop

6.5.2	Countertops appeared to be in good overall condition. Approximately three units were observed with worn, scratched, and/or areas of charred finish. Refer to the unit printout for specific unit locations. Reglazing of the deficient counters is recommended.	3	EA	\$500		\$1,500	\$1,500

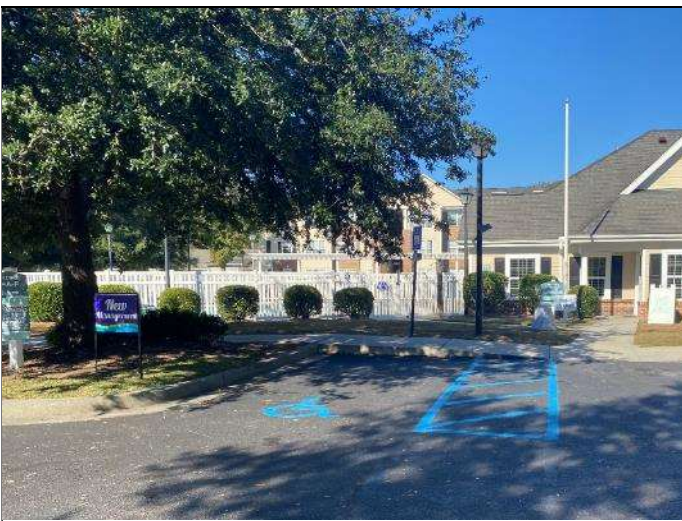
113. Office van accessible stall with noncompliant aisle width and ramp access
