## PROPERTY CONDITION REPORT

### Appian Way Apartments

8465 Patriot Blvd  
North Charleston, South Carolina 29420

24-452279.1

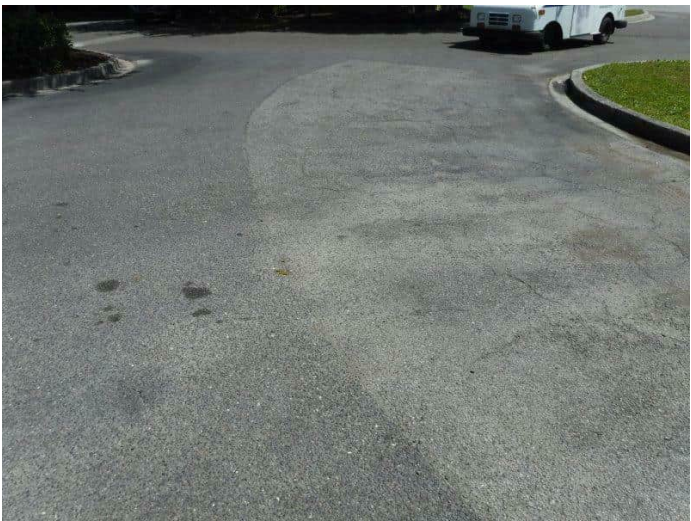
114. Typical asphalt pavement with minor linear cracking

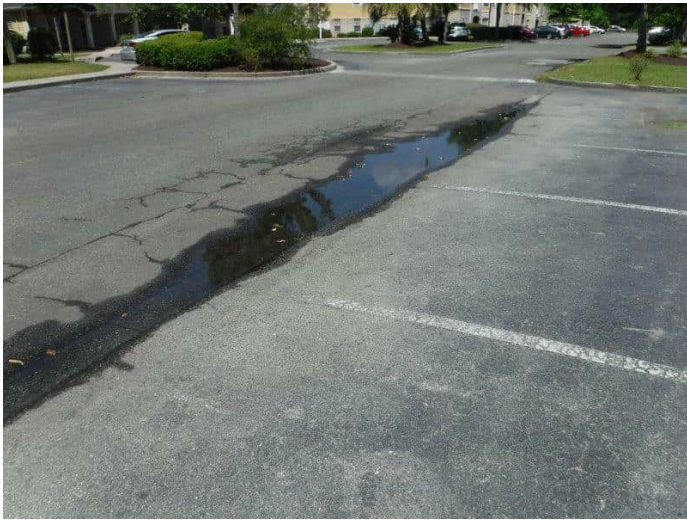
116. Ponding in the north drive aisle

Item	Repair Type	Unit of Measure	Quantity	Per Item Costs	Total Costs	Comments
Pavement	PR	SF	105700.00	\$0.20	\$21,140.00	Repair, reseal, restripe pavement
Concrete flatwork	PR-90	EA	1.00	\$7,500.00	\$7,500.00	Repair differential settlement
<b>Subtotal</b>					<b>\$28,640.00</b>

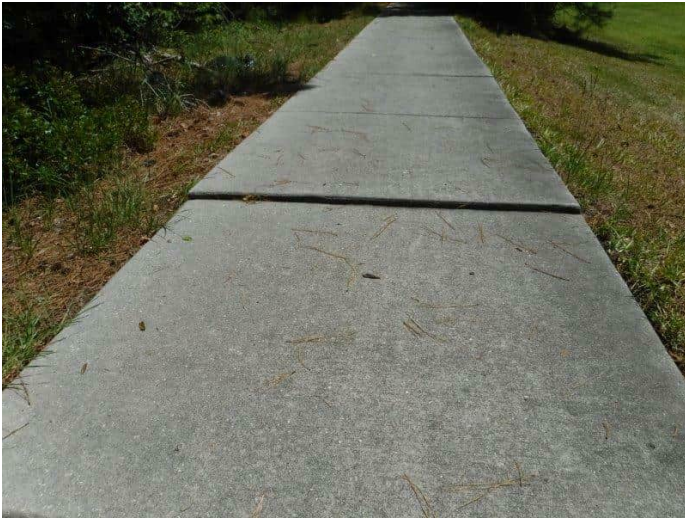
120. Trip hazards on the west side of the north detention basin

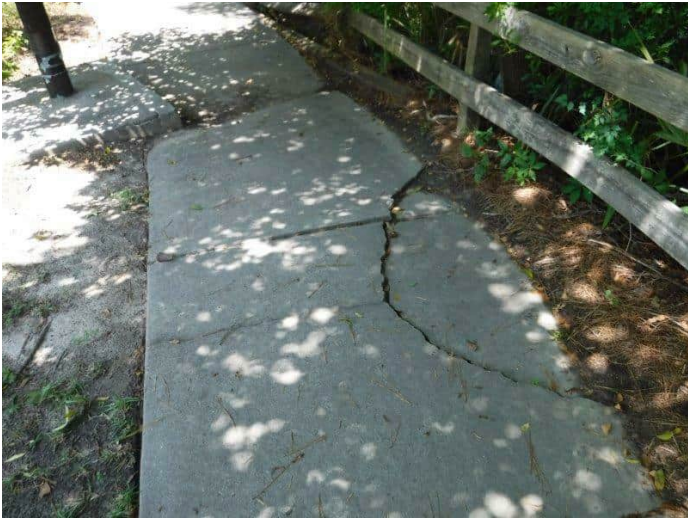
121. Trip hazard on the west side of the north detention basin

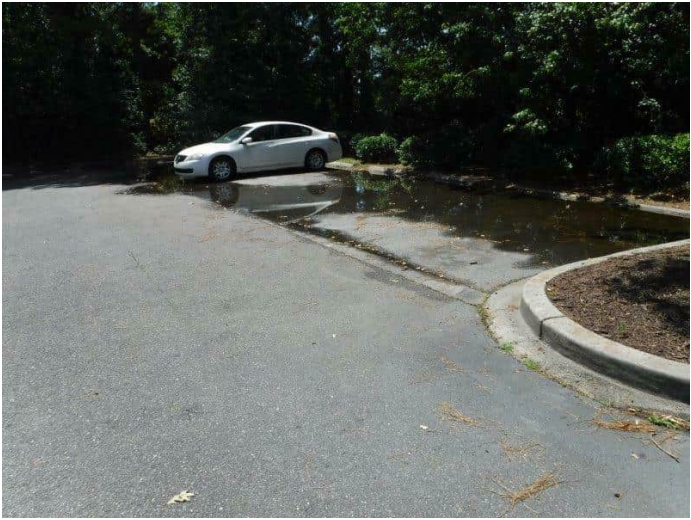
131. Ponding in the south drive aisle by Building 100

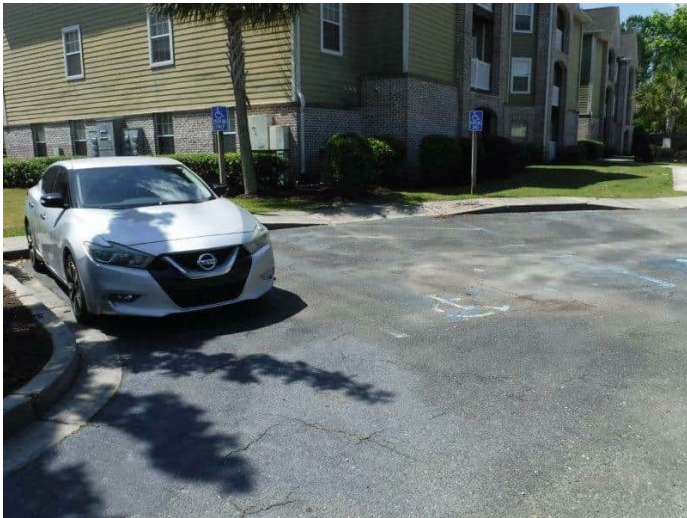
133. Clubhouse ADA parking. No van designated space

Description
Repair plumbing in Unit 101
Add ADA van space at clubhouse
Add plumbing piping padding to restroom
