## PHYSICAL NEEDS ASSESSMENT

### RADCLIFFE MANOR APARTMENTS CHARLESTON, SOUTH CAROLINA

Job #S7002/26  
January 28, 2026

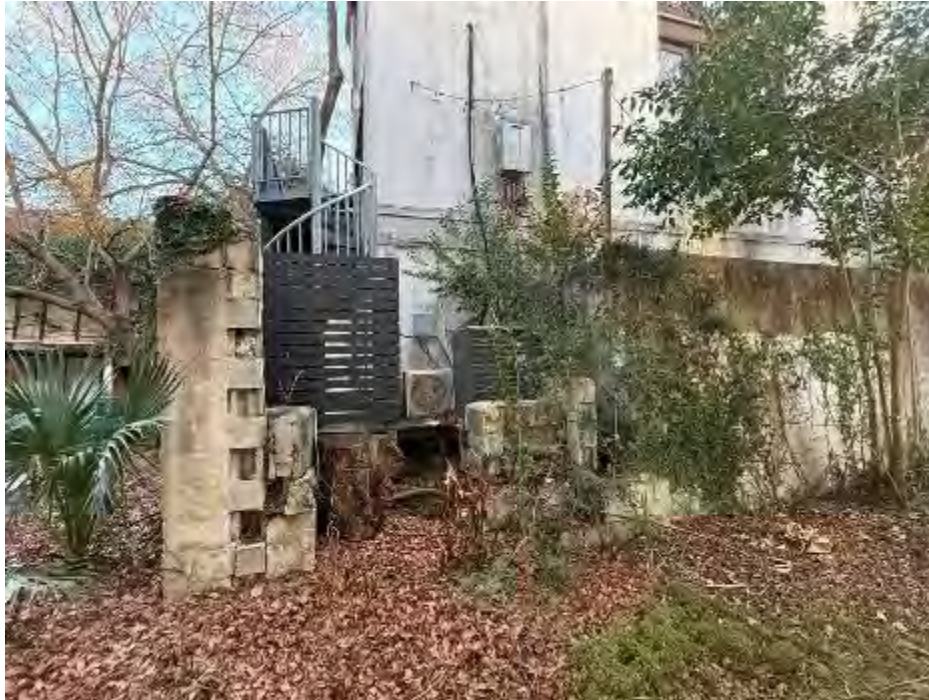
There is a CMU wall around the perimeter of the property, it was not immediately evident who the owner of this CMU wall was. We note that large portions of the wall were covered in vines and trees and were not visible. We did observe two areas near the northern side of Building B where the wall was damaged. Due to the height and presumed age of the wall, we recommend that a structural engineer evaluate the wall and the damaged portion of the wall to determine its structural integrity. Additionally, we recommend that the owner of the wall is determined.

Photo 38: Area of Damaged CMU Perimeter Wall North of Building B

damage. We recommend that the fence is painted and areas of damage are corrected. We have included a small allowance within the immediate needs chart to repair the CMU perimeter wall, paint the frontage fence, and repair any damage to the frontage fence.

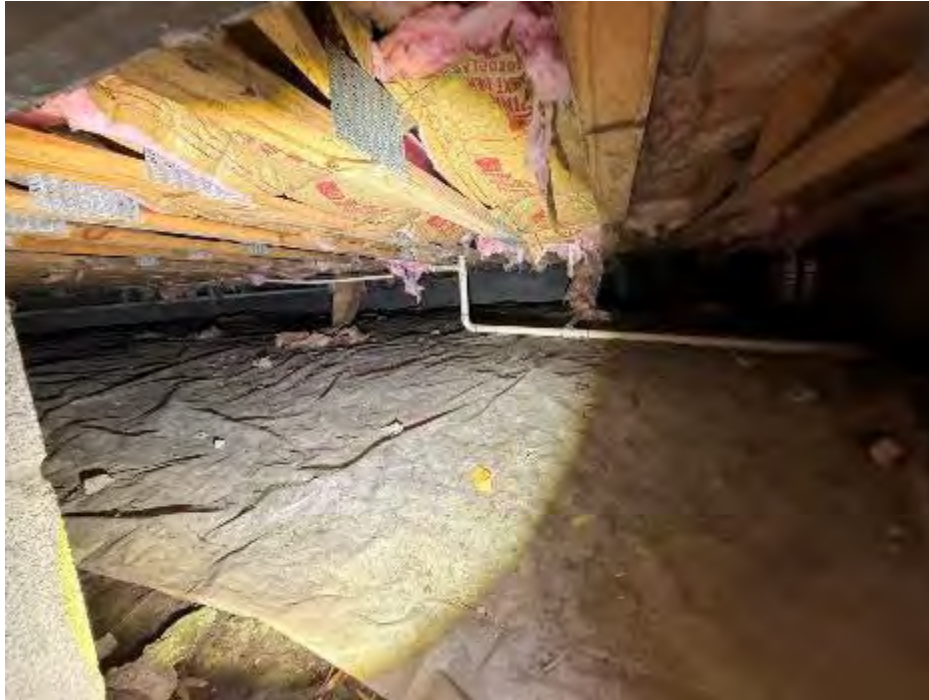
Within the crawlspace of Building B, we noted standing water and damaged insulation at the floor joists in select areas. We noted that there were plumbing pipes within both crawl spaces that appeared to empty out into the crawl space and were not connected to the sewer system. We recommend that these areas are evaluated and corrected.

Photo 44: Areas of Standing Water and Plumbing Piping Terminating Within Building B Crawlspace

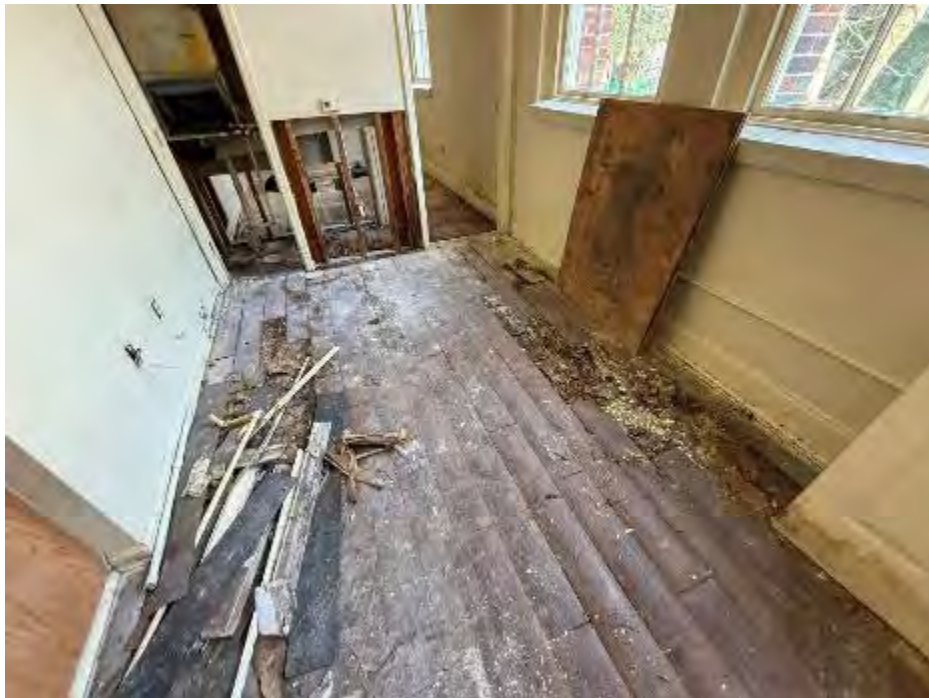
Within Unit A307, we noted a large hole in the kitchen/ living room ceiling, the tenant noted that this was from a previous leak. It appeared that some of the corrugated metal decking had deteriorated in these areas. We recommend that the structure is evaluated in this area to determine if any steel or wood has deteriorated and needs to be replaced.

Within Unit A307, we noted a large hole in the kitchen/ living room ceiling, the tenant noted that this was from a previous leak. It appeared that some of the corrugated metal decking had deteriorated in this area. We recommend that the structure is evaluated in this area to determine if any steel or wood has deteriorated and needs to be replaced. We have included an allowance within the immediate needs chart to repair the damaged drywall and corrugated steel decking.

Photo 81: Ceiling Deterioration Within Kitchen/Living Room of Unit A307

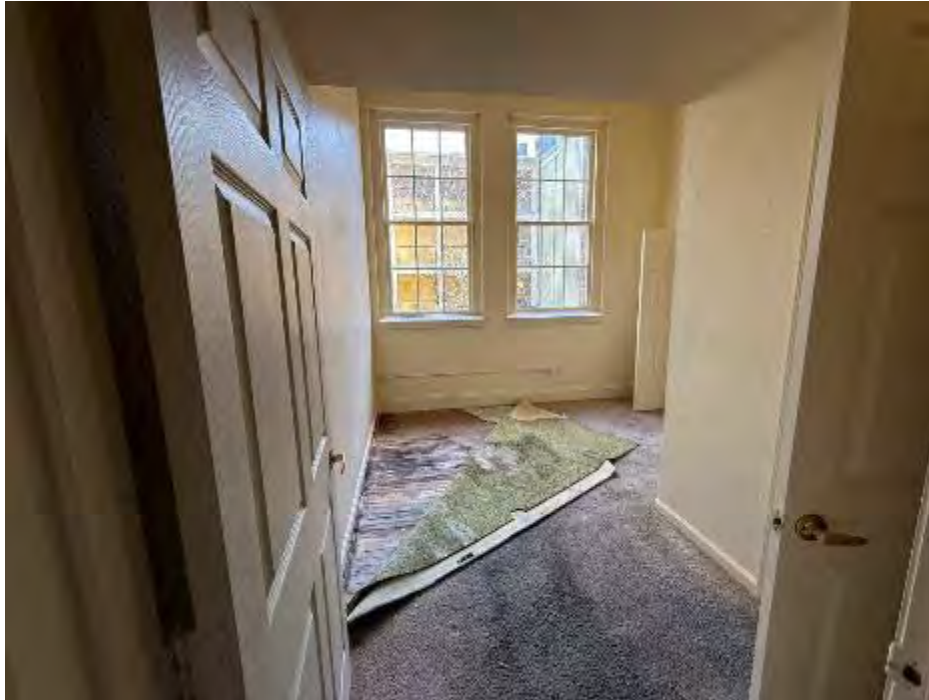
Within Building A, we noted several areas that appeared to show signs of a “soft floor”. Areas where a soft floor were noted within Building A are within the elevator equipment room on the first floor and units A102, A104, A105, and A202 (visible damage to flooring was noted within unit A105). Areas where “soft floors” were noted within Building B are within the third-floor mechanical room (a visible hole through the gypcrete and floor were noted), the bathroom within unit B103, and the hallway of B304. We recommend that the wooden flooring within the first floor of Building A is evaluated to determine the cause of the “soft floors” and that these floors are replaced. Our limited viewing of the crawl space did not provide indications of active water leaks.

Photos 82-83: Apparent Flooring Deterioration Within Unit A105

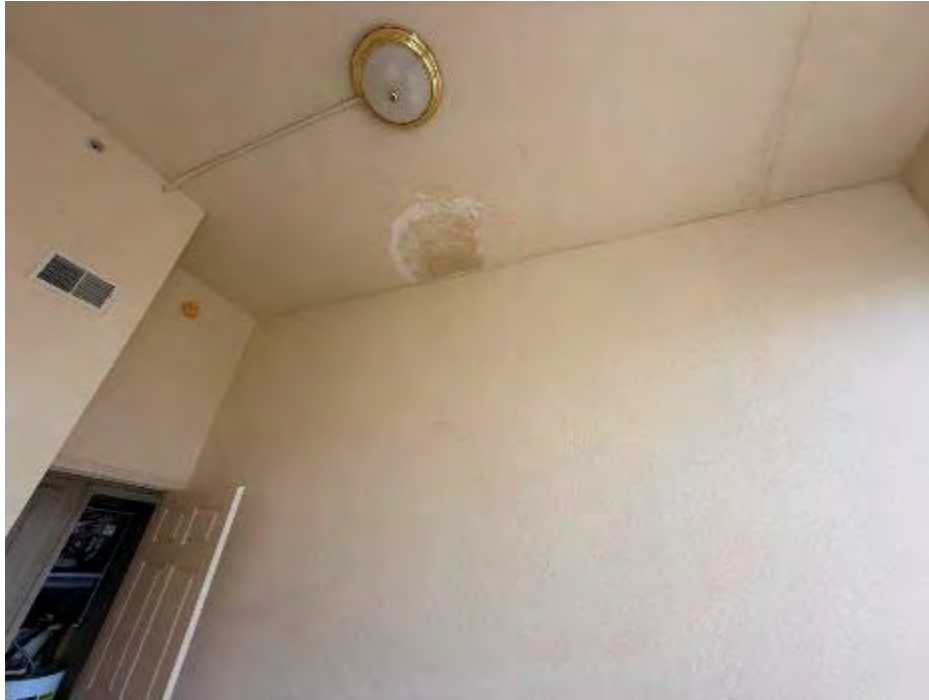
Photo 86: Apparent Ceiling Plaster Peeling Within Select Building A Units

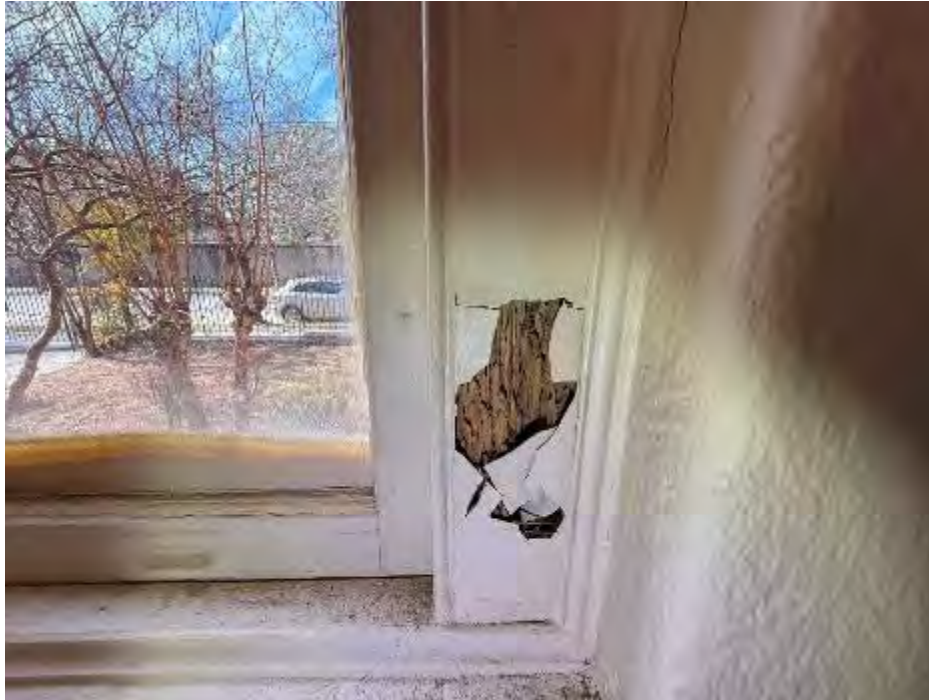
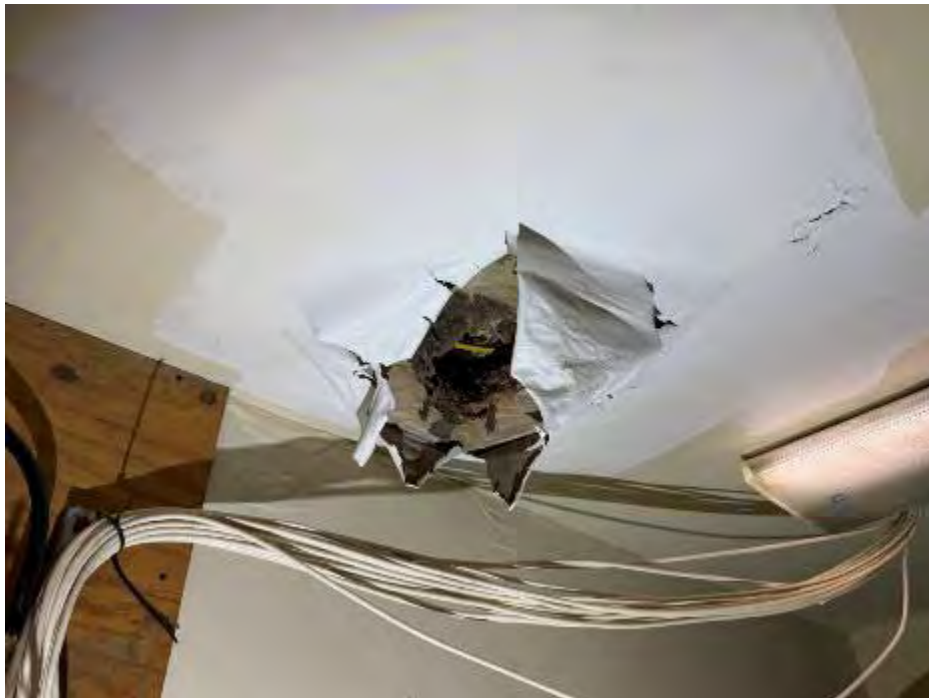
Photos 88-89: Typical Window Coverings and Apparent Wood Window Deterioration Within Building A Units

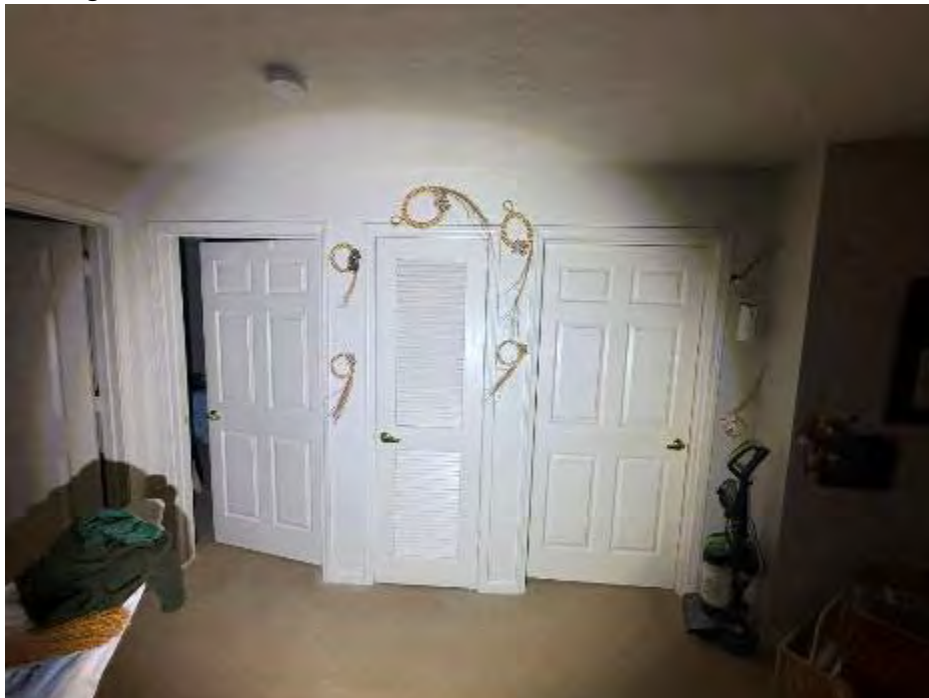
At Building B, we noted that most of the units we visited featured vertical and horizontal cracking within the drywall at some bedroom doors. Additionally, it was noted that the doors in these areas appeared to be out of plumb and did not close correctly. This could be evidence of a structural problem within the building. Our limited viewing of the crawl space did not provide indications of cracking of the CMU foundations. We recommend that a structural engineer reviews the building in its entirety to determine the cause of the drywall cracking.

Photo 101: Apparent Cracking above Interior Doors Within Most Units at Building B

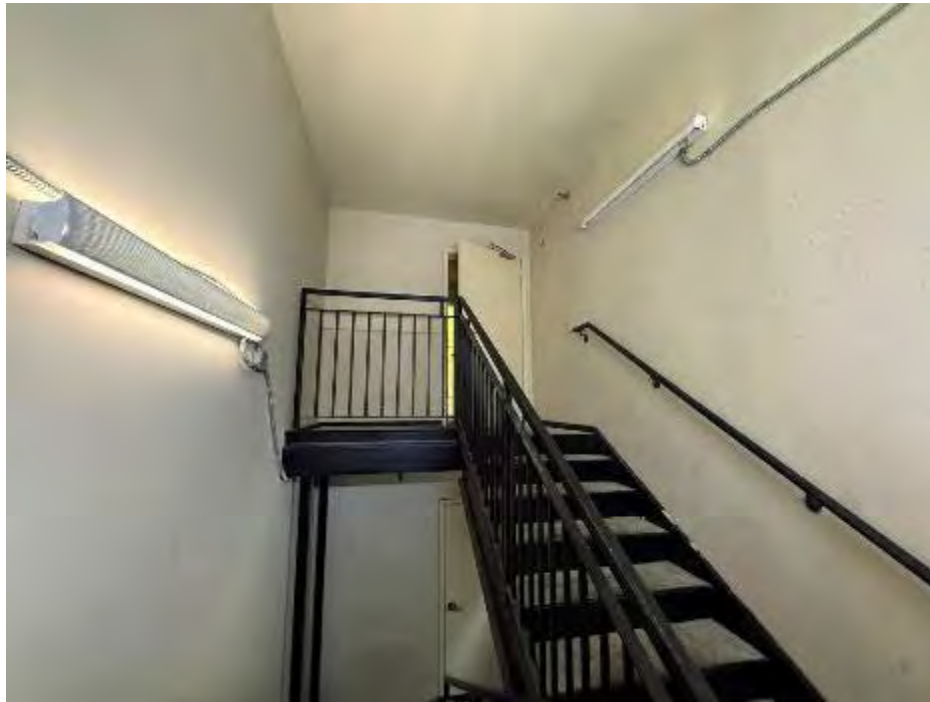
Within Building A, we noted several areas within the southern stairwell and within units A102, A105, A209, and A302 that appeared to show evidence of wood destroying organisms. The property manager noted that pest control services have visited the site and noted that the wood destroying organisms are not “active.” We recommend that the pest control company treats both buildings, and that the areas within the Building A southern stairwell and units A102, A105, A209, and A302 that show previous signs of infestation are investigated and repaired.

As noted previously within this report, evidence of wood destroying organisms was observed within the southern stairwell of Building A and within units A102, A105, A209, and A302. With these conditions observed, we recommend that the surrounding areas are investigated to determine the extent of damage to the structure.

Photo 108: Apparent Evidence of Wood Destroying Organisms Within Building  
A Southern Stairwell
