SC Housing Accessibility Consultant Qualifications and Requirements

ACCESSIBILITY PLAN REVIEW

Battery Park Senior Apartments

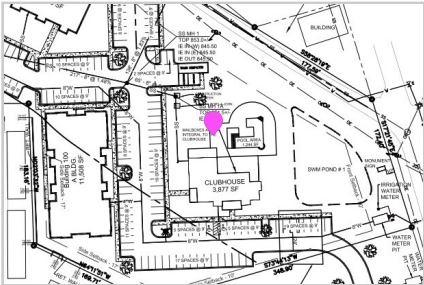
#11 - Mail Boxes

Melissa Middleton	Issue: The site plan calls for the mail boxes to be at the Clubhouse; however, plans or elevations of the mail boxes were not found in the plans. Please provide.	14 Mar 03:34 PM
-------------------	---	-----------------

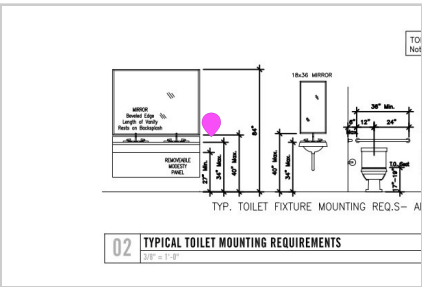
#13 - Restroom Lavatory Counter Height

Melissa Middleton Issue: Per the details, the counter is noted to be within 34" from finish floor; however, the rim of the lavatory should be within 34" from finish floor. Please review. 14 Mar 03:44 PM

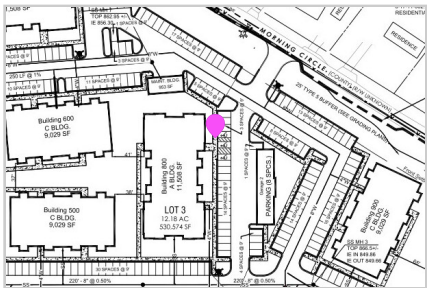
● **#10 - Building 800: Curb Ramp**
Plan Review | Emmanuel Belleau | Site-Paths
Plan: CV-5 - Site Utility Plan | Location: Parking

Task messages (time in EDT)
Emmanuel Belleau Issue: Missing curb ramp details at the accessible parking spaces.

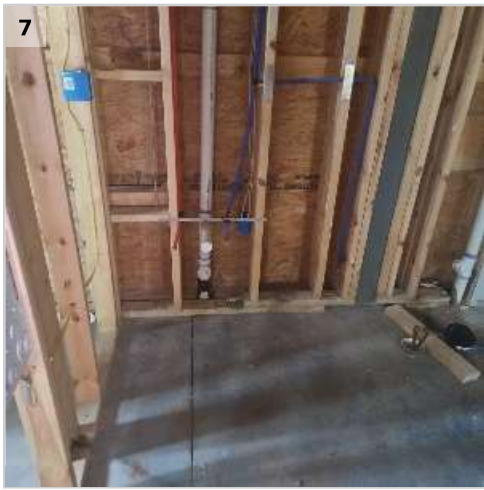
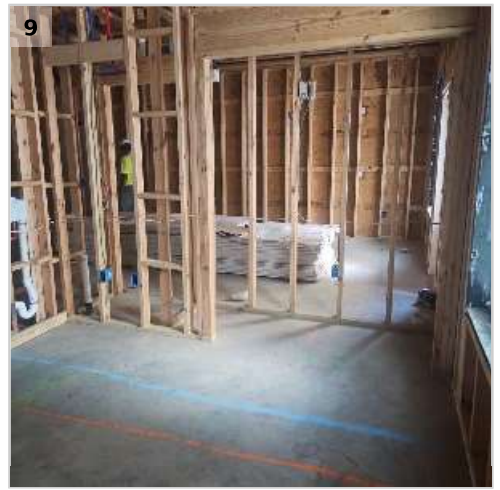
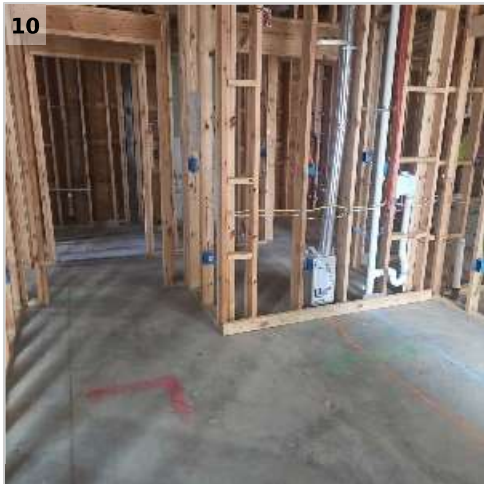
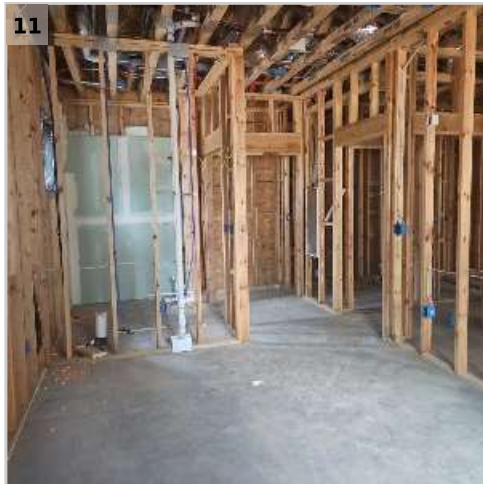
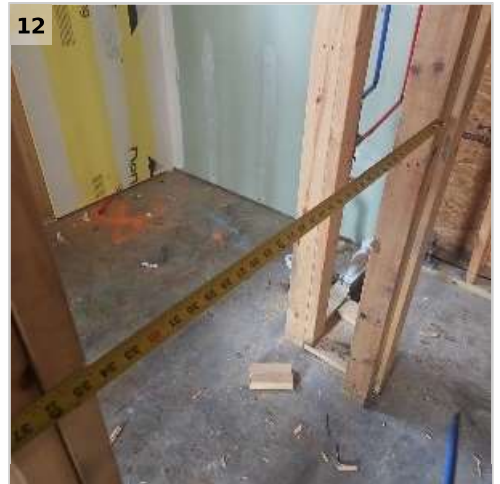
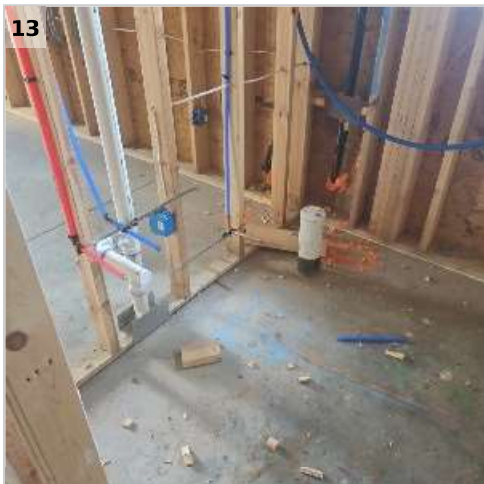
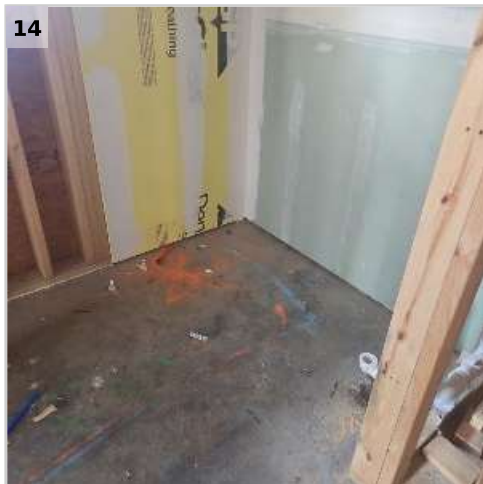
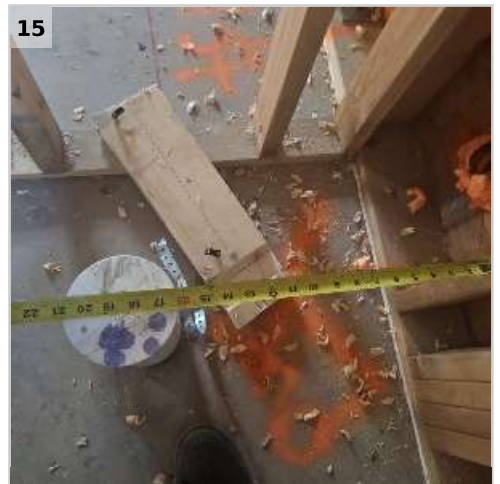
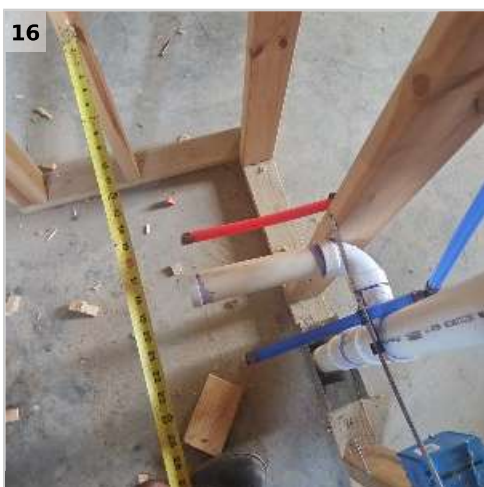
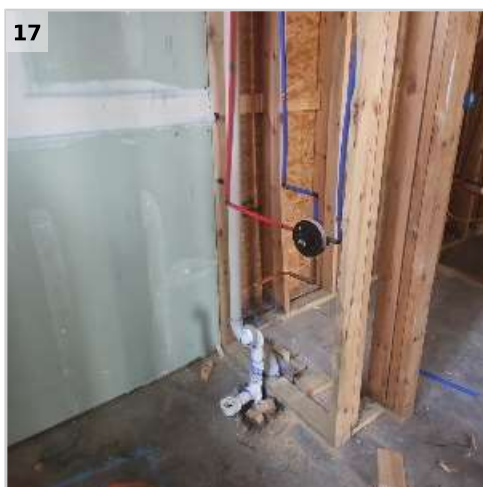
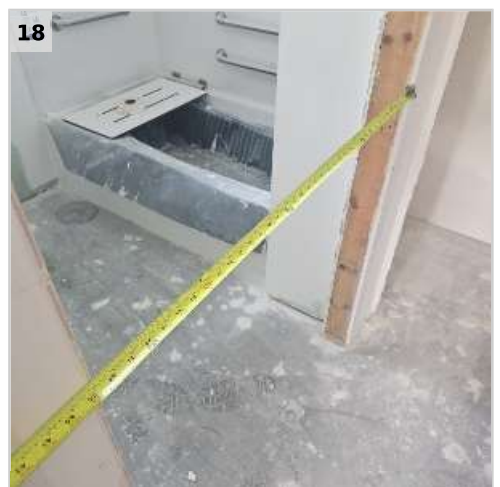
Photos

Melissa Middleton	Photo 28 - GPS: 32.9744507, -80.139874	26 Dec 11:41 AM
Melissa Middleton	Photo 29 - GPS: 32.9743501, -80.1397093	26 Dec 11:42 AM
Melissa Middleton	Photo 30 - GPS: 32.9744302, -80.1398395	26 Dec 11:42 AM
Melissa Middleton	Issue: The toilet and bathroom accessories are to be installed.	26 Dec 11:44 AM

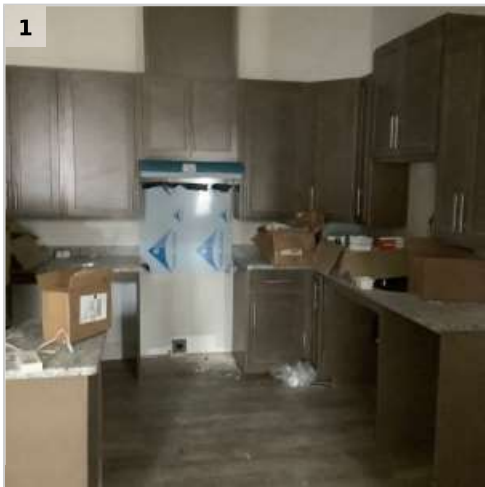
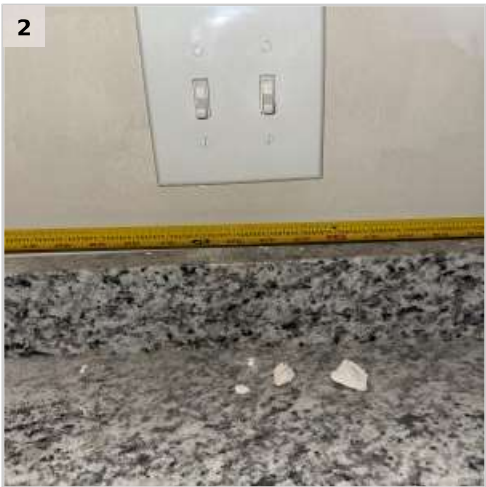
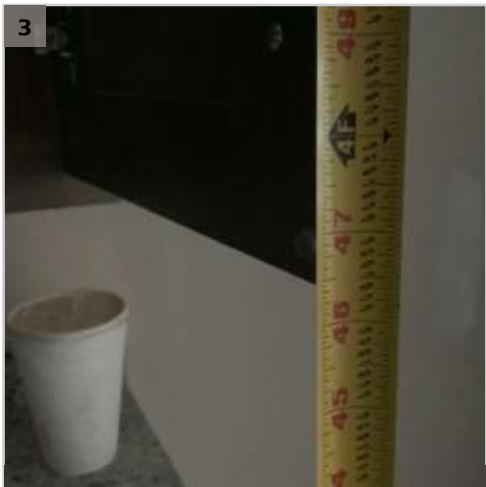
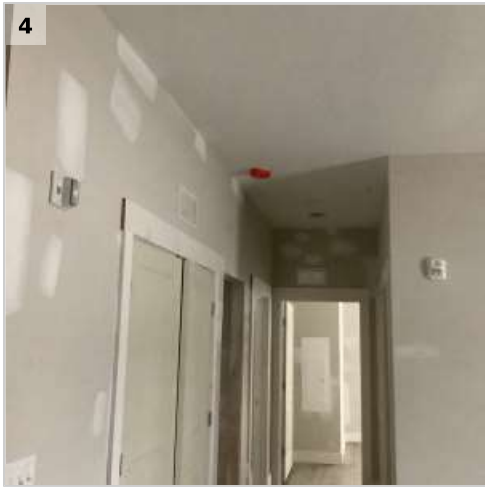
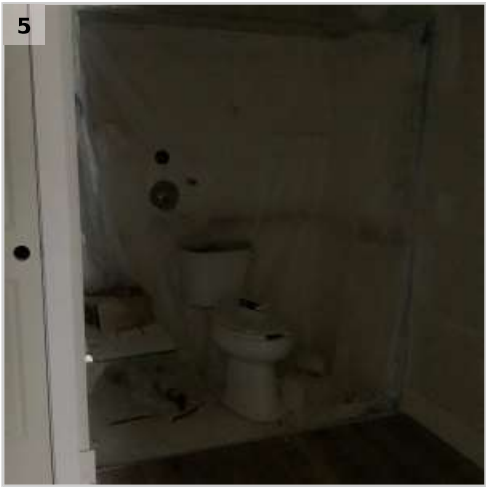
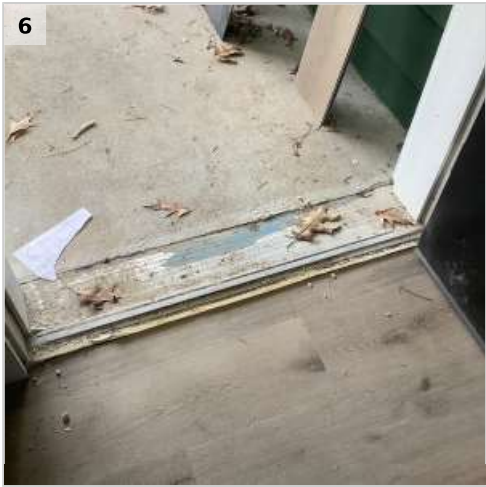
● **#21 - Myrtle Mobility Unit #2101**
Field Issue | Emmanuel Belleau | Unit-Mobility
Plan: A1.1_101 - Apartment 10 Plan | Location: Unit 2x2 HCS
Tags: #mobility

Melissa Middleton	Photo 1 - GPS: 32.9740005, -80.1399836	26 Dec 12:05 PM
Melissa Middleton	Photo 2 - GPS: 32.9743364, -80.140152	26 Dec 12:07 PM
Melissa Middleton	Issue: The switches provided near the range for the hood light and fan are within 34" from a corner and should be located beyond 36" from a corner condition, since a work surface is not provided near the switches.	26 Dec 12:07 PM
Melissa Middleton	Photo 3 - GPS: 32.9745607, -80.1400597	26 Dec 12:08 PM
Melissa Middleton	Photo 4 - GPS: 32.9742025, -80.140055	26 Dec 12:09 PM
Melissa Middleton	Photo 5 - GPS: 32.9740503, -80.1400572	26 Dec 12:10 PM
Melissa Middleton	Photo 6 - GPS: 32.9751409, -80.1404847	26 Dec 12:13 PM
Melissa Middleton	Issue: The toilet and bathroom accessories are to be installed.	05 Jan 09:57 PM

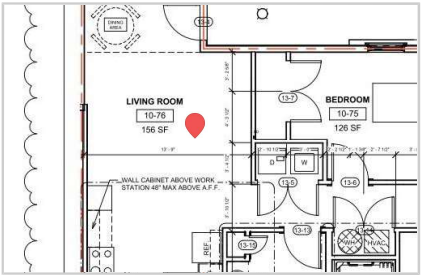
● **#17 - Willow Mobility Unit #4104**

Field Issue | Emmanuel Belleau | Unit-Mobility
Plan: A1.1_131 B - UNIT X104 - 'WILLOW' TYPE A | Location: Unit 3x2 HCS
Tags: #mobility

Emmanuel Belleau	Photo 1 - GPS: 32.9747626, -80.1396268	05 Jun 09:07 AM
Emmanuel Belleau	Photo 2 - GPS: 32.9743025, -80.139762	05 Jun 09:07 AM
Emmanuel Belleau	Photo 3 - GPS: 32.9747457, -80.1397798	05 Jun 09:07 AM
Emmanuel Belleau	Photo 4 - GPS: 32.9747626, -80.1396268	05 Jun 09:07 AM
Emmanuel Belleau	Photo 5 - GPS: 32.9747626, -80.1396268	05 Jun 09:07 AM
Emmanuel Belleau	Photo 6 - GPS: 32.9747626, -80.1396268	05 Jun 09:07 AM
Emmanuel Belleau	Photo 7 - GPS: 32.9741405, -80.1396873	05 Jun 09:07 AM
Emmanuel Belleau	Photo 8 - GPS: 32.9743025, -80.139762	05 Jun 09:07 AM
Emmanuel Belleau	Photo 9 - GPS: 32.9747457, -80.1397798	05 Jun 09:07 AM
Emmanuel Belleau	Photo 10 - GPS: 32.9746665, -80.13945	05 Jun 09:08 AM
Emmanuel Belleau	Photo 11 - GPS: 32.9746665, -80.13945	05 Jun 09:08 AM
Emmanuel Belleau	Photo 12 - GPS: 32.9746665, -80.13945	05 Jun 09:08 AM
Emmanuel Belleau	Photo 13 - GPS: 32.9742754, -80.1399852	05 Jun 09:08 AM

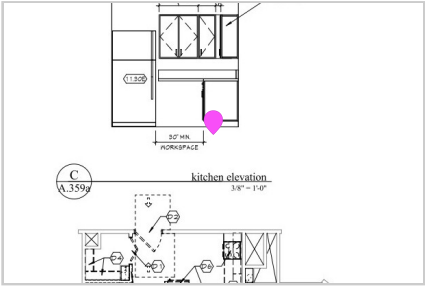
● #2 - Unit Mobility: Kitchen workspace

Katie Rich Issue: We recommend that the work surface be located adjacent to the range/oven. 04 Apr 03:07 PM

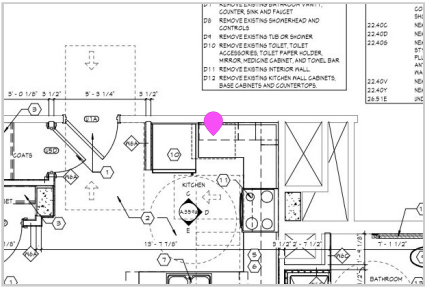
● #4 - Mobility Unit 1.10: Kitchen Work Surface

Katie Rich Issue: We recommend that the work surface be located adjacent to the range/oven. Per NCHFA, the switches for the range hood and light are to be located behind the work station which per the electrical plan is located to the right of the range. Coordinate the work surface area and the switches. 25 Mar 08:48 AM

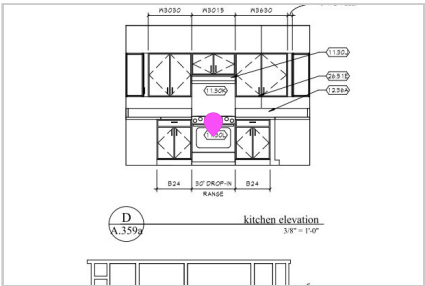
● #7 - Mobility Unit 1.10: Range Controls

Katie Rich Issue: Mobility units must have controls located on the front of range. It is recommended that the same range type (11.30C) used in mobility Unit 2.4a is used in Unit 1.10. 25 Mar 09:49 AM

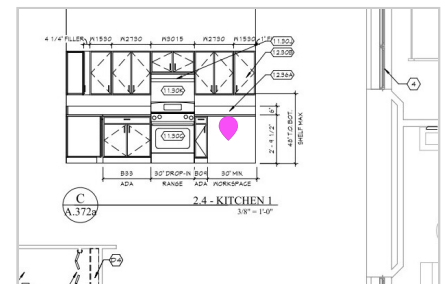
Plan: A.372a - UNIT 2.4 - ANSI TYPE A | Location: UNIT 2.4

Melissa Middleton Issue: We recommend that the work surface be located directly adjacent to the range/oven. 05 Apr 02:59 PM

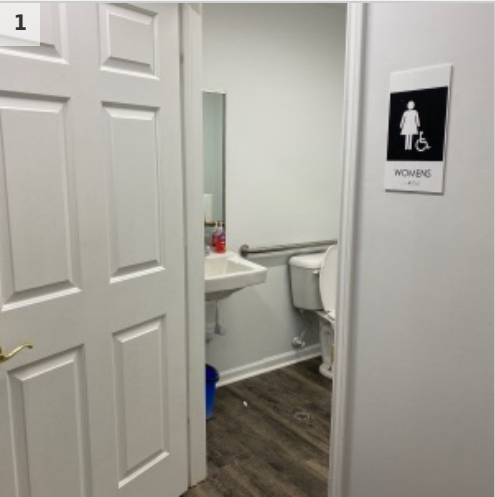
Sahand Saljooghi	Photo 1	02 Feb 09:02 AM
Sahand Saljooghi	Photo 2	02 Feb 09:02 AM
Sahand Saljooghi	Photo 3	02 Feb 09:02 AM
Sahand Saljooghi	Photo 4	02 Feb 09:02 AM
Sahand Saljooghi	Photo 5	02 Feb 09:03 AM
Sahand Saljooghi	Photo 6	02 Feb 09:03 AM
Sahand Saljooghi	Photo 7	02 Feb 09:03 AM
Sahand Saljooghi	Photo 8	02 Feb 09:03 AM
Sahand Saljooghi	Photo 9	02 Feb 09:03 AM
Sahand Saljooghi	Photo 10	02 Feb 09:03 AM
Sahand Saljooghi	Issue: The paper tower dispenser is 54" above finish floor and should be lowered to a minimum of 48".	02 Feb 09:21 AM

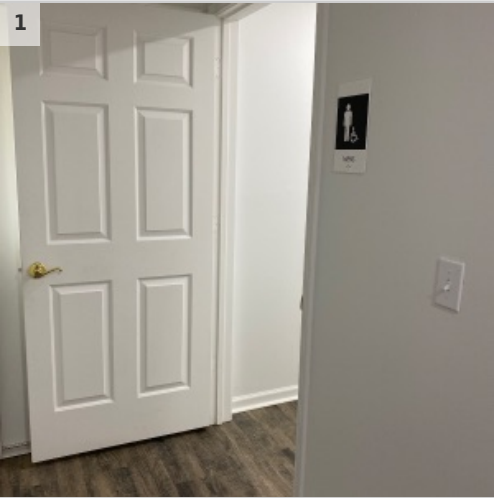
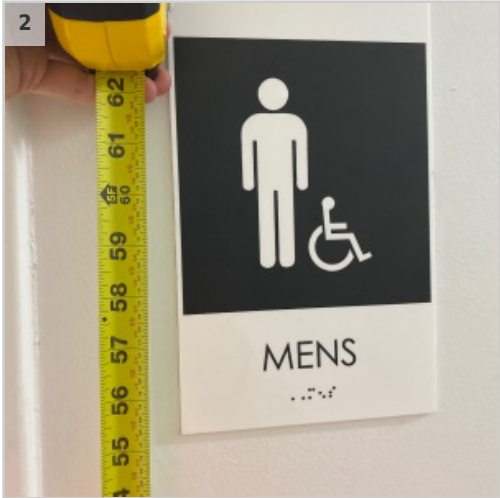
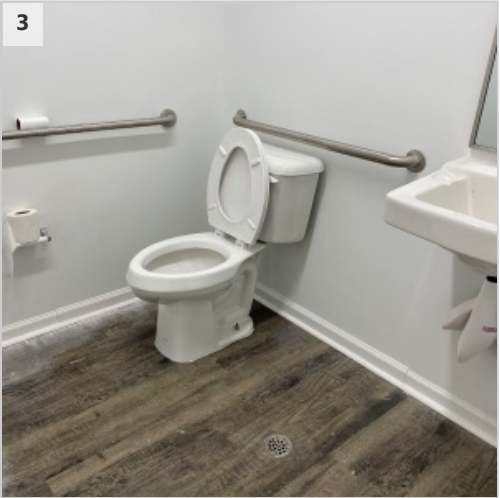
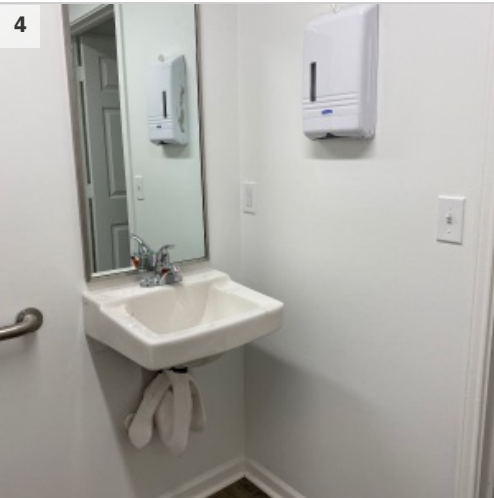
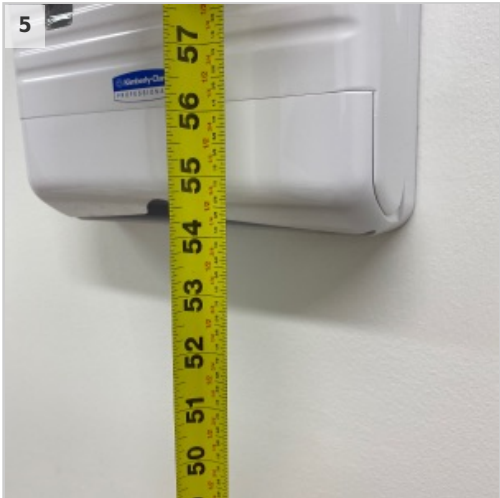
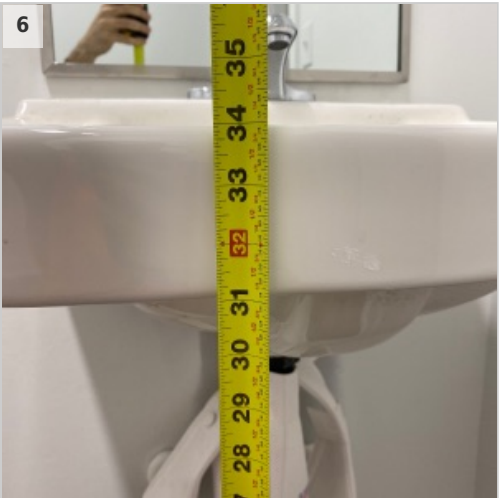
● **#29 - Men's Restroom**

Sahand Saljooghi	Photo 1	02 Feb 09:06 AM
Sahand Saljooghi	Photo 2	02 Feb 09:06 AM
Sahand Saljooghi	Photo 3	02 Feb 09:07 AM
Sahand Saljooghi	Photo 4	02 Feb 09:07 AM
Sahand Saljooghi	Photo 5	02 Feb 09:07 AM
Sahand Saljooghi	Photo 6	02 Feb 09:07 AM
Sahand Saljooghi	Photo 7	02 Feb 09:07 AM
Sahand Saljooghi	Photo 8	02 Feb 09:07 AM
Sahand Saljooghi	Photo 9	02 Feb 09:07 AM
Sahand Saljooghi	Photo 10	02 Feb 09:08 AM
Sahand Saljooghi	Issue: The paper tower dispenser is 54" above finish floor and should be lowered to a minimum of 48".	02 Feb 09:09 AM

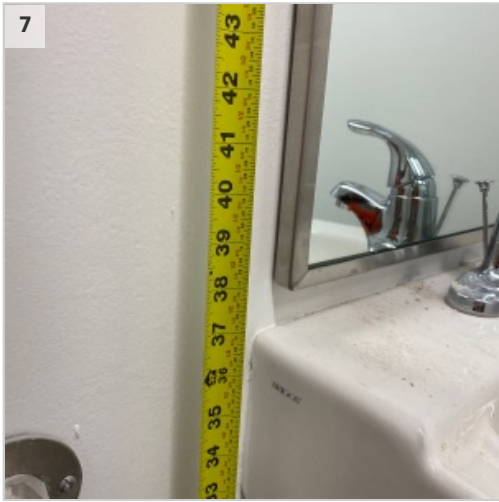
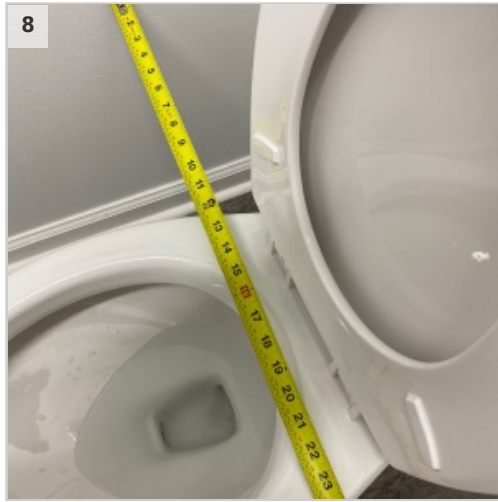
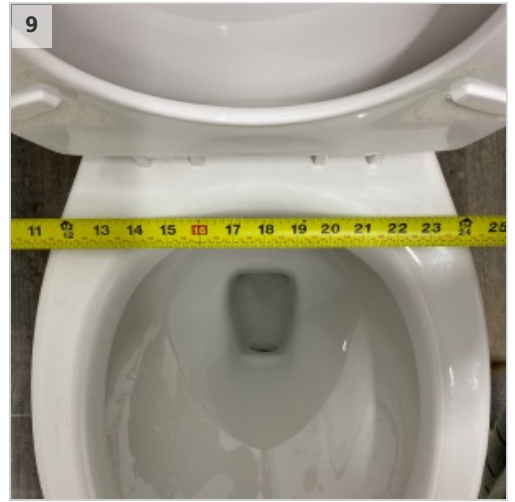
Field Issue | Sahand Saljooghi | Restroom-Public
Plan: A3.1 - COMMUNITY BUILDING FLOOR PLANS AND SCHEDULES
