# **REPORT OF PHASE I ENVIRONMENTAL SITE ASSESSMENT**

**for  
SWANN MEADOWS APARTMENTS  
1091 PARKLAND PLACE ROAD  
GREENWOOD, GREENWOOD COUNTY, SOUTH CAROLINA**

**Report Date: April 21, 2025 (Valid through September 22, 2025)  
JPEG Project: #3511-25**

**Subject: Report of Phase I Environmental Site Assessment  
Swann Meadows Apartments (TMS #6876-020-344)  
1091 Parkland Place Road  
Greenwood, Greenwood County, South Carolina  
JPEG Project #3511-25**

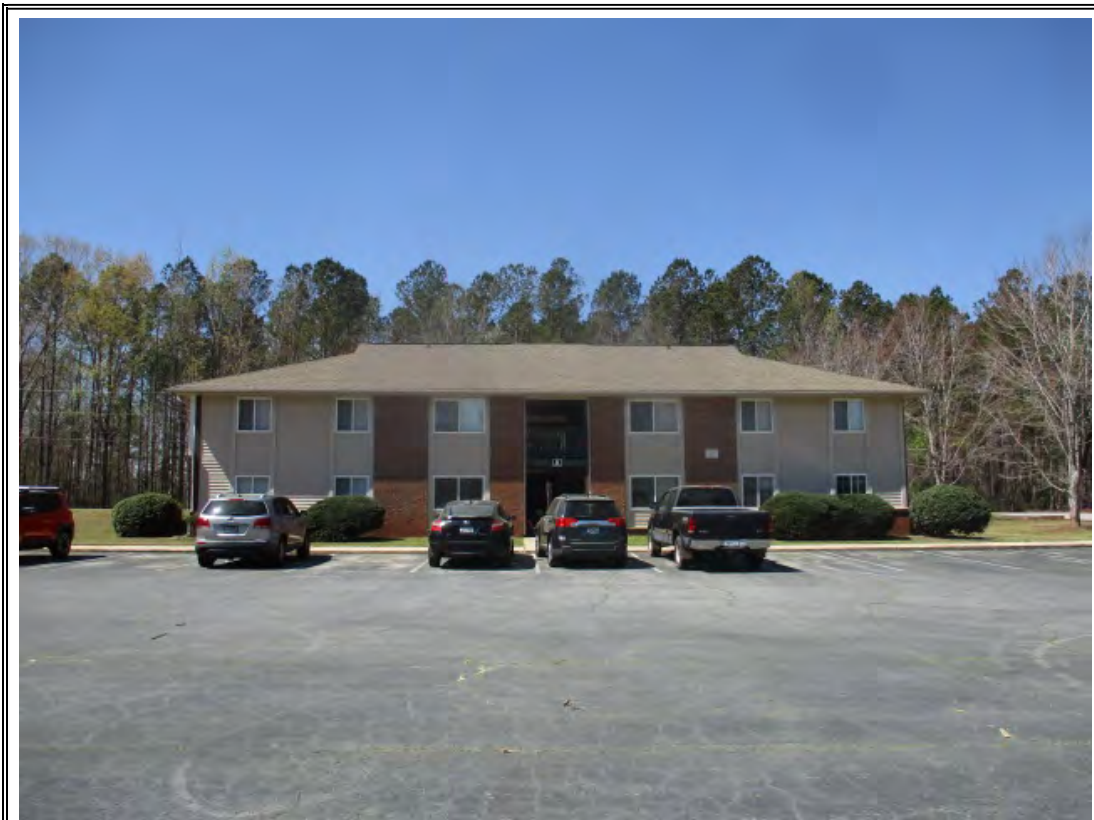
Photo 4: View depicts example subject property building (front side).

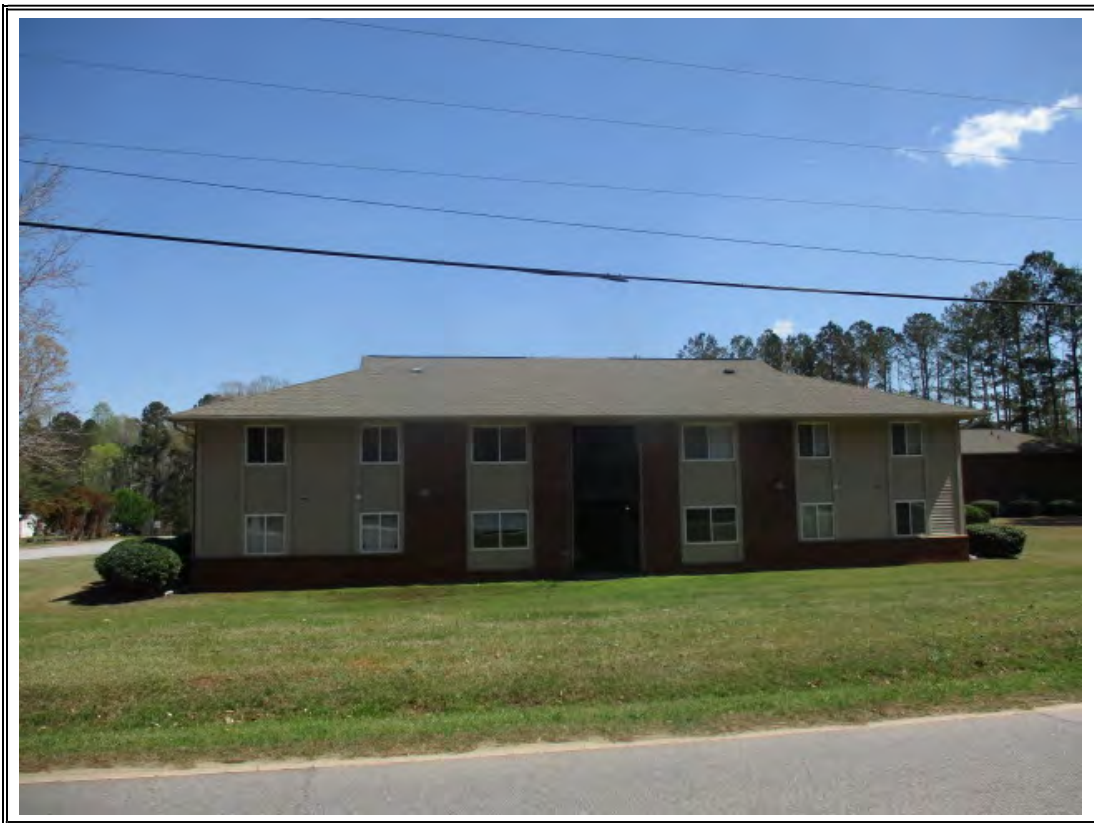
Photo 5: View depicts example subject property building (back side).

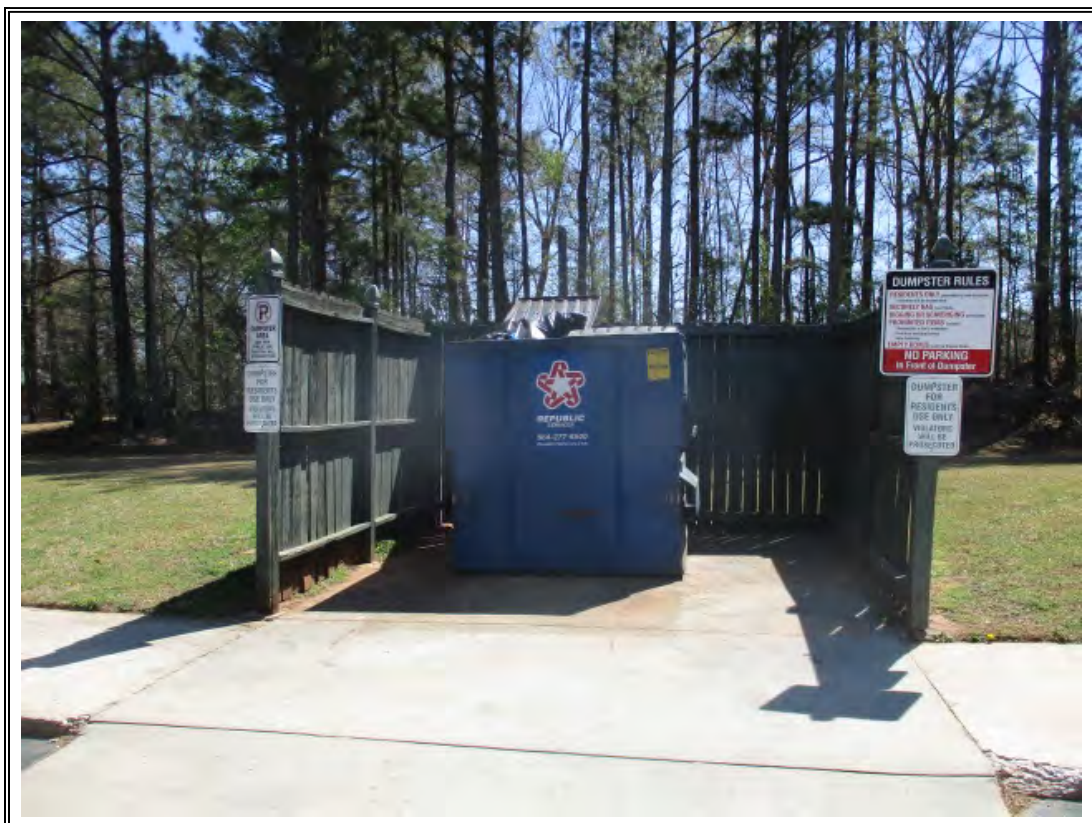
Bulk quantities of abandoned/discarded solid waste debris were not observed at the subject property. Refuse from tenant apartments is collected into two-fronting loading dumpsters which are located on the subject property (Photograph 11, Appendix B). One dumpster is located on the west portion of the complex between Buildings B and C, and the second dumpster is located on east portion of the complex between Buildings F and G. The dumpsters are owned and operated by Republic Waste Services and serviced twice per week. Surplus/overflow debris was not observed around the trash dumpsters.

Photo 11: View depicts 1 of 2 trash dumpsters located at subject property.

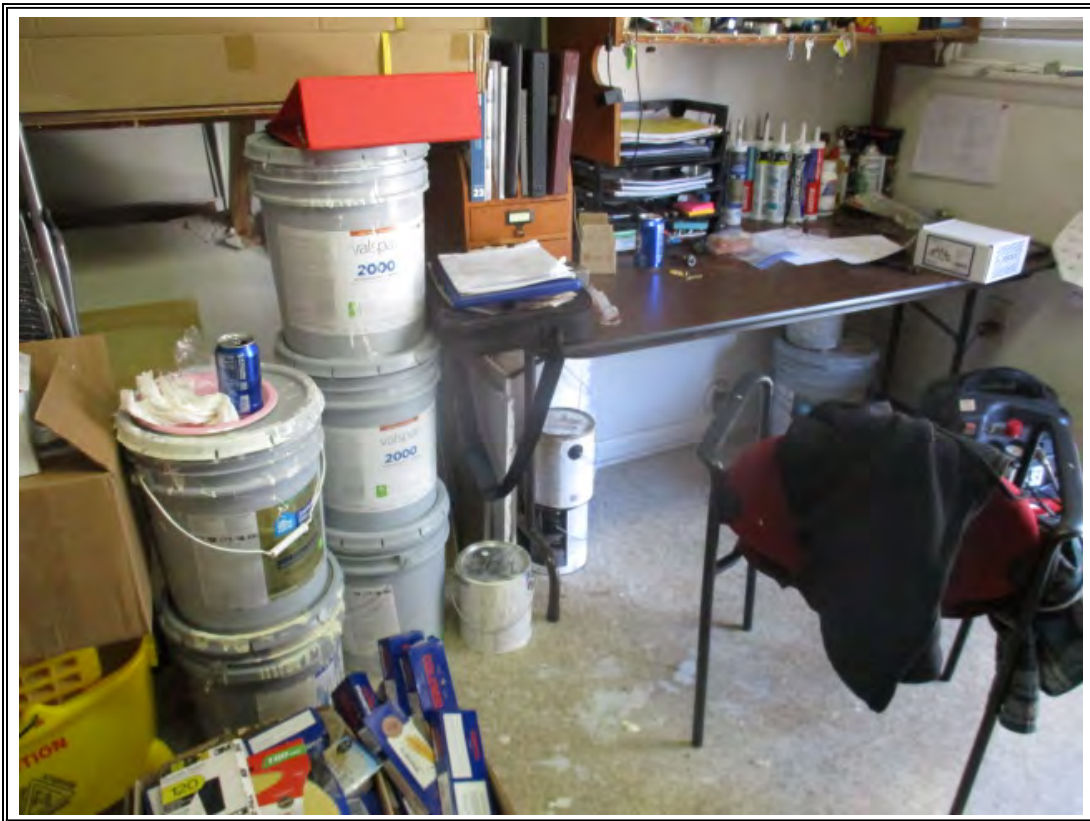
Bulk quantities of hazardous and/or petroleum products were not observed to be used, stored, abandoned, or discarded on the subject property. It is noted minor quantities of paint were observed within the maintenance office to include six (6) 5-gallon paint buckets and three (3) 1-gallon paint cans (Photograph 15, Appendix B). The paint containers were predominantly empty. Mr. Weaver confirmed paint is purchased on an as needed basis to prepare units prior to turnover. The integrity of the paint containers appeared sound and no stained flooring, pooled liquids, or other evidence of product

mismanagement were observed. The presence of the paint containers does not represent an REC to the subject property.

Photo 15: View of paint containers observed within the maintenance office.

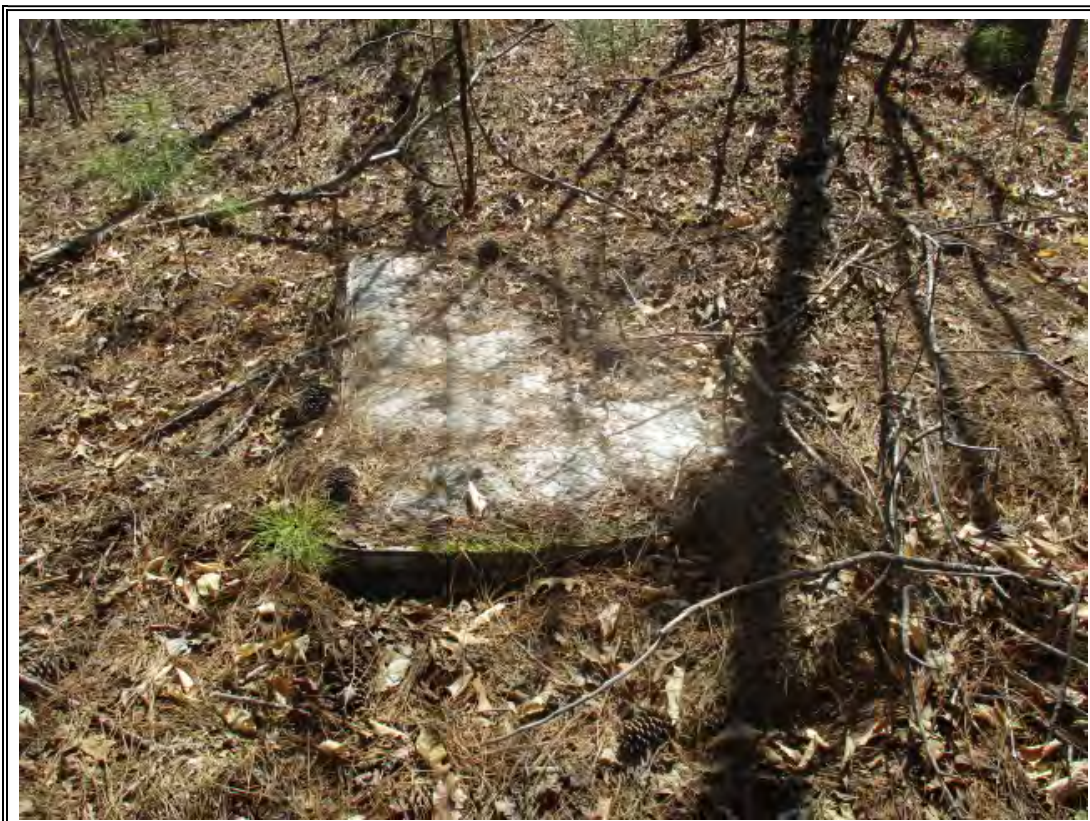
It is noted a significantly weathered mattress (estimated queen-size) was observed on the southwest portion of the subject property within the wood line behind Building B (Photograph 16, Appendix B). Proper disposal of the mattress can be accomplished without specialized sampling and handling requirements. The presence of the mattress does not represent an environmental concern to the subject property.

Photo 16: View of weathered mattress observed behind Building B.

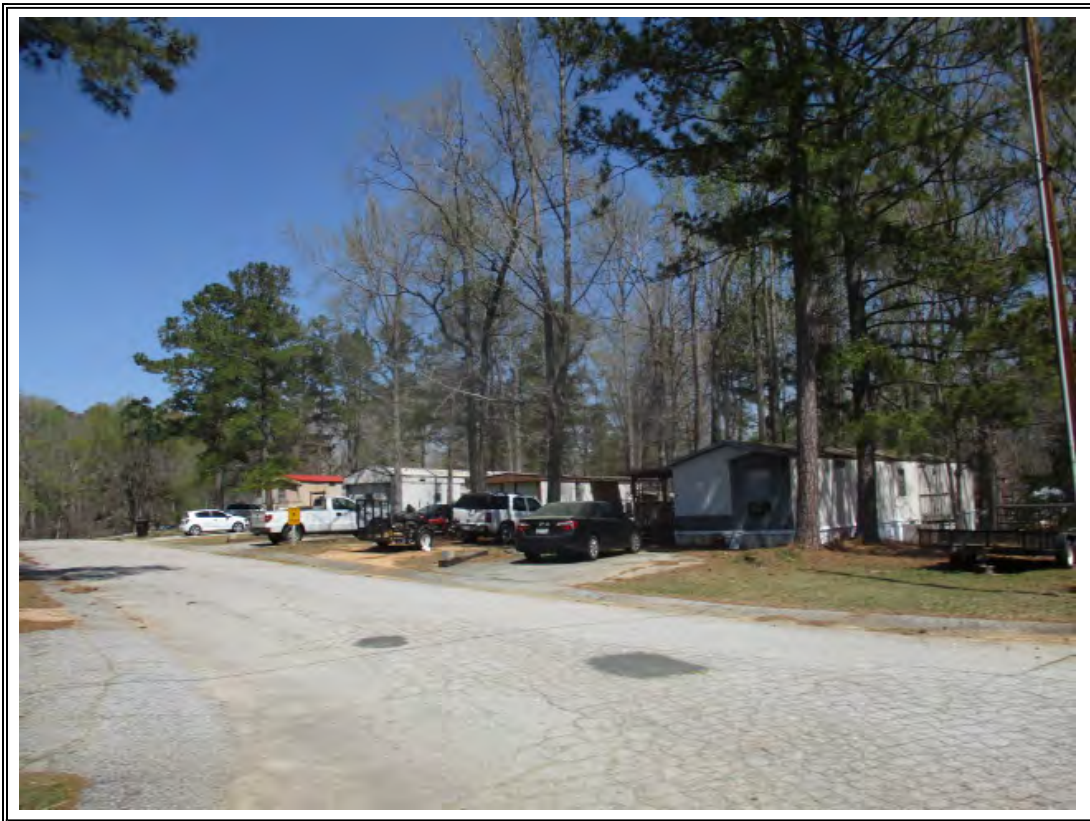
Past: Property located north of the subject property is depicted as wooded, undeveloped land in aerial photography dated 1951 through 1982. The existing mobile home park is initially depicted north of the subject property in the 1989 aerial photograph. The extent of mobile home park development located north of the subject property is generally depicted similar to present day conditions since 1994.

Photo 17: View of mobile home park located on adjacent property north.

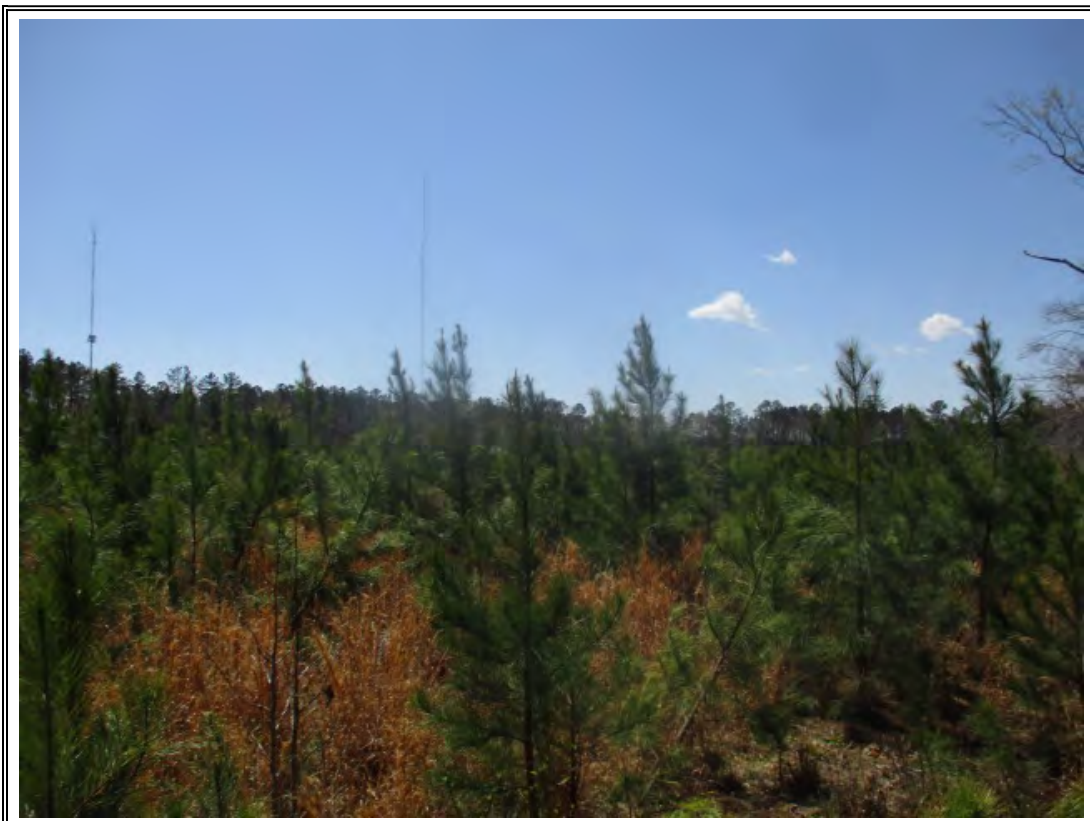
Photo 18: View of wooded land located on adjoining property south.
