Site Construction Review

Created: 04-04-2024
Creator: Thomas White (@TWH)
Status: Priority 1, Priority 2
Dates: 03-28-2024 - 04-04-2024

Mockingbird Landing

MONROEVILLE, ALABAMA
GROUND-FLOOR UNIT NUMBERS SHOWN

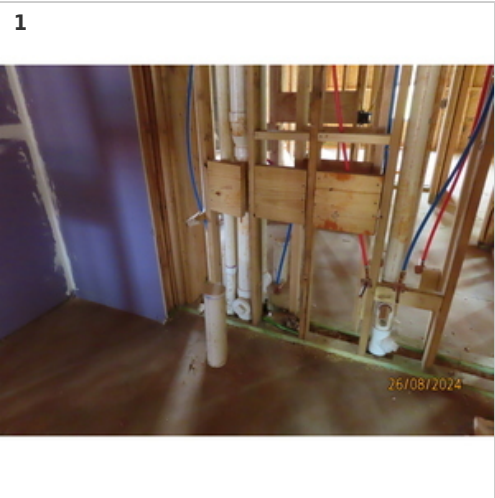
● **#10 - Blocking behind the toilet wasn't complete at this visit,**
Priority 2 | Thomas White | 2024-0404 Visit
Plan: 3br (unit C) - FH/Accessible | Location: Accessible (HOME) > 1102(3br) > Bath #2

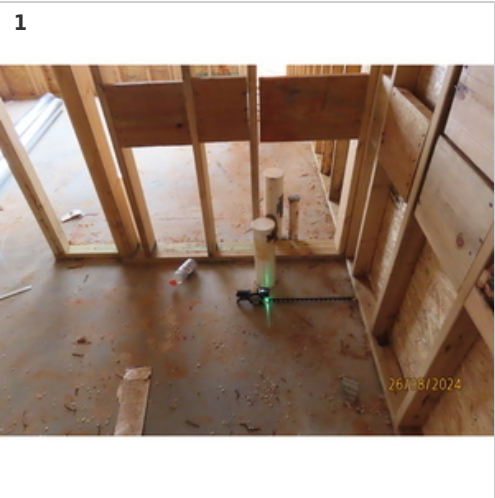
● **#45 - The toilet centerline may not end up within 16-18 inches off the finished side wall per ADA 2010 (HOME).**

Priority 2 | Thomas White | 2024-0404 Visit
Plan: 1Br (Unit A) - FH/SI/Accessible | Location: Accessible (HOME) > 5110(1br)

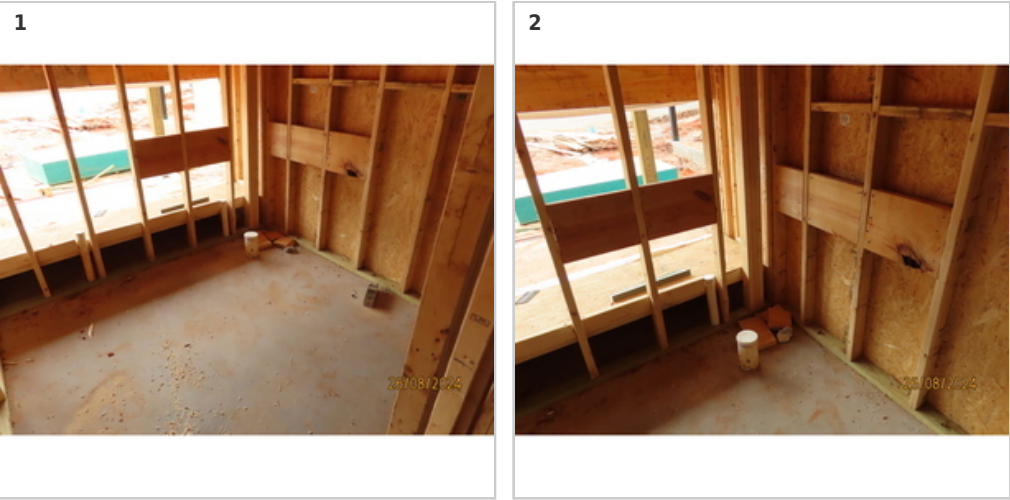
● **#1 - Blocking not complete at the time of this visit.**

Priority 2 | Thomas White | 2024-0404 Visit
Plan: Clubhouse | Location: Clubhouse > Men's Restroom

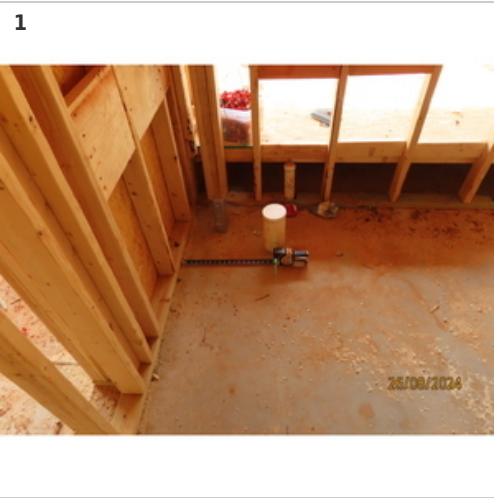
● **#4 - The centerline of this toilet could end up more than 18-inches off the finished side wall.**

Priority 2 | Thomas White | 2024-0404 Visit
Plan: Clubhouse | Location: Clubhouse > Women's Restroom

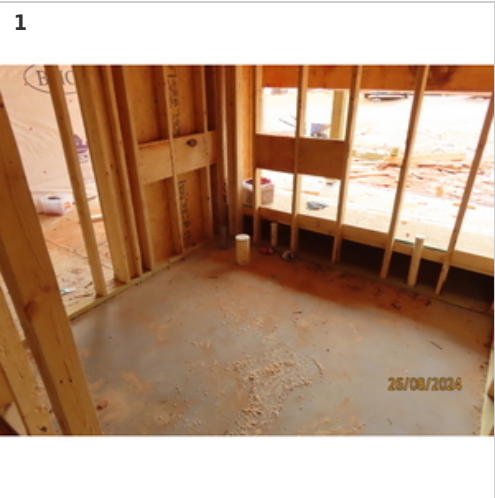
● **#3 - Blocking not complete at the time of this visit.**

Priority 2 | Thomas White | 2024-0404 Visit
Plan: Clubhouse | Location: Clubhouse > Women's Restroom

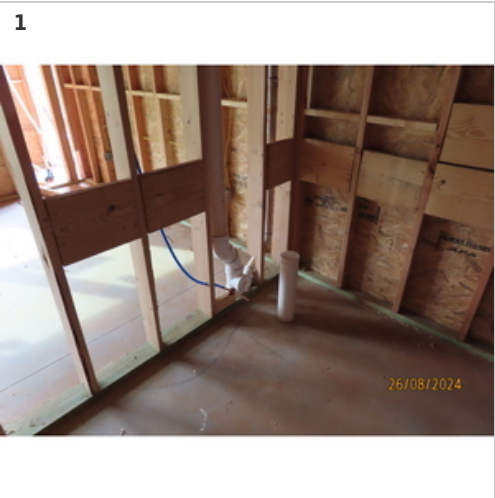
● **#14 - Blocking not complete at the time of this visit.**

Priority 2 | Thomas White | 2024-0404 Visit
Plan: 2Br (unit B) - FH/Accessible | Location: FHA > 1103-2br > Bath #1

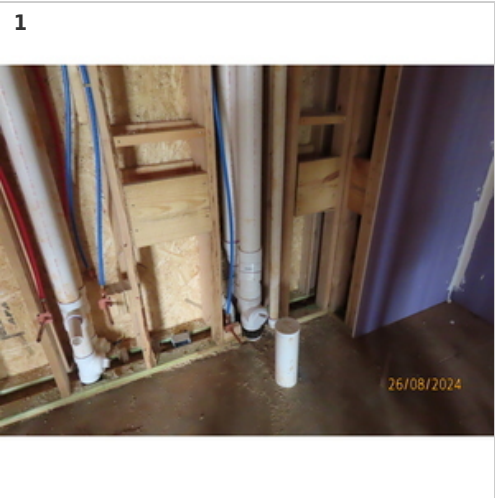
● **#17 - Blocking not complete at the time of this visit.**

Priority 2 | Thomas White | 2024-0404 Visit
Plan: 2Br (unit B) - FH/Accessible | Location: FHA > 1103-2br > Bath #2

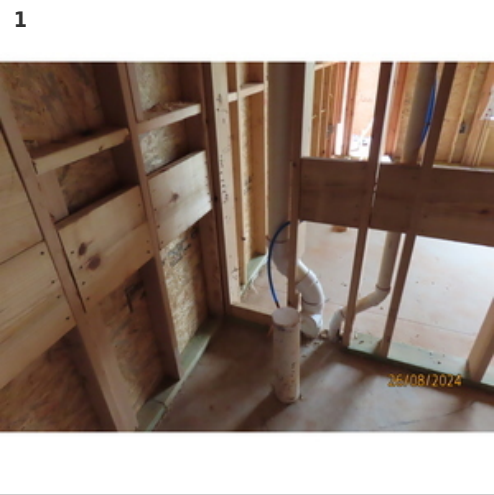
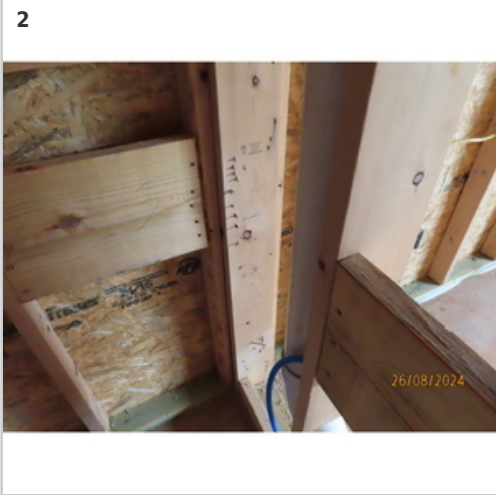
● **#12 - Blocking not complete at the time of this visit.**

Priority 2 | Thomas White | 2024-0404 Visit
Plan: 3br (unit C) - FH/Accessible | Location: FHA > 1104-3br > Bath #1

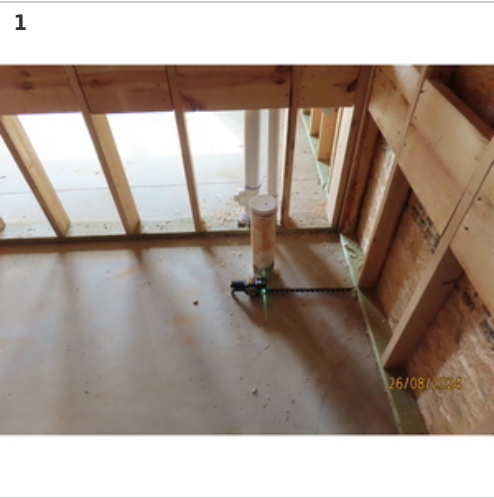
● **#26 - The toilet centerline could end up less than 18-inches of the finished side wall.**

Priority 2 | Thomas White | 2024-0404 Visit
Plan: 3br (unit C) - FH/Accessible | Location: FHA > 2103-3br > Bath #1

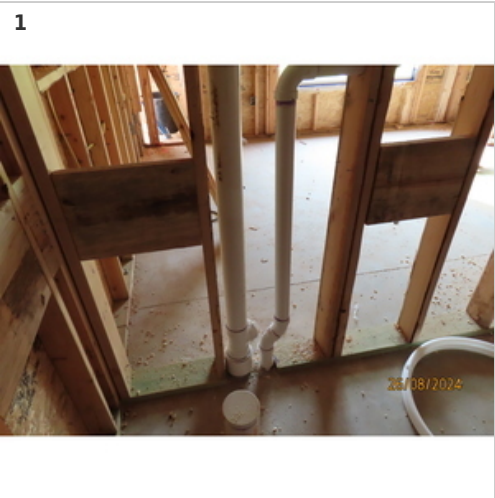
● **#24 - Blocking not complete at the time of this visit.**

Priority 2 | Thomas White | 2024-0404 Visit
Plan: 3br (unit C) - FH/Accessible | Location: FHA > 2104-3br > Bath #1

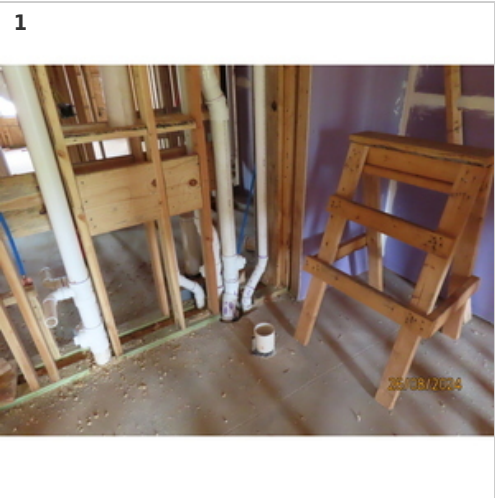
● **#23 - Blocking not complete at the time of this visit.**

Priority 2 | Thomas White | 2024-0404 Visit
Plan: 3br (unit C) - FH/Accessible | Location: FHA > 2104-3br > Bath #2

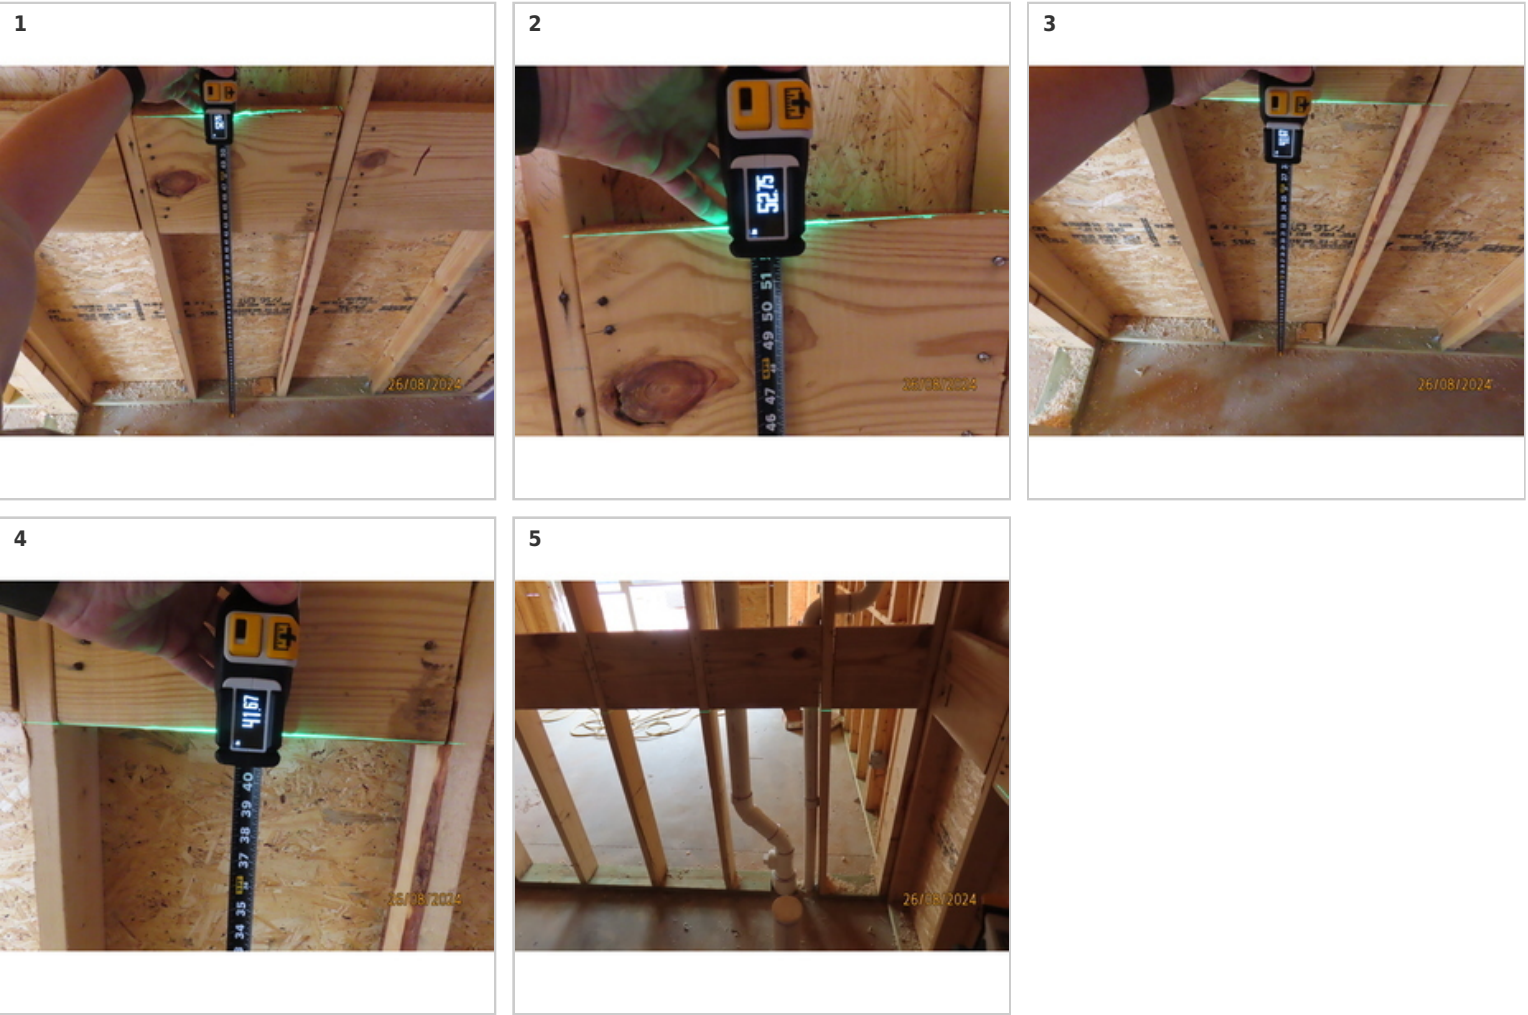
#30 - All blocking for the toilet area is above the FHA range of 32-38 inches above the floor, please correct to the range show on sheet A1.5.

Priority 2 | Thomas White | 2024-0404 Visit
 Plan: 2Br (unit B) - FH/Accessible | Location: FHA > 3102-2br > Bath #1

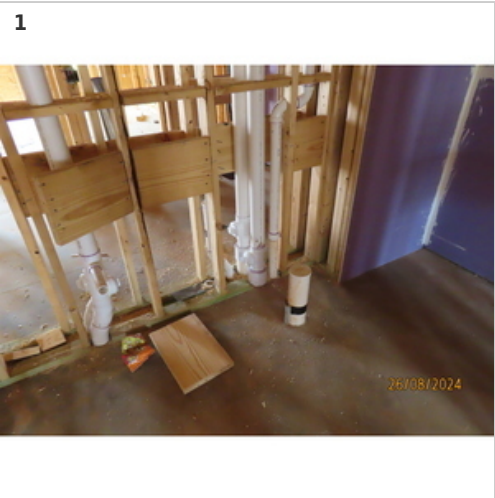
● **#31 - Blocking not complete at the time of this visit.**

Priority 2 | Thomas White | 2024-0404 Visit
Plan: 2Br (unit B) - FH/Accessible | Location: FHA > 3102-2br > Bath #2

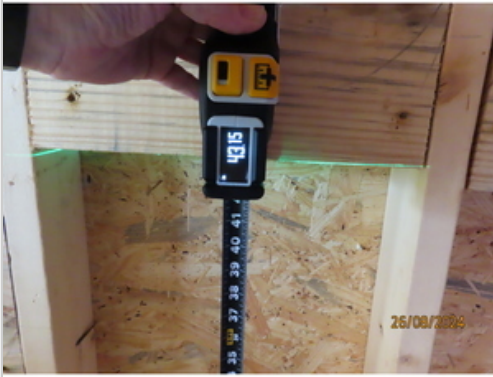
#34 - Side wall blocking for the toilet area is above the FHA range of 32-38 inches above the floor, please correct to the range show on sheet A1.5.

Priority 2 | Thomas White | 2024-0404 Visit
 Plan: 2Br (unit B) - FH/Accessible | Location: FHA > 3103-2br > Bath #1

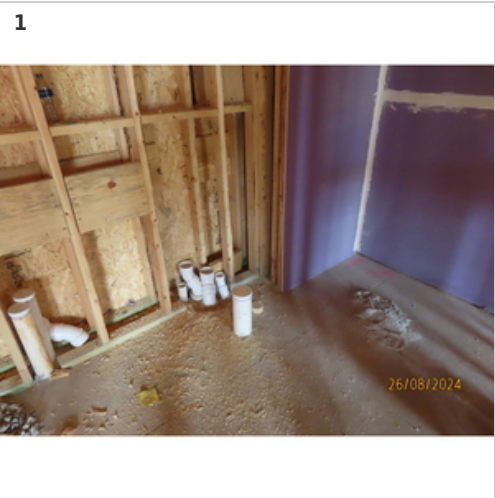
● **#35 - Blocking not complete at the time of this visit.**

Priority 2 | Thomas White | 2024-0404 Visit
Plan: 2Br (unit B) - FH/Accessible | Location: FHA > 3103-2br > Bath #2

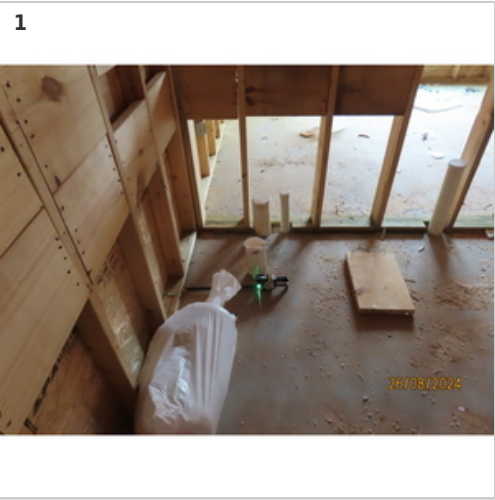
● **#40 - The toilet centerline might end up less than 18-inches from the finished side wall.**

Priority 2 | Thomas White | 2024-0404 Visit
Plan: 2Br (unit B) - FH/Accessible | Location: FHA > 4102-2br > Bath #1

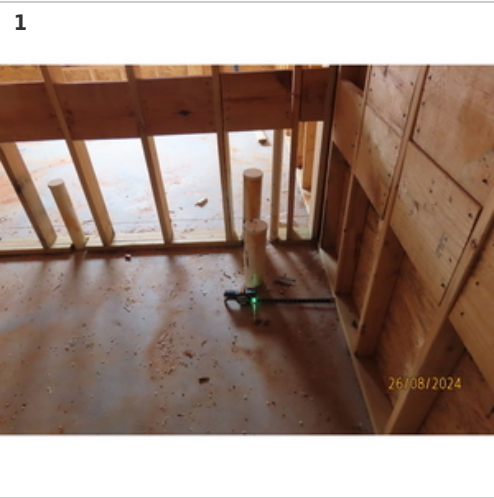
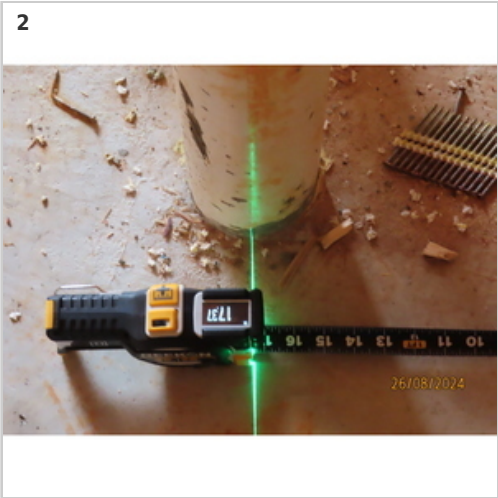
● **#49 - The toilet centerline might end up less than 18-inches from the finished side wall.**

Priority 2 | Thomas White | 2024-0404 Visit
Plan: 2Br (unit B) - FH/Accessible | Location: FHA > 5101-2br > Bath #1

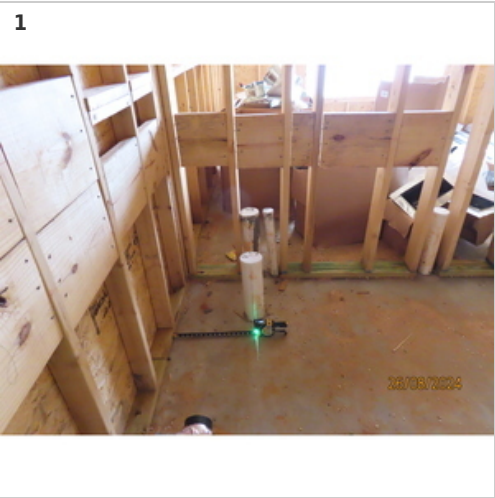
● **#50 - The toilet centerline might end up less than 18-inches from the finished side wall.**

Priority 2 | Thomas White | 2024-0404 Visit
Plan: 2Br (unit B) - FH/Accessible | Location: FHA > 5102-2br > Bath #1

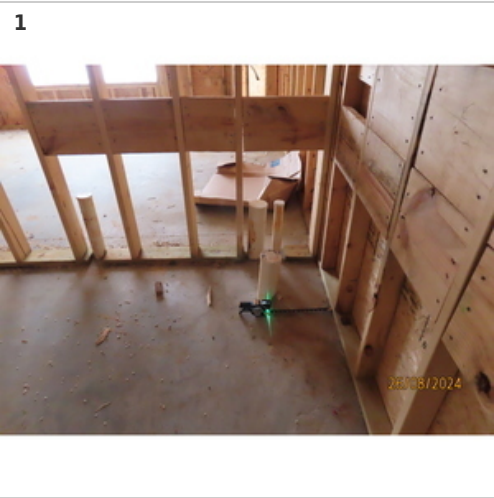
● **#47 - The toilet centerline might end up less than 18-inches from the finished side wall.**

Priority 2 | Thomas White | 2024-0404 Visit
Plan: 1Br (Unit A) - FH/SI/Accessible | Location: FHA > 5105-1br
