Reference: **Jurisdictional Waters Assessment**  
**Harmony at Horizon Village**  
Columbia, Richland County, South Carolina  
S&ME Project No. 26610216

# Identification of Wetlands

**Development:** Harmony at Horizon Village Multifamily

Reference: **Jurisdictional Waters Assessment**  
**Allen Benedict Court – Multi-Family Site (10.5 Acres)**  
Columbia, Richland County, South Carolina  
S&ME Project No. 23610466

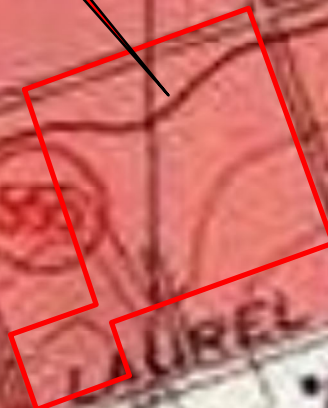
EXHIBIT NO.

### Topographic Exhibit

Source: USGS 7.5-Minute Topo Quad Columbia North, SC 1972 (Revised 1990)

The USGS mapping depicted no blue-line drainage features or surface waters on the site (Exhibit 2). USDA-NRCS mapping depicted the Urban Land (Ur) soil series on the site. USFWS-NWI mapping indicated there were no wetlands or drainage features present on the site (Exhibit 5). FEMA mapping depicted the site is located within the one percent Annual Chance Flood Hazard (Zone X) (Exhibit 7).

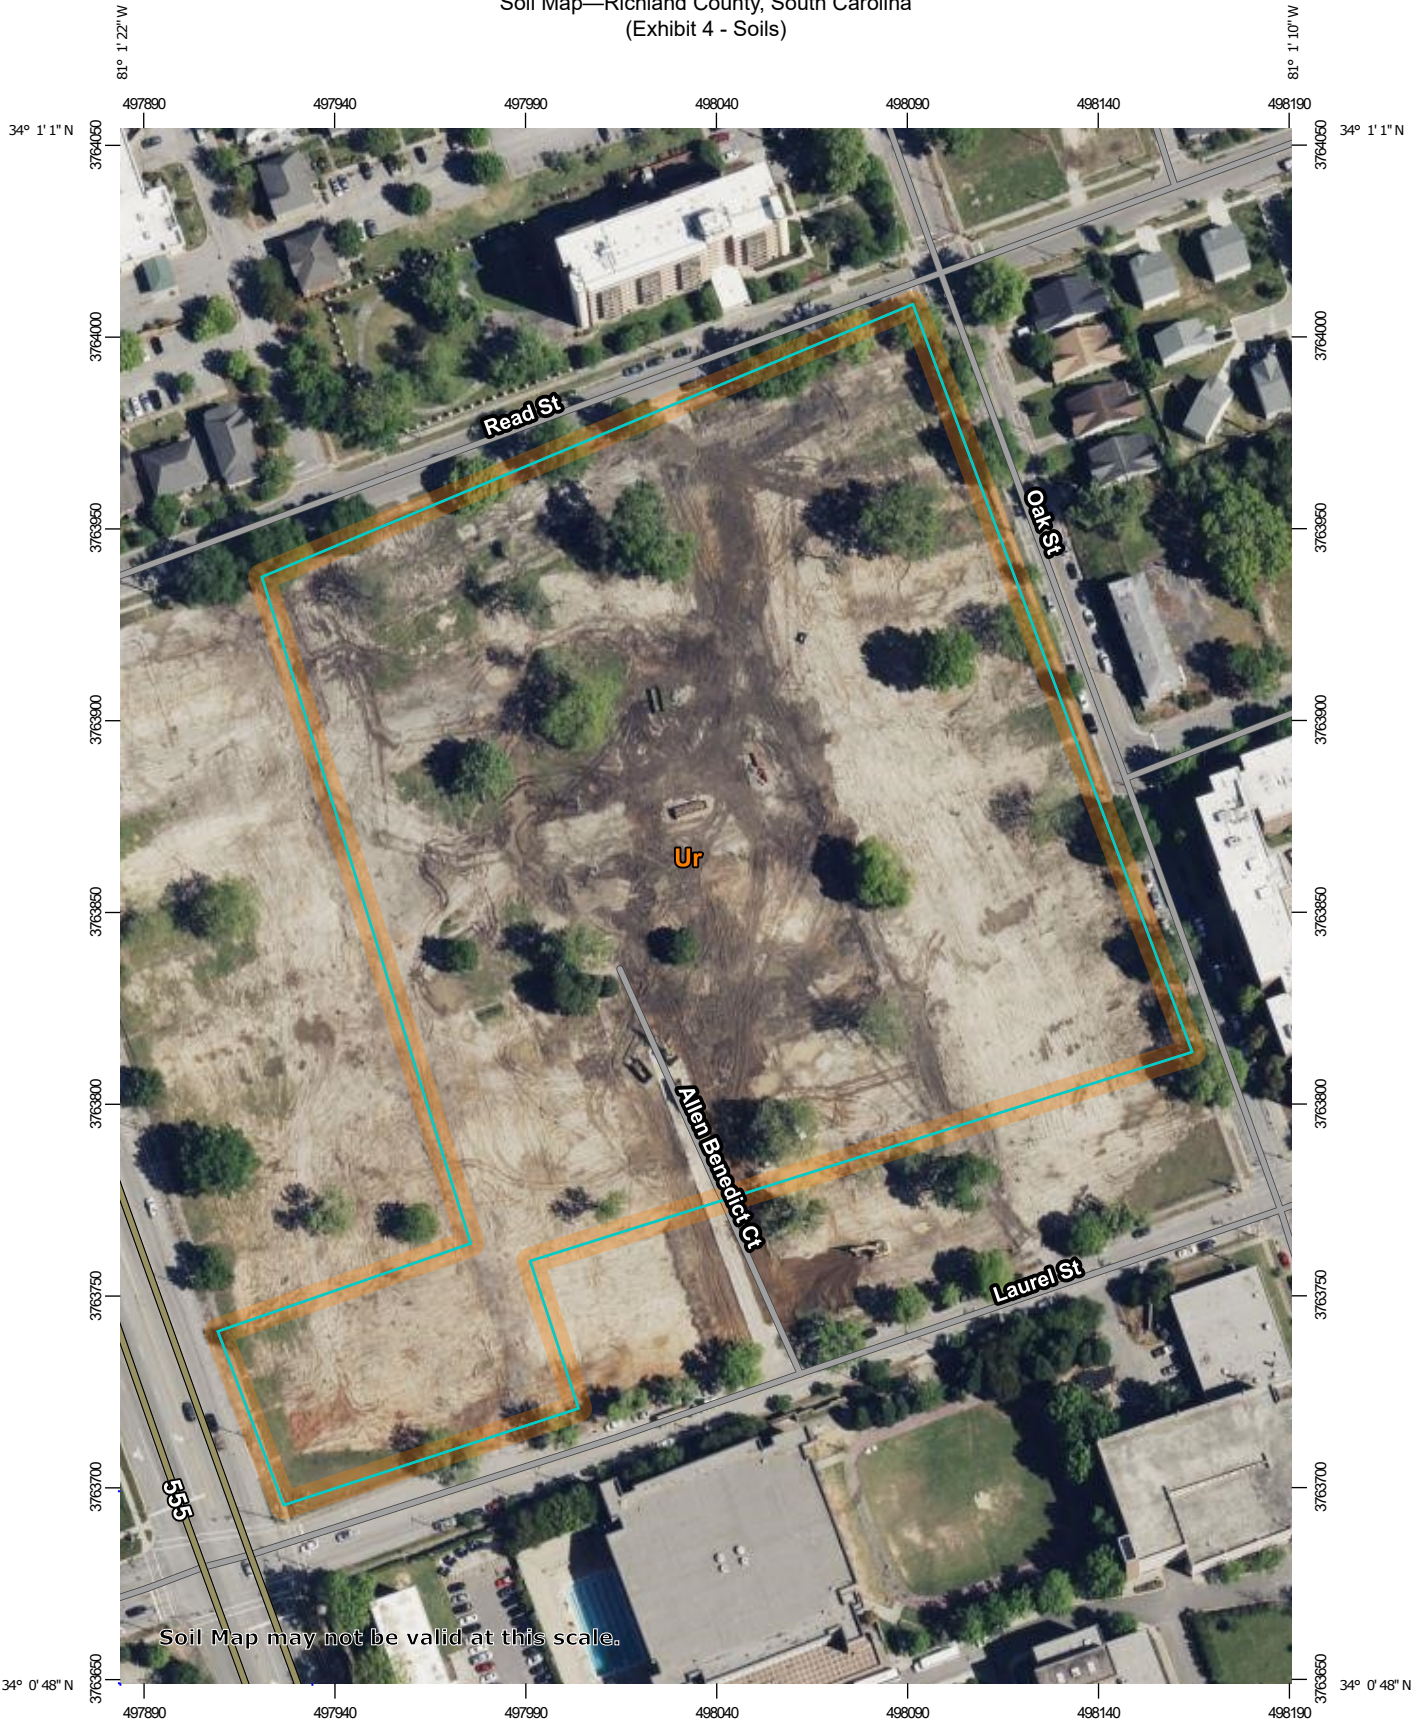
Soil Map—Richland County, South Carolina  
(Exhibit 4 - Soils)

| Map Unit Symbol | Map Unit Name | Acres in AOI | Percent of AOI |
|---|---|---|---|
| Ur | Urban land | 10.4 | 100.0% |

According to the USDA-NRCS Web Soil Survey and the Soil Survey for Richland County, the soil series listed on the site includes Urban Land (Ur). This soil series is not a listed hydric soil for Richland County.

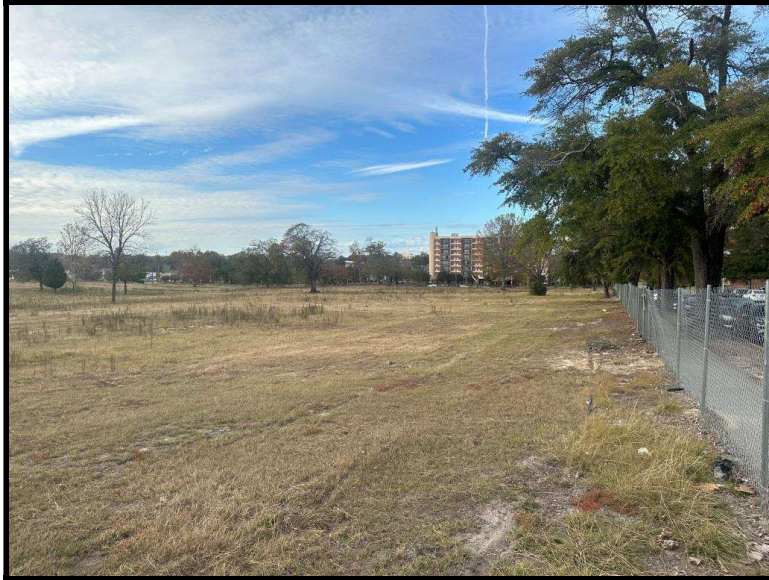
**1** Upland on the southeastern portion of the site facing north.

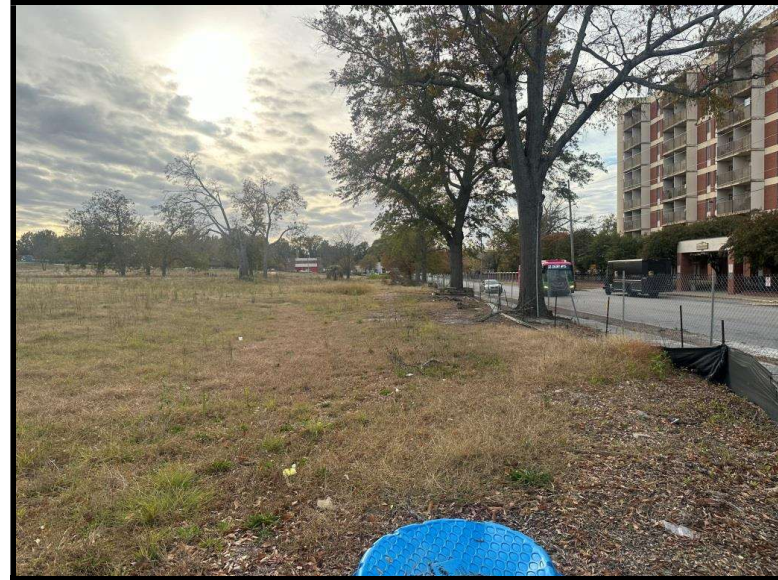
**2** Upland on the northern portion of the site facing west.

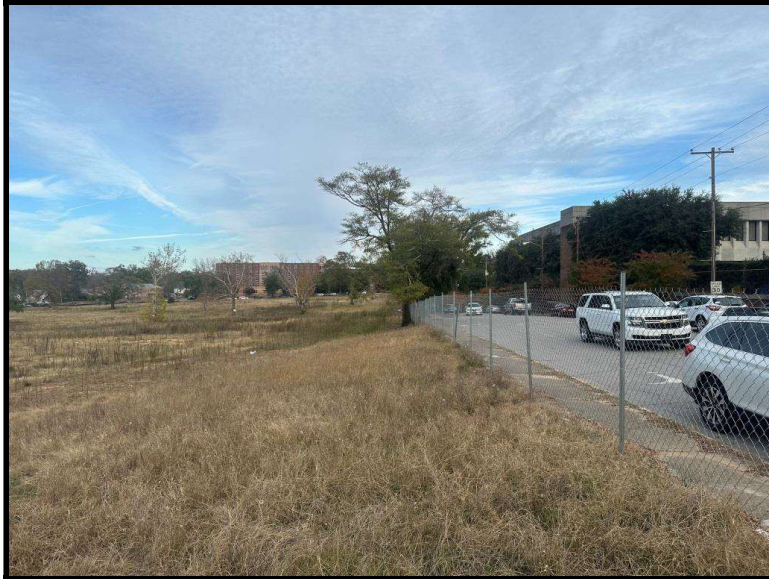
**3** Upland on the southwestern portion of the site facing east.

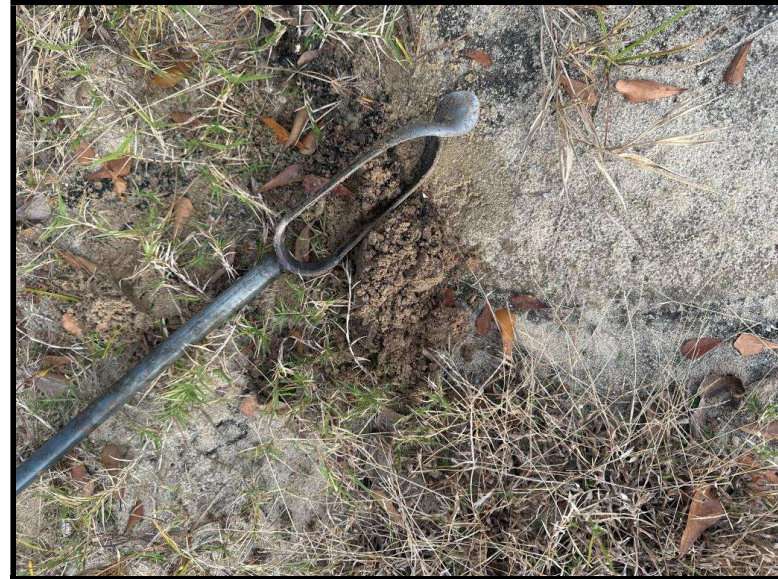
**4** Soils observed at data point location were 10YR 4/3 Sand (1-12 inches). No indicators of hydric soil were observed.

Hydric Soils not observed.
