# REPORT

Preliminary Aquatic Resource  
Investigation  
Kingston Pointe  
Putt Putt Drive  
Anderson, Anderson County, South  
Carolina

April 29, 2026

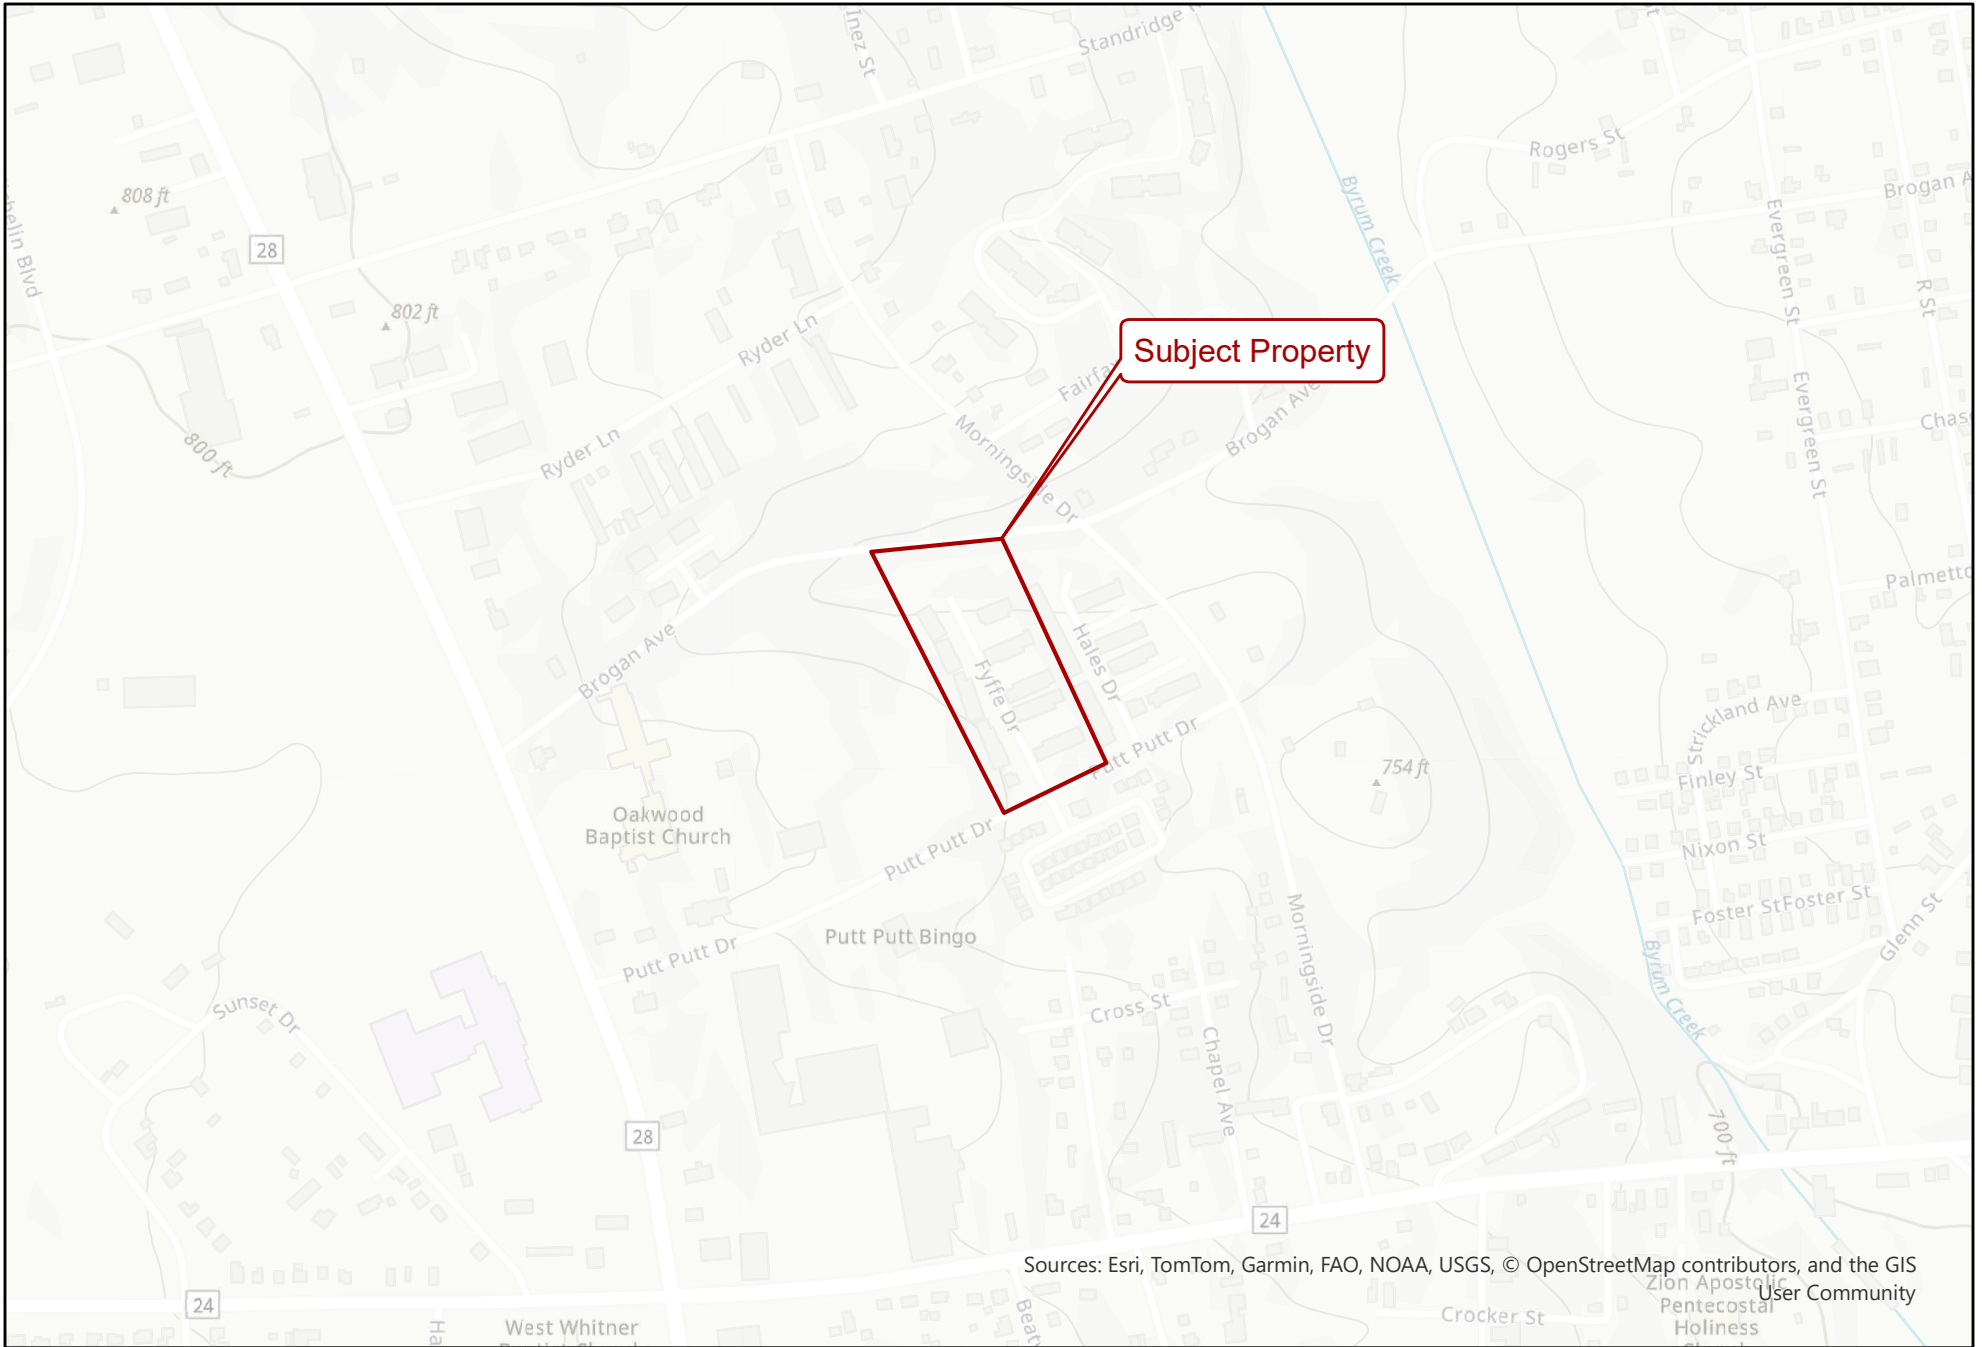
| <b>UNITED CONSULTING</b> | <br><b>Figure Scale</b><br><br>Scale: 1:7,200 | <b>Prepared By:</b> DSB | <b>Figure Title:</b> USGS Topographic Map | <b>FIG. 2</b> |

The U.S. Geological Survey National Topographic Map of the area was reviewed prior to the site visit. No streams or wetlands were mapped within the interior of the Subject Property. A drainage swale was mapped on the northern portion of the Subject Property. A copy of the USGS topographic map showing the approximate Subject Property boundaries is attached as Figure 2.

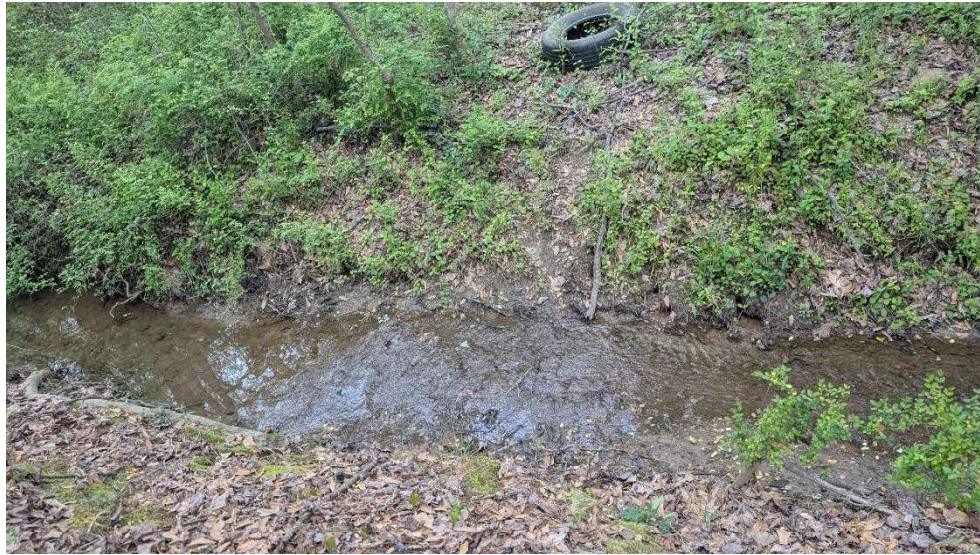
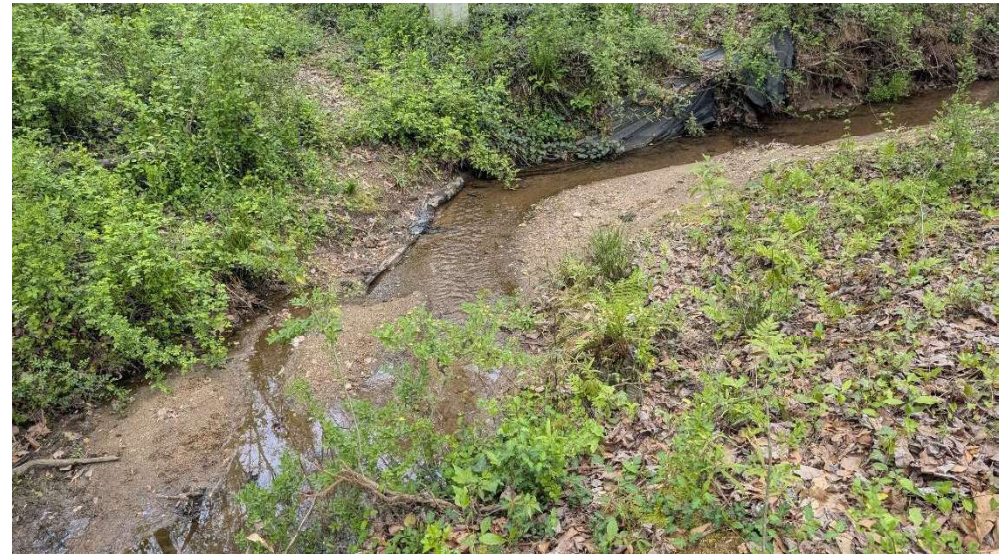
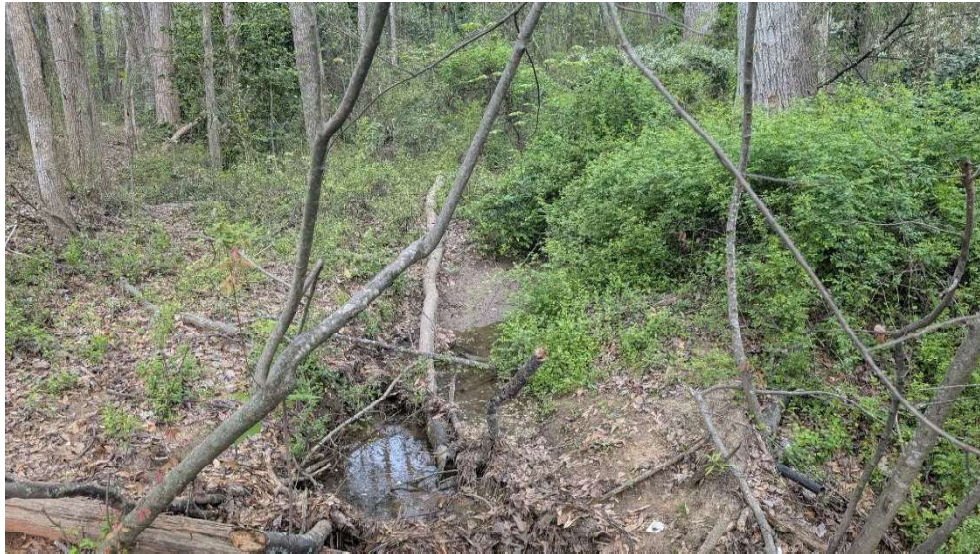
Photo: On site perennial stream.

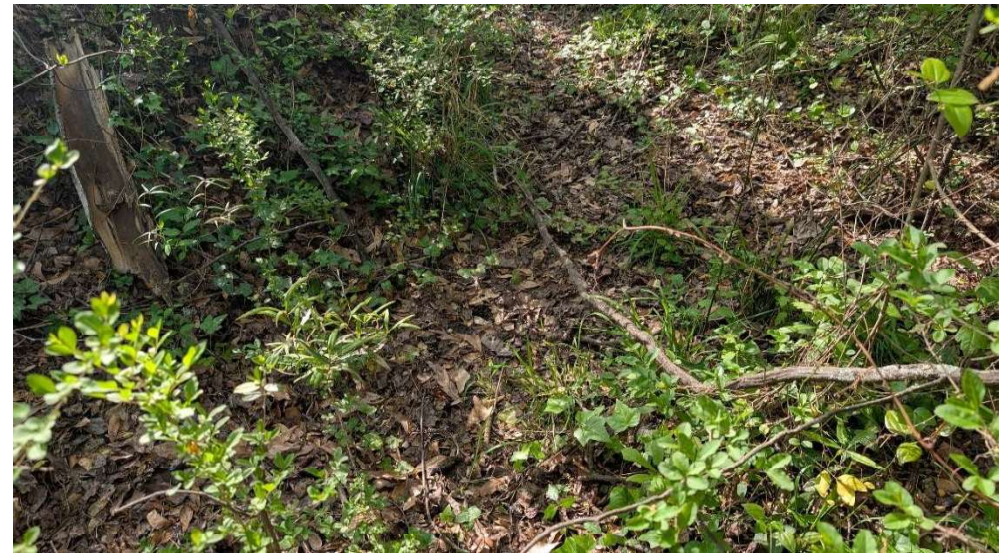
A wetland area was observed on the northwestern portion of the Subject Property along the western boundary of the Subject Property. The wetland was approximately 10 to 20 feet wide and contained saturated soil, wetland vegetation and hydric soil. This feature sloped north and drained into an apparent perennial stream feature. The perennial stream feature flowed east onto the Subject Property across the western boundary of the Subject Property and generally flowed east parallel to Brogan Avenue. The stream feature was characterized by continuous flowing water, a clear ordinary high water mark (OHWM), the presence of pools and riffles, and a coarse substrate including rocks and gravel. The stream was approximately two to seven feet in width.

Photo: On site wetland area.
