# Accessibility Construction Progress Observation Report #3 Final

Limehouse Landing  
Summerville, South Carolina

January 6, 2025 | Project Number: F8216166

SC Housing Project Number NH-21001

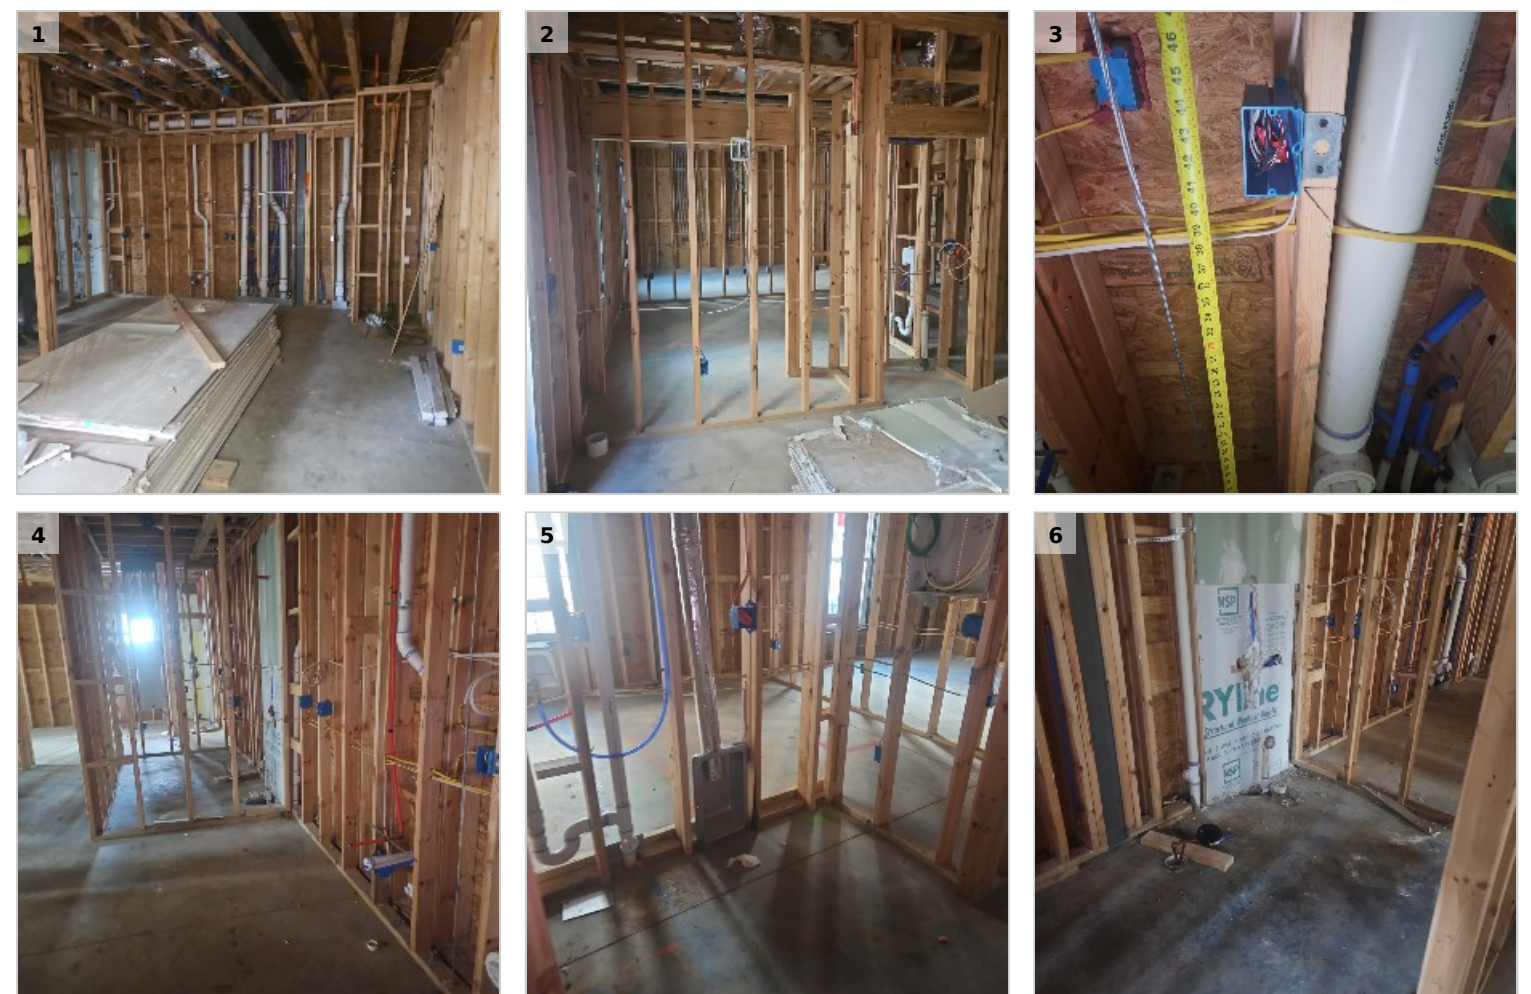
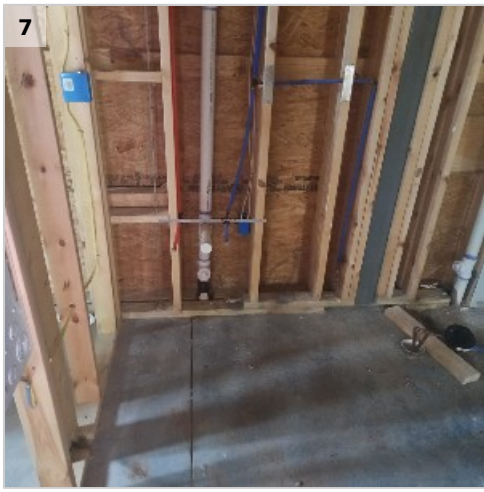
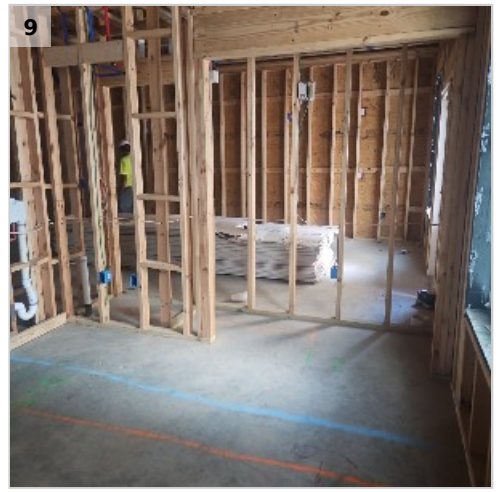
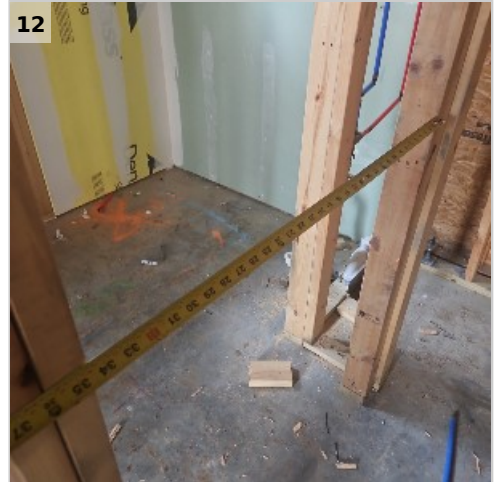
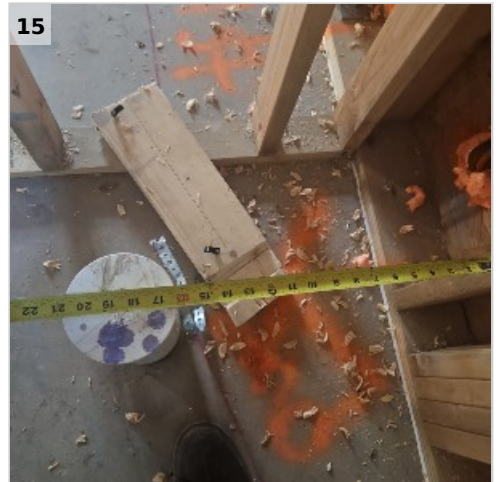
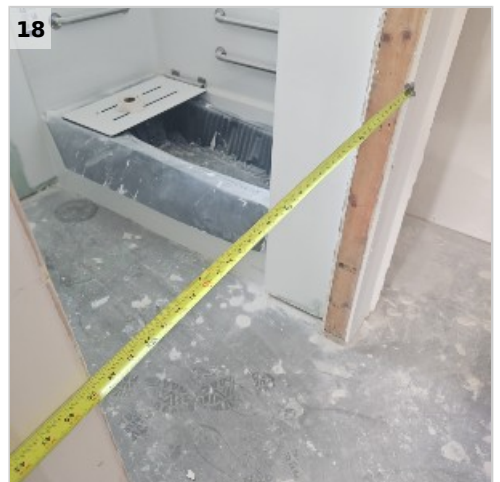
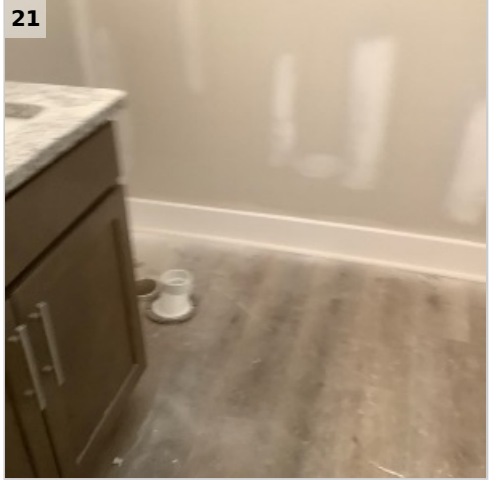
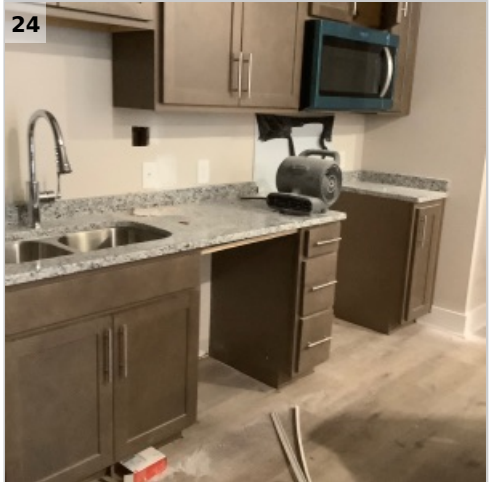
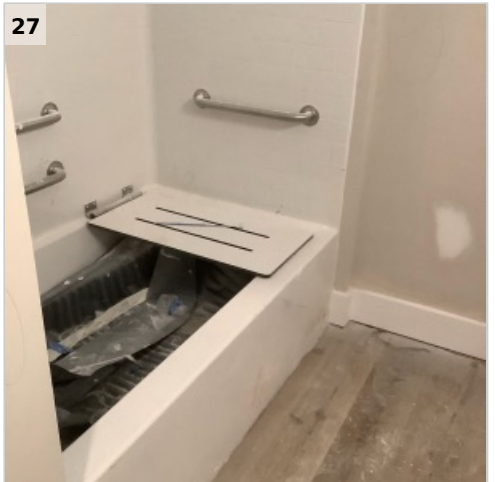
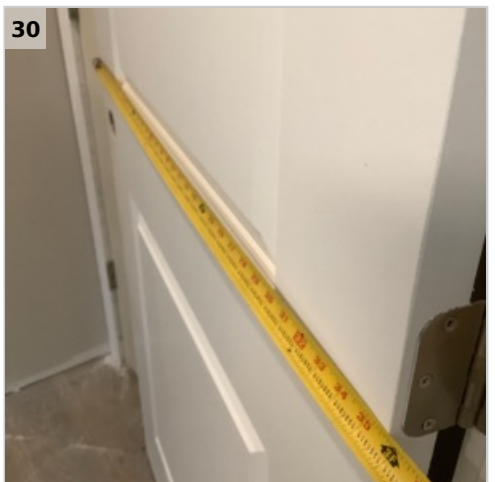
| Emmanuel Belleau | Issue from previous report: The master bathroom does not provide the minimum 30" by 48" clear floor space in the bathroom outside of the door swing. We recommend reversing the door to swing out into the bedroom.<br>ITEM CLOSED 12/26/2024 | 05 Jun 10:09 AM |

| Melissa Middleton | Issue: The toilet and bathroom accessories are to be installed. | 26 Dec 11:44 AM |

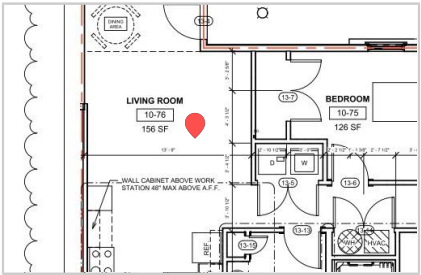
● **#17 - Willow Mobility Unit #4104**

Field Issue | Emmanuel Belleau | Unit-Mobility  
Plan: A1.1\_131 B - UNIT X104 - 'WILLOW' TYPE A | Location: Unit 3x2 HCS  
Tags: #mobility

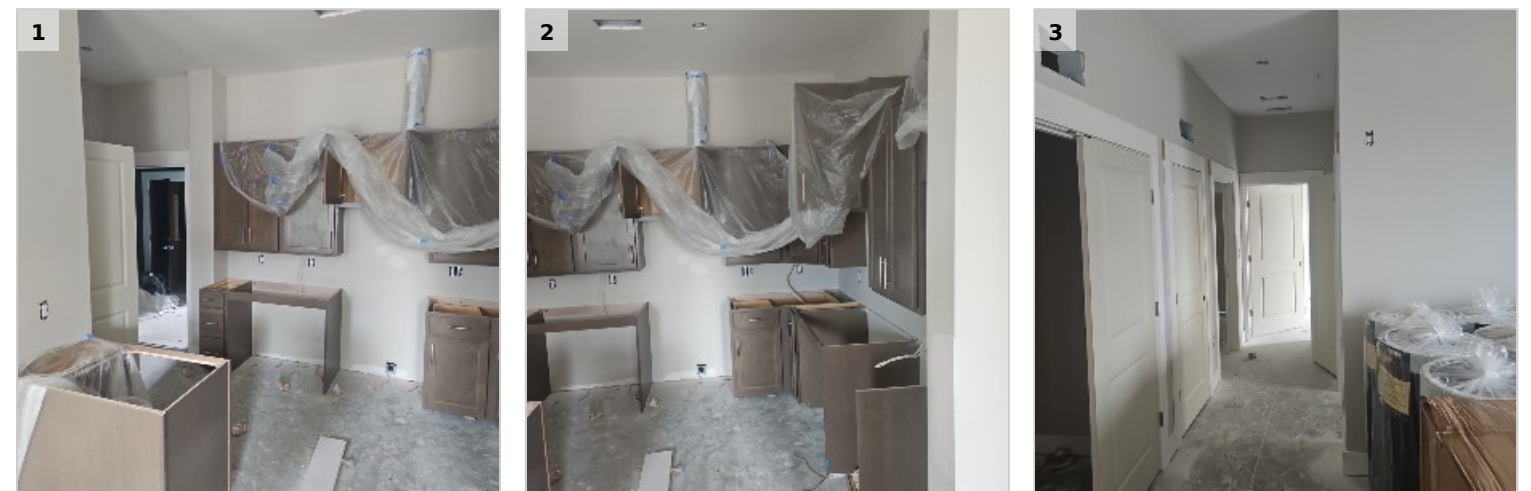
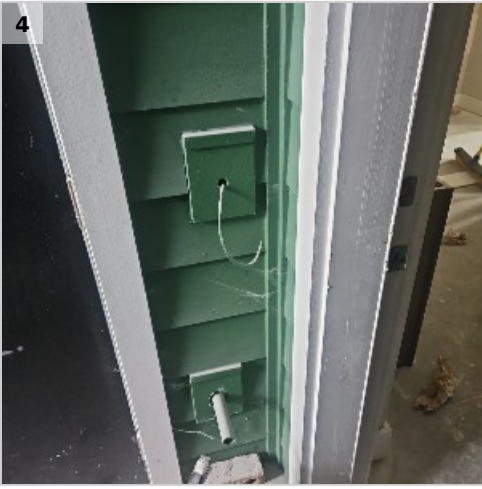
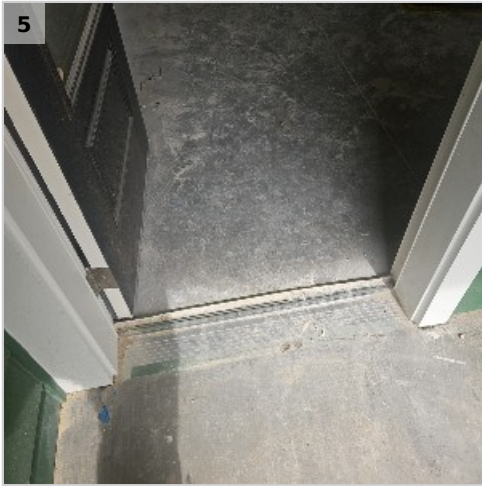
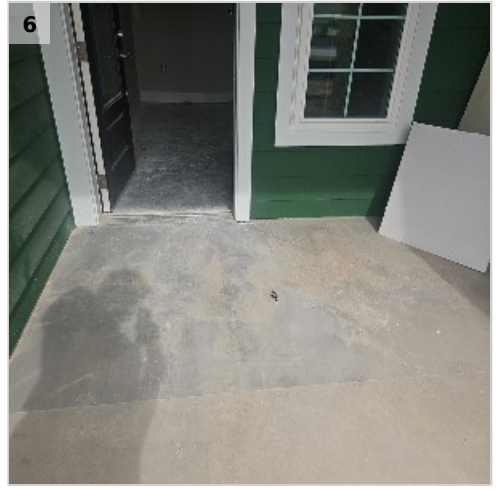
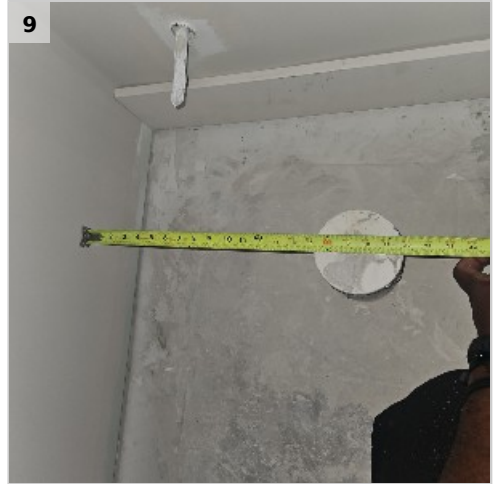
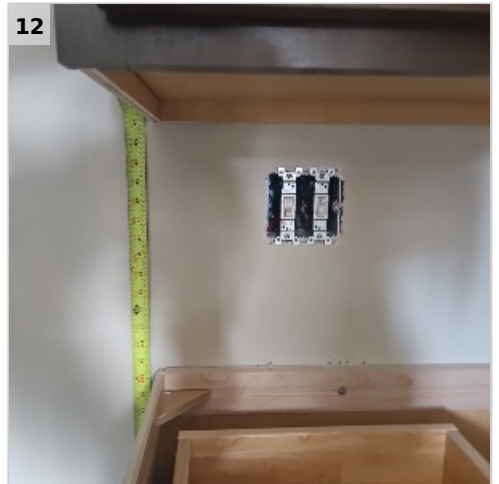
## #13 - Myrtle Sensory Unit #3101

| Melissa Middleton | Issue: There is a fire alarm system with strobe alarms provided; however, strobes are not provided on the smoke detectors. We recommend installing smoke detectors with a strobe alarm in the designated communication dwelling unit. | 26 Dec 10:58 AM |
