ZEFFERT & ASSOCIATES

Accessibility Site Visit (Master)

| Project Name | Sample Property |
| Date of Inspection | 01-15-2020 |

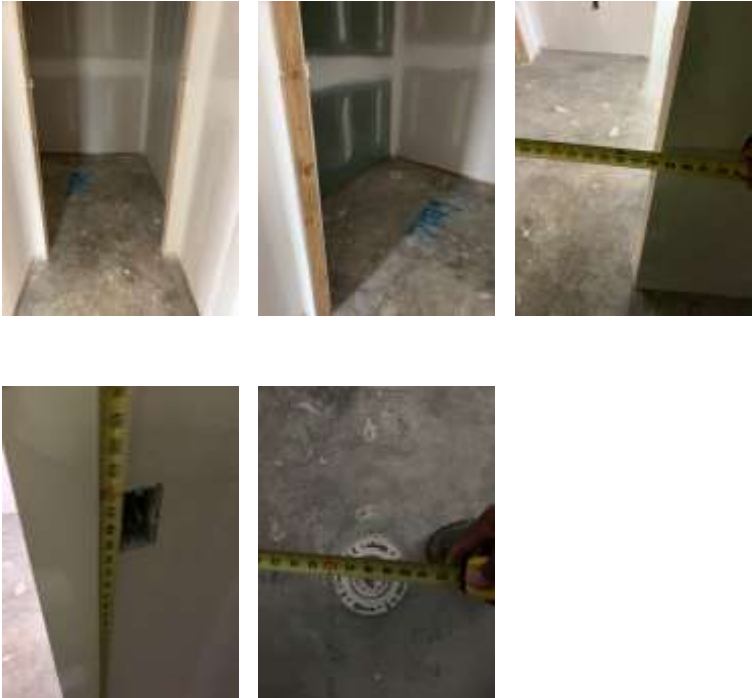
| Restroom Photos | |

| Public Restroom Description | Community Building Women's |
| Status of this area | Drywall stage |
| Doorway has a clear opening width 32" min. (ADA 404.2.3) | Yes |

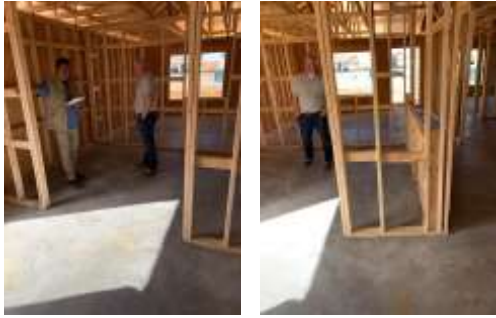
| HC Unit Kitchen Photos | |

| Entry and/or door 32" min. (UFAS 4.13.5) | Yes |
| Additional Comments for HC Unit Kitchen | No electrical installed at the time of inspection |

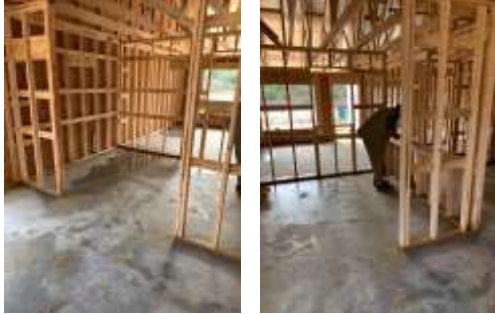
| HC Unit Kitchen Photos | |

| Status of this area | Framing stage |
| Additional Comments for HC Unit Kitchen | No electrical installed at the time of inspection |
