Accessibility Site Visit Report - HC - ANSI

Project Name	Sample Property
Visit Type	3rd
Date of Inspection	02-12-2020
Inspector	Brian White
Site Visit Accompaniment	Jason Pendly
Street Address	123 Main St
City	Greenville
State	South Carolina
Zip Code	29605
Accessibility Codes for this project (Check if used)	2010 ADA, ANSI A117.1, UFAS
Number of Buildings	1
Total Number of Units	80
Number of HC Accessible Units	5
Number of A/V Units	0
Number 1 Bedroom Units (Std/HC)	80/5
General Project Notes:	NOTE – Element Findings at Time of Inspection: This inspection report indicates individual elements as Yes, No, or N/A. Each

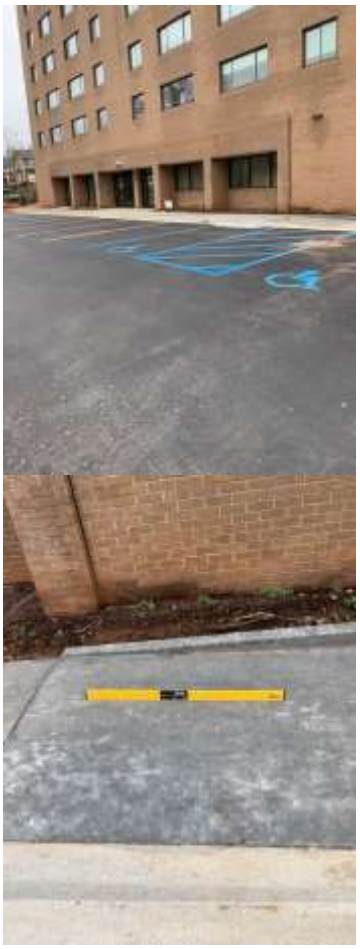
Location of Parking	Basement Entrance
HC Parking Status	Finished
Surface type	Asphalt
HC parking spaces the closest parking to the nearest location: (2010 ADA 208.3.1 UFAS: 4.6.2 FHA 2.20)	Yes
Parking space at least 96" wide (ADA 502.2 UFAS 4.6.3 FHA 2.21)	Yes
Is access aisle the full length of the parking space (ADA 502.3.2 UFAS 4.6.3 FHA 2.21)	Yes
Is access aisle proper width 5' (ADA 502.3.1 UFAS 4.6.3 FHA 2.21)	Yes
Is the slope and cross-slope of parking space no more than 2% in all directions (ADA 502.4 UFAS 4.6.3)	Yes
Is the slope and cross-slope of access aisle no more than 2% in all directions (ADA 502.4 UFAS 4.6.3)	Yes
Does each HC parking space have a sign with ISA mounted at least 60" above the	No

space to the bottom of the signage (ADA 502.6 UFAS 4.6.4 FHA 2.21)	
Curb ramp slope does not exceed 8.33% (ADA 405.2 UFAS 4.8.2)	Yes
Curb ramp cross-slope no more than 2% (ADA 405.3 UFAS 4.8.6)	Yes
Curb ramp at least 36" wide (Flared sides) 48" min. C/I ramp (ADA 405.5 UFAS 4.8.3)	Yes
Cut-In curb ramp landing at least as wide as curb ramp and adjoining accessible route (UFAS 4.8.4)	Yes
Accessible Parking Photos

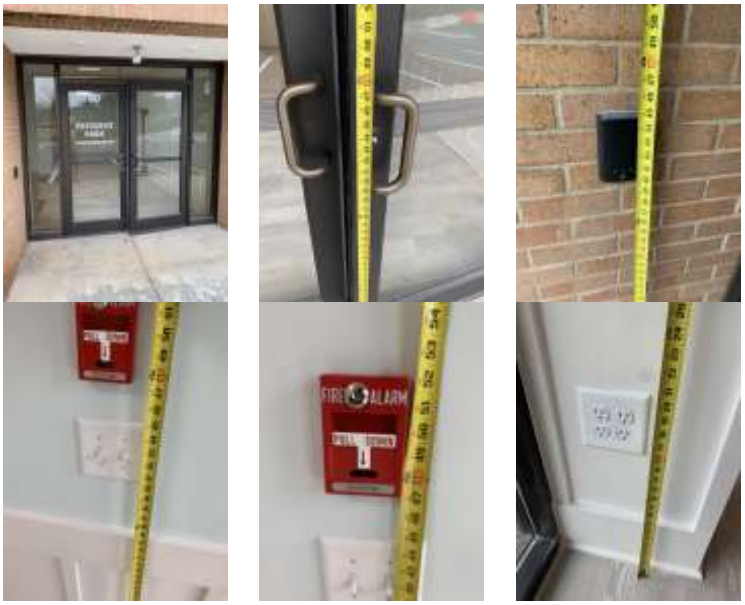
12" min. clearance on the push side of the door (with door closure) (ADA 404.2.1)	Yes
Does the door take at least 5 seconds to close (2010 ADA 404.2.8.1)	Yes
Electric switches 48" max. AFF and outlets 15" min. (unobstructed) (ADA 308.2.1)	Yes
Interior signs mounted (latch side) have tactile characters (measured from the baseline) between 48" min. - 60" max. (ADA 703.4.1)	Yes
Interior sign characters at least 5/8" but no more than 2" tall (ADA 703.5.5)	Yes
If required per NFPA fire alarm pull station permanently installed 48" max. AFF	No
Community Room Photos

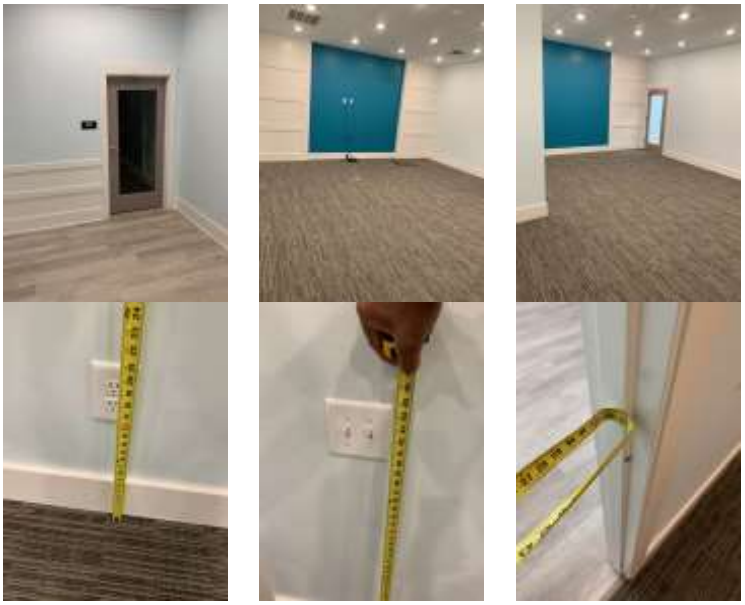
Description of Community Area	**Media Center**
Status of this area	Finished stage
Doorway has a clear opening width 32" min. (ADA 404.2.3)	Yes
Threshold less than 1/2" with bevel or 1/4" no bevel	Yes
12" min. clearance on push side of the door (with door closure)	Yes
Does the door take at least 5 seconds to close (2010 ADA 404.28.1)	Yes

Interior signs mounted (latch side) have tactile characters (measured from the baseline) between 48" min. - 60" max. (ADA 703.4.1)	Yes
Interior sign characters at least 5/8" but no more than 2" tall	Yes
Electric switches 48" max. AFF and outlets 15" min.	Yes
Other Community Area Photos
