## Arrington Mannor

### Evaluation of the Structural Framing and Facade

#### FINAL REPORT

October 11, 2024  
WJE No. 2024.5543

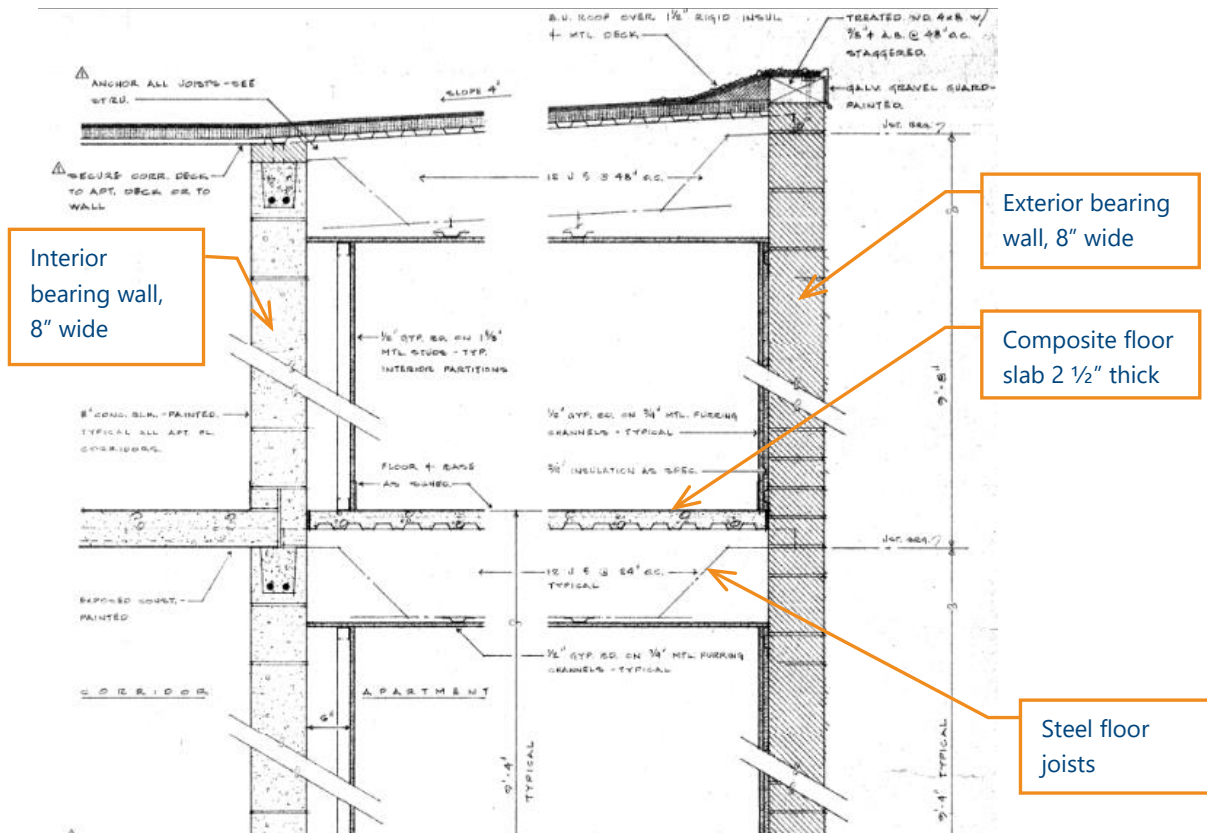
Figure 6. Section (north-south direction) through the exterior and interior bearing walls

Exterior walls of the building are constructed with 8-inch wide (one-wythe) and 12-inch long hollow masonry units. The north and south exterior walls oriented in the east-west direction are load bearing while the walls oriented in the north/south direction are not (Figure 6).

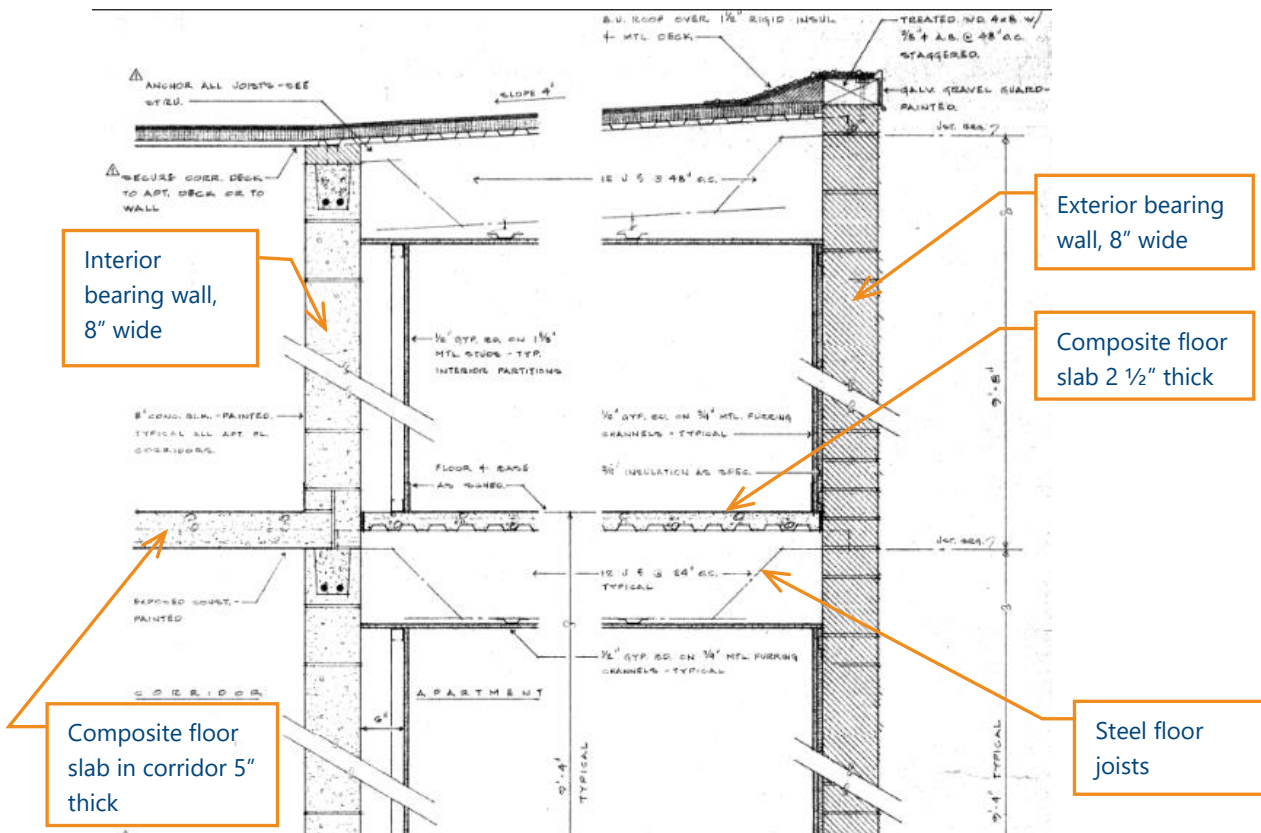
Figure 7. Section (north-south direction) through the exterior and interior bearing walls

Exterior walls of the building are constructed with 8-inch wide (one-wythe) and 12-inch long hollow masonry units. The north and south exterior walls oriented in the east-west direction are load bearing while the walls oriented in the north/south direction are not (Figure 7).

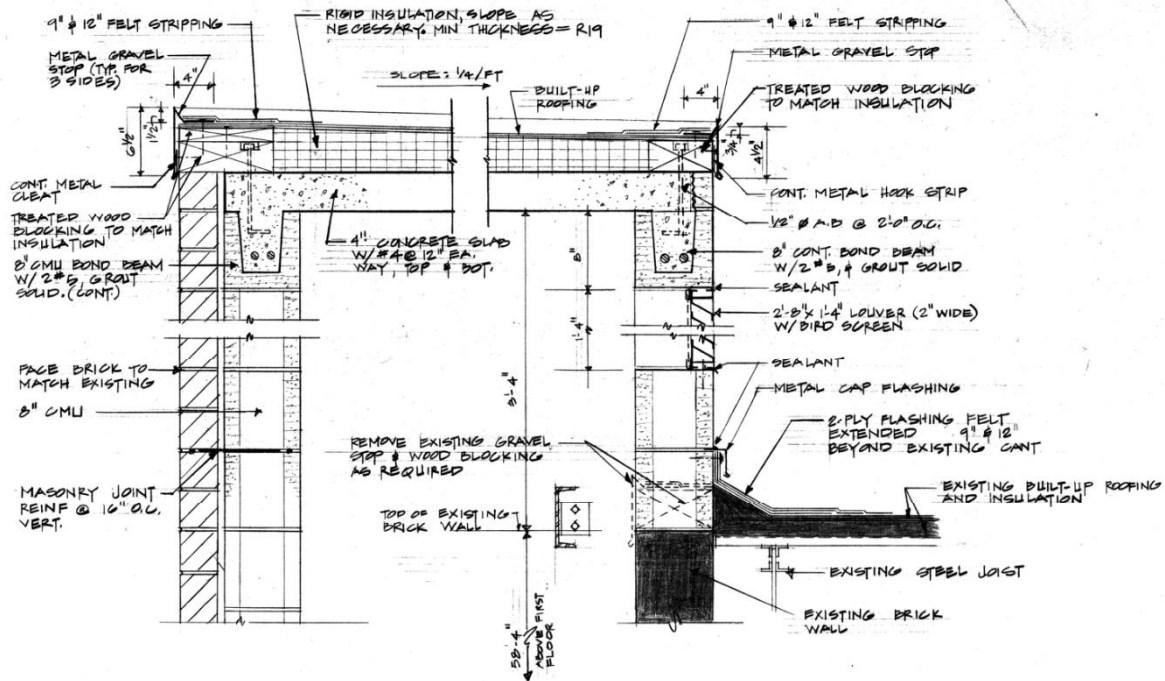
Figure 8. Section at west elevator tower roof

The exterior walls of the west elevator shaft comprise of 8-inch-wide concrete masonry block units (CMU) and 4-inch-wide brick cladding (Figure 8).

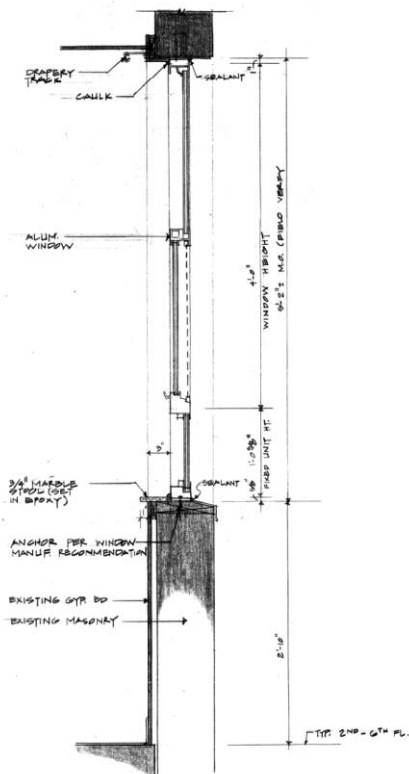
Figure 9. Section through typical window 2<sup>nd</sup> through 6<sup>th</sup> floor

Four types of aluminum single hung punched through windows with insulating glass are present on the north, east and south elevations (Figure 9). Asbestos cement boards are present at windows on the north and south elevation at the first floor (Figure 10). Steel window lintels above windows comprise of two steel angles 2L 3 ½ x 3 ½ x 1/4 for 3 feet-4-inch-wide openings and 2L 6 x 3 ½ x 1/4 for 6 feet wide openings. Steel angles are positioned back-to-back. Steel window lintels are bricked off with 4-inch-wide soldier bricks on their exterior side.
