**Physical Needs Assessment
As Is**

Swann Meadows Apartments

1091 Parkland Place Rd
Greenwood, SC 29646

Report Date- 05/14/2025

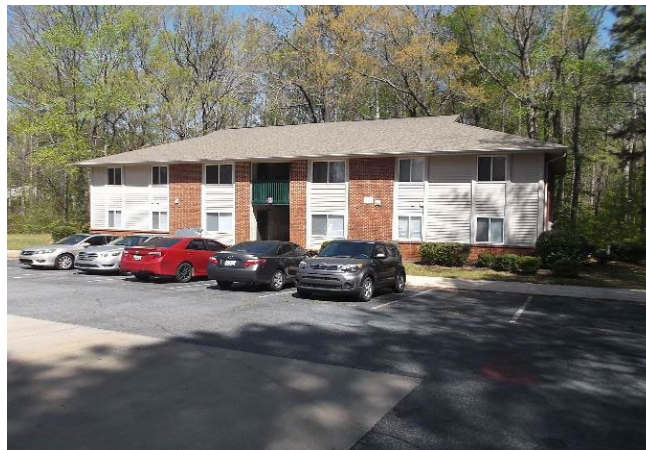
Building Exterior

The overall condition of the property on the day of the inspection seemed to indicate a property that is very well managed and maintained. The kitchen cabinets and bath vanities were in decent condition and were probably replaced in 2003 during the rehab. The asphalt driveway and parking areas are in poor condition and showing signs of significant wear and tear that will require an asphalt overlay during the term of this assessment. Most of the appliances and major systems indicate effective routine maintenance; however, the remaining useful life on most of the major systems will expire during the term of this assessment. The roofing material is an unknown age but more than likely replaced during the rehab. The property is equipped with central electric HVAC systems and one common area HVAC system that was replaced during the rehab in 2003. All of the dwelling units are equipped with vinyl dwelling unit windows (replaced during rehab), original exterior doors and interior doors. Each building has treated wood stairs that are contained within the building and wood common area walkways. The building exterior siding is brick, vinyl and T-111 in the breezeways with aluminum soffits. It is reasonable to assume that the vinyl siding and soffit was replaced during the rehab however the T-111 siding is original to the date of construction.
