## ZEFFERT & ASSOCIATES

### Accessibility Site Visit (Master)

| <b>Project Name</b> | Sample Property |
| <b>Date of Inspection</b> | 01-15-2020 |

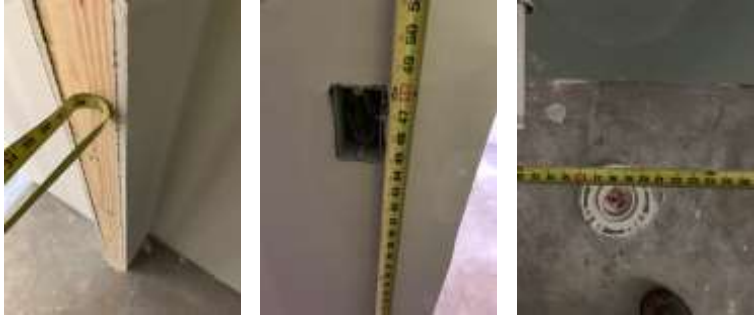
| <b>Restroom Photos</b> | |

| <b>Public Restroom Description</b> | Community Building Men's |
| <b>Status of this area</b> | Drywall stage |
