**Physical Needs Assessment  
As Is  
West Yards Lofts Apartments**  
2375 Noisette Blvd.  
North Charleston, SC 29405

**Report Date- 06/16/2025  
ID# 05162025-1-FINAL**

Unit Count: 60  
Bld Count: 1  
Family  
2010

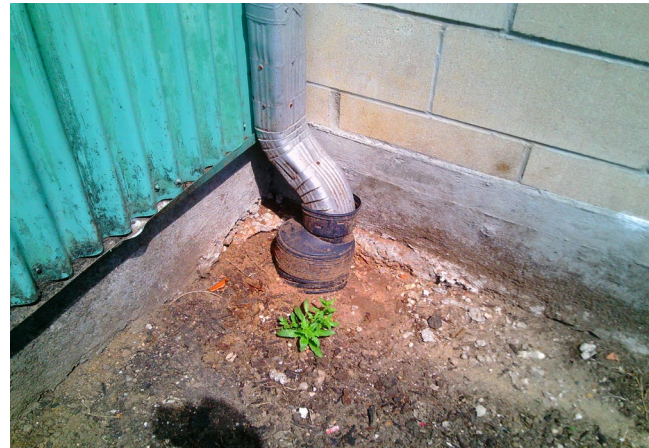
MetersDownspout

| Item | EUL | AGE | RUL | Cond | Action | DUR | QTY | Unit | Unit Cost | Total Cost | Comments |
|---|---|---|---|---|---|---|---|---|---|---|---|
| Gutters/Downspouts: aluminum/vinyl | 20 | 15 | 5 | Good | Replace | 1 | 450 | LF | 25 | 11250 | repairs anticipated |

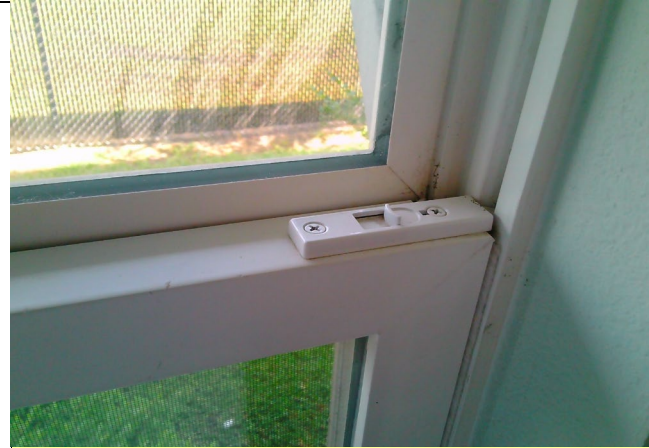
Interior Window

| Item | EUL | AGE | RUL | Cond | Action | DUR | QTY | Unit | Unit Cost | Total Cost | Comments |
|---|---|---|---|---|---|---|---|---|---|---|---|
| Windows: vinyl | 30 | 15 | 15 | Good | Replace | 1 | 798 | ea | 1250 | 997500 | anticipate replacement of windows |

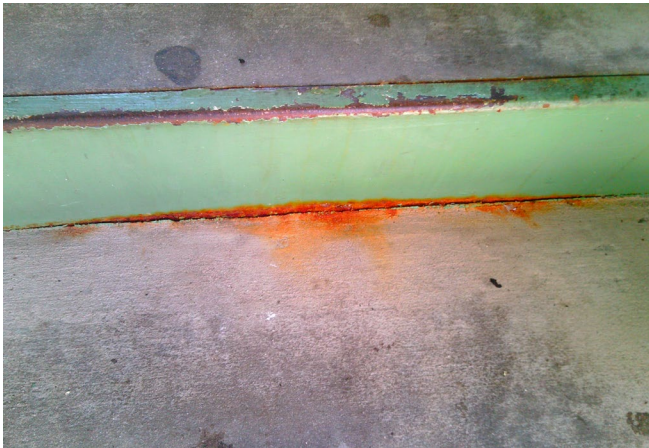
Stairs

| Item | EUL | AGE | RUL | Cond | Action | DUR | QTY | Unit | Unit Cost | Total Cost | Comments |
|---|---|---|---|---|---|---|---|---|---|---|---|
| Stair, Exterior: tread - metal, concrete filled | 40 | 15 | 1 | Fair | Maintain | 1 | 2 | ea | 90000 | 180000 | significant repairs are needed |
