Re: **South Carolina Housing  
Manning Gardens  
214 Alfred Henery Street  
Manning, South Carolina 29102**

## Accessibility Plan Review

## **Construction Inspection- Framing**

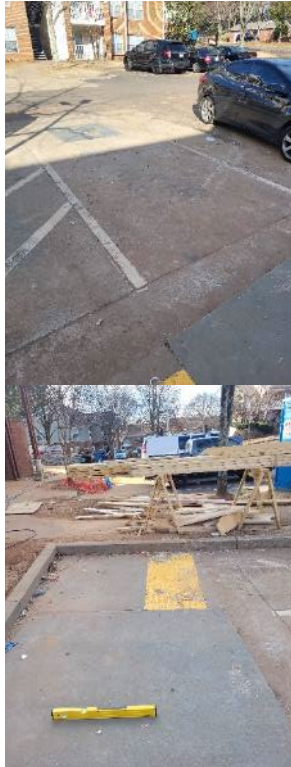
| Item # | Date | Location | Item | Issue | Applicable Citation* | Contractor Response | Status Closed/ Open |
|---|---|---|---|---|---|---|---|
| 5. | 2-20-24 | Building 1400 | Accessible Parking | 2 accessible parking spaces provided at this building. Striping has not been provided for accessible parking or adjacent access aisle. | | | Open |

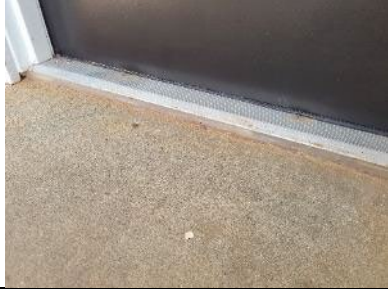
| Item # | Date | Location | Item | Issue | Applicable Citation* | Contractor Response | Status Closed/ Open |
|---|---|---|---|---|---|---|---|
| 14. | 2-20-24 | Building 1100- Unit 1105 | Entry Threshold | <p>Entry door threshold elevation change measures 1 1/8 inches. Requires ½ inch maximum elevation change with 1:2 bevel at these locations. Ensure entry door maneuvering clearance slope/ cross slope at 2% maximum.</p> | | | Open |

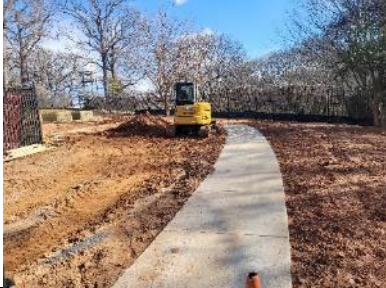
| Item # | Date | Location | Item | Issue | Applicable Citation* | Contractor Response | Status Closed/ Open |
|---|---|---|---|---|---|---|---|
| 19. | 2-20-24 | Garden | Accessible Route | Fencing has not been installed at time of inspection. Review at next opportunity.<br> | | | Open |

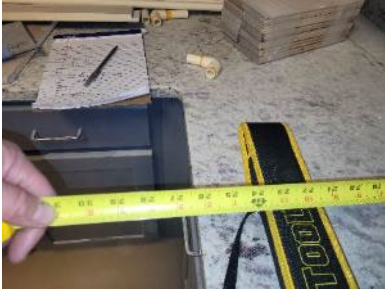
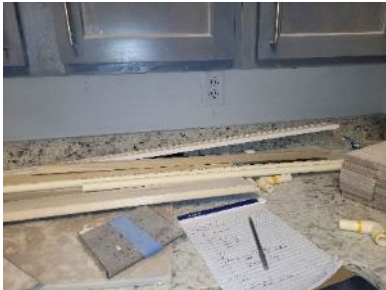
| Item # | Date | Location | Item | Issue | Applicable Citation* | Contractor Response | Status Closed/ Open |
|---|---|---|---|---|---|---|---|
| 22. | 2-20-24 | Unit 1413- Kitchen | Reach Range | Outlets located on the back splash requires 25 ½ inch deep reach with parallel approach. Requires 24 inch maximum reach.<br><br> | | | Open |

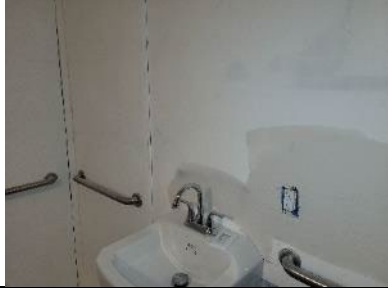
| Item # | Date | Location | Item | Issue | Applicable Citation* | Contractor Response | Status Closed/ Open |
|---|---|---|---|---|---|---|---|
| 23. | 2-20-24 | Unit 1413- Bathroom | Mirror | <p>Bathroom had not been provided with mirror at time of the inspection.</p> | | | Open |

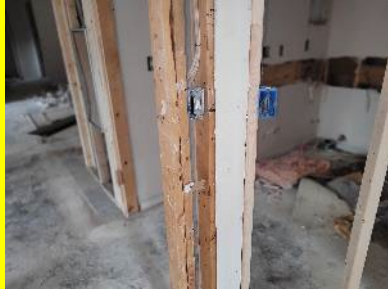
| Item # | Date | Location | Item | Issue | Applicable Citation* | Contractor Response | Status Closed/ Open |
|---|---|---|---|---|---|---|---|
| 25. | 4-11-24 | Unit 1303- Bedroom | Door Maneuvering Clearance | <p>Bedroom (2) right side of unit does not achieve 18 inches pull side clearance within 8 inches of door face with the use of angled wall. Recommend providing door hinged on the opposite side.</p> | | | Open |

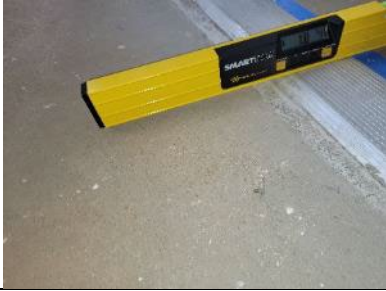
| Item # | Date | Location | Item | Issue | Applicable Citation* | Contractor Response | Status Closed/ Open |
|---|---|---|---|---|---|---|---|
| 28. | 2-20-24 | Unit 1414- Entry | Threshold | <p>Entry door threshold elevation change measures ¾ inches. Requires ½ inch maximum elevation change.</p> | | | Open |

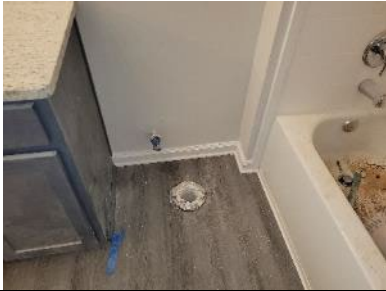
| Item # | Date | Location | Item | Issue | Applicable Citation* | Contractor Response | Status Closed/ Open |
|---|---|---|---|---|---|---|---|
| 29. | 2-20-24 | Bathroom | Water Closet Centerline | <p>Water closet has not been installed at time of the inspection. Requires centerline at 16 to 18 inches from edge of the bathing fixture.</p> | | | Open |

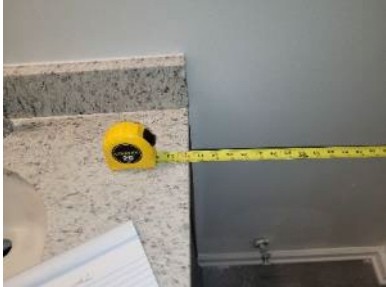
| Item # | Date | Location | Item | Issue | Applicable Citation* | Contractor Response | Status Closed/ Open |
|---|---|---|---|---|---|---|---|
| 30. | 2-20-24 | | Water Closet Clear Floor Space | <p>Water closet clear floor space measures 32 inches from edge of bathing fixture to edge of the countertop overhang.</p> | | | Open |

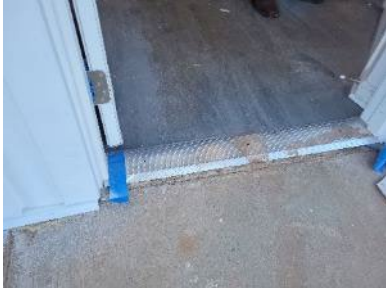
| Item # | Date | Location | Item | Issue | Applicable Citation* | Contractor Response | Status Closed/ Open |
|---|---|---|---|---|---|---|---|
| 31. | 2-20-24 | Unit 1408- Entry | Threshold | <p>Entry door threshold elevation change measures ¾ inches. Requires ½ inch maximum elevation change.</p> | | | Open |

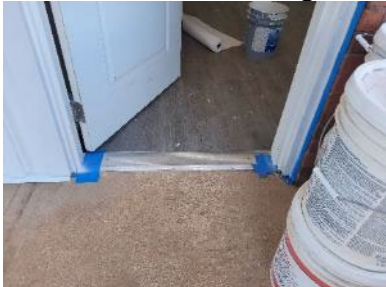
| Item # | Date | Location | Item | Issue | Applicable Citation* | Contractor Response | Status Closed/ Open |
|---|---|---|---|---|---|---|---|
| 32. | 2-20-24 | Unit 1407- Entry | Threshold | <p>Entry door threshold elevation change measures ¾ inches. Requires ½ inch maximum elevation change.</p> | | | Open |

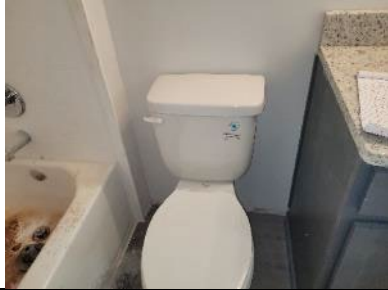
| Item # | Date | Location | Item | Issue | Applicable Citation* | Contractor Response | Status Closed/ Open |
|---|---|---|---|---|---|---|---|
| 36. | 2-20-24 | | Water Closet Clear Floor Space | Water closet clear floor space measures 32 inches from edge of bathing fixture to edge of the countertop overhang.<br> | | | Open |

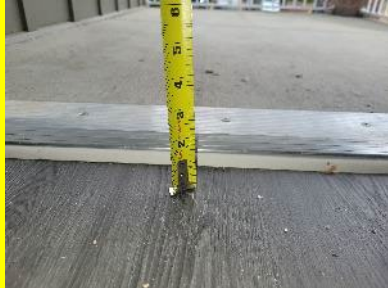
| Item # | Date | Location | Item | Issue | Applicable Citation* | Contractor Response | Status Closed/ Open |
|---|---|---|---|---|---|---|---|
| 37. | 4-11-24 | Unit 805- Entry | Threshold | Entry door threshold elevation change measures 5/8 inches. Requires ½ inch maximum elevation change.<br> | | | Open |

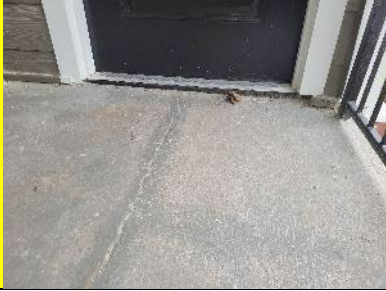
| Item # | Date | Location | Item | Issue | Applicable Citation* | Contractor Response | Status Closed/ Open |
|---|---|---|---|---|---|---|---|
| 39. | 4-11-24 | Unit 803- Entry | Threshold | <p>Entry door threshold elevation change measures 1 ¼ inches. Requires ½ inch maximum elevation change.</p> | | | Open |

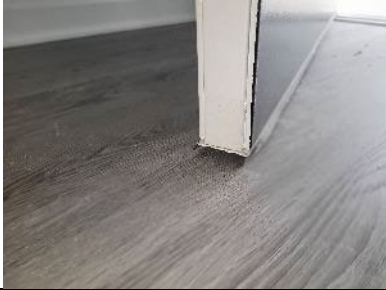
| Item # | Date | Location | Item | Issue | Applicable Citation* | Contractor Response | Status Closed/ Open |
|---|---|---|---|---|---|---|---|
| 40. | 4-11-24 | Unit 803- Patio Interior | Threshold | <p>Entry door threshold elevation change measures 1 inches. Requires ½ inch maximum elevation change.</p> | | Technically infeasible. Floor structural defect prevents correction. | Closed |

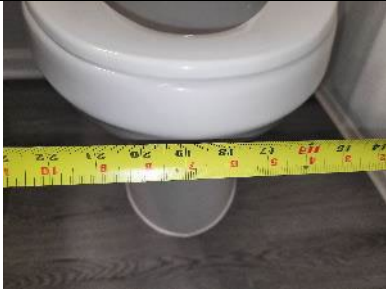
| Item # | Date | Location | Item | Issue | Applicable Citation* | Contractor Response | Status Closed/ Open |
|---|---|---|---|---|---|---|---|
| 41. | 4-11-24 | Unit 805- Bathroom 2- Right Side | Water Closet Centerline | <p>Water closet centerline measures 18 ½ inches from edge of tub. Requires 16 to 18 inches from the edge of the tub.</p> | | | Open |

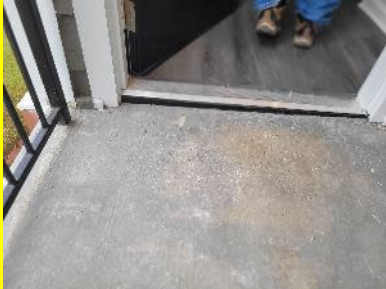
| Item # | Date | Location | Item | Issue | Applicable Citation* | Contractor Response | Status Closed/ Open |
|---|---|---|---|---|---|---|---|
| 42. | 4-11-24 | Unit 804- Entry | Threshold | <p>Entry door threshold elevation change measures 1 ¼ inches. Requires ½ inch maximum elevation change.</p> | | | Open |

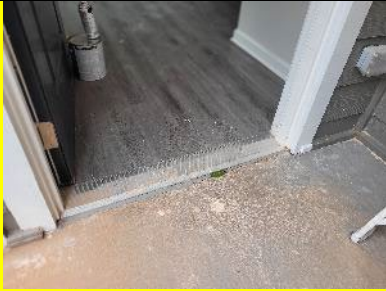
| Item # | Date | Location | Item | Issue | Applicable Citation* | Contractor Response | Status Closed/ Open |
|---|---|---|---|---|---|---|---|
| 43. | 4-11-24 | Unit 802- Entry | Threshold | <p>Entry door threshold elevation change measures 1 inches. Requires ½ inch maximum elevation change.</p> | | | Open |

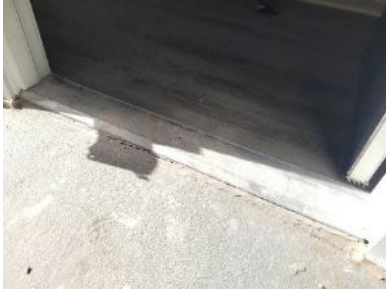
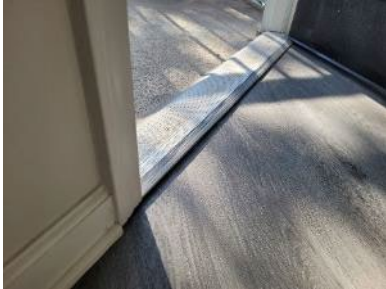
| Item # | Date | Location | Item | Issue | Applicable Citation* | Contractor Response | Status Closed/ Open |
|---|---|---|---|---|---|---|---|
| 44. | 6-03-24 | Unit 1205- Entry | Threshold | <p>Entry door threshold elevation change measures 1 inch exterior and <math>\frac{3}{4}</math> inch interior elevation change. Requires <math>\frac{1}{2}</math> inch maximum elevation change.</p> | FHA | | Open |

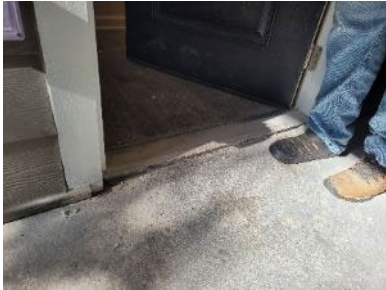
| Item # | Date | Location | Item | Issue | Applicable Citation* | Contractor Response | Status Closed/ Open |
|---|---|---|---|---|---|---|---|
| 48. | 6-03-24 | Unit 1201- Entry | Threshold | <p>Entry door threshold elevation change measures 1 inch exterior elevation change. Requires ½ inch maximum elevation change.</p> | UFAS | | Closed-7-18-24 |

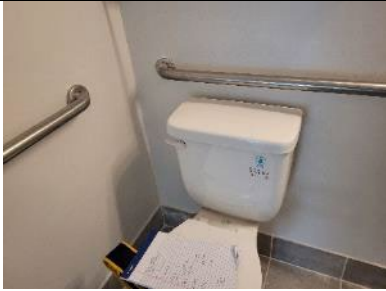
| Item # | Date | Location | Item | Issue | Applicable Citation* | Contractor Response | Status Closed/ Open |
|---|---|---|---|---|---|---|---|
| 49. | 6-03-24 | Unit 1201- Bathroom | Flush Valve | Water closet flush valve located to the side wall of water closet clear floor space. Requires flush valve to the open side of water closet clear floor space. | UFAS | | |

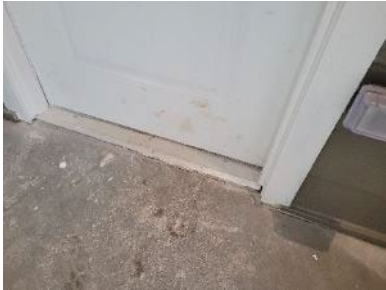
| Item # | Date | Location | Item | Issue | Applicable Citation* | Contractor Response | Status Closed/ Open |
|---|---|---|---|---|---|---|---|
| 51. | 6-03-24 | Unit 906- Entry | Threshold | Entry door threshold elevation change measures 1 inch exterior elevation change. Requires ½ inch maximum elevation change.<br> | FHA | | Open |

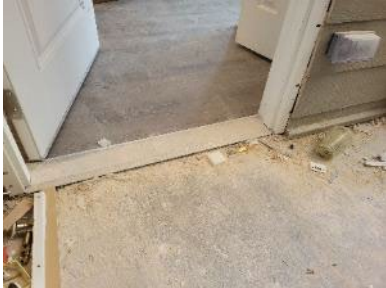
| Item # | Date | Location | Item | Issue | Applicable Citation* | Contractor Response | Status Closed/ Open |
|---|---|---|---|---|---|---|---|
| 54. | 6-03-24 | Unit 904- Entry | Threshold | Entry door threshold elevation change measures 1 inch exterior elevation change. Requires ½ inch maximum elevation change.<br> | FHA | | Open |

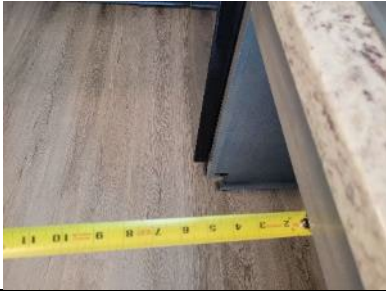
| Item # | Date | Location | Item | Issue | Applicable Citation* | Contractor Response | Status Closed/ Open |
|---|---|---|---|---|---|---|---|
| 56. | 7-18-24 | Kitchen | Sink Knee Clearance | Knee clearance at sink measures 2 inches and not correctly attached at the top. If fully attached would measure 6 inches at 27 inches AFF. Requires 8 inches minimum knee clearance depth.<br> | UFAS | | Open |

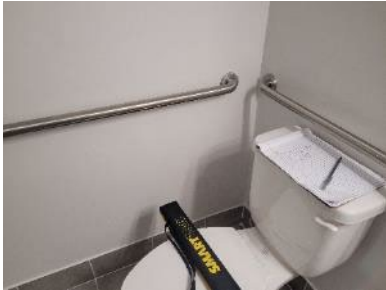
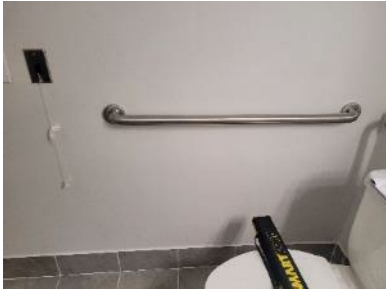
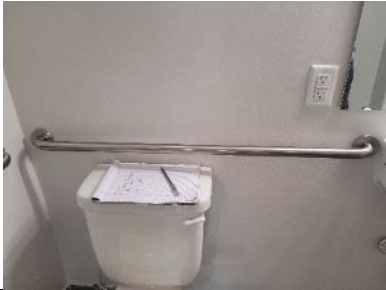
| Item # | Date | Location | Item | Issue | Applicable Citation* | Contractor Response | Status Closed/ Open |
|---|---|---|---|---|---|---|---|
| 57. | 7-18-24 | Bathroom | Grab Bars | <p>Grab bar have been switched. 42-inch bar located at rear wall and 36-inch bar located at side wall. Requires 42-inch bar at side wall and 36-inch bar at rear wall.</p> | UFAS | | Open |

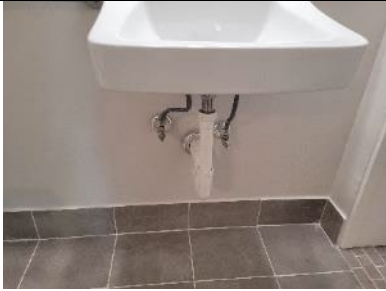
| Item # | Date | Location | Item | Issue | Applicable Citation* | Contractor Response | Status Closed/ Open |
|---|---|---|---|---|---|---|---|
| 58. | 7-18-24 | | Pipe Protection | <p>Exposed piping below the lavatory has not been provided. Pipe protection required at all under lavatory exposed piping.</p> | UFAS | | Open |
