## Kingston Pointe I

Anderson, South Carolina

Project #R-7125

April 9, 2026

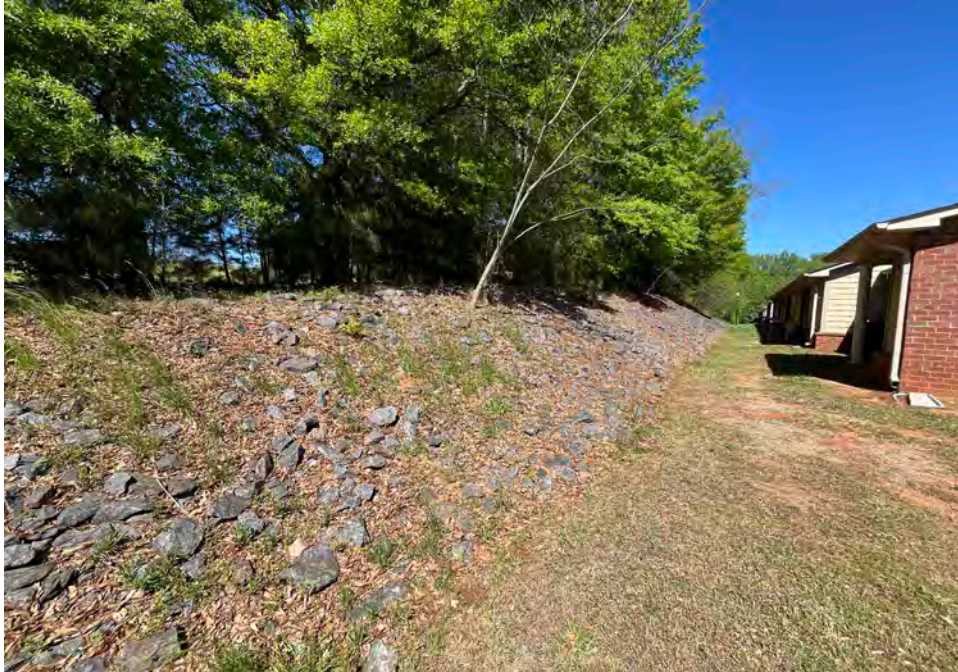
13 – View of the slope at the west side of the property

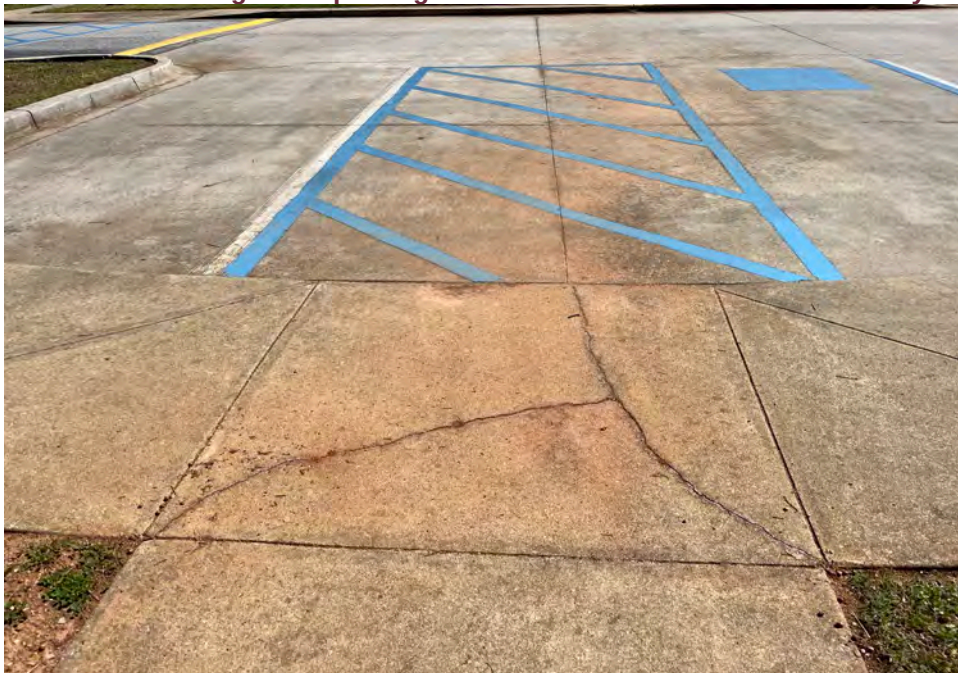
14 – View of the cracking at the parking area and sidewalk near the community building

2. Concrete sidewalk repairs at the walkways throughout the property (Estimated Cost = \$2,750.00)
3. Replace/repair covers at the tele/data boxes and water service disconnect boxes (Estimated Cost = \$1,250.00)

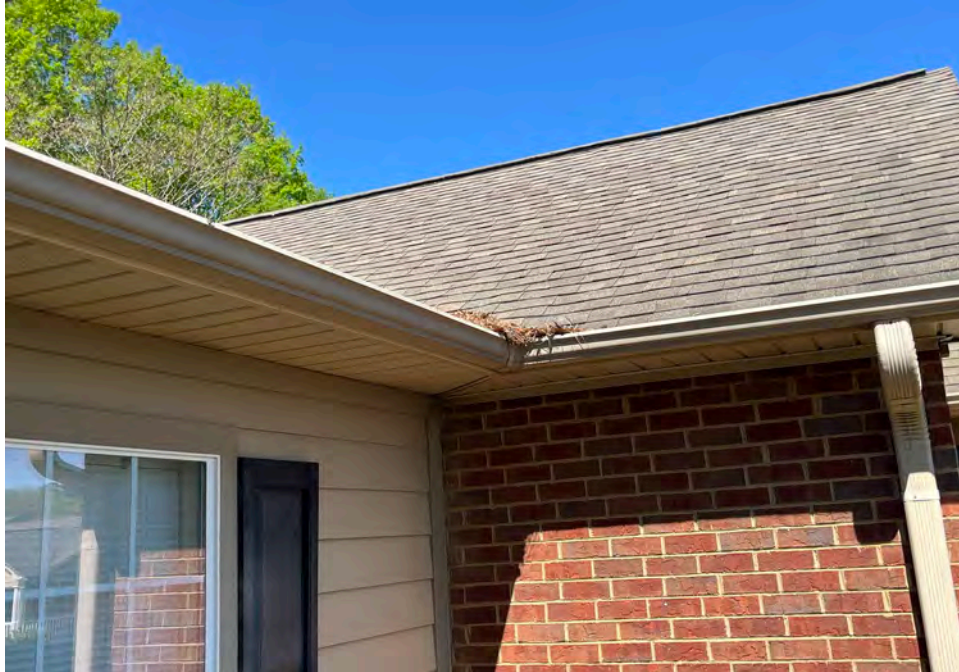
21 – Vegetation is collecting in the gutters and should be removed periodically

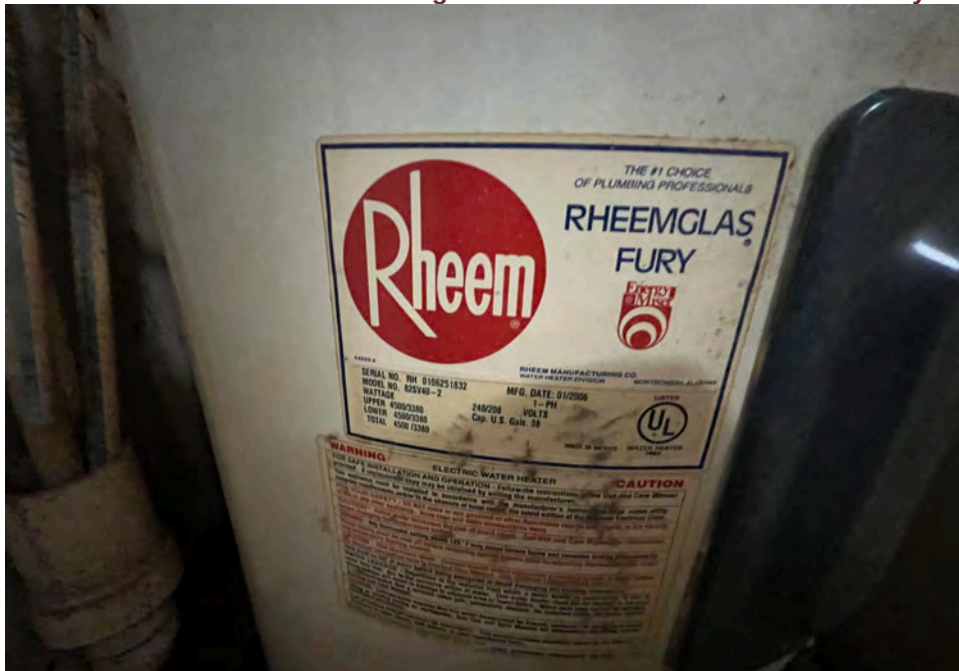
36 – The water heater information tag states a manufacture date of January 2006

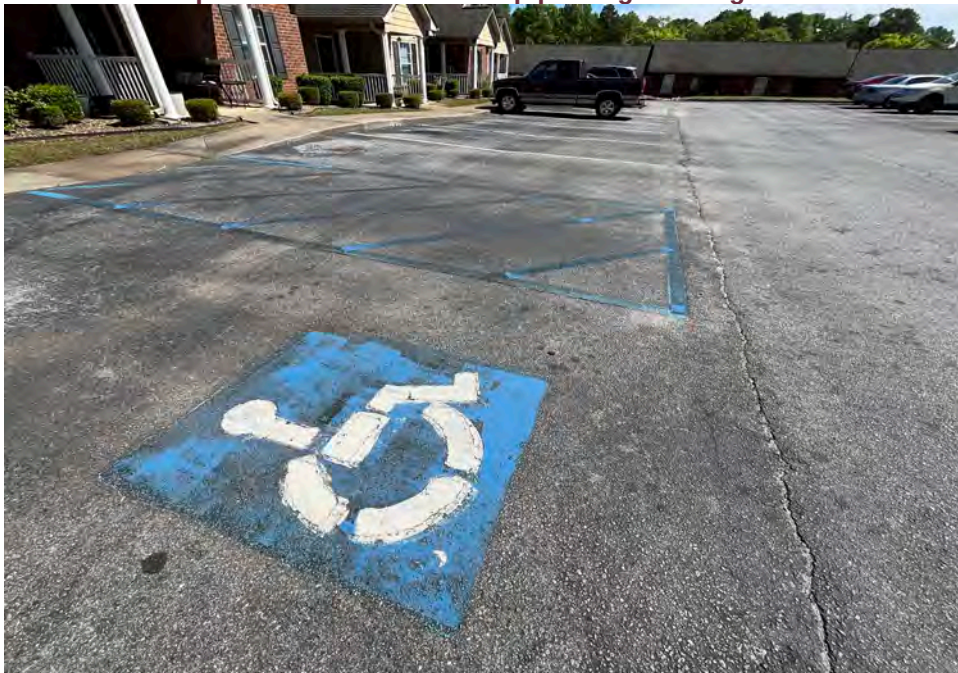
40 – The painted lane and handicap parking markings are faded

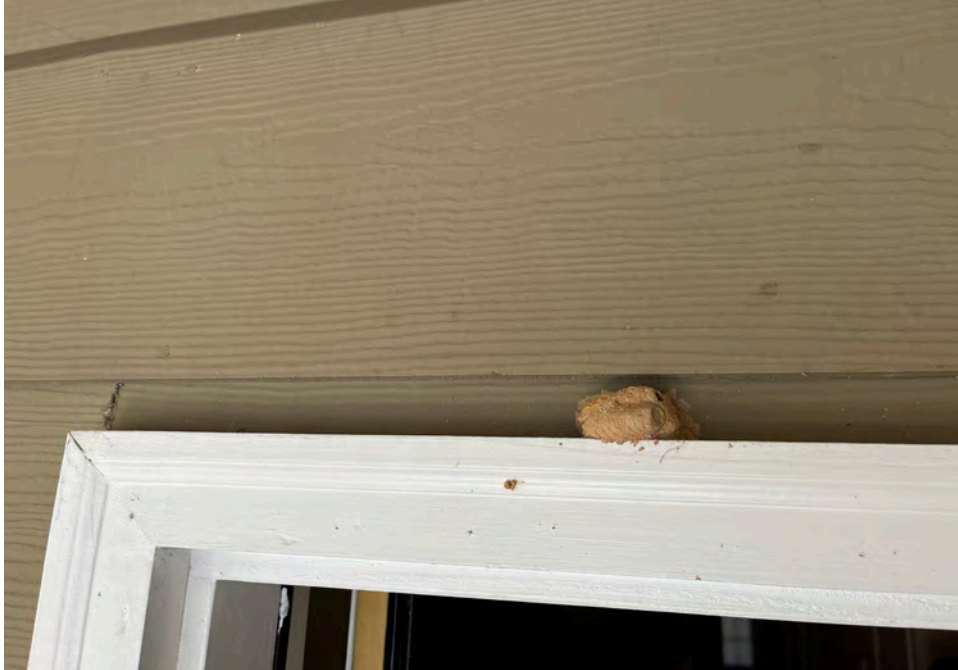
41 – Insect nesting is present at various locations throughout the property

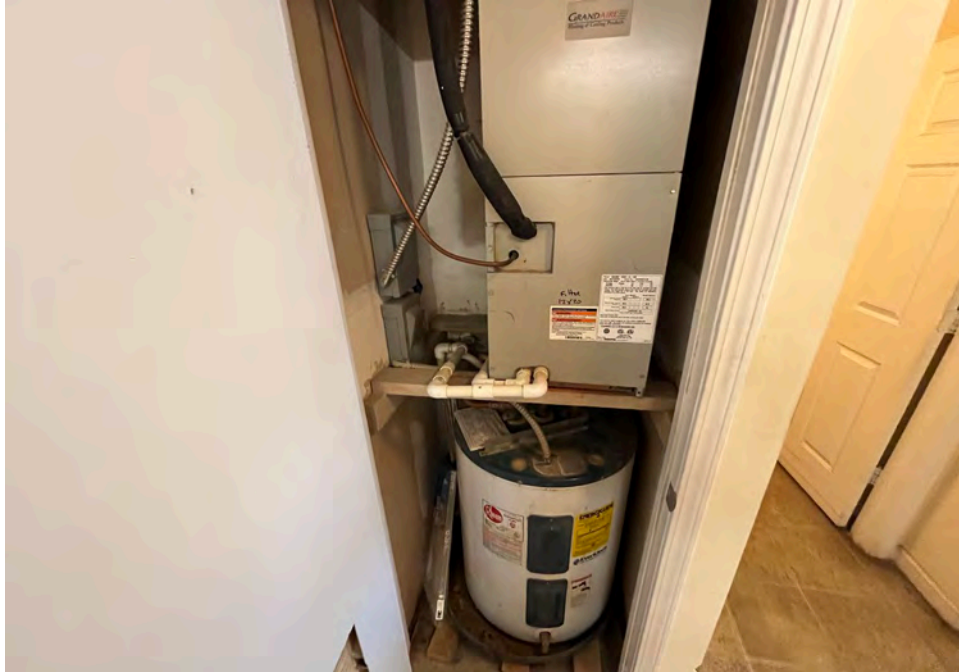
49 – It appears the original air handler and water heater are installed throughout the majority of units

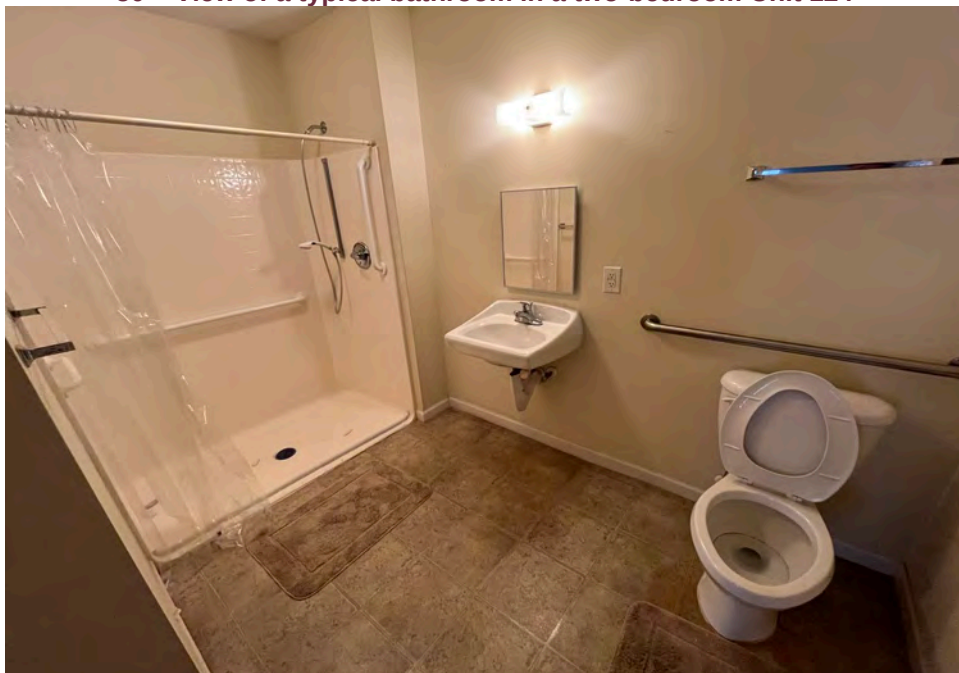
51 – The height of the ADA sink appears to be appropriate

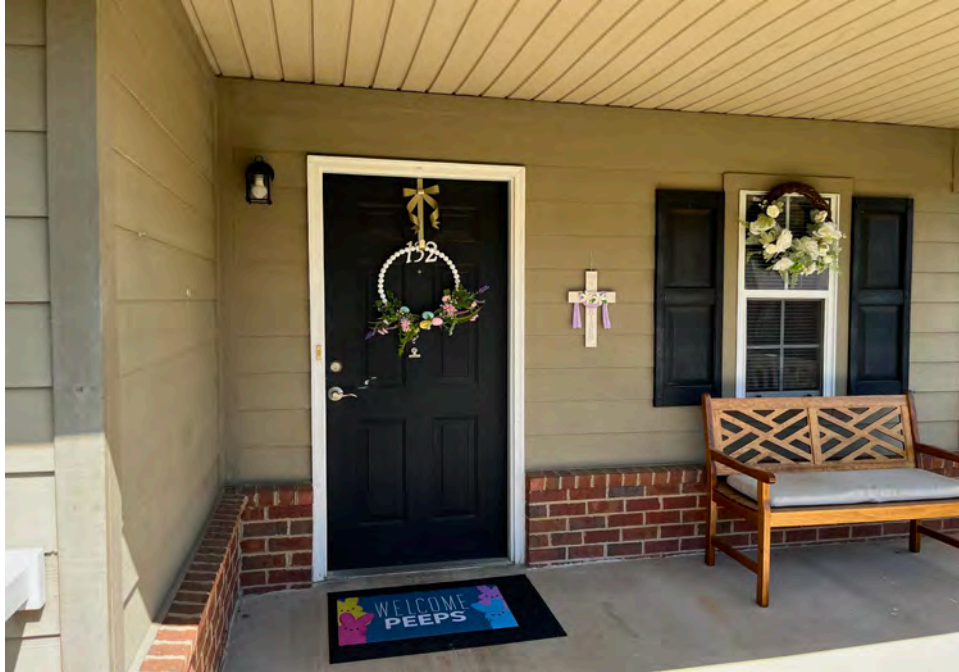
58 – The finishes throughout the unit kitchens appear to be original to the development

| Kingston Pointe I 101 Fyffe Drive, Anderson, SC 29625 April 9, 2026 | | | | | | | | | | | | | | | | | | | | |
|---|---|---|---|---|---|---|---|---|---|---|---|---|---|---|---|---|---|---|---|---|
| 14 | Replace cabinets and countertops | \$0 | 15 | 21 | 0 | 49 | EA | 2,750.00 | | \$33,000 | | \$33,000 | | \$33,000 | | \$33,000 | | | \$132,000 | |

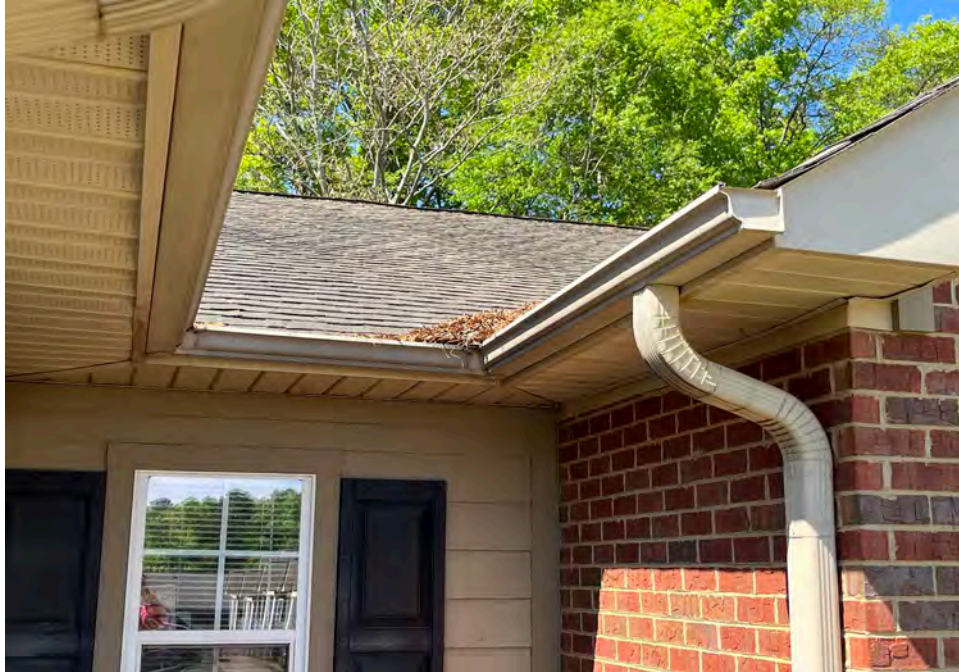
64 – The roofing appears to be original throughout the development

| Kingston Pointe I 101 Fyffe Drive, Anderson, SC 29625 April 9, 2026 | | | | | | | | | | | | | | | | | | | | |
|---|---|---|---|---|---|---|---|---|---|---|---|---|---|---|---|---|---|---|---|---|
| 18 | Roof replacement | \$0 | 25 | 21 | 4 | 1 | LS | 96,000.00 | | | | | \$96,000 | | | | | | \$96,000 | |

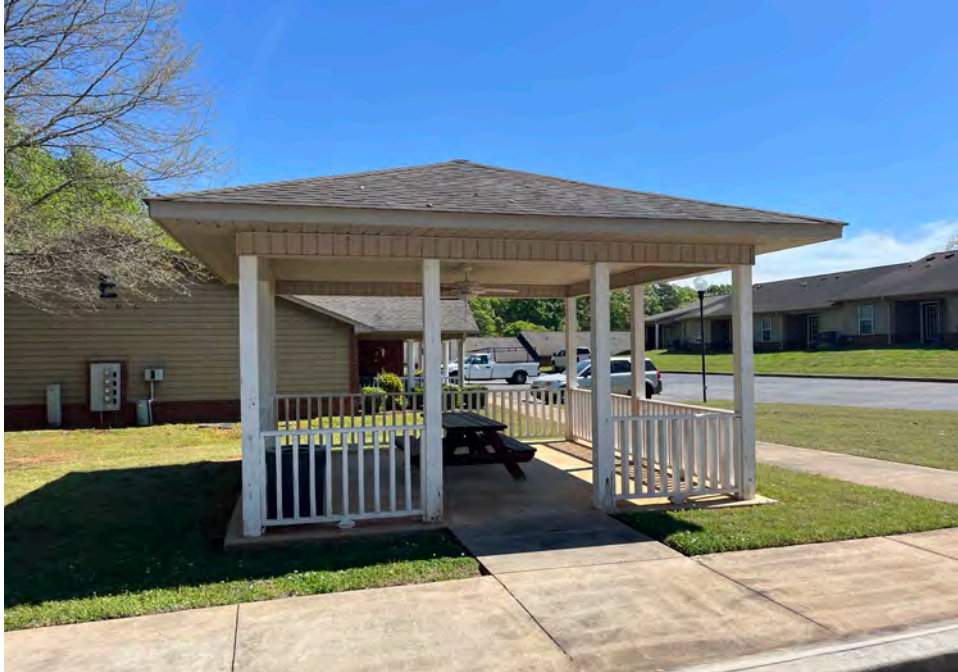
88 – The gazebo appears to be original to the development and repairs and paint are necessary

| Kingston Pointe I 101 Fyffe Drive, Anderson, SC 29625 April 9, 2026 | | | | | | | | | | | | | | | | | | | | |
|---|---|---|---|---|---|---|---|---|---|---|---|---|---|---|---|---|---|---|---|---|
| 7 | Repair gazebo structure | \$2,500 | 15 | 21 | 0 | 1 | LS | 2,500.00 | | | | | | | | | | | \$0 | |

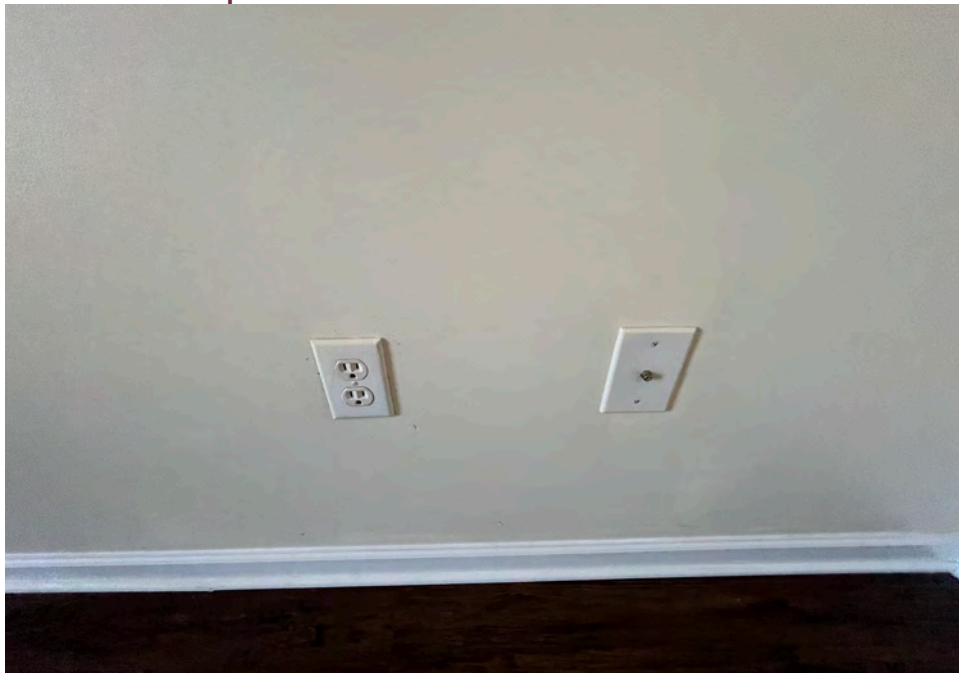
99 - Telephone and cable outlets are available in each unit

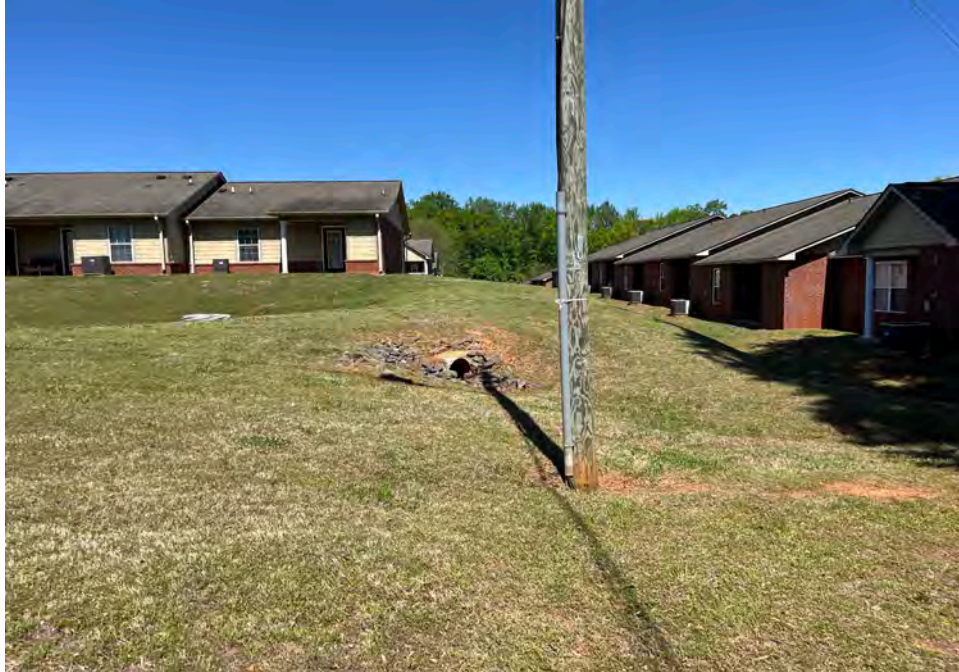
136 – View of the overgrowth at the stormwater culvert at the site entrance
