## PHYSICAL NEEDS ASSESSMENT

### RADCLIFFE MANOR APARTMENTS CHARLESTON, SOUTH CAROLINA

Job #S7002/26  
January 28, 2026

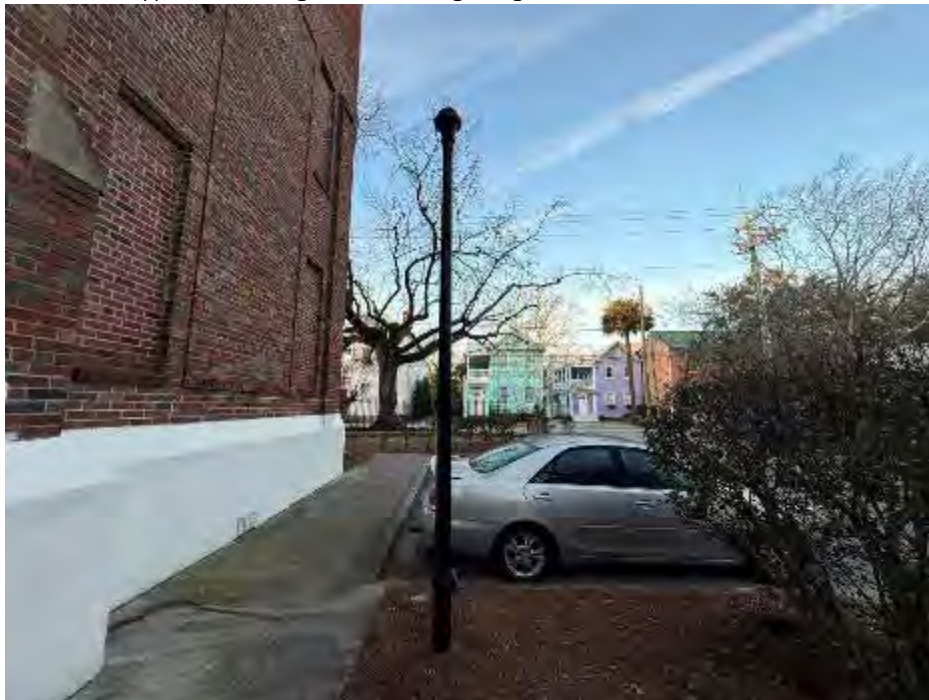
Photo 22: Typical Site Light Poles with Missing Globes and Lights

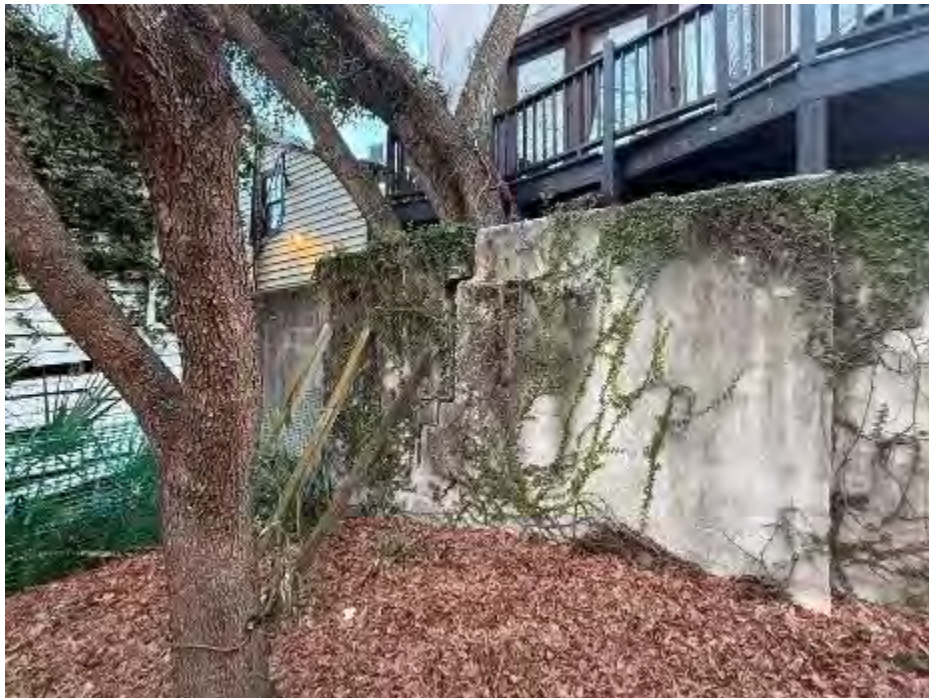
Photo 38: Area of Damaged CMU Perimeter Wall North of Building B

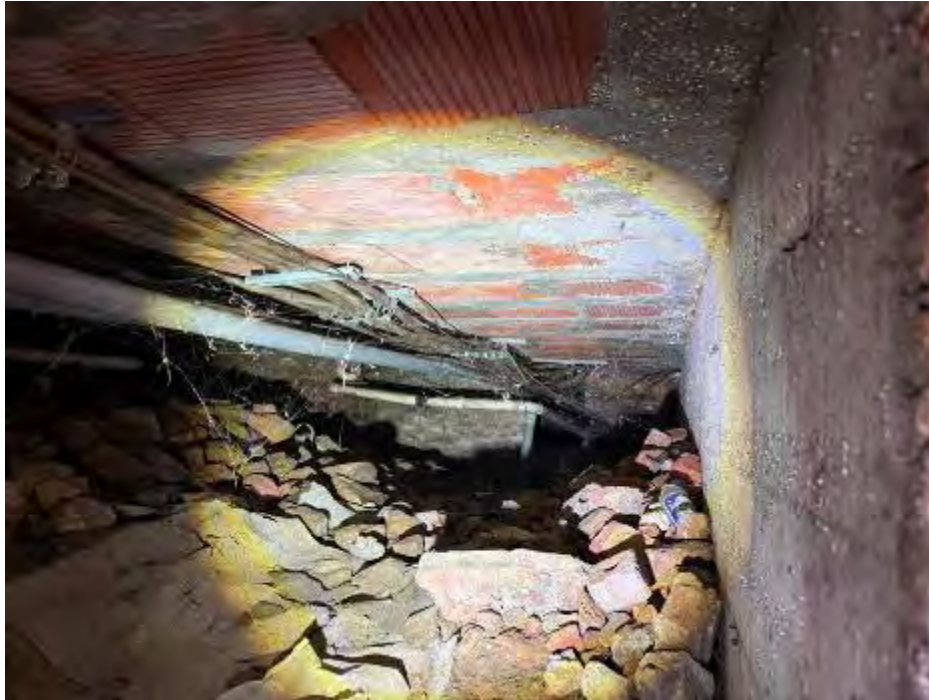
Photo 41: Building A Crawl Space, Foundations and Brick Foundation Walls

Building A appears to feature a structure of brick veneer foundation walls with a crawl space, concrete and brick exterior walls and floors, and steel girders. The building features a flat roof design which is topped with a TPO membrane system. Brick veneer, solid wood entry doors, and a combination of original wooden windows and select replacement insulated vinyl window materials are used for building exterior finishes. Brick veneer appears to cover most of the building exterior wall surfaces while the remainder of the walls feature painted concrete and what appears to be stone reveals. Prefinished aluminum gutters and downspouts are provided at the rear of Building A.

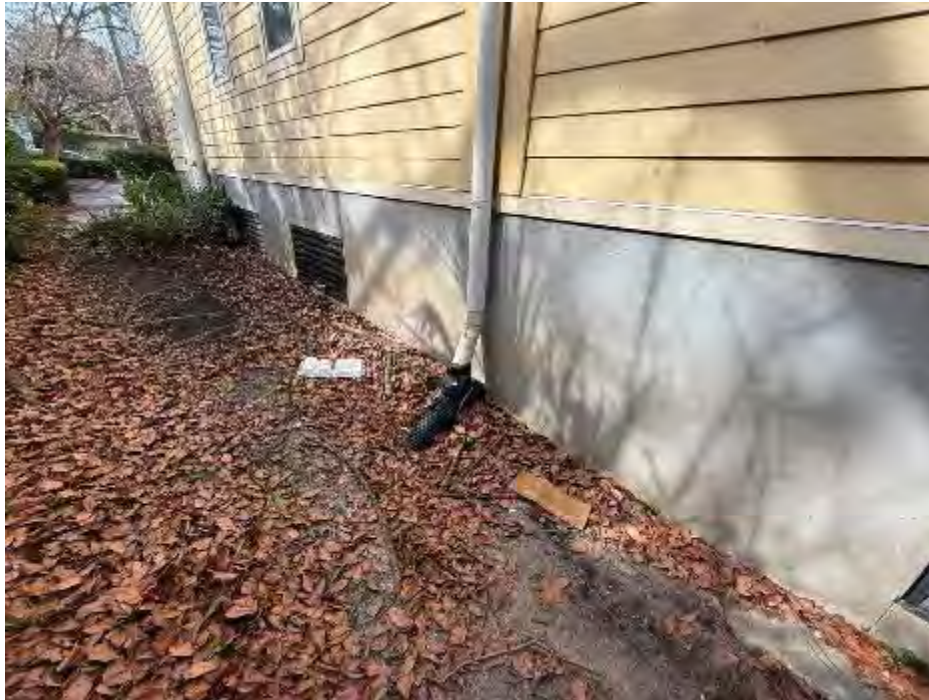
Photo 42: Building B Exterior Foundation Walls with Venting

Building B appears to feature a structure of CMU foundations with a crawl space, thickened footings along the perimeter and interior load-bearing walls, wood-framed exterior walls and floors, and pre-engineered wooden roof trusses. The building features a pitched roof which is topped with a combination of architectural shingles and standing seam metal roofing and areas of flat roofing that feature a TPO membrane system. Brick veneer, fiber cement siding & soffit, painted fiber cement window trims, corner boards and fascia, metal entry doors, and insulated vinyl window materials are used for building exterior finishes. Brick veneer appears to cover roughly 20% of the building's exterior wall surfaces. Prefinished aluminum gutters and downspouts and grated roof drains are provided at Building B.

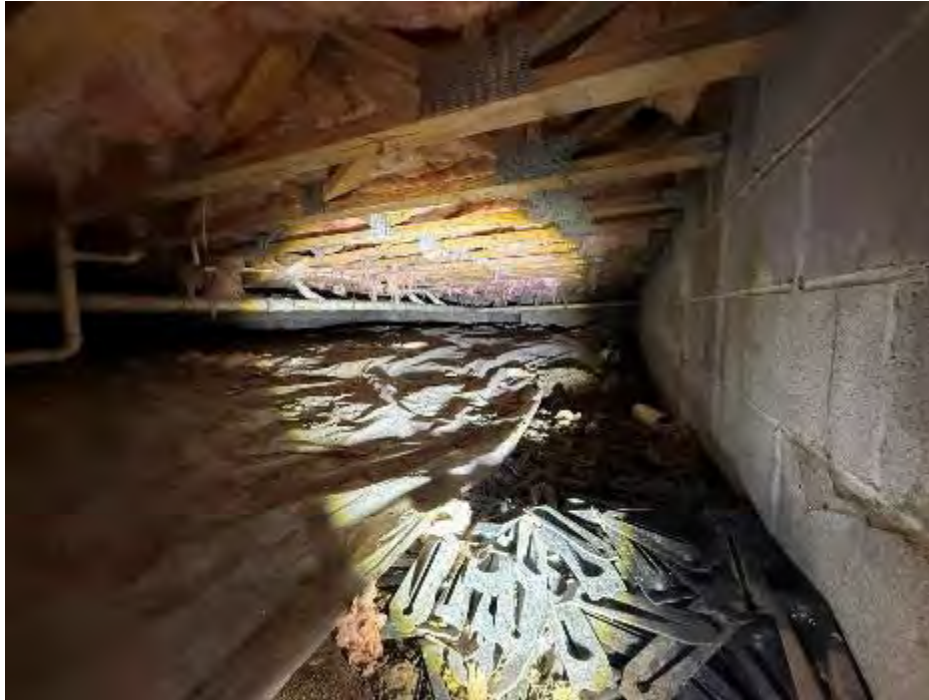
Photo 43: Building B Crawlspace and CMU Foundation Walls

| Building Architecture ITEM | QUANTITY | UNIT COST | TOTAL COST | DM | COMMENTS |
|---|---|---|---|---|---|
| Crawl Spaces | Allow | \$ 12,000 | \$ 12,000 | | Determine Cause of standing water in crawl space of Building B and correct the issue. |

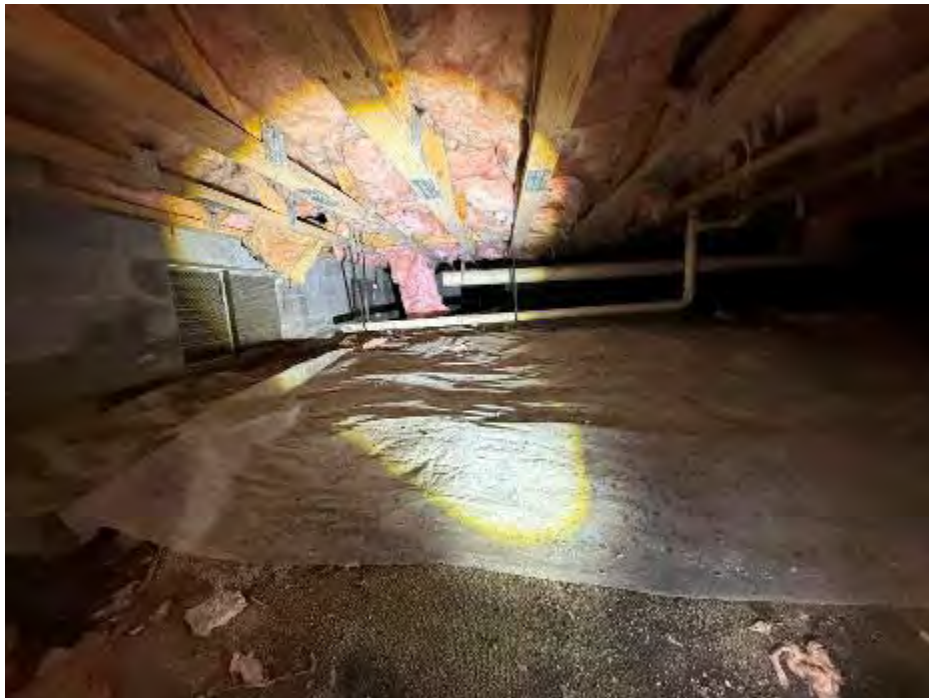
Photo 44: Areas of Standing Water and Plumbing Piping Terminating Within Building B Crawlspace

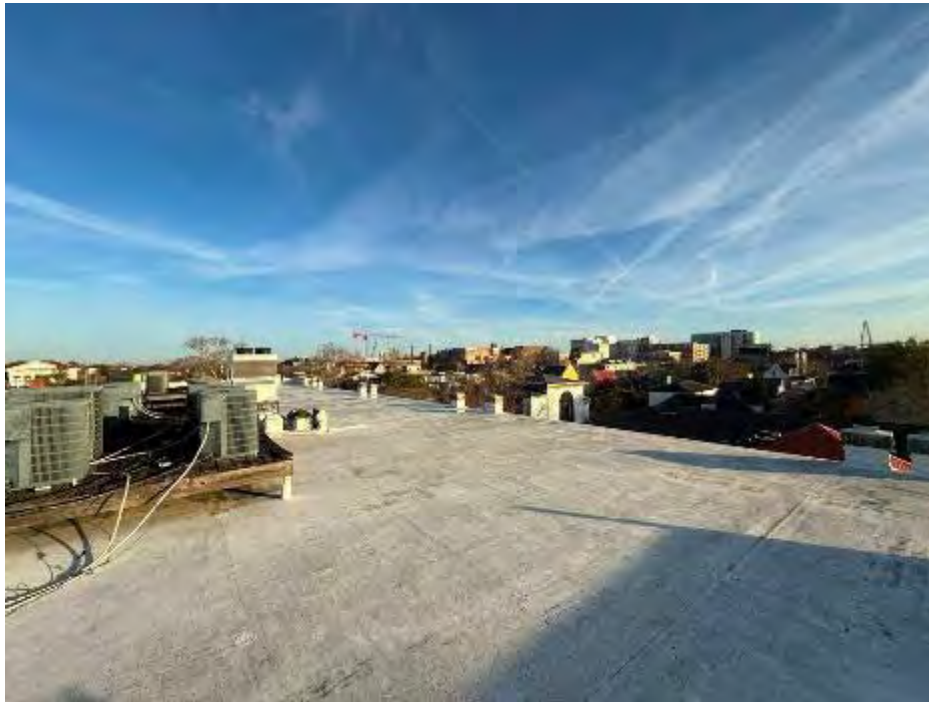
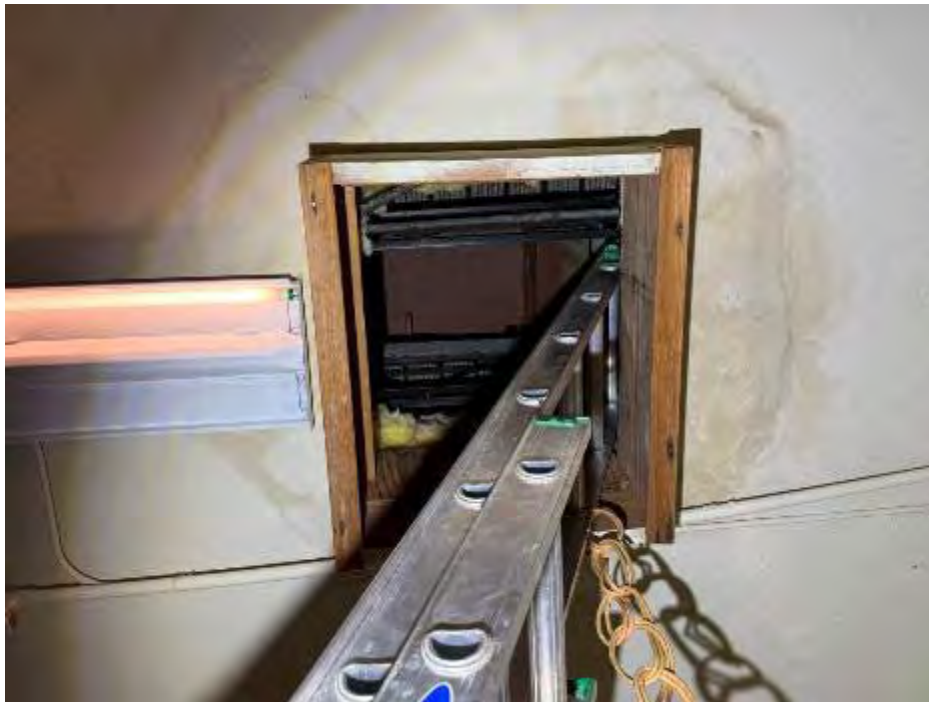
Photos 48-49: Building A TPO Roofing

| Building Architecture ITEM | QUANTITY | UNIT COST | TOTAL COST | DM | COMMENTS |
|---|---|---|---|---|---|
| Roofing | Allow | \$ 176,250 | \$ 176,250 | | Wholesale replacement of TPO, corrugated metal, and Shingle roofing at both buildings; Replace Awning at rear of Building B |

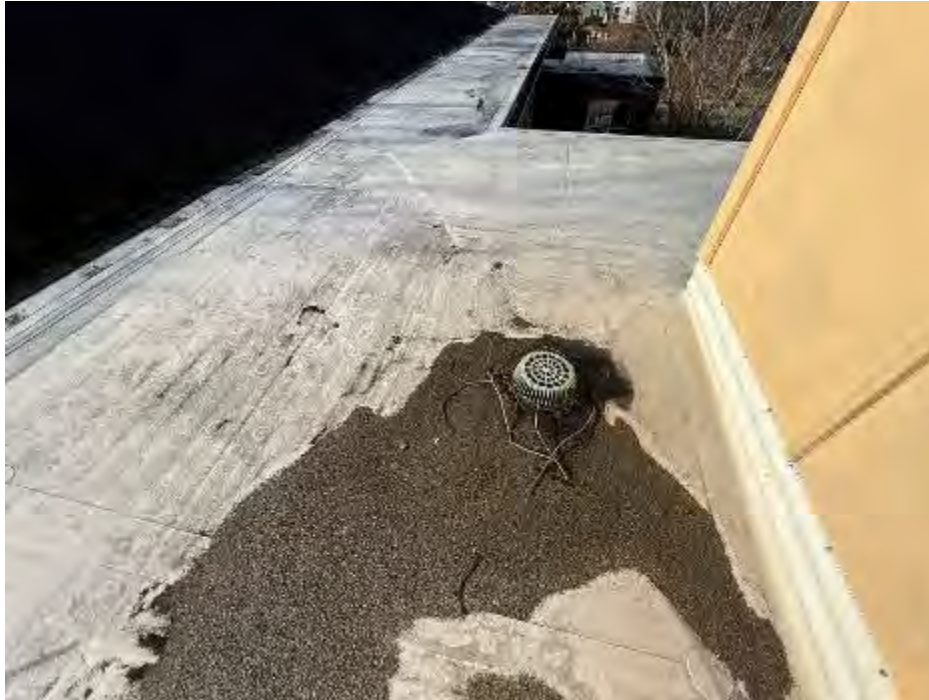
Photo 52: Building B TPO Roofing

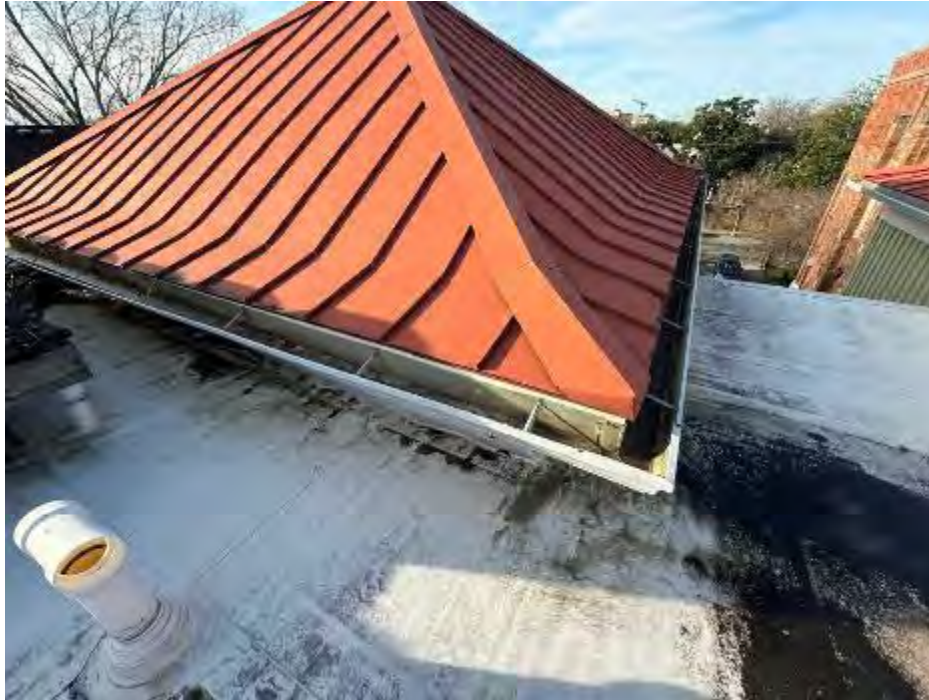
Photo 54: Building B Shingle Roofing

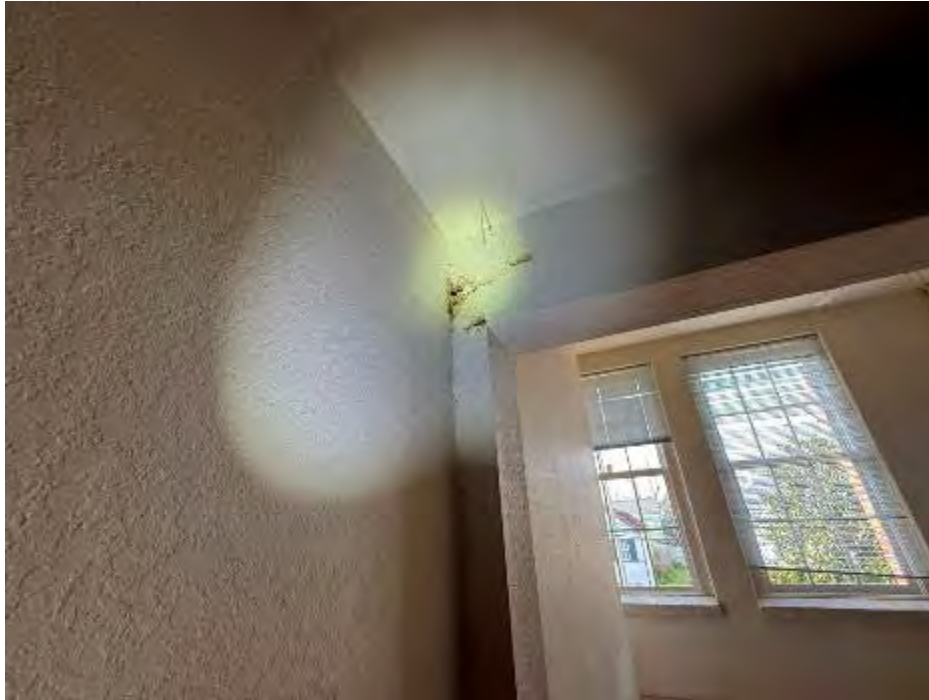
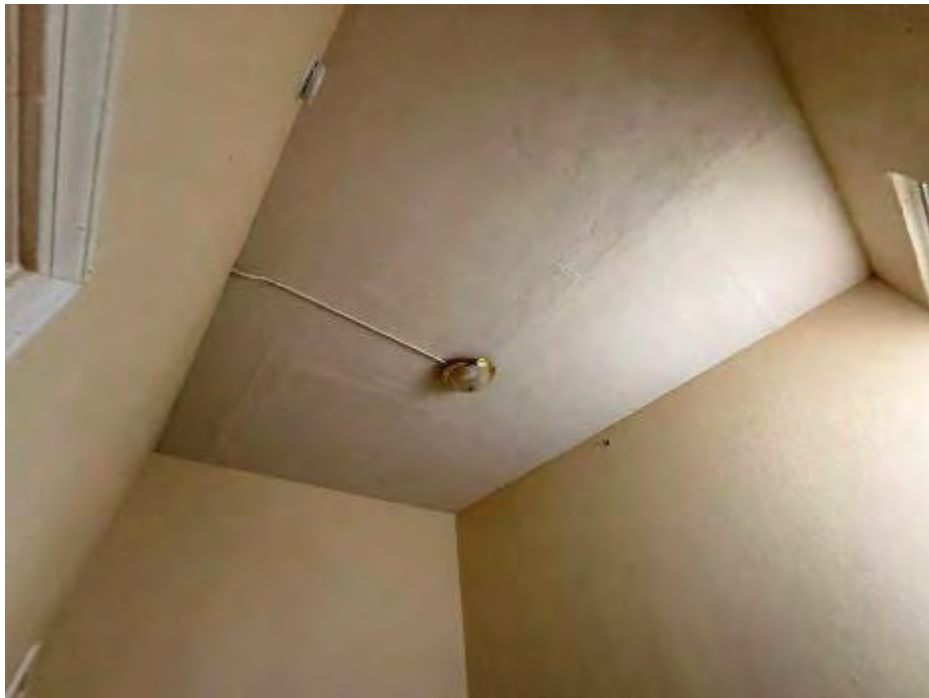
Photos 84-85: Apparent Evidence of Wood Destroying Organisms Within Unit A209

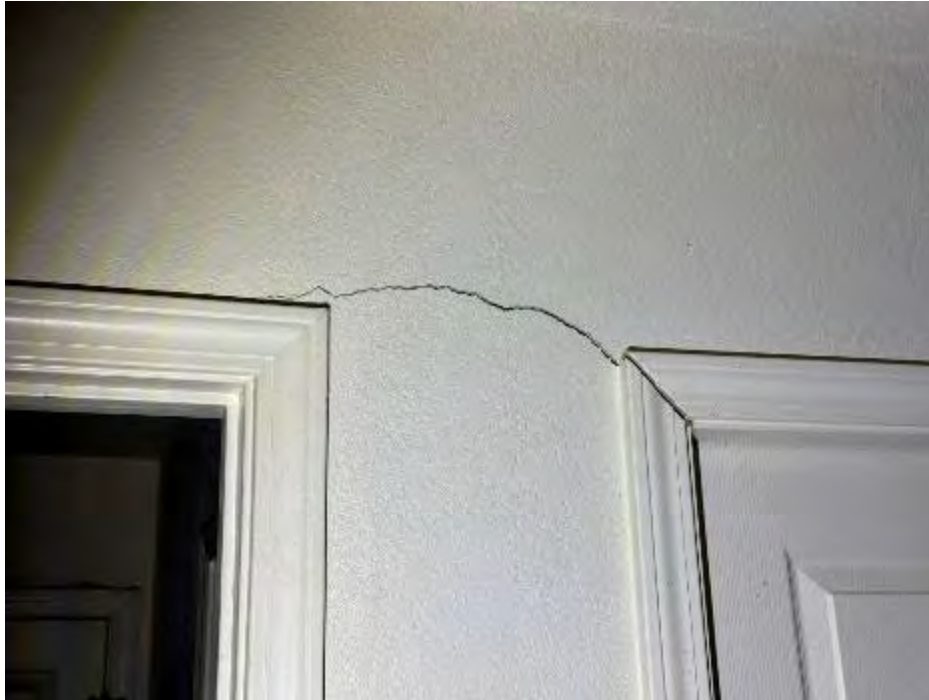
Photo 101: Apparent Cracking above Interior Doors Within Most Units at Building B

| Dwelling Units<br>ITEM | QUANTITY | UNIT<br>COST | TOTAL<br>COST | DM | COMMENTS |
|---|---|---|---|---|---|
| Interior Wall Sheathing | 63 | \$ 1,500 | \$ 94,500 | | Drywall/ Plaster repair as needed |

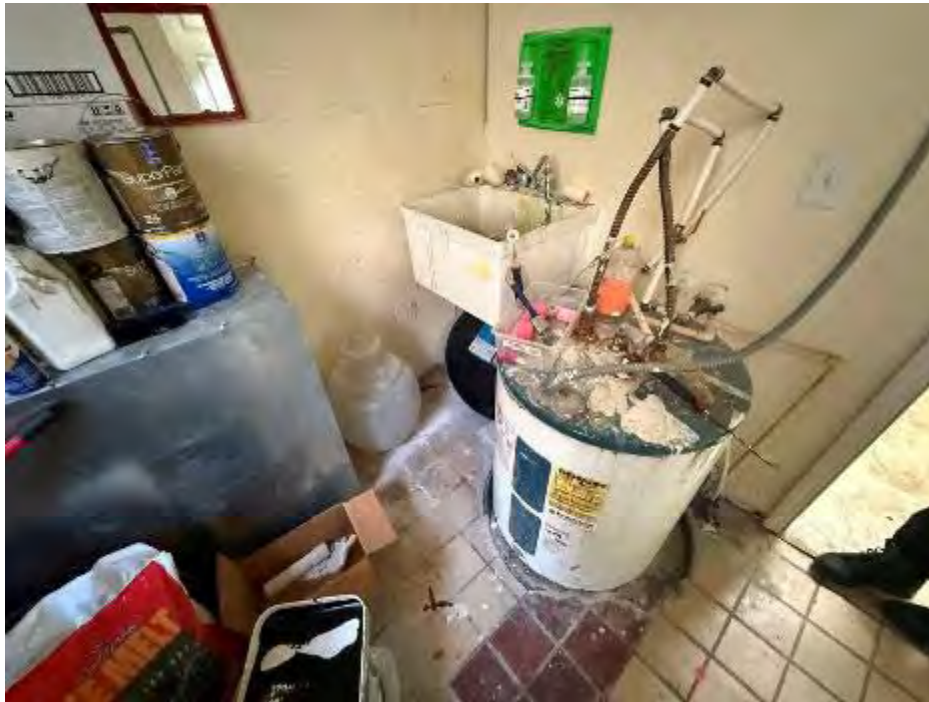
Photo 116: Apparent Building A Domestic Water Riser

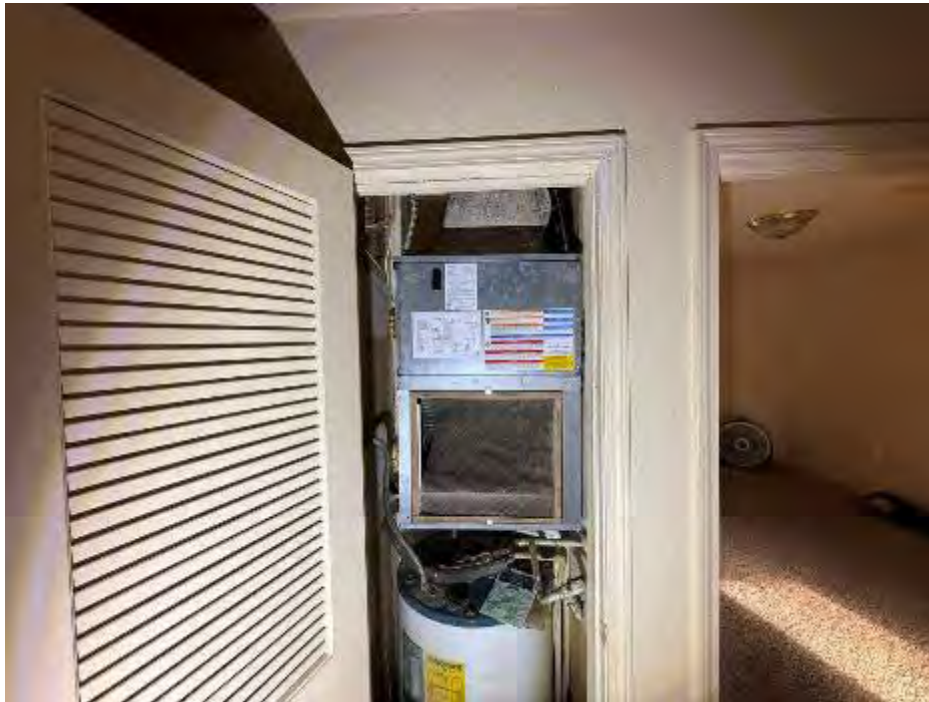
Photo 122: Building B Domestic Water Pump and Tank

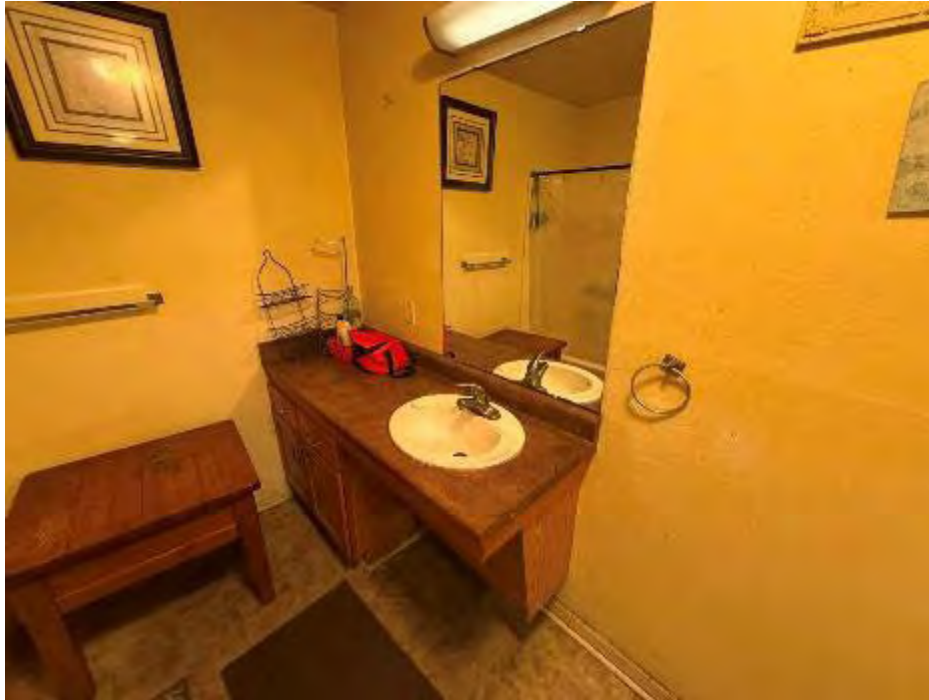
Photo 130: Typical Unit Fixtures Within Building A (Exposed Conduit)

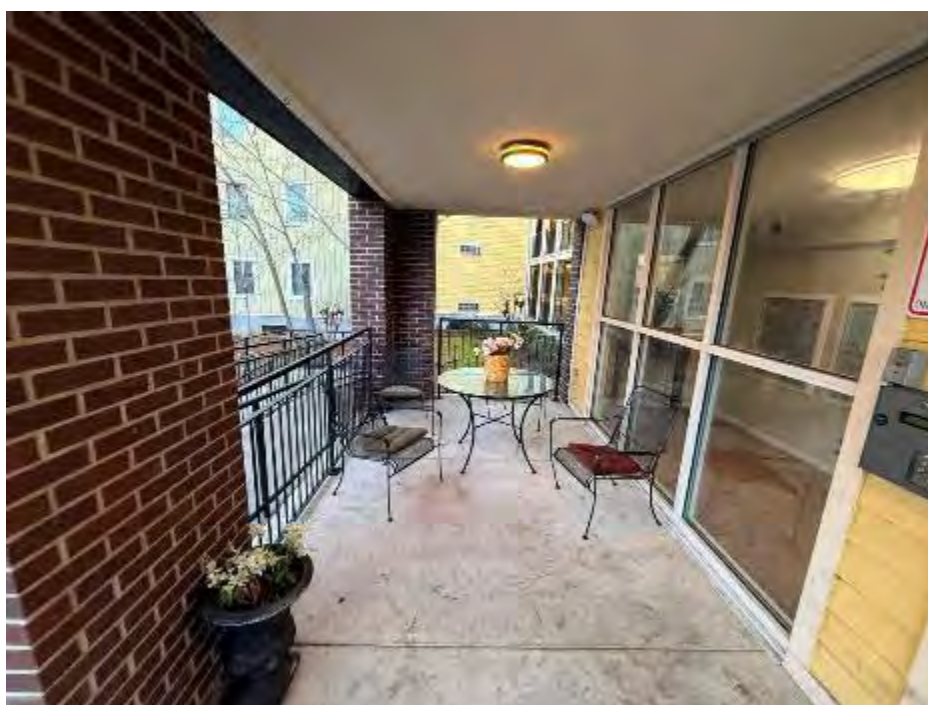
Photo 140: Building B Covered Porch

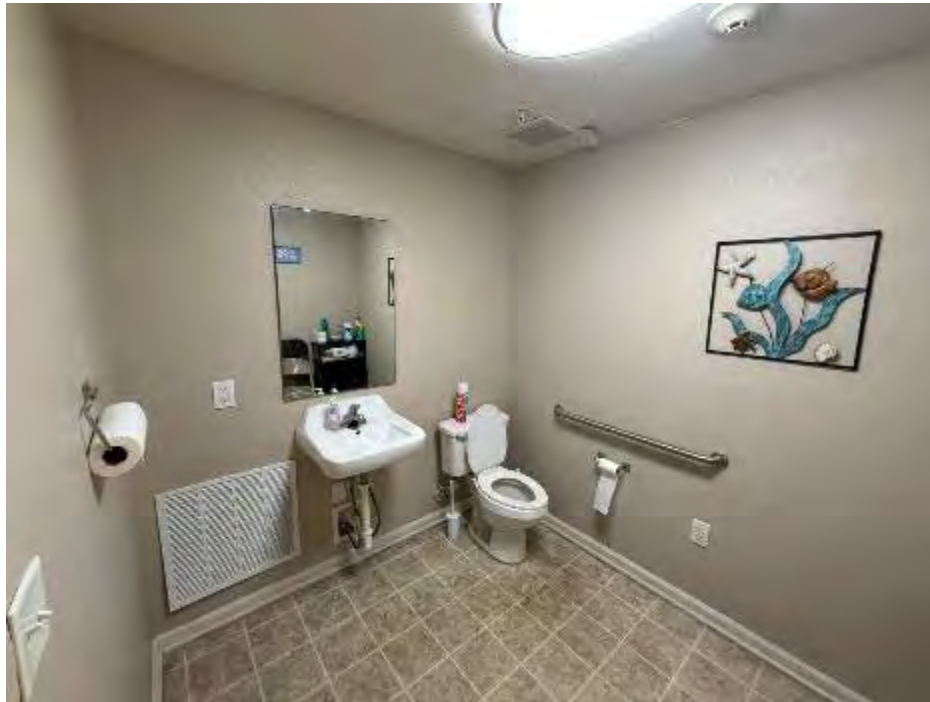
Photo 141: Building B Second Floor Public Restroom

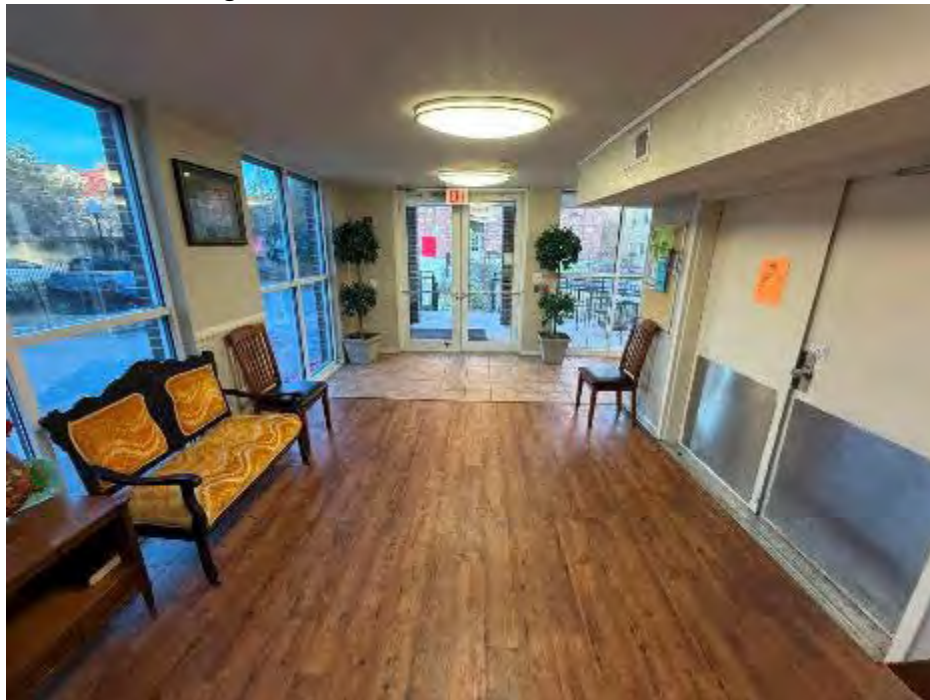
Photo 142: Building B Main Entrance and Leasing Office Area

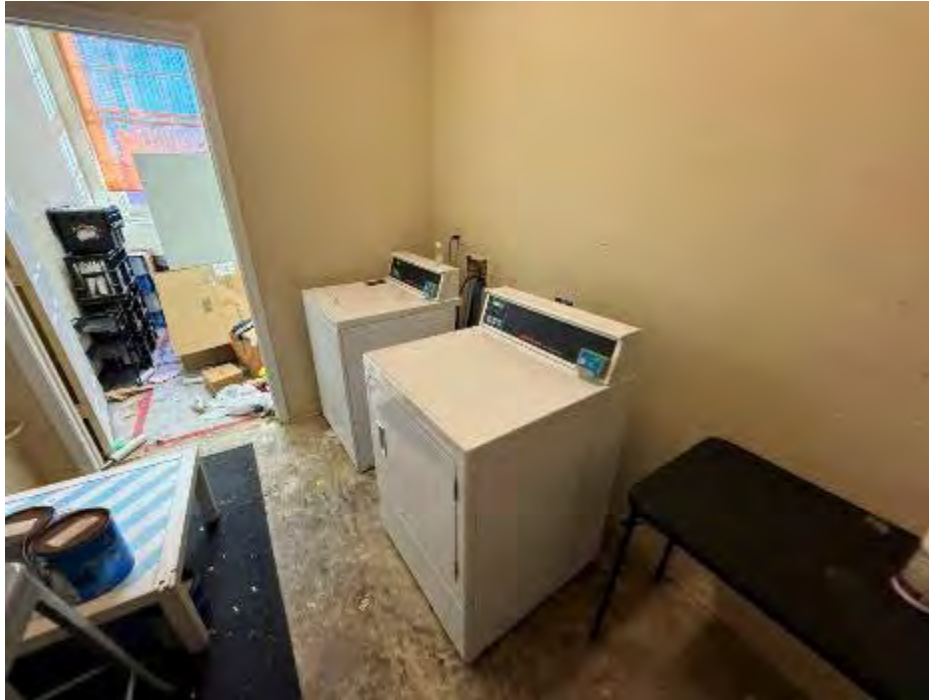
Photo 143: Typical Laundry Room (All Floors of Both Buildings)

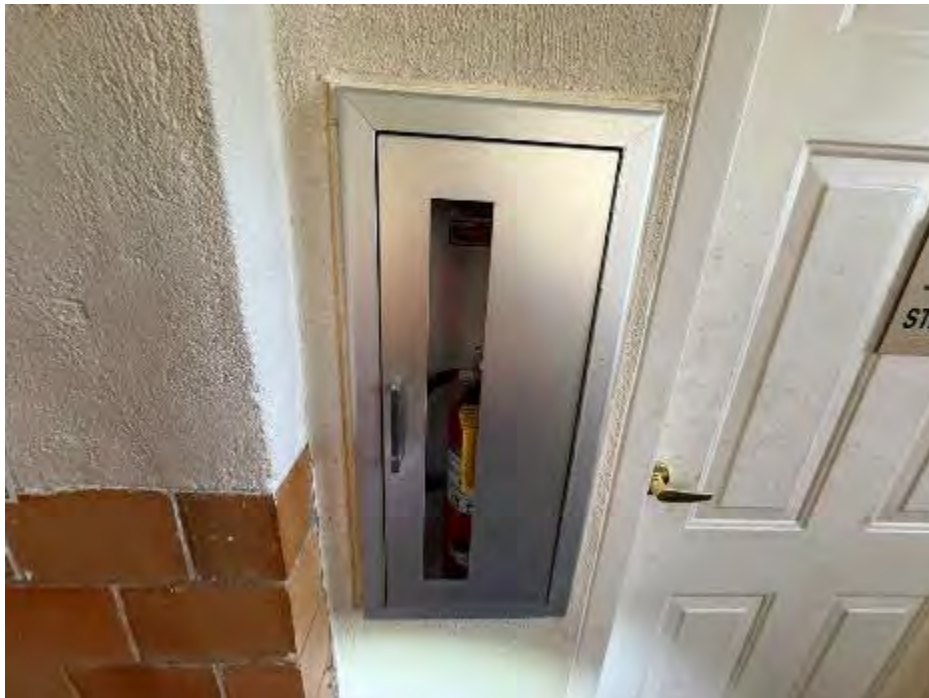
Photo 144: Building A Wall Mounted Fire Extinguishers

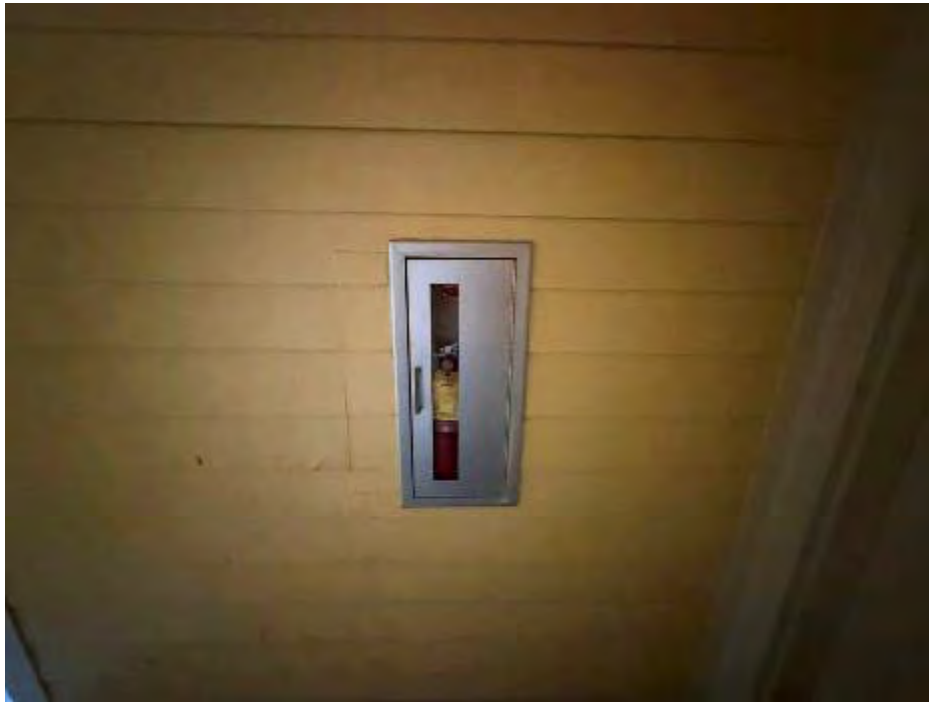
Photo 145: Building B Wall Mounted Fire Extinguishers

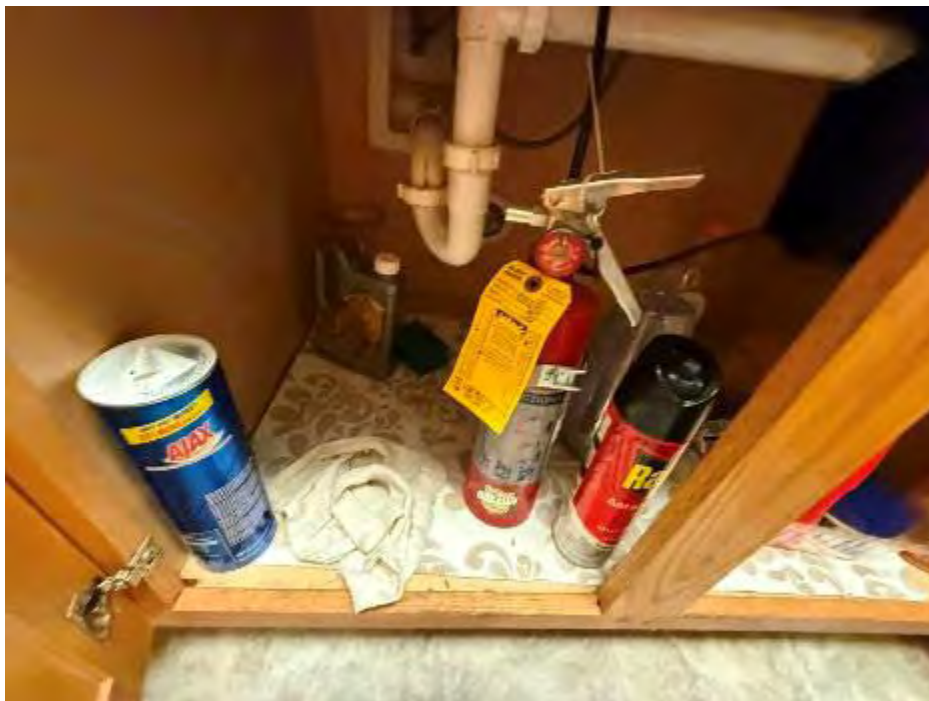
Photo 146: Typical Under Sink Fire Extinguishers

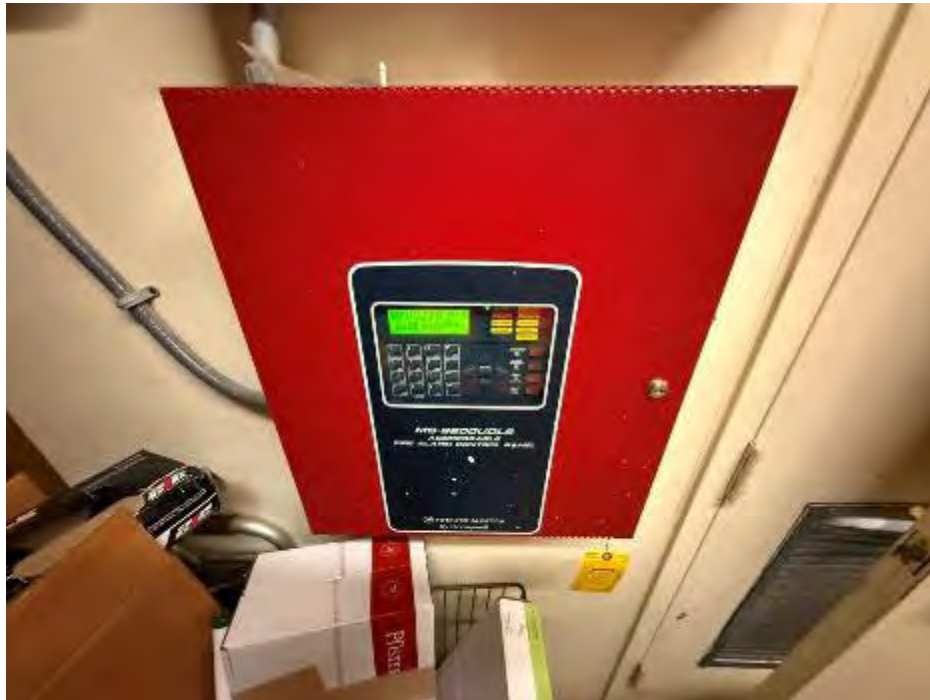
Photo 147: Typical Fire Alarm System Panel

| Dwelling Units<br>ITEM | QUANTITY | UNIT<br>COST | TOTAL<br>COST | DM | COMMENTS |
|---|---|---|---|---|---|
| Fire Alarm | 2 | \$ 3,000 | \$ 6,000 | | Inspect and repair fire alarm system as needed |

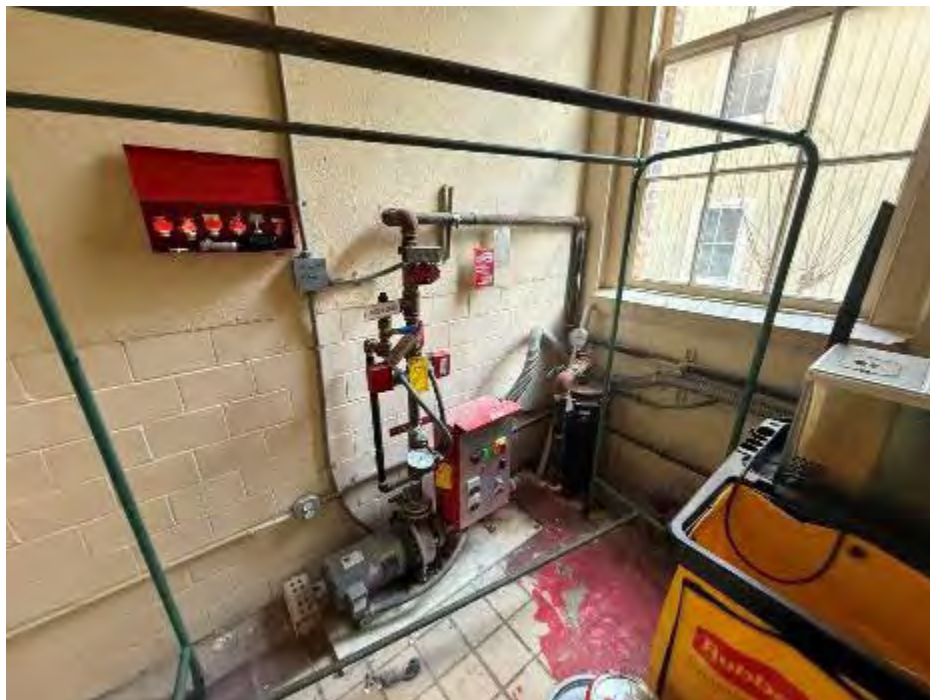
Photo 148: Building A Fire Pump

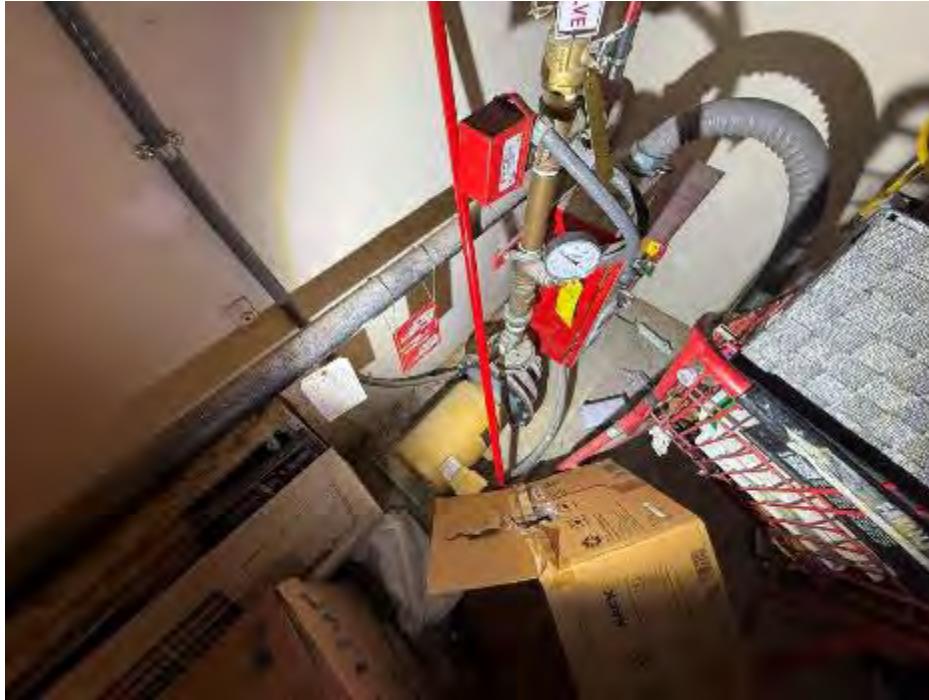
Photo 149: Building B Fire Pump

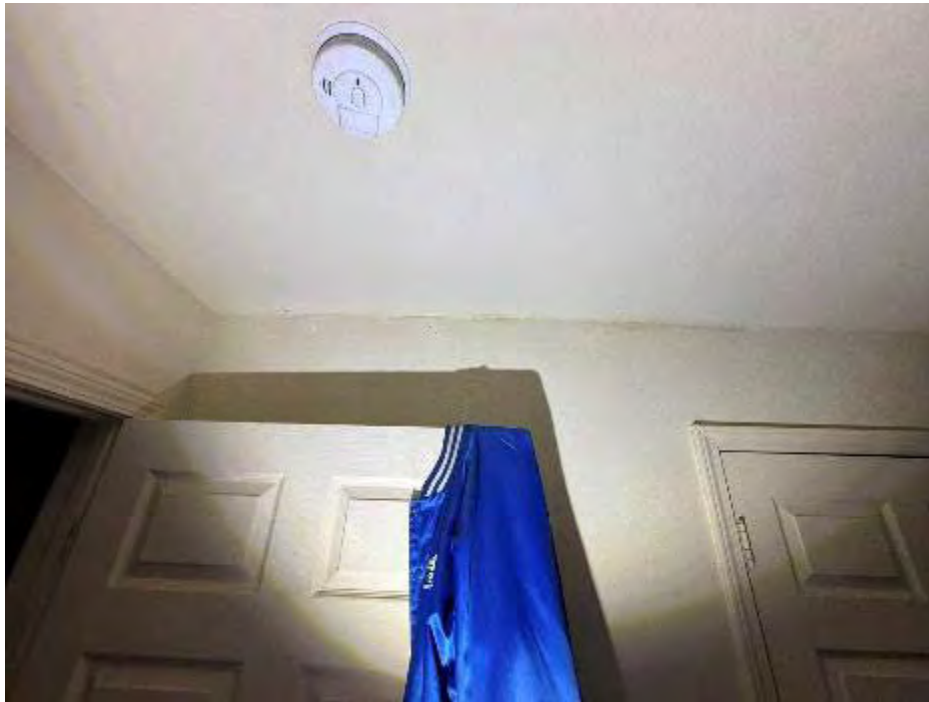
Photo 151: Typical Smoke Detector (Both Buildings)

| Dwelling Units<br>ITEM | QUANTITY | UNIT<br>COST | TOTAL<br>COST | DM | COMMENTS |
|---|---|---|---|---|---|
| Unit Smoke Detectors | 63 | \$ 400 | \$ 25,200 | | Wholesale replacement |

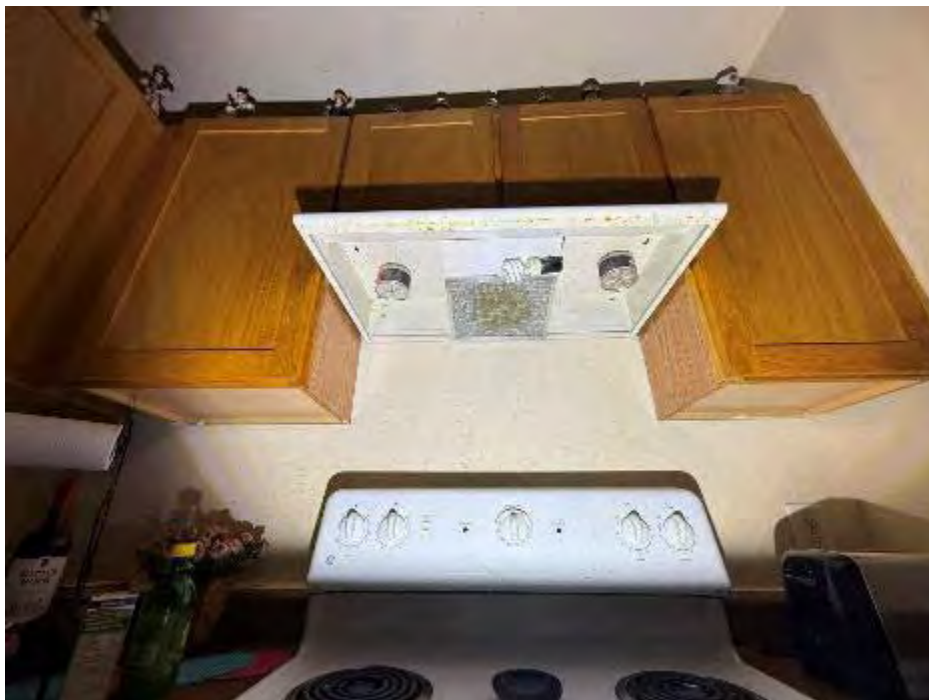
Photo 152: Typical Over Range Fire Suppression Canisters

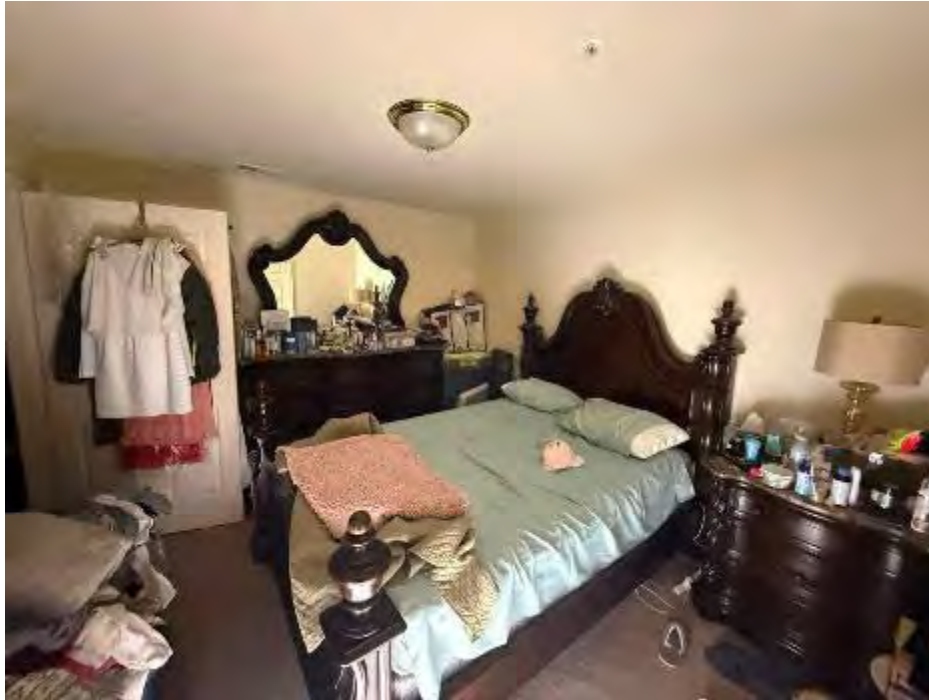
Photo 153: Typical Sprinkler
