Asbestos and Lead-Based Paint Assessment  
Proposed Parkside Commons  
901 South 9<sup>th</sup> Avenue  
Dillon, Dillon County, South Carolina  
S&ME Project No. 26630033

Reference: **Asbestos and Lead-Based Paint Assessment  
Proposed Parkside Commons**  
901 S. 9<sup>th</sup> Avenue  
Dillon, Dillon County, South Carolina  
S&ME Project No. 26630033

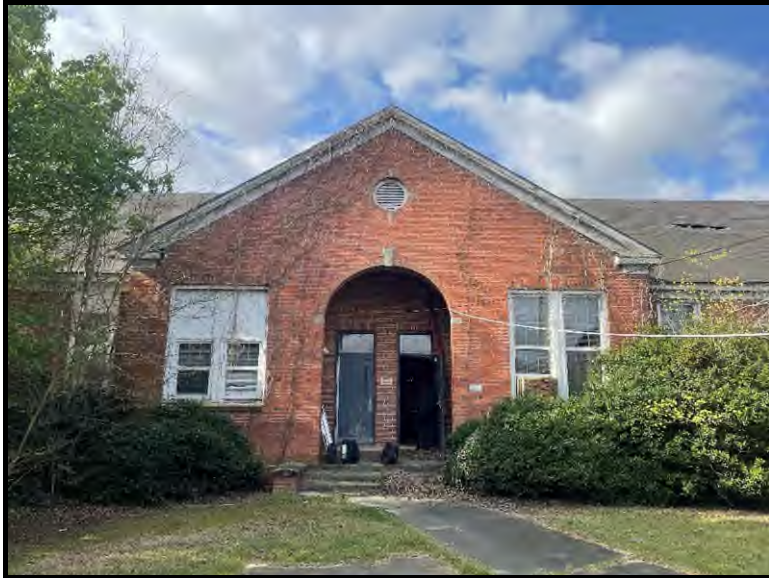
1 Exterior view of #1 South Building.

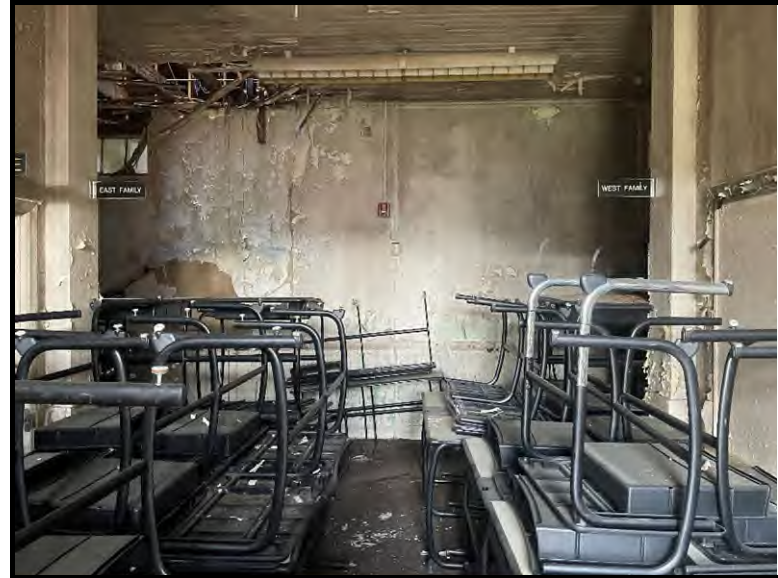
2 Interior view of #1 South Building.

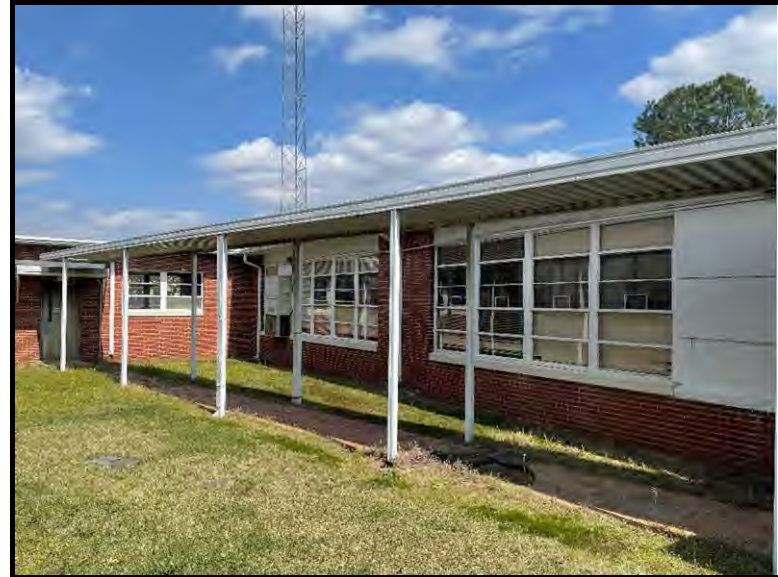
**24** Exterior view of #2 Middle Building.

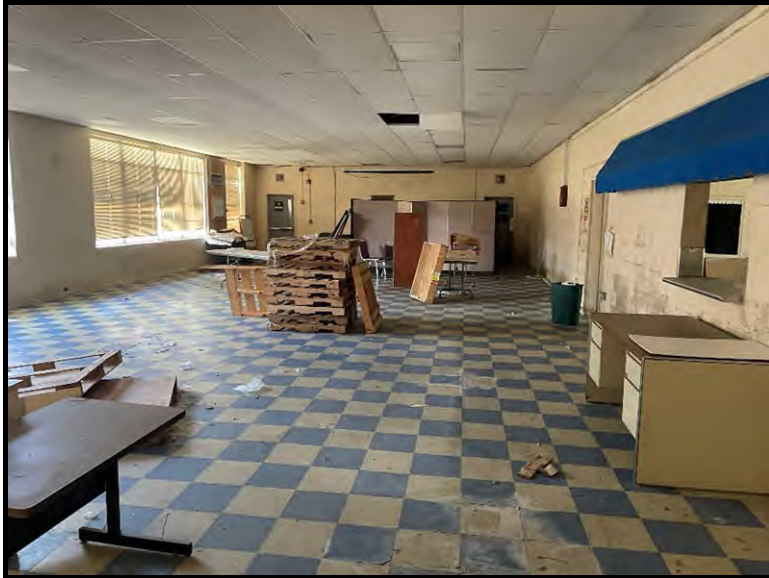
**25** Interior view of #2 Middle Building (Staff Development).

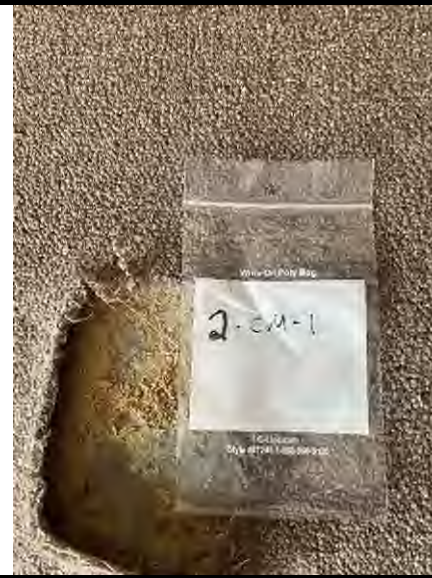
**26** View of carpet mastic (Southeast Section). No asbestos detected.

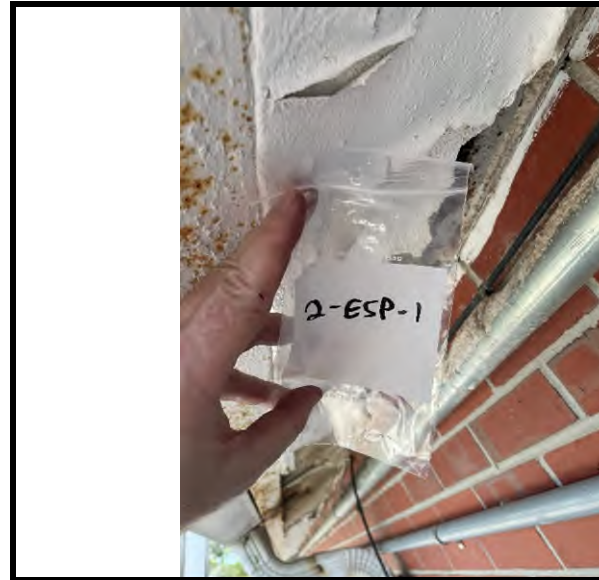
**46** View of plaster (exterior soffit). No asbestos detected.

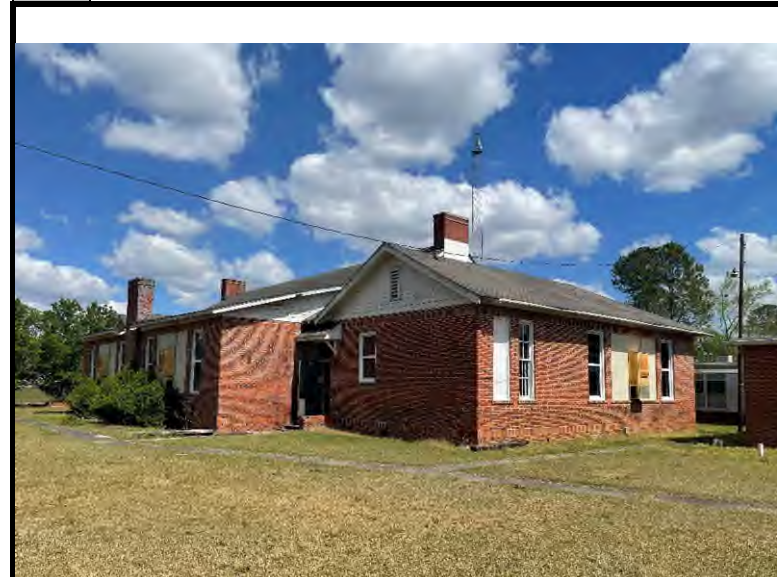
**56** Exterior view of #3 Northwest Building.

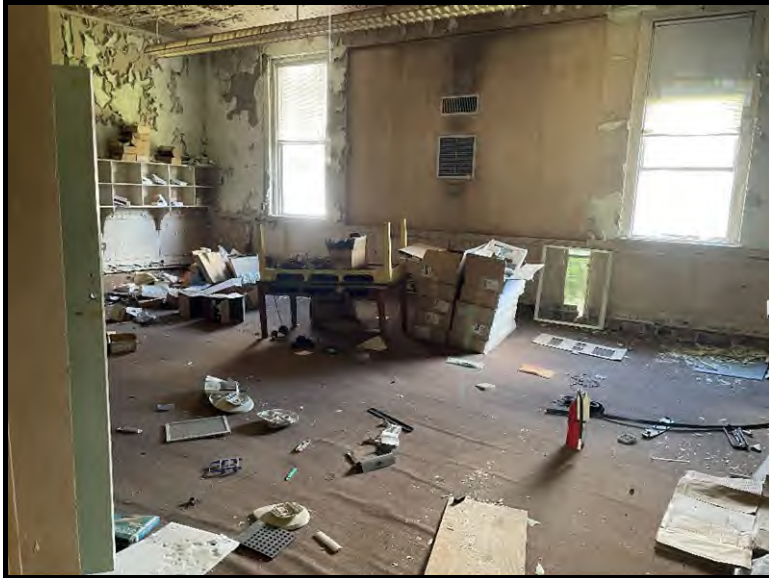
**57** Interior view of #3 Northwest Building.
