PROPERTY CONDITION ASSESSMENT

Highland Square Apartments

200 Pine Creek Court Extension
Greenville, South Carolina 29605

October 1, 2024

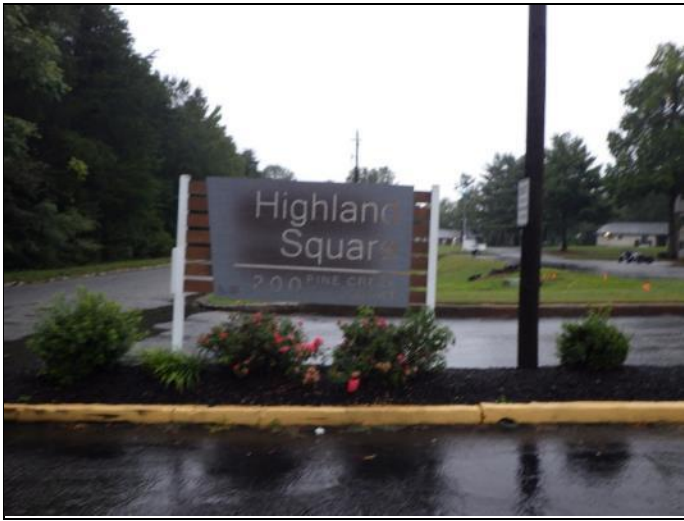
1. Property identification signage.

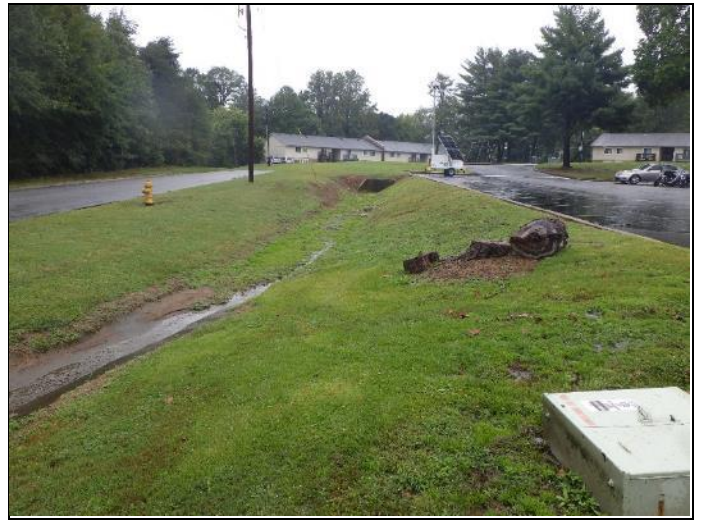
2. Storm drainage ditch to municipal system.

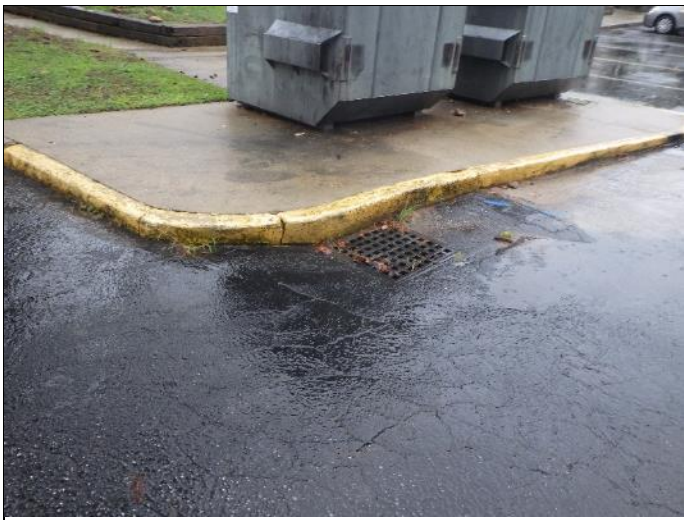
3. Catch basin provided throughout the site.

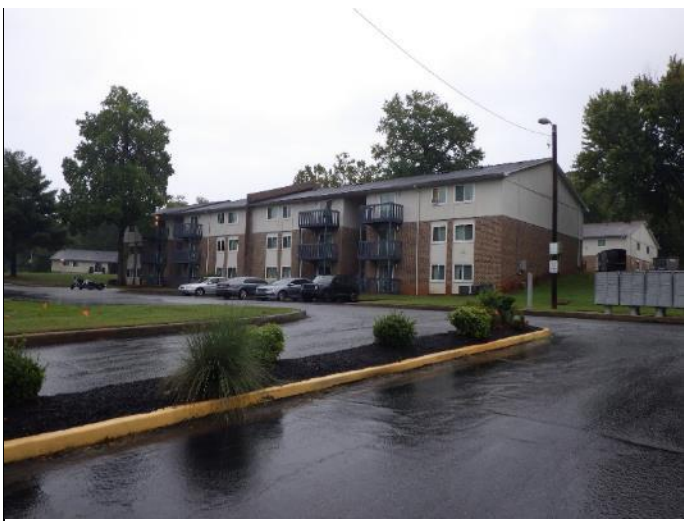
5. The main entrance and landscaping on site.

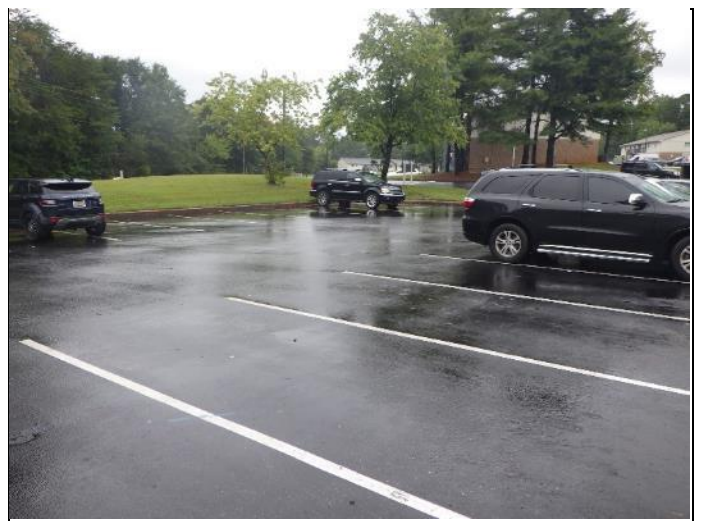
6. Asphalt pavement is used throughout.

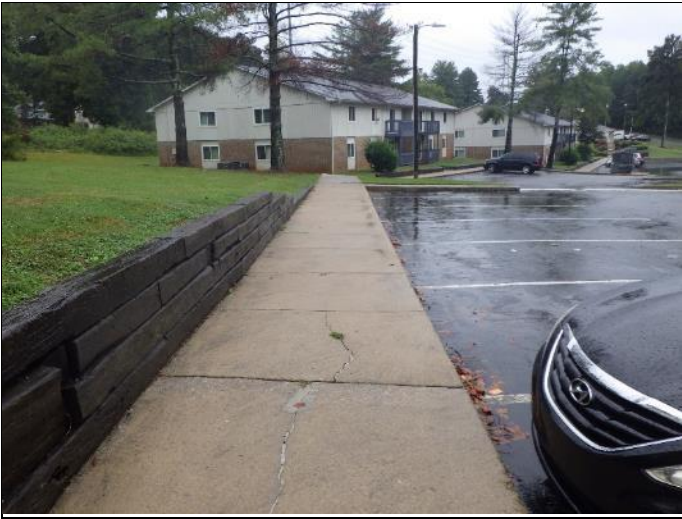
7. Concrete sidewalks are provided.

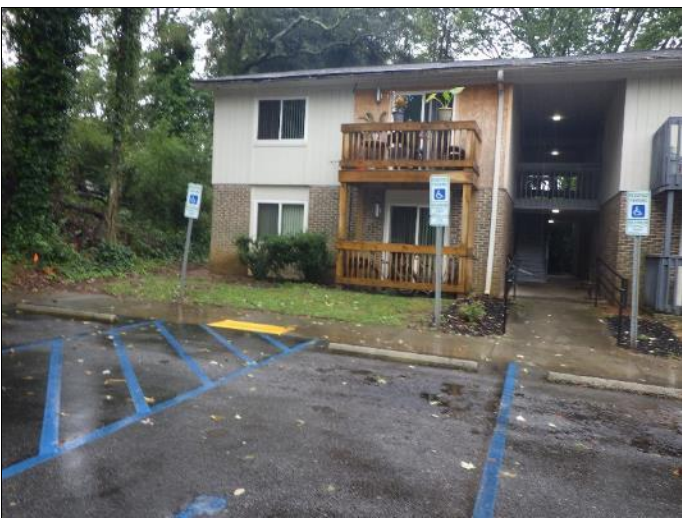
11. Van accessible parking at A building.

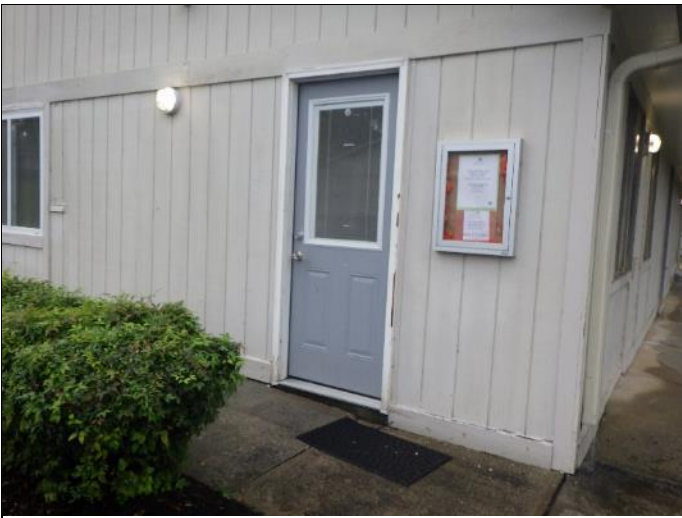
15. Entry to leasing office with exceeded threshold.

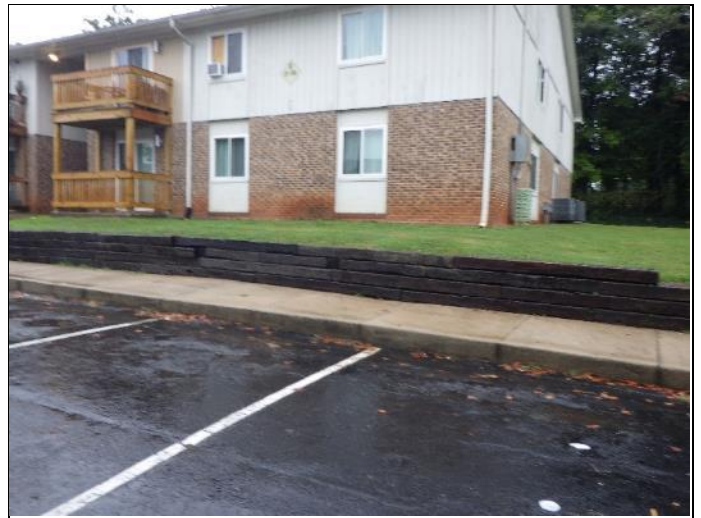
16. Crosstie retaining walls are provided.

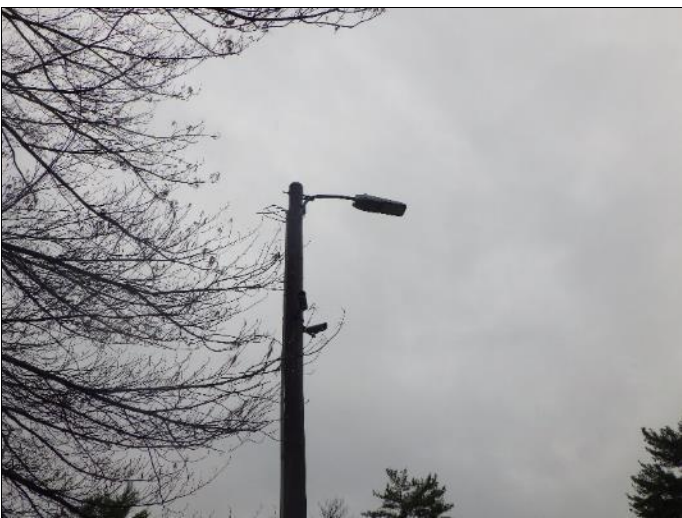
17. Typical site lighting pole on the property.

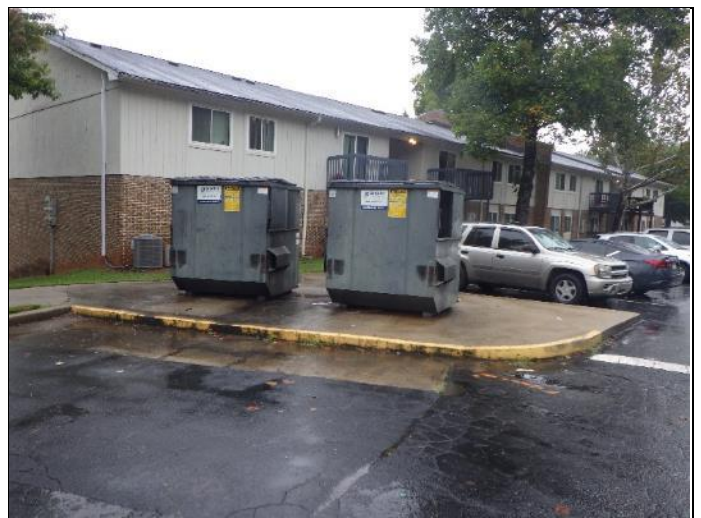
18. Solid waste dumpster staging area.

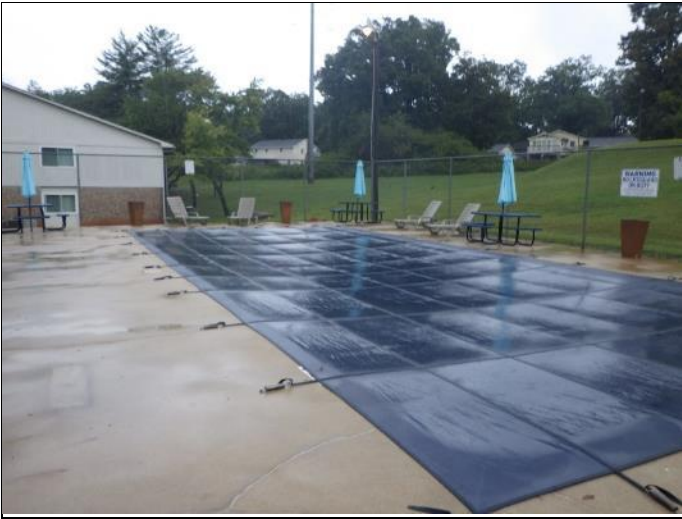
19. Swimming pool at the leasing office; closed for season.

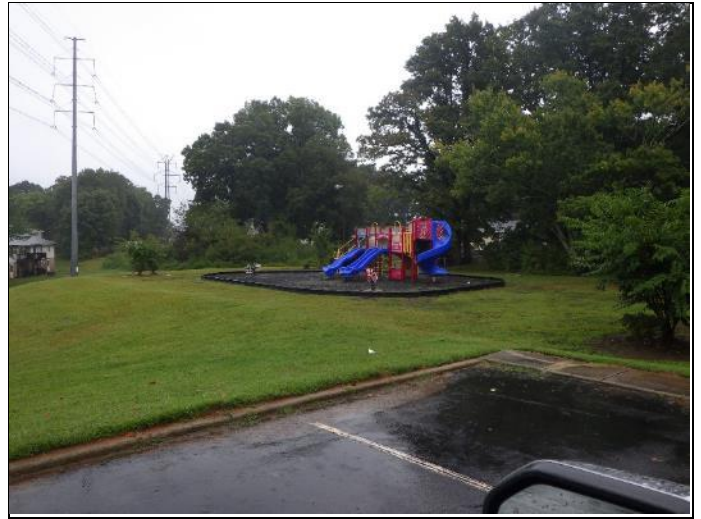
20. Playground area.

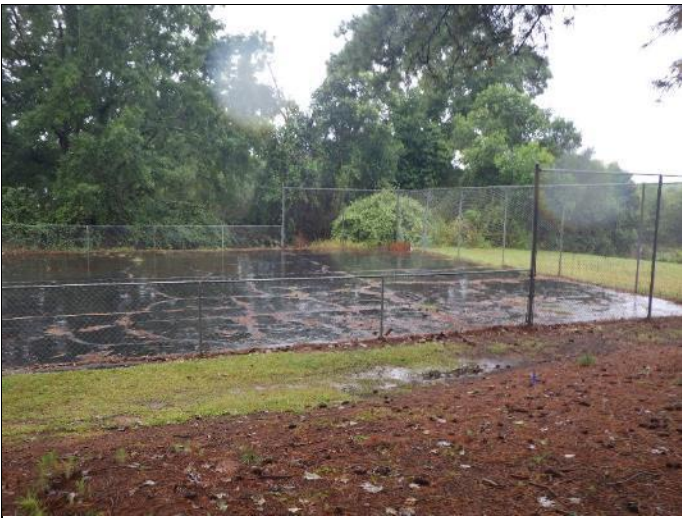
21. Tennis court.

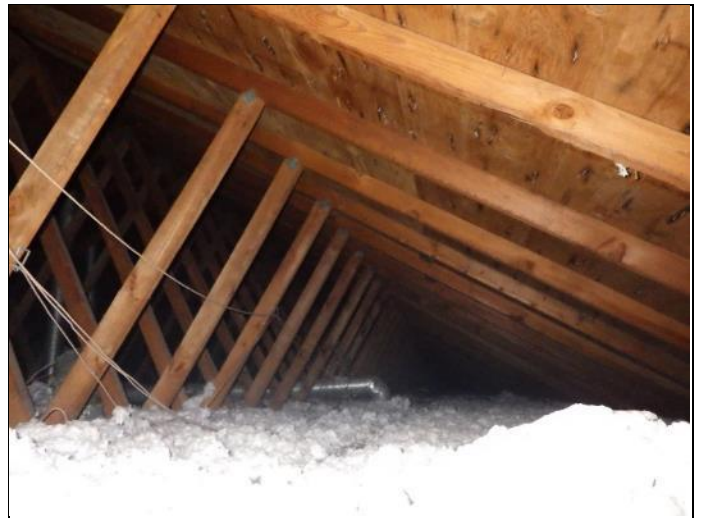
22. Wood framing and sheathing is used.

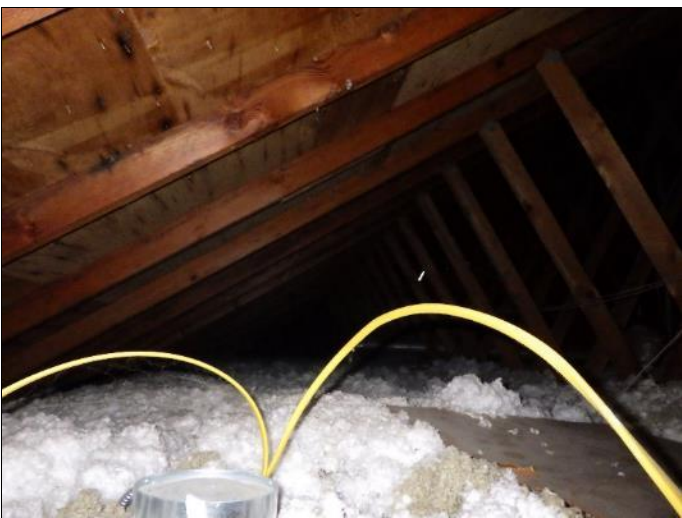
23. Wood framing is used in each building.

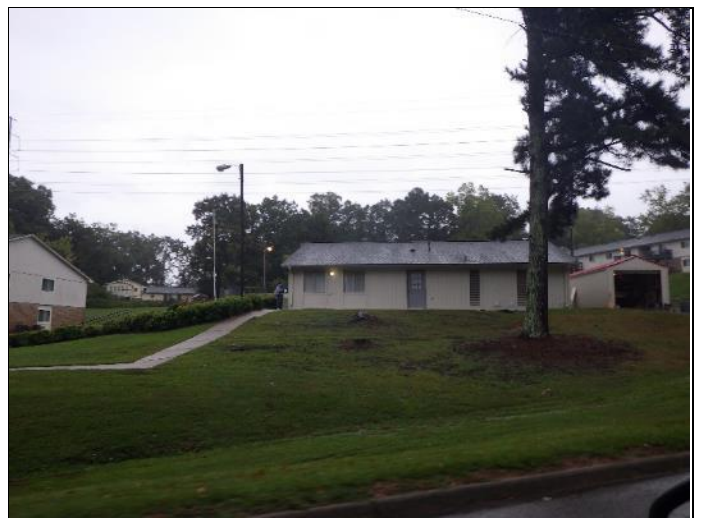
24. Leasing office and maintenance shed.

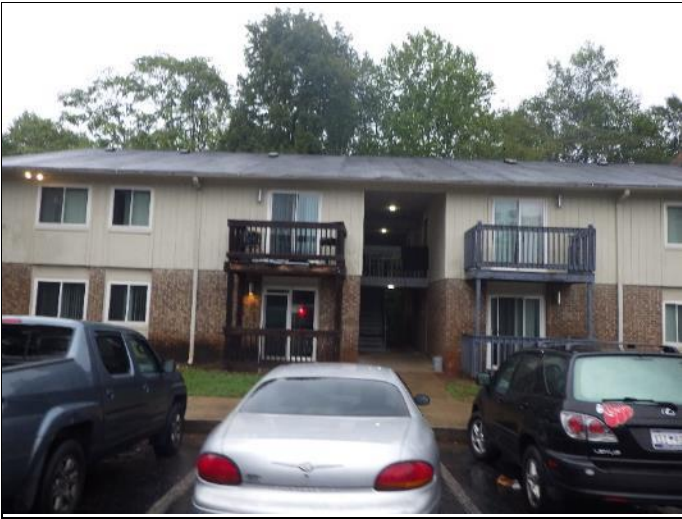
25. An exterior of brick and wood siding.

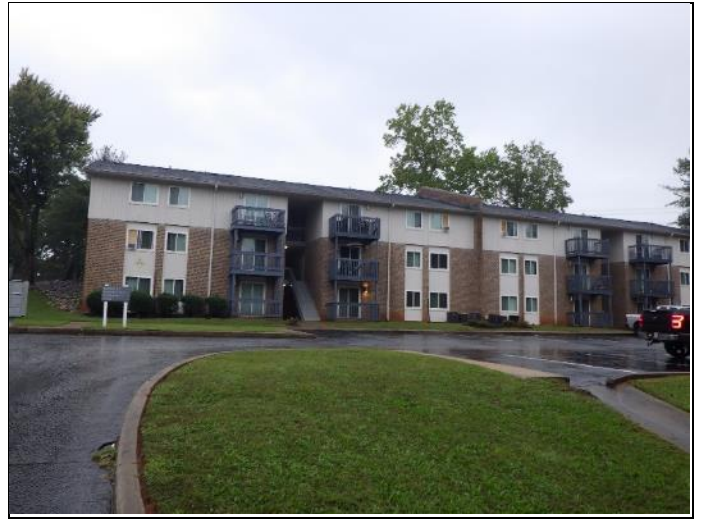
26. A typical building on the property.

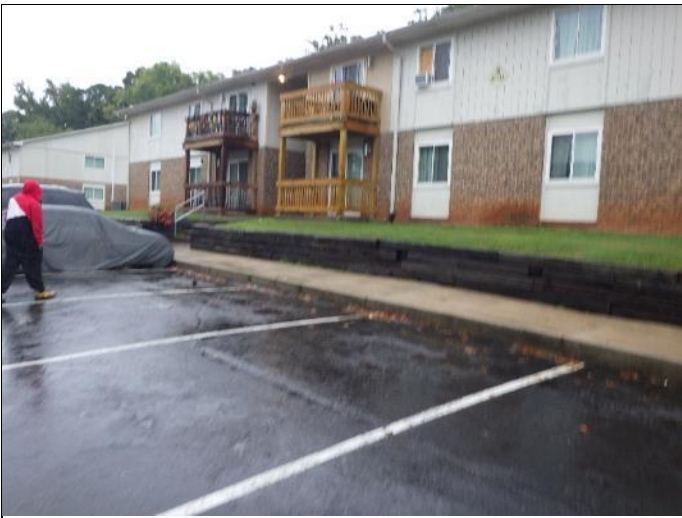
27. The buildings have wood framed balconies.

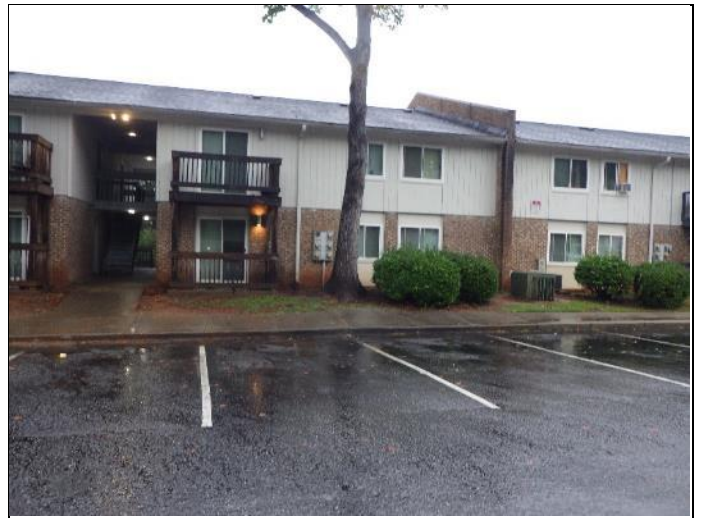
28. A typical building on site.

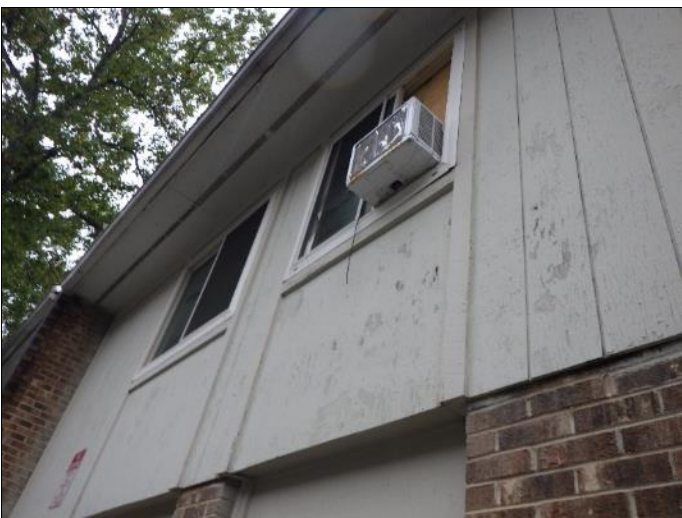
29. T1-11 wood siding is used on each building.

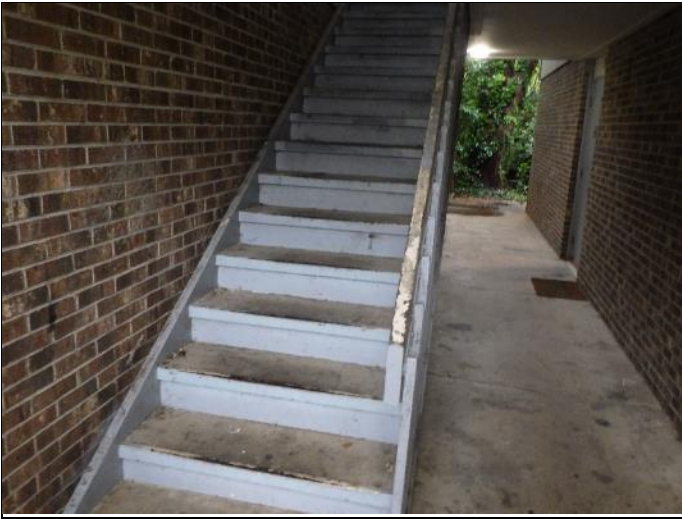
31. Typical stair system in a breezeway.

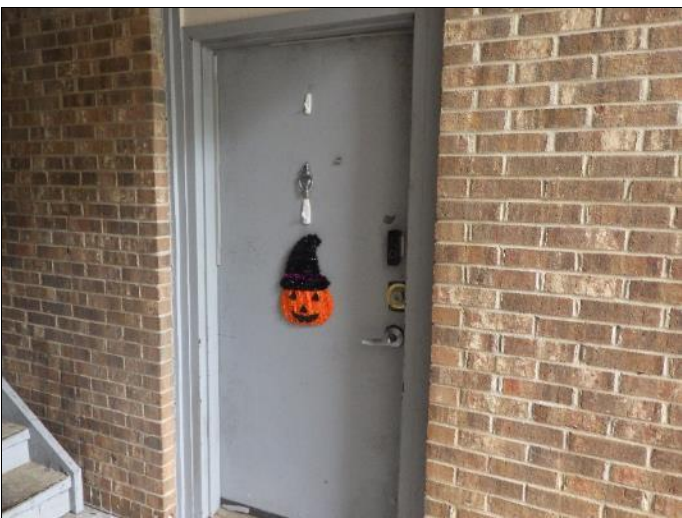
35. A typical entry door to a unit.

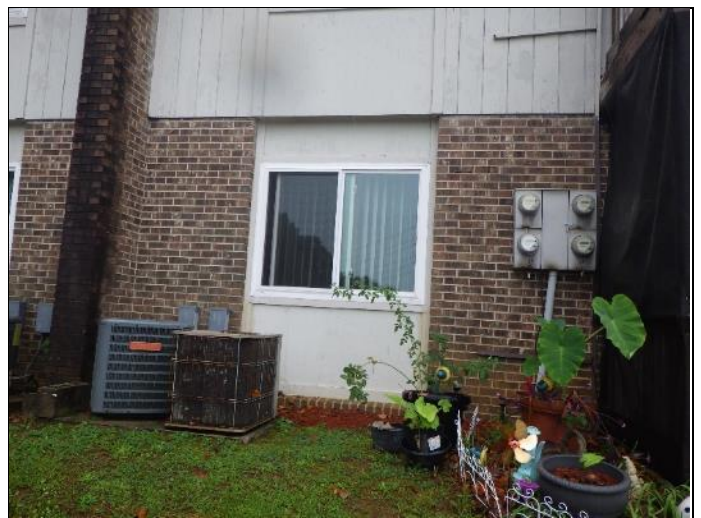
36. New windows install in every unit.

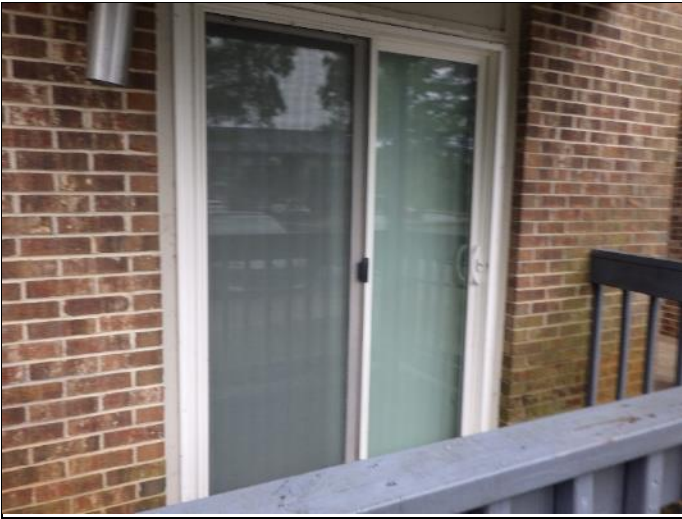
37. New sliding glass doors were installed.

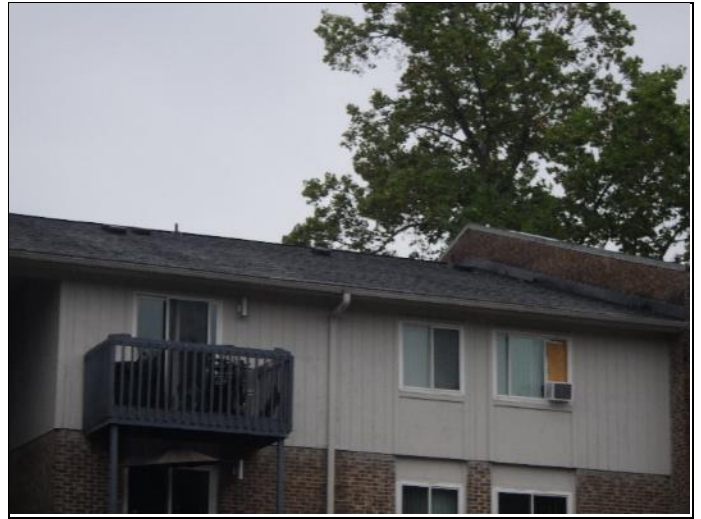
38. Pitched roof with shingles are provided.

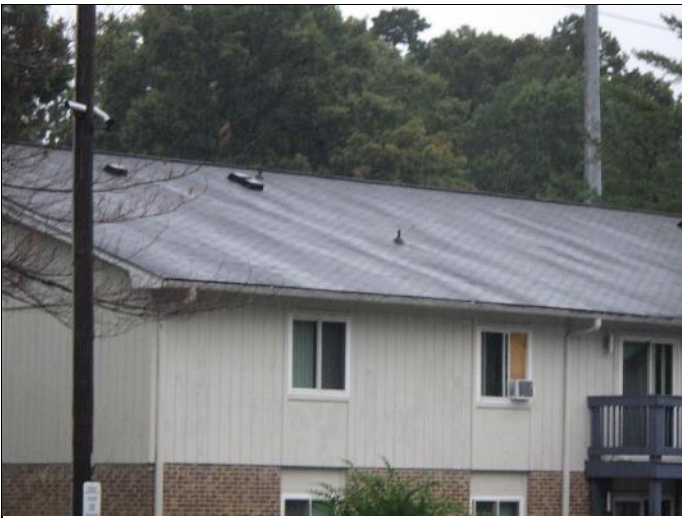
39. Pitched roof with shingles are provided.

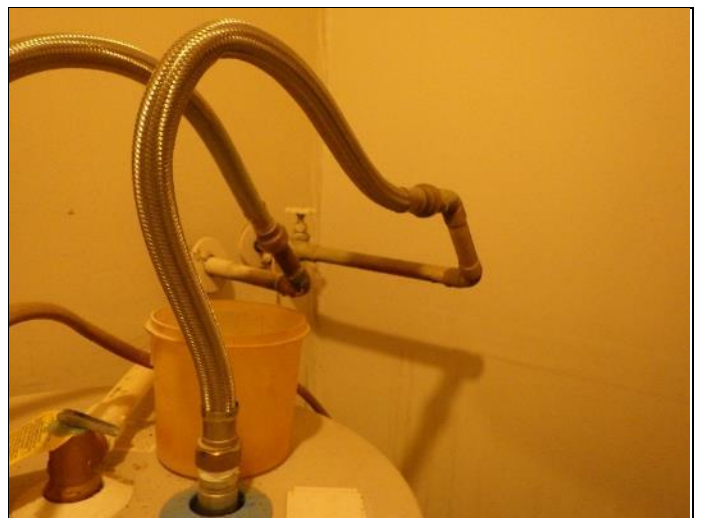
42. Copper pipe is used throughout the site.

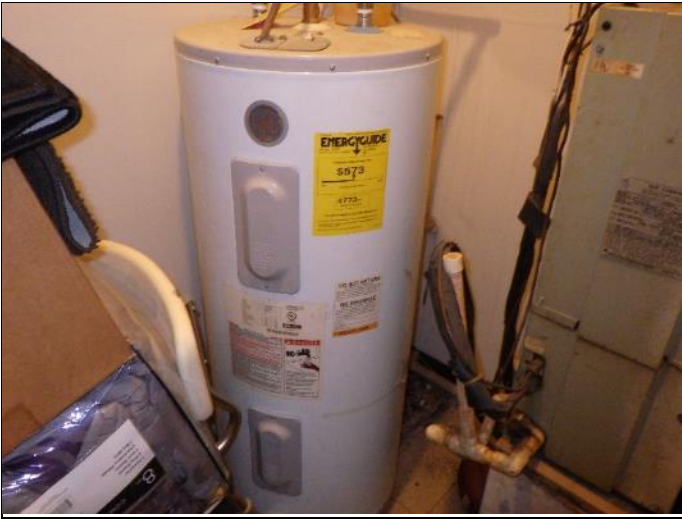
43. Individual domestic water heater.

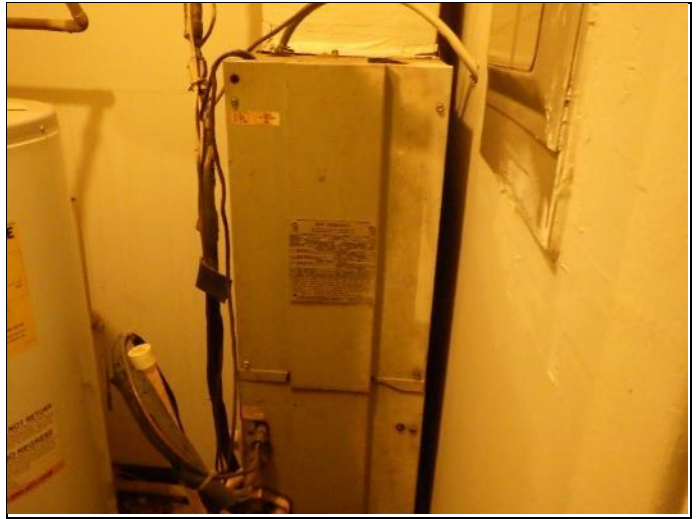
44. Split system air handler/furnace in a unit.

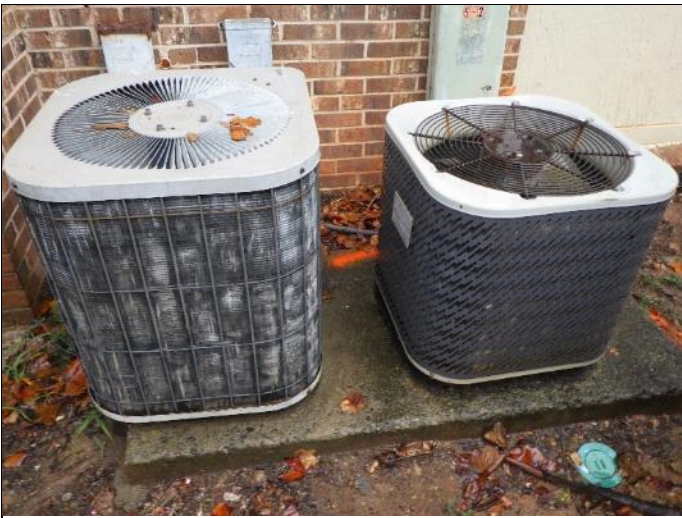
45. Split system condenser units.

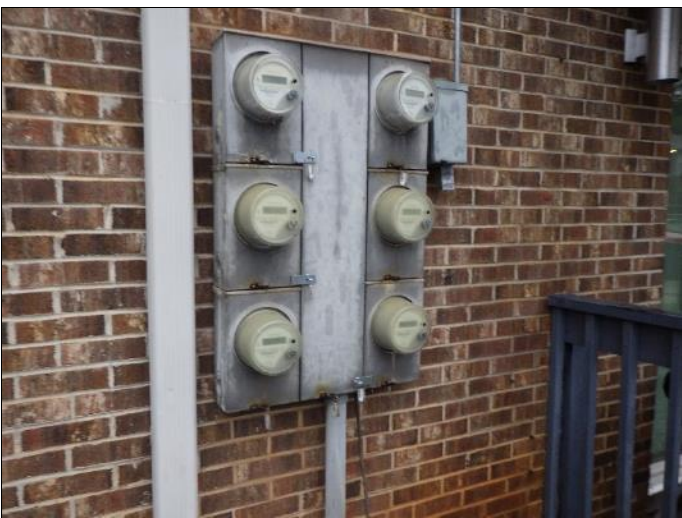
47. Individual electrical meter bank.

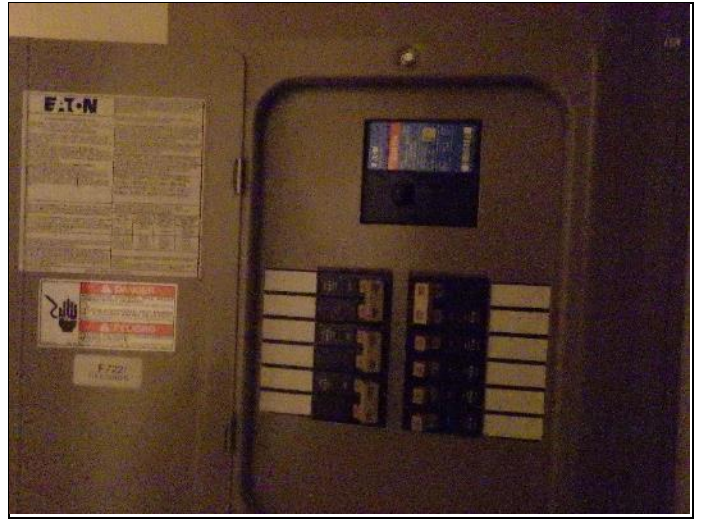
50. New Eaton panels in every unit.

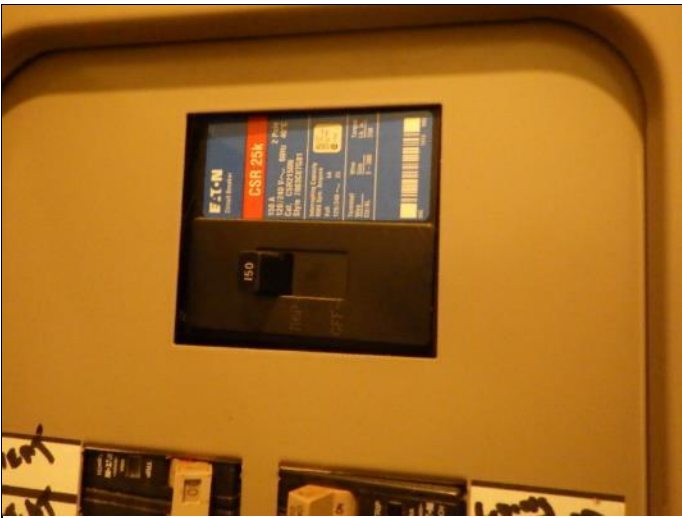
51. Main breaker for a unit.

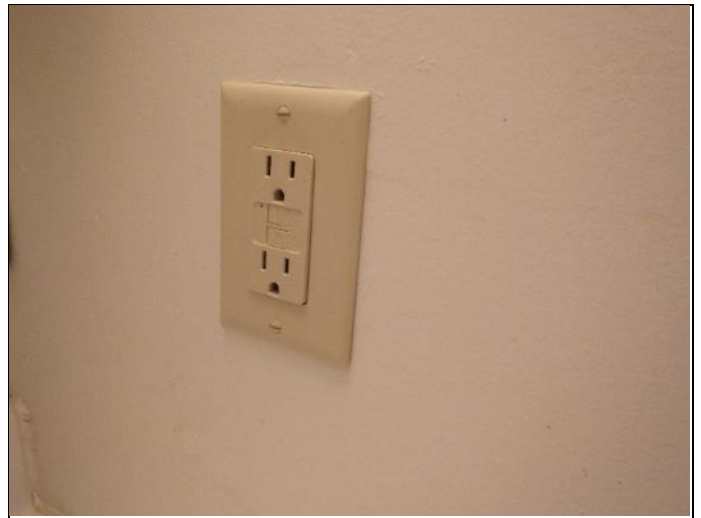
52. GFCI outlets are provided in each unit.

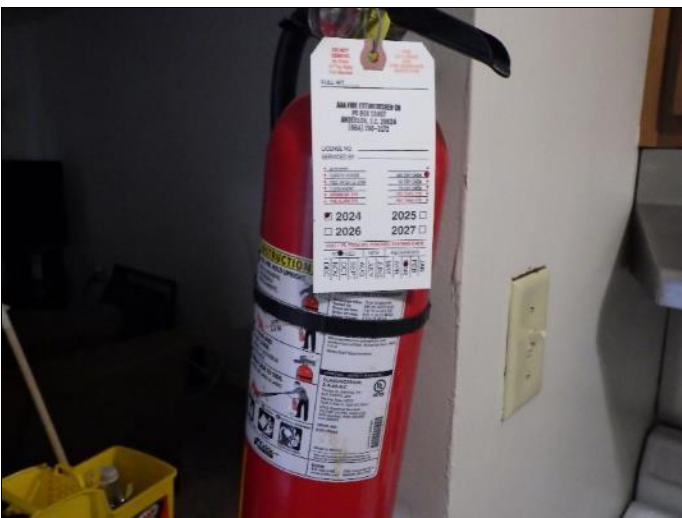
53. Fire extinguisher in every unit.

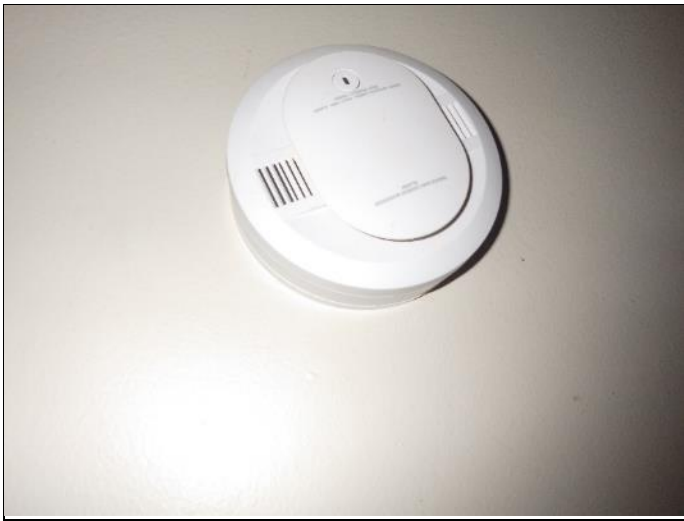
55. Smoke detectors in every unit.

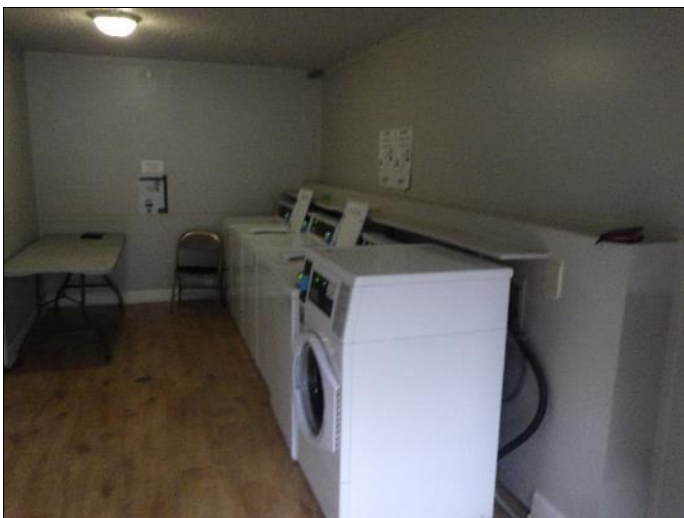
59. Common laundry room.

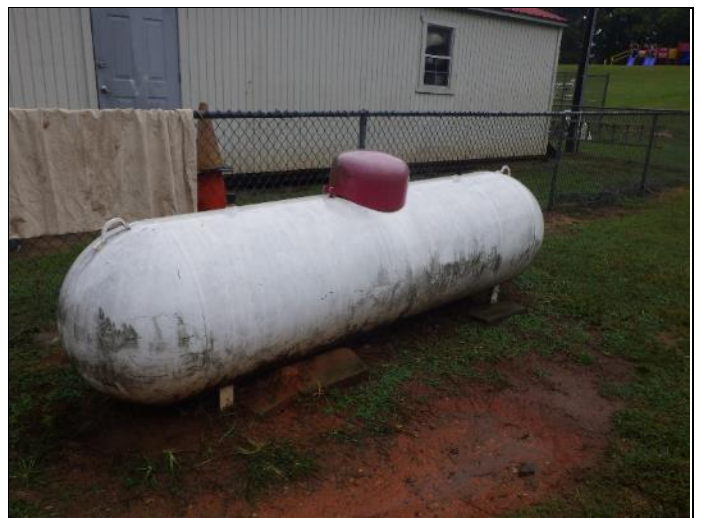
60. Propane tank for laundry room equipment.

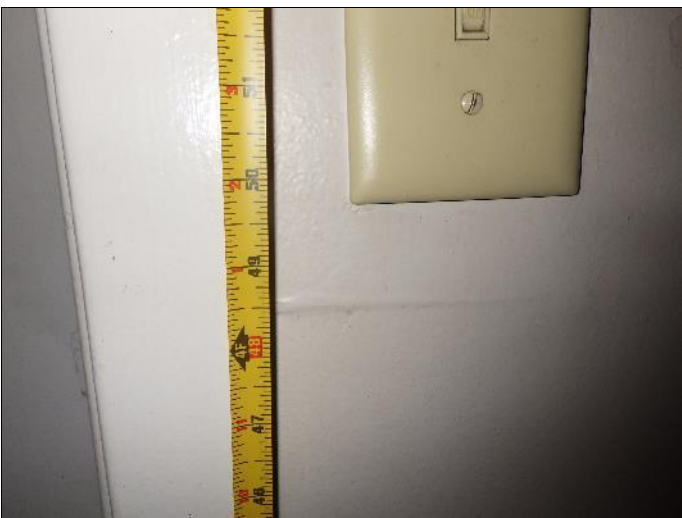
65. Designated accessible unit light switch; note height exceeds 48" AFF.

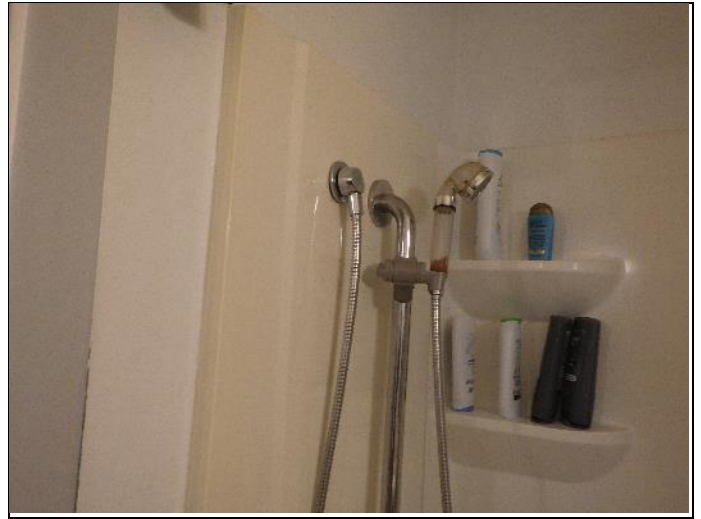
68. Designated accessible unit; wand-type shower head provided.

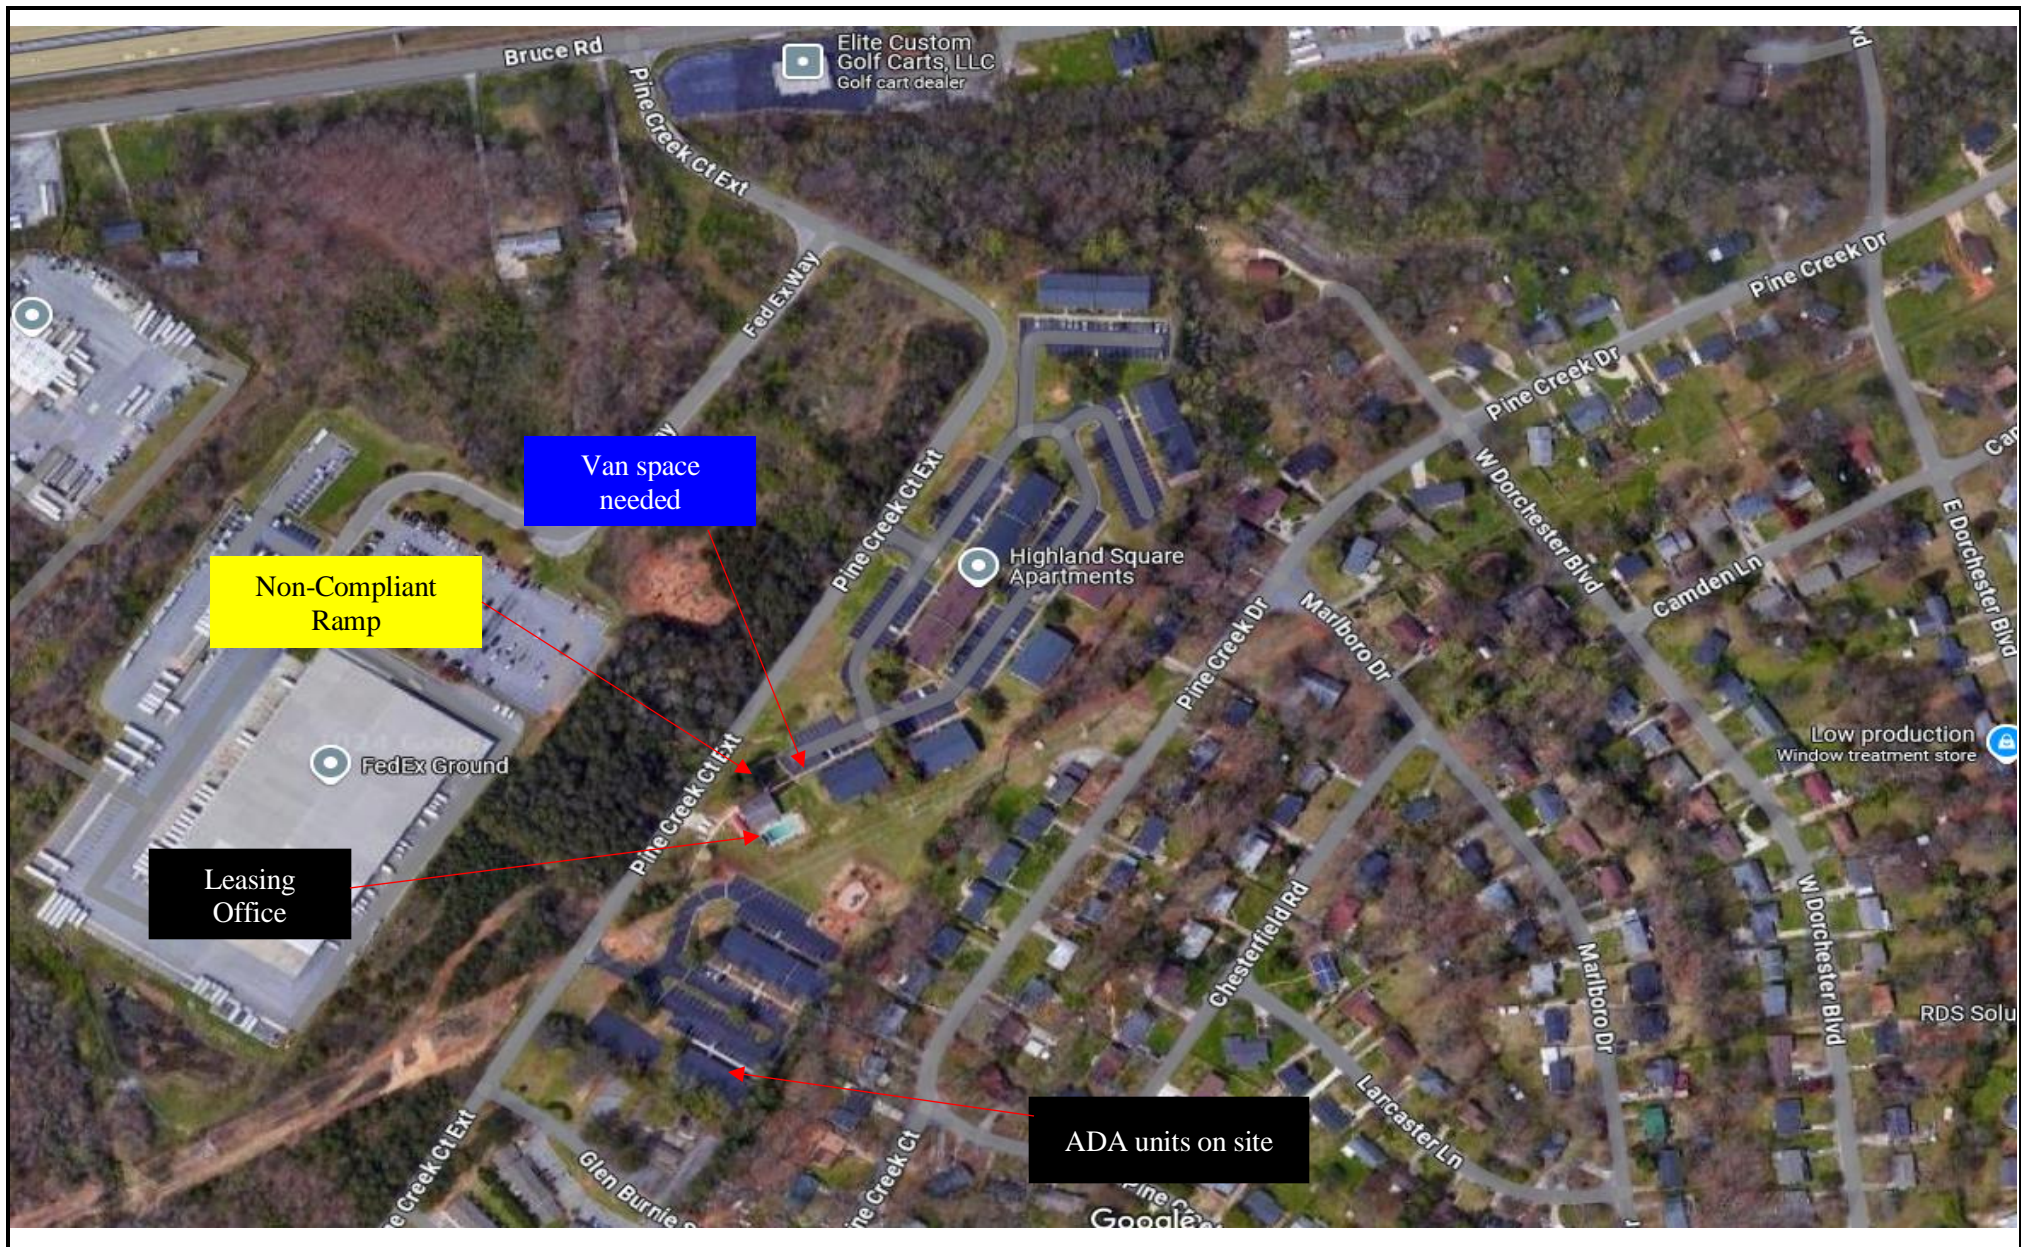
- Key:
- Non-compliant walkway/ramp (exceeds 5% or 8.33% slope)
 - Non-compliant cross slope (exceeds 2%)
 - Missing curb cut and/or crosswalk
 - Missing accessible route
 - Non-compliant/missing designated accessible parking
 - Non-compliant entryway/door
