**CAPITAL NEEDS ASSESSMENT
NORTHGATE MANOR
220 BIBLEBROOK DRIVE
GREER, SOUTH CAROLINA 29651**

**D3G PROJECT NUMBER:
2024-1708**

**REPORT ISSUE DATE:
SEPTEMBER 27, 2024**

**INSPECTION DATE:
JULY 15 - 17, 2024**

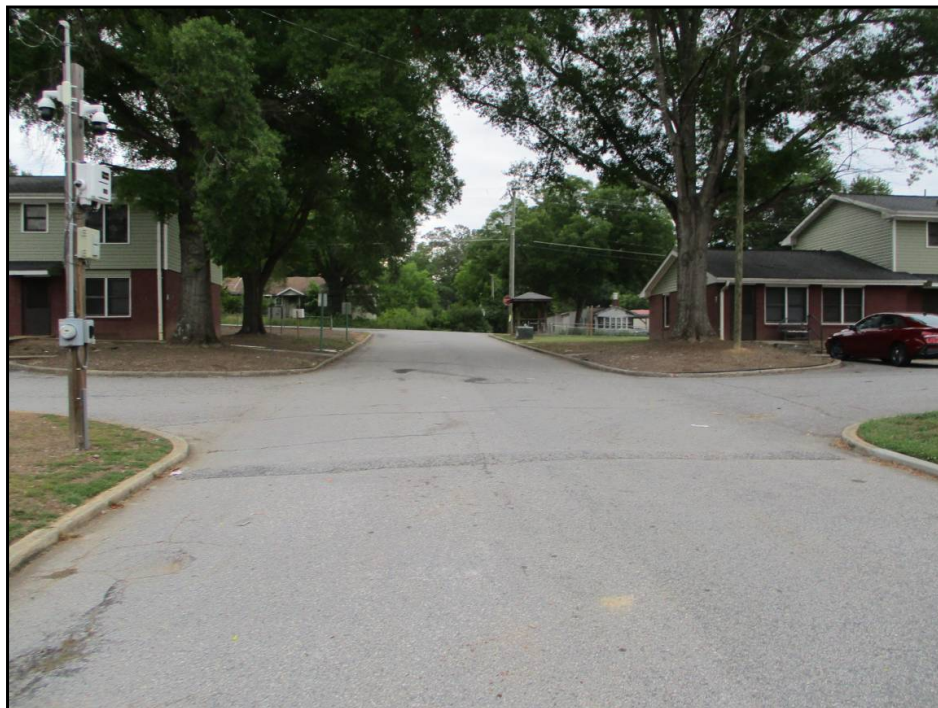
2: Main Entry Drive

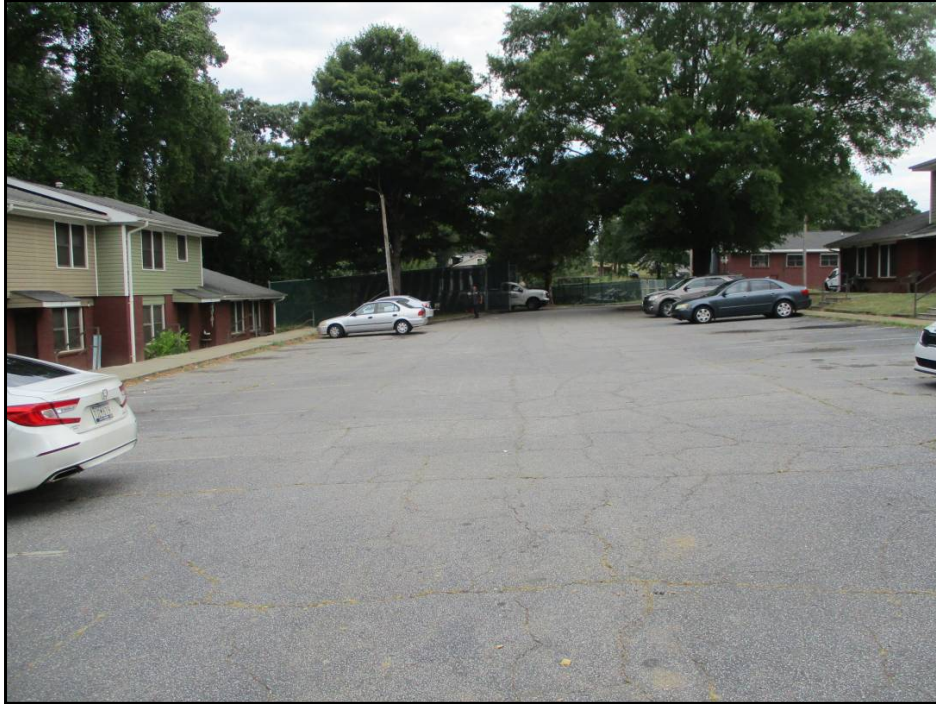
3: Parking Area

The drive lane and parking area surfaces were observed to be in fair physical condition; however, they are nearing the end of their EUL and their refurbishment has been recommended (Non-Critical Repairs). Additionally, the re-striping of the asphalt pavement has also been recommended within the Non-Critical Repairs. In addition, the property features concrete sidewalks and steps at select locations throughout the site. The sidewalk and steps concrete surfaces were observed in fair physical condition; however, they are beyond their EUL and their refurbishment has been recommended (Non-Critical Repairs).

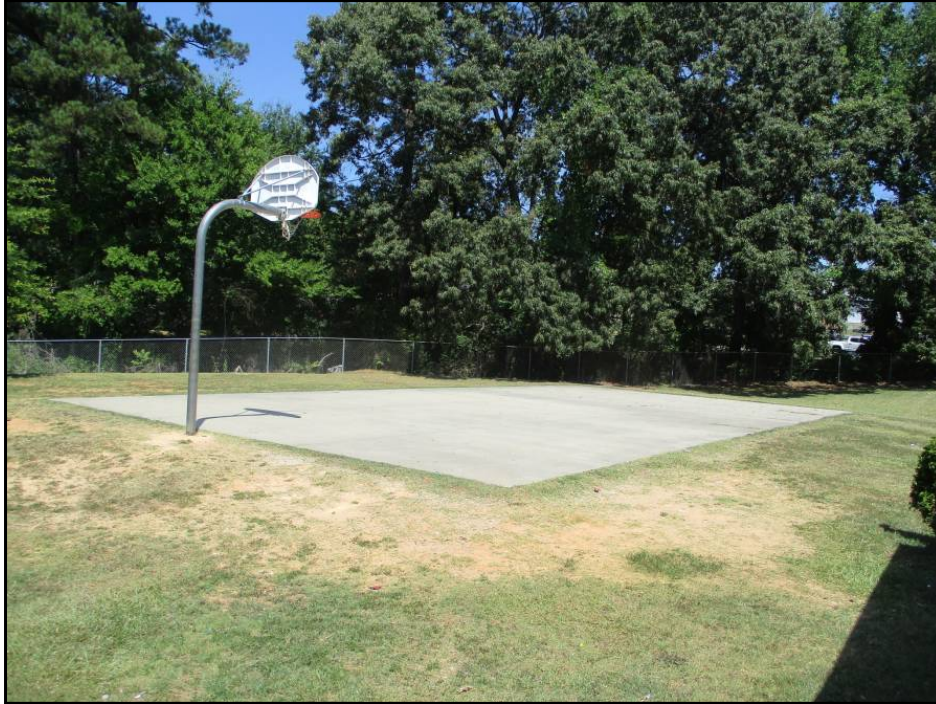
The property features a concrete basketball court. The basketball court and equipment were reportedly installed in 2020 and observed to be in good physical condition.

9: Basketball Court

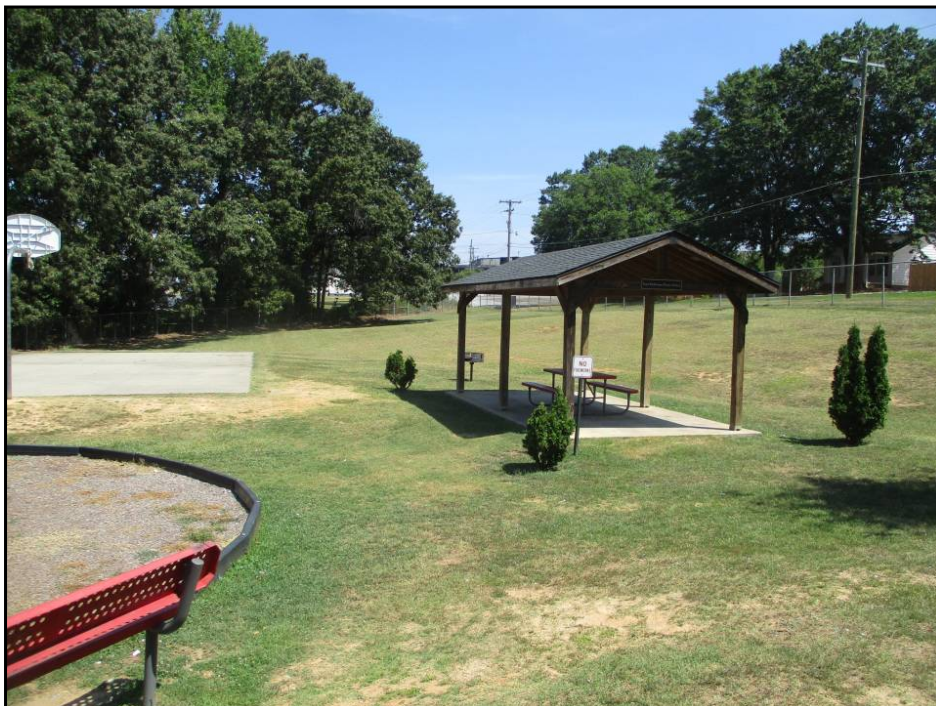
10: Wooden Gazebo

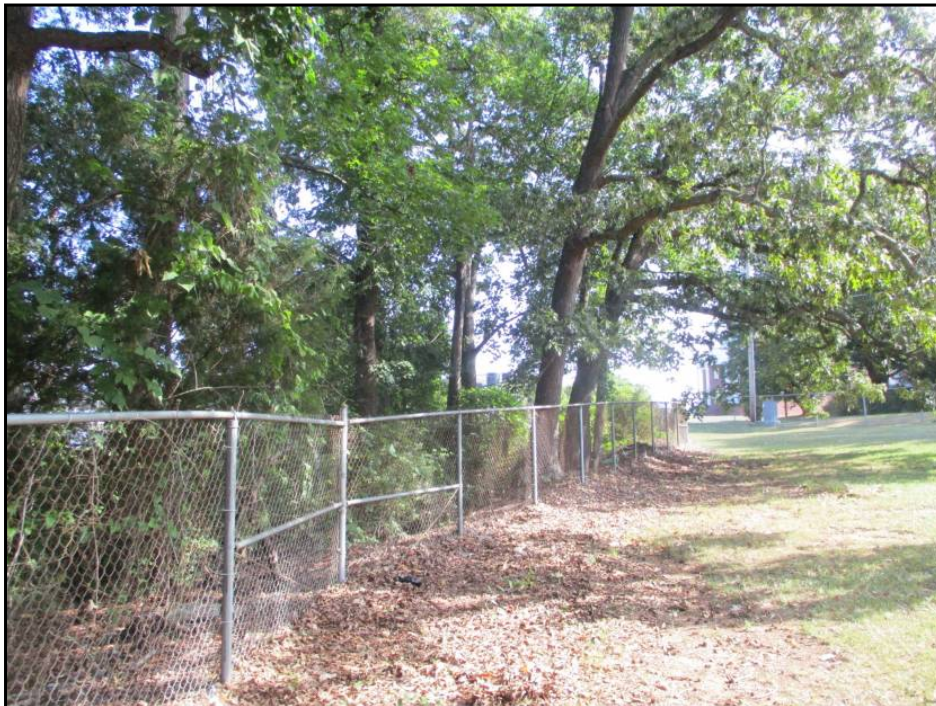
12: Chain Link Fencing
