**PHASE I ENVIRONMENTAL SITE ASSESSMENT  
NORTHGATE MANOR  
220 BIBLEBROOK DRIVE  
CITY OF GREER, SPARTANBURG COUNTY, SOUTH CAROLINA  
29651**

**D3G PROJECT NUMBER:**  
**2024-001708**

**REPORT ISSUE DATE:**  
**OCTOBER 17, 2024**

**PREPARED FOR:**  
**GREENVILLE HOUSING FUND  
1615-A WADE HAMPTON BOULEVARD  
GREENVILLE, SOUTH CAROLINA 29609**

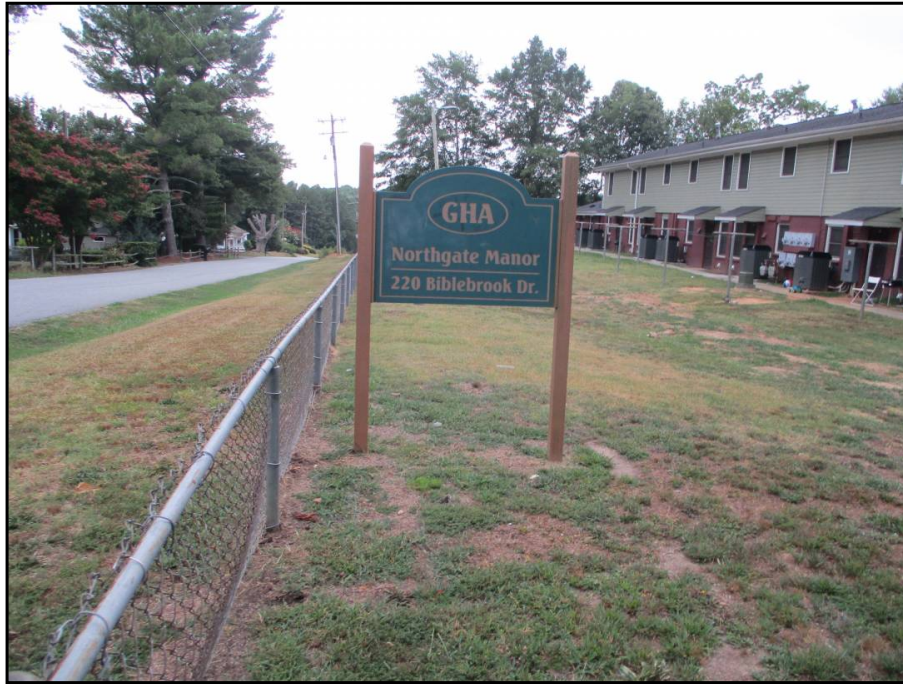
1: View of the subject property signage

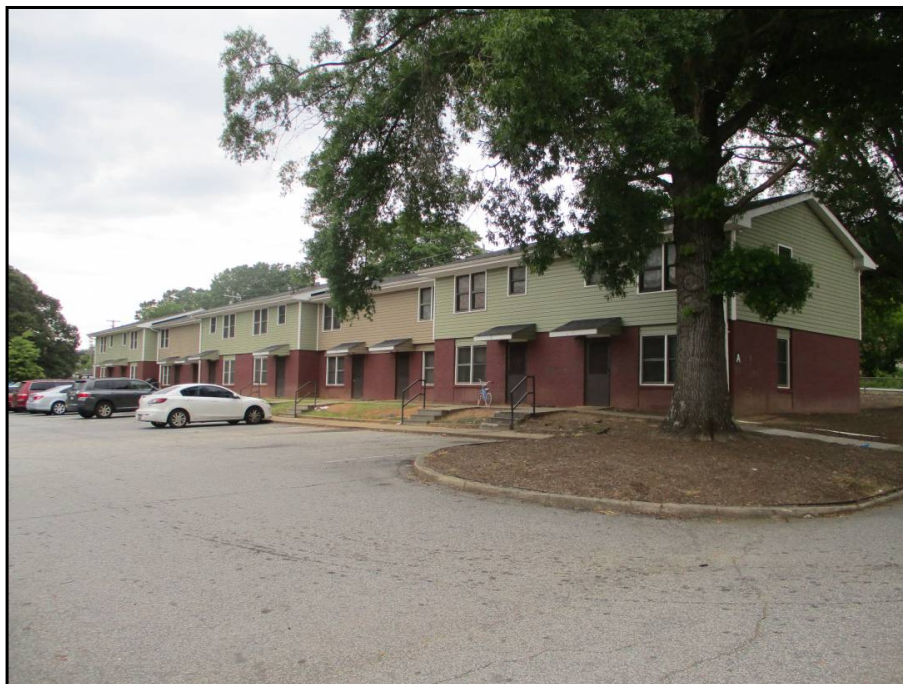
2: View of the subject property

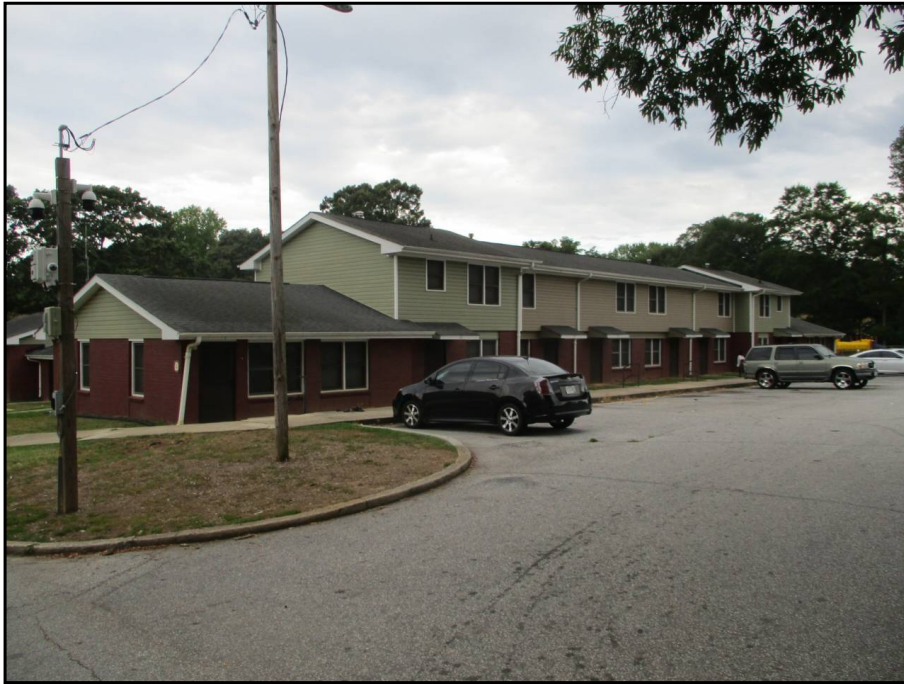
3: View of the subject property

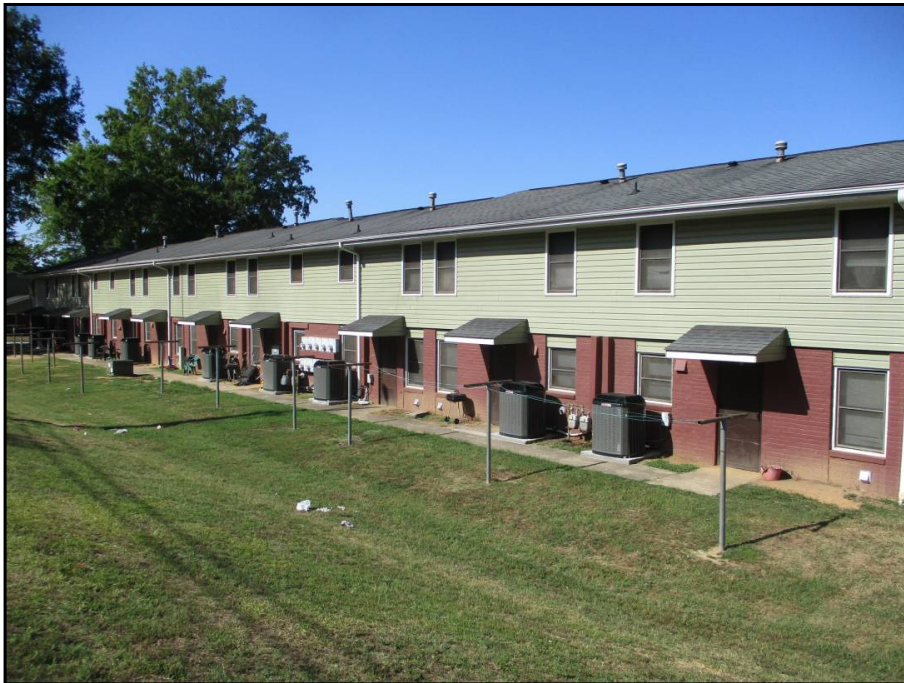
4: View of the subject property

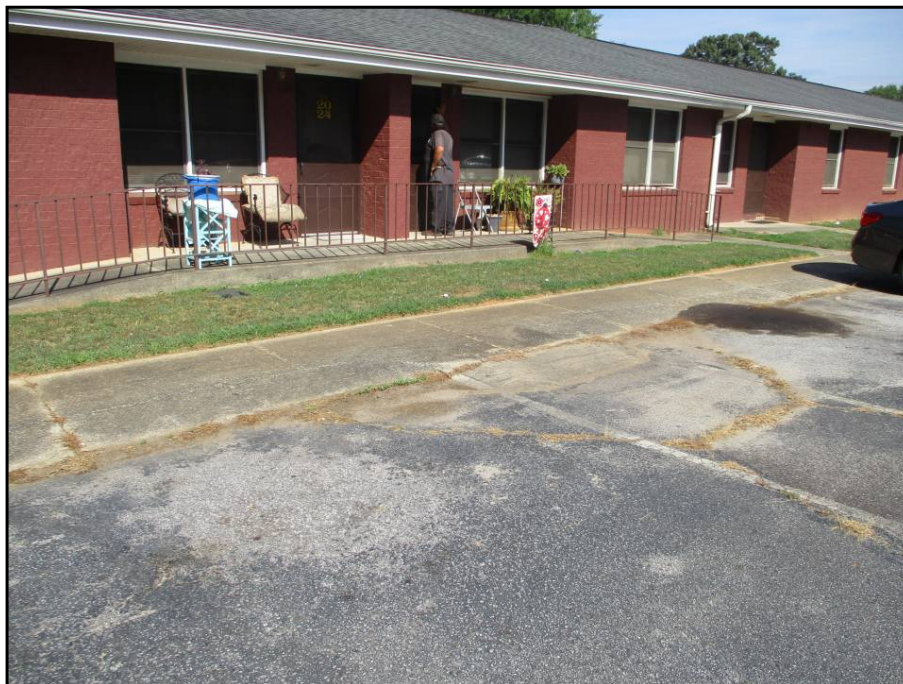
5: View of the subject property

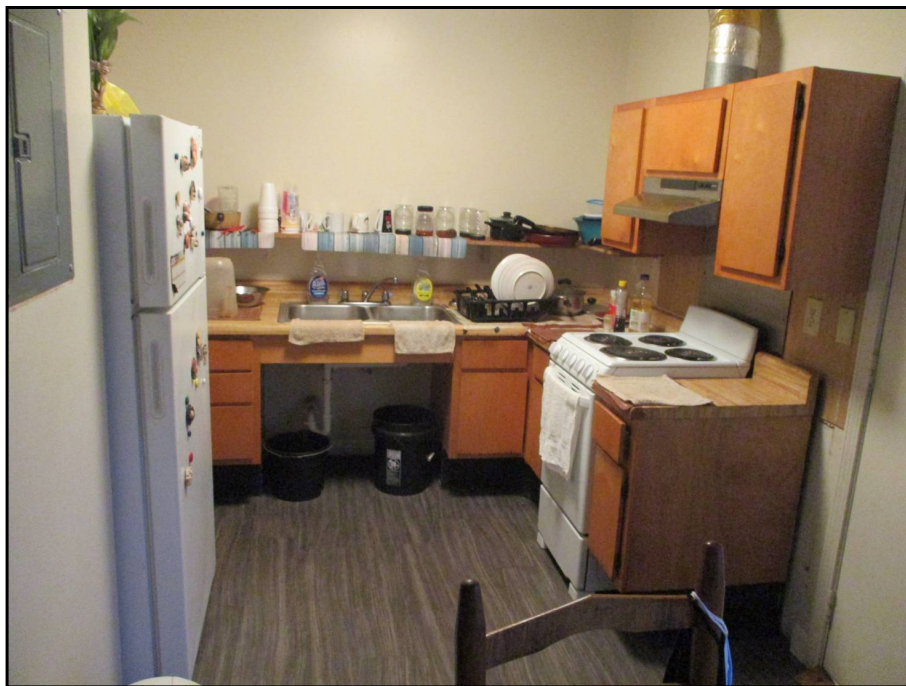
8: View of the typical residential unit kitchen

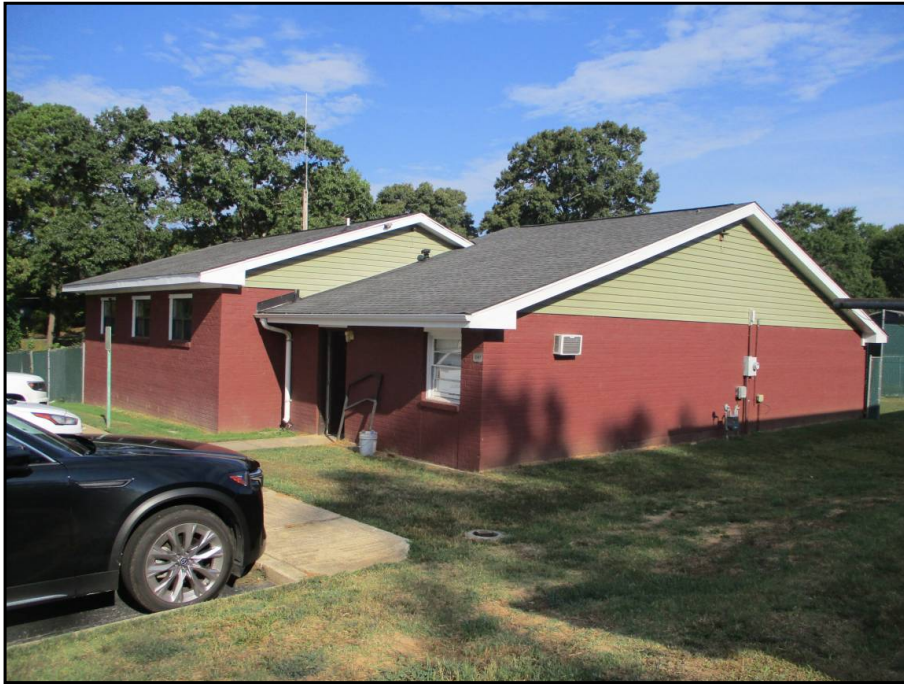
11: View of the maintenance garage

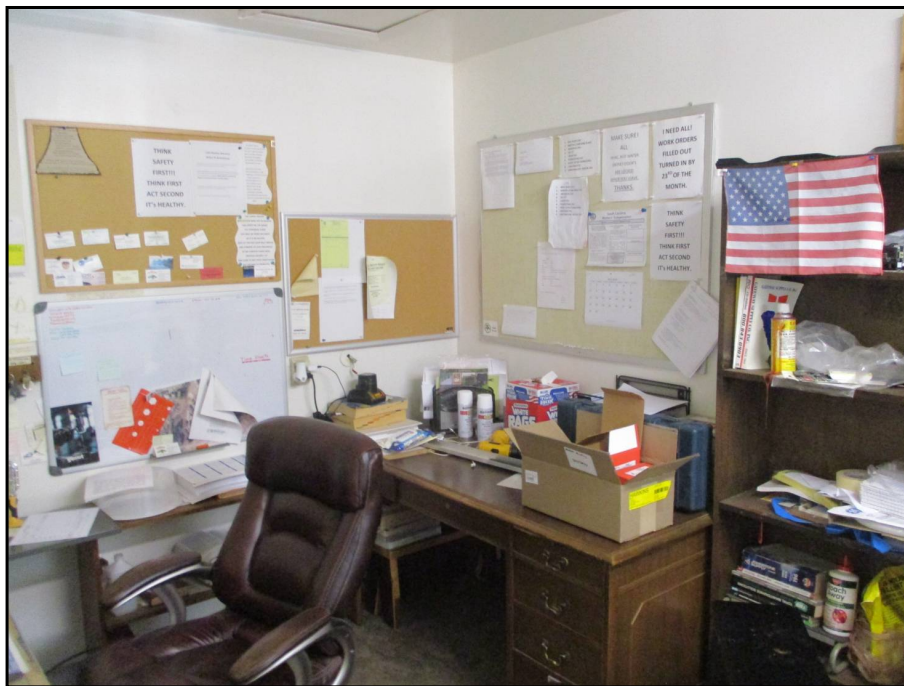
12: View of the maintenance office

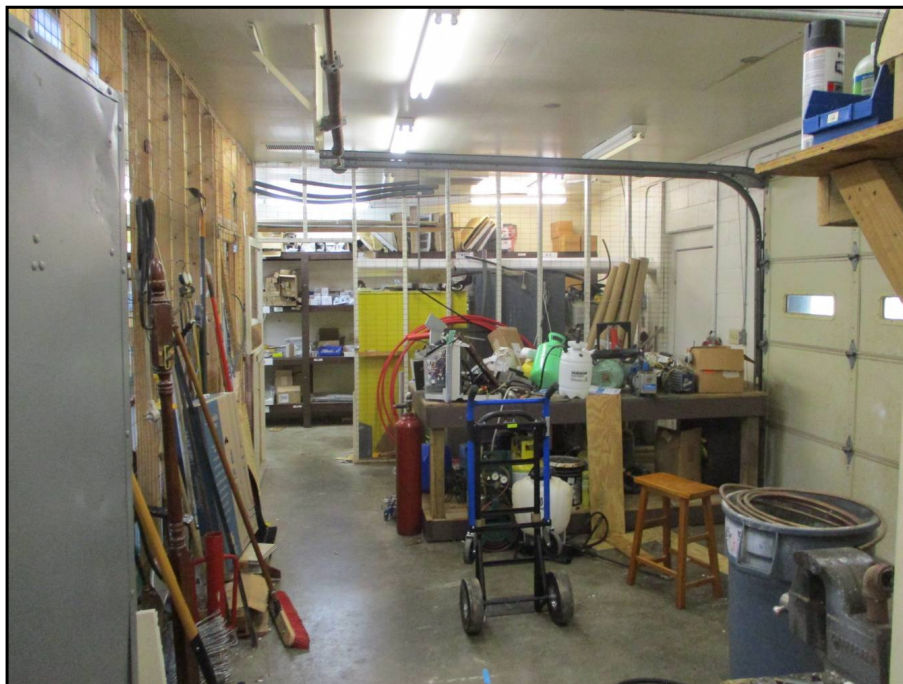
13: View of the maintenance garage

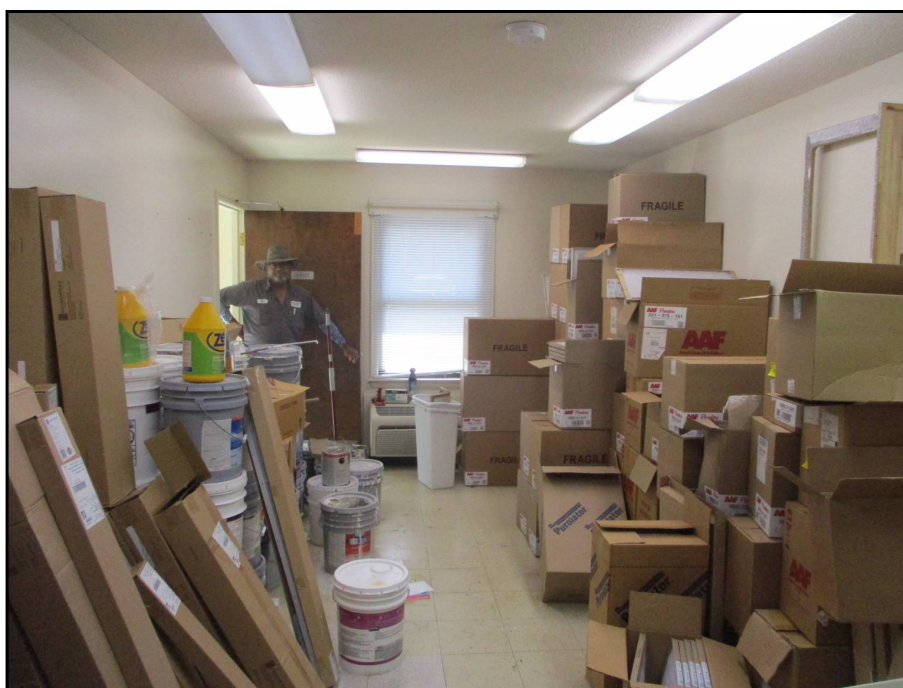
14: View of a typical maintenance storage area

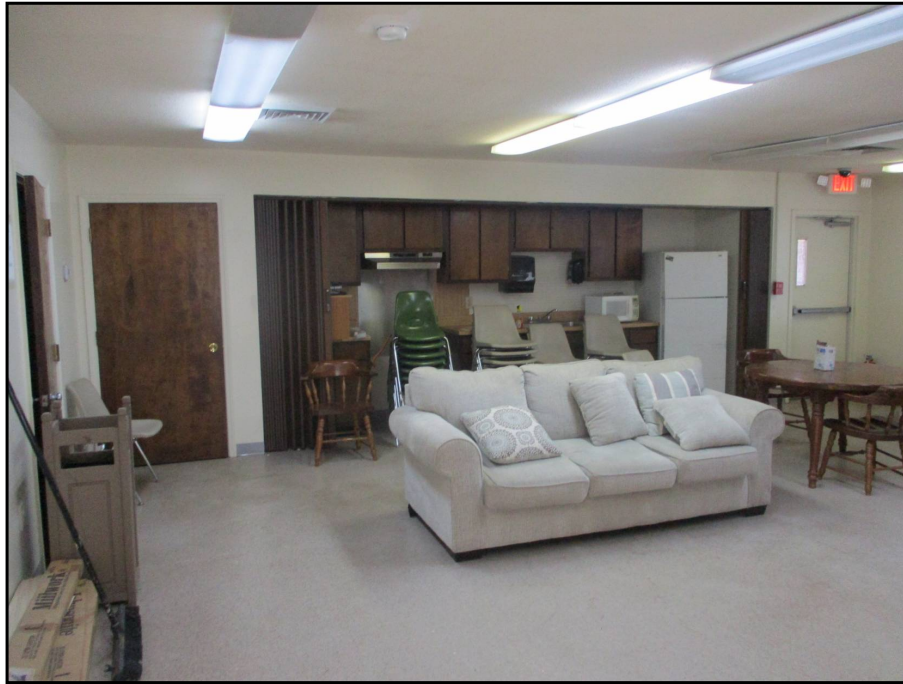
15: View of a typical office area

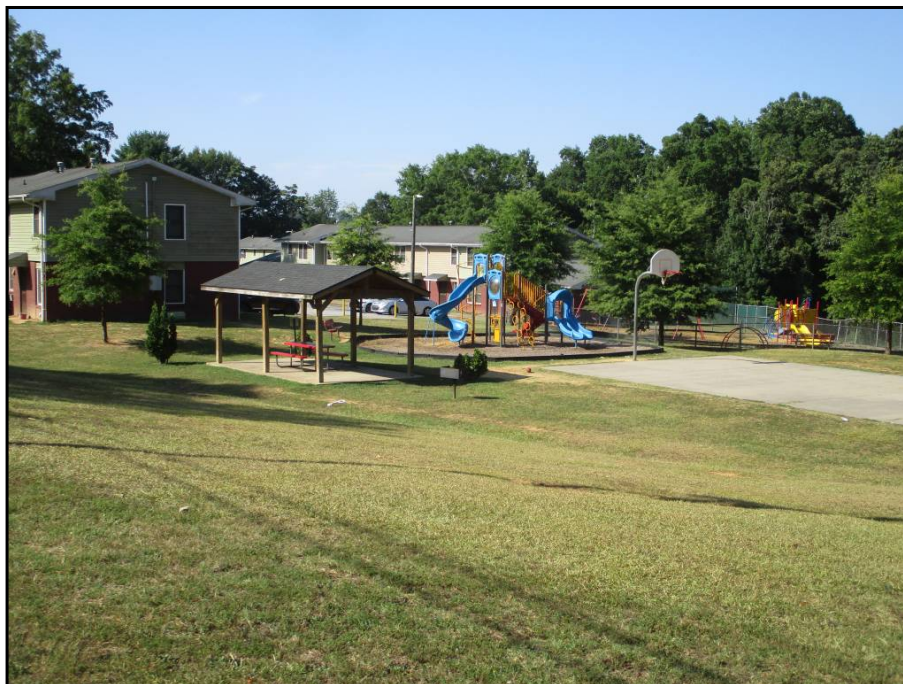
16: View of the playgrounds, basketball court, and picnic area

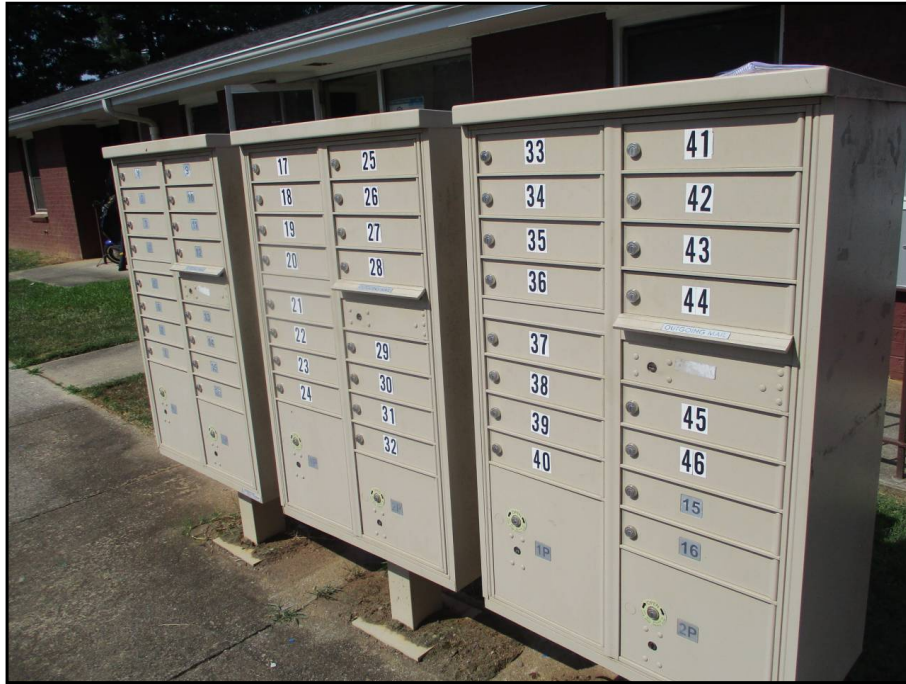
17: View of the typical mail kiosks

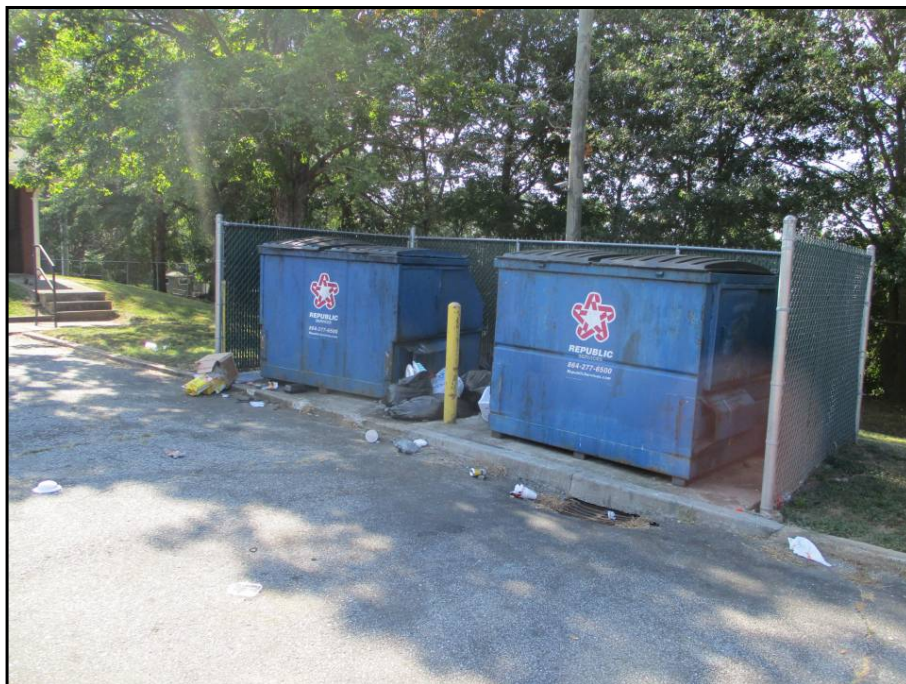
18: View of the typical solid waste dumpsters

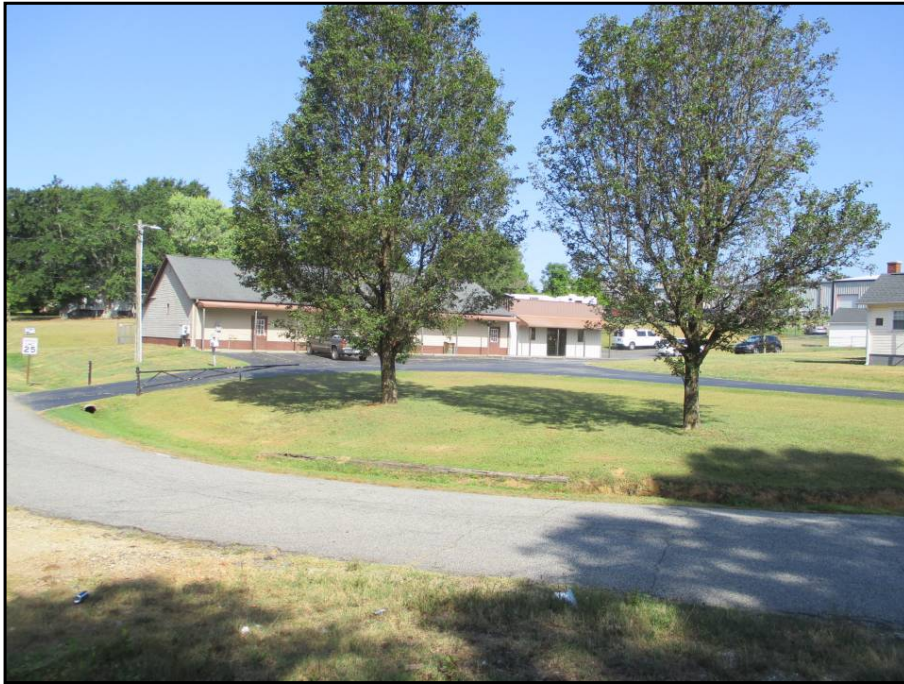
19: View of the northern adjacent Crawford's Saw & Tool, Inc.

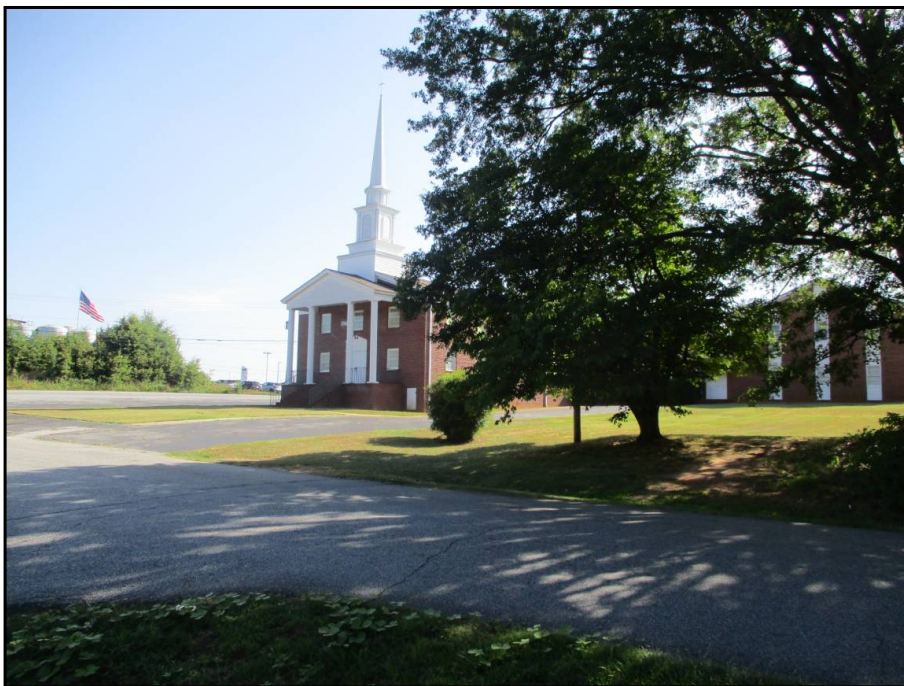
20: View of the northern adjacent Hillcrest Baptist Church

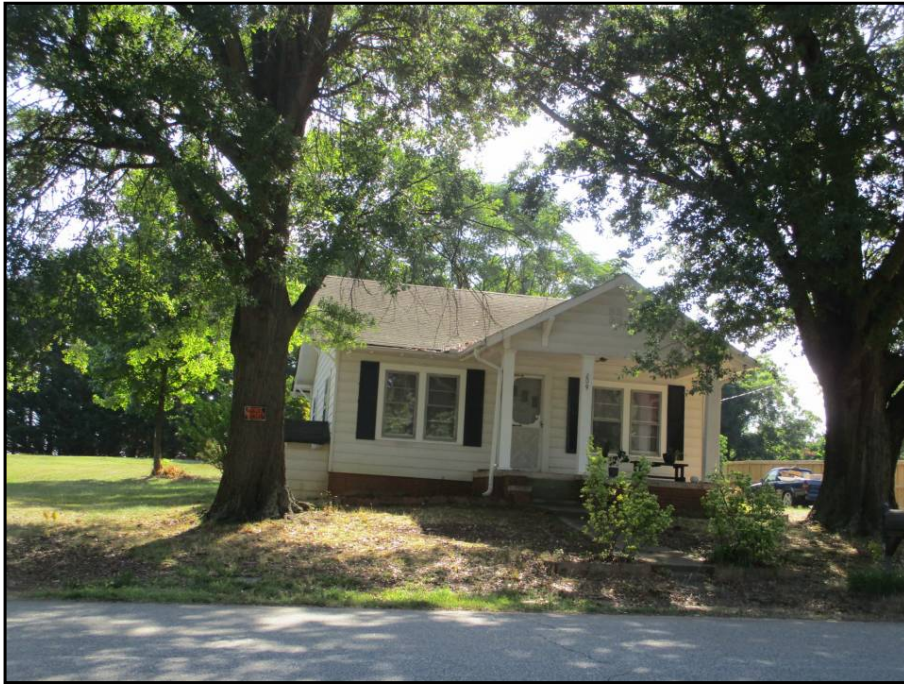
21: View of the typical eastern adjacent single-family residential

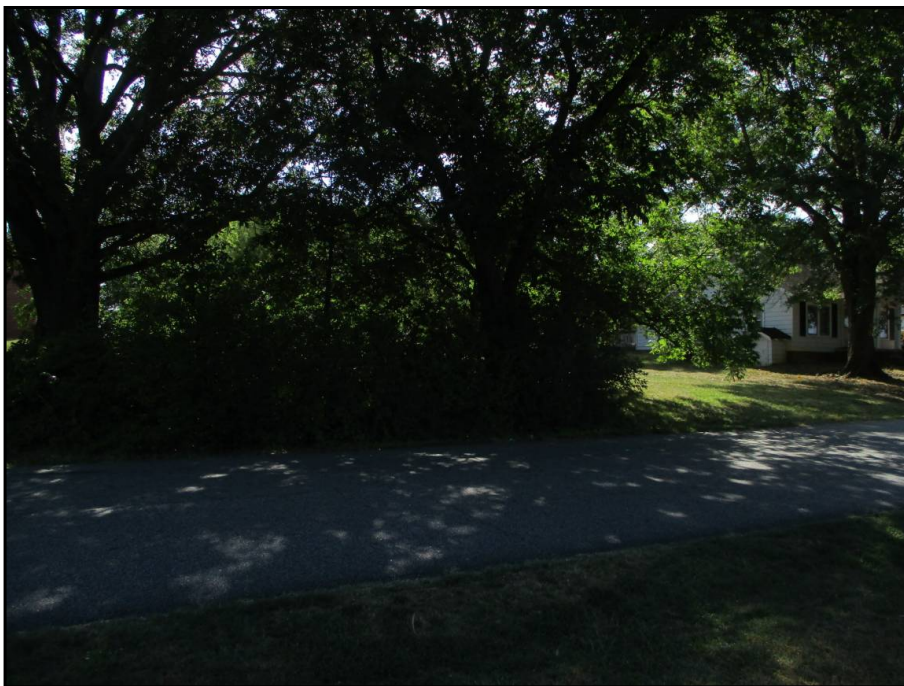
22: View of the eastern adjacent vacant land

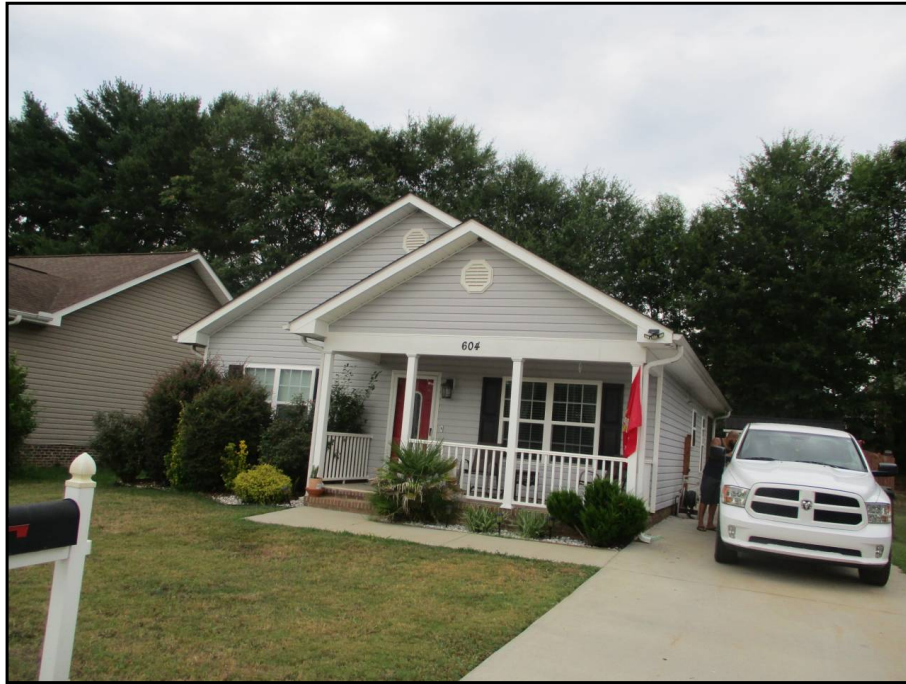
23: View of the typical southern adjacent single-family residential

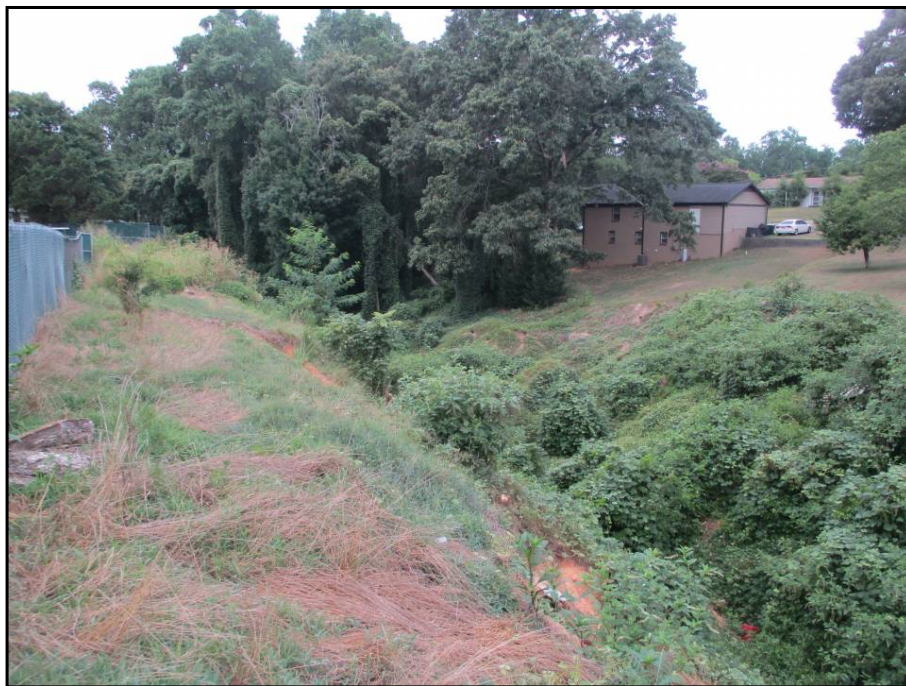
24: View of the western adjacent vacant land and typical single-family residential

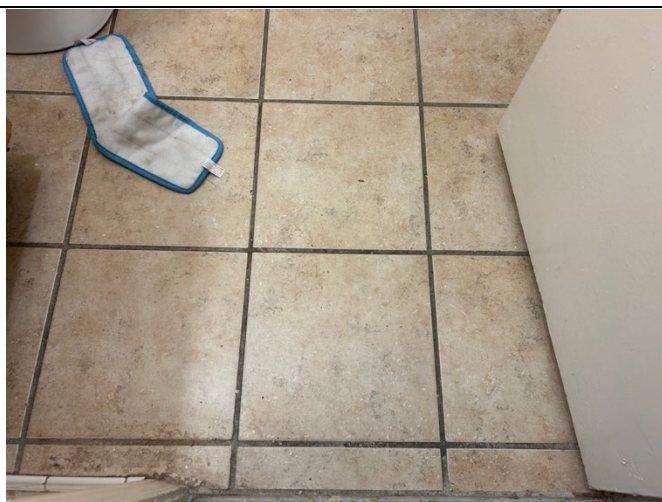
**BEIGE GROUT/MORTAR 12"X12" TILE**

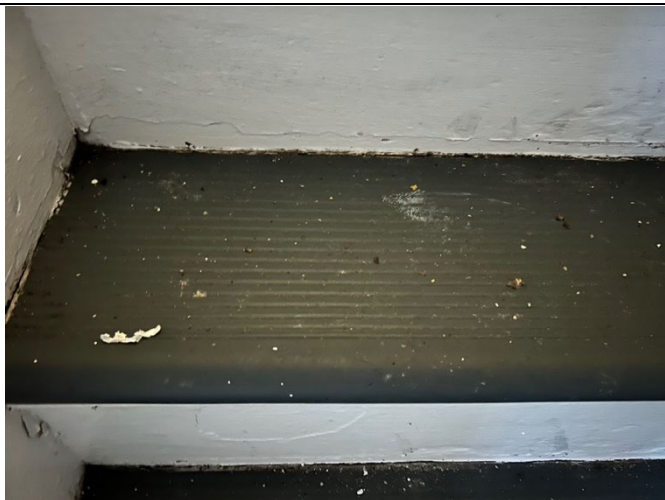
**BLACK VINYL FLOOR TREAD**

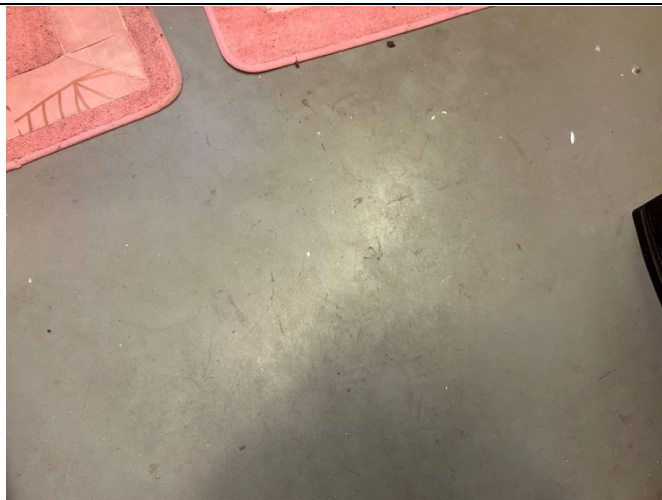
**GRAY VINYL SHEET FLOOR**

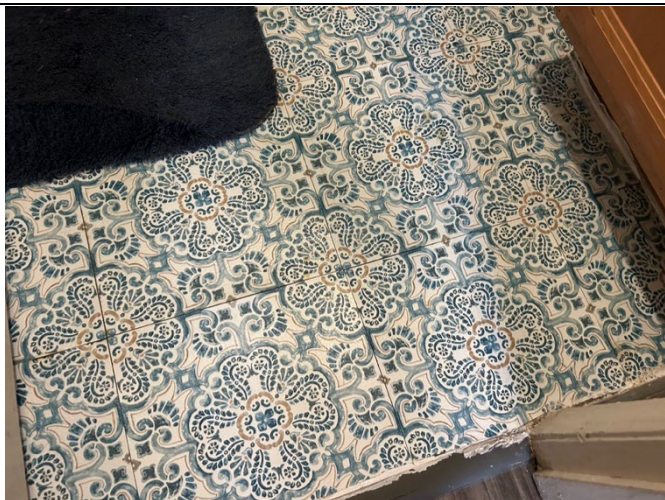
**BLUE/WHITE VINYL SHEET FLOOR**

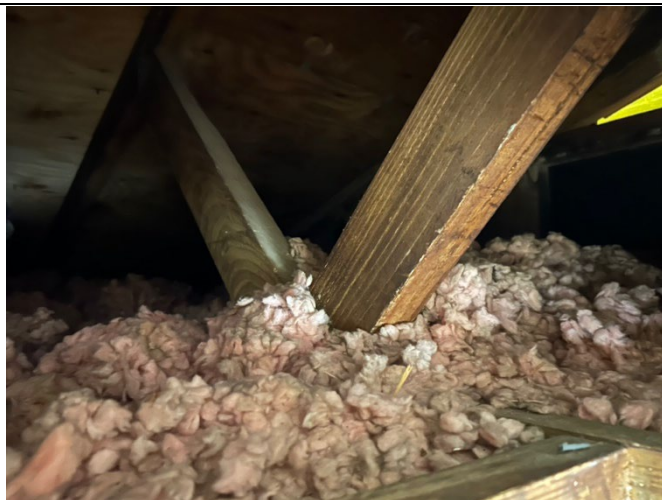
**FIBERGLASS ATTIC INSULATION**

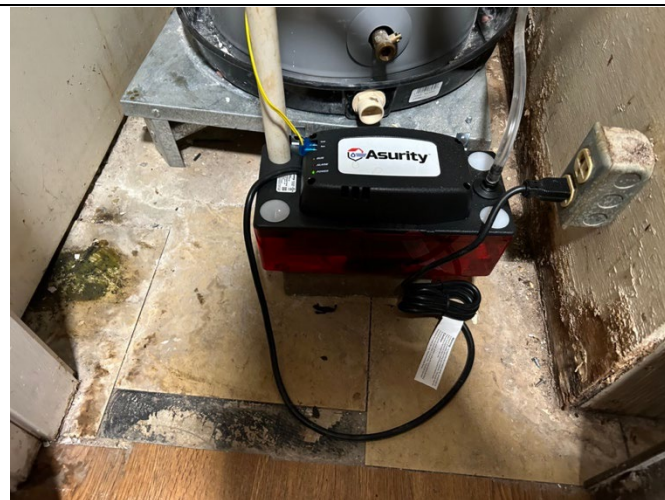
**12"X12" VINYL FLOOR TILE – UNIT 36**

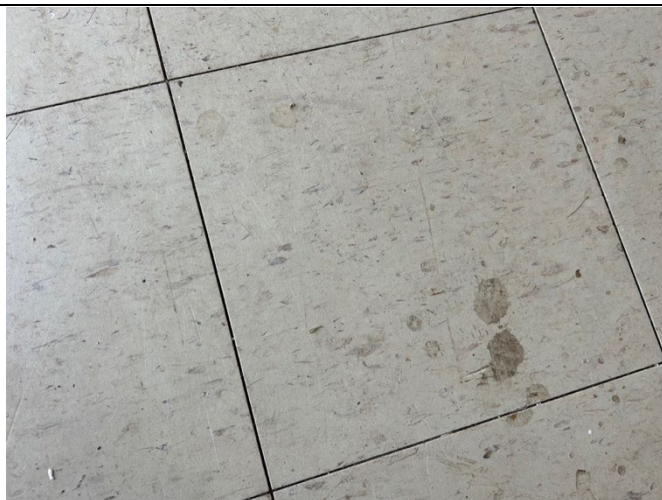
**GRAY 12"X12" VINYL FLOOR TILE- OFFICE**

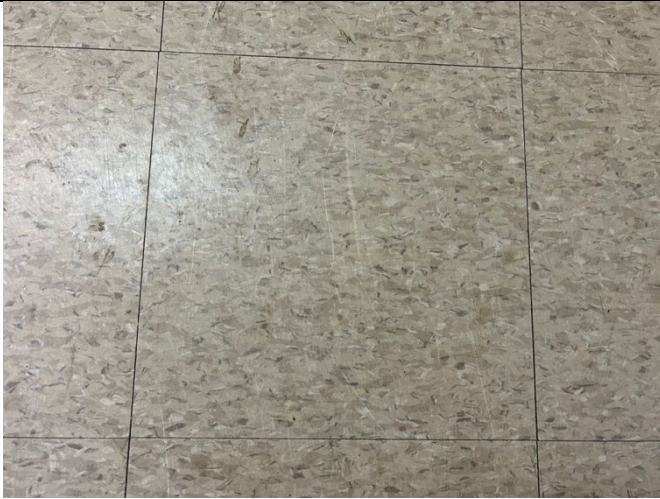
**BEIGE 12"X12" VINYL FLOOR TILE -  
OFFICE**

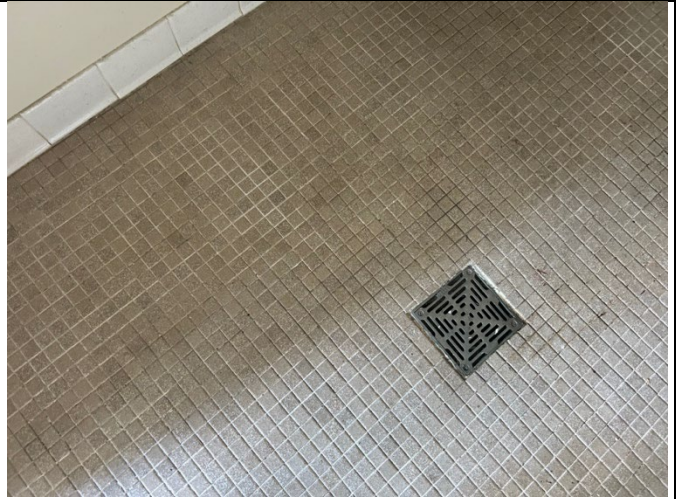
**GROUT/MORTAR 1"X1" CERAMIC FLOOR  
TILE - OFFICE BATHROOMS**

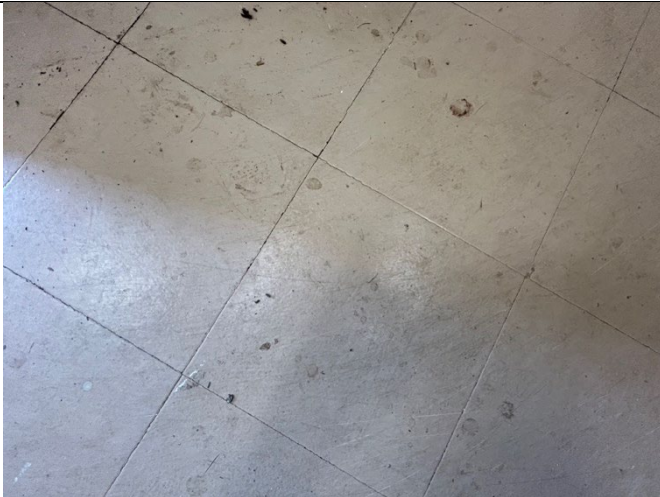
**BEIGE 12"X12" VINYL FLOOR TILE -  
MAINTENANCE BUILDING**

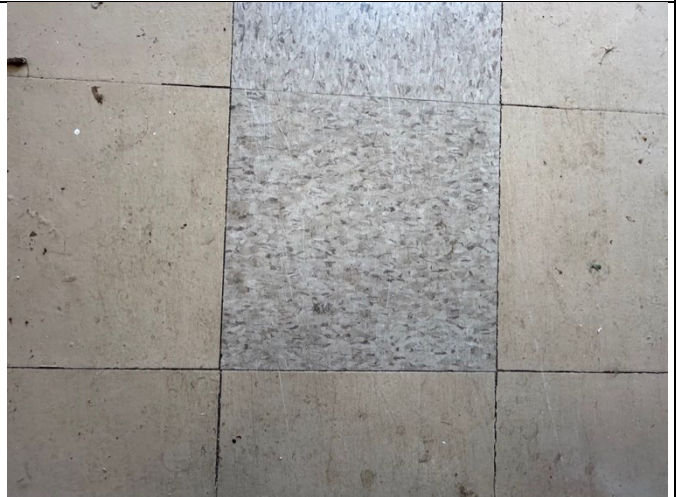
**BEIGE 12"X12" VINYL FLOOR TILE -  
MAINTENANCE BUILDING**

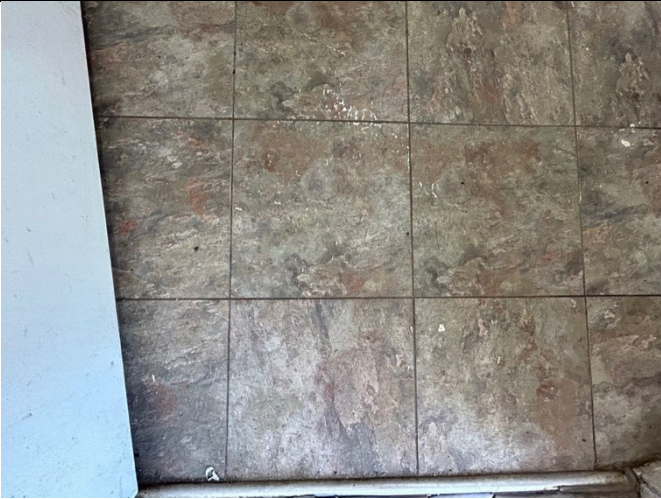
**GROUT/MORTAR 12"X12" RED CERAMIC  
FLOOR TILE – MAINTENANCE BUILDING**

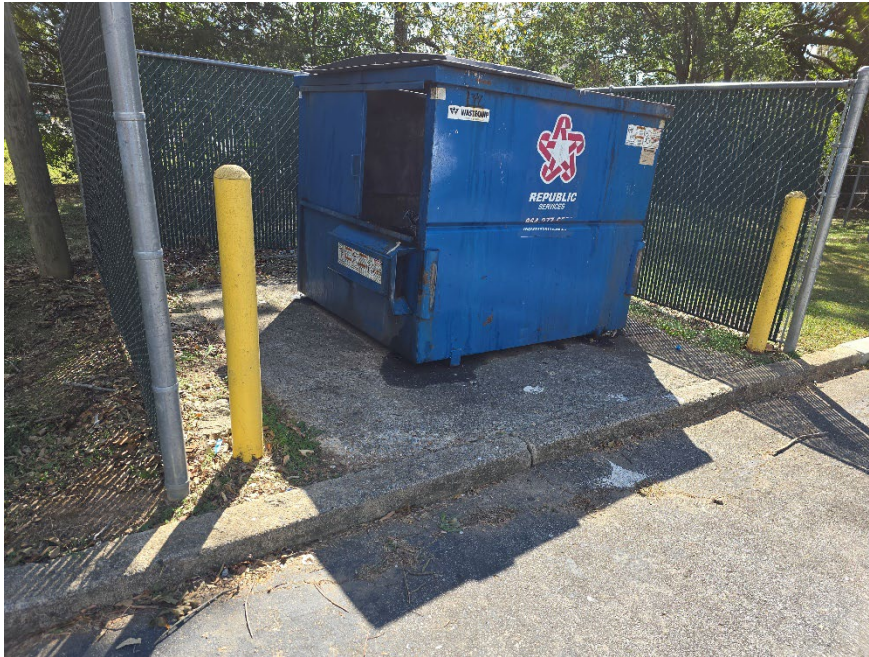
| Locations of Surfaces With Lead-Based Paint Hazards | | | | |
|---|---|---|--|---|
| Deteriorated Lead-Based Paint | Exterior | Metal Bollards Type 2 | Component Removal and Replacement or Paint Stabilization | |
| Deteriorated Lead-Based Paint | Exterior | Concrete Bollards Type 1 | Component Removal and Replacement or Paint Stabilization | |

15. LBP Hazards for  
Bollards at Dumpster  
in Bldgs C/D Parking  
Lot

One Source Environmental, LLC recommends paint stabilization or abatement and dust cleanup, followed by clearance testing, and ongoing monitoring and maintenance of components identified as containing lead-based paint. This will assist the Owner in preventing future
