PROPERTY CONDITION ASSESSMENT

Palms on Ashley River

4370 Ladson Road
Summerville, South Carolina 29456

June 3, 2025

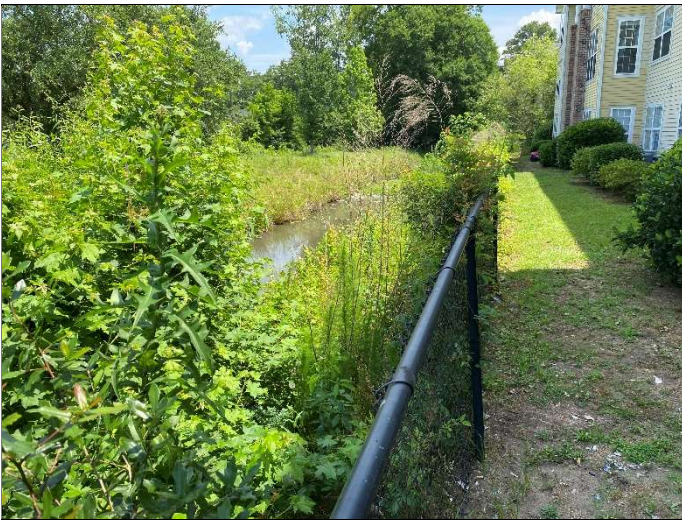
15. Retention pond; note quantity of rubbish

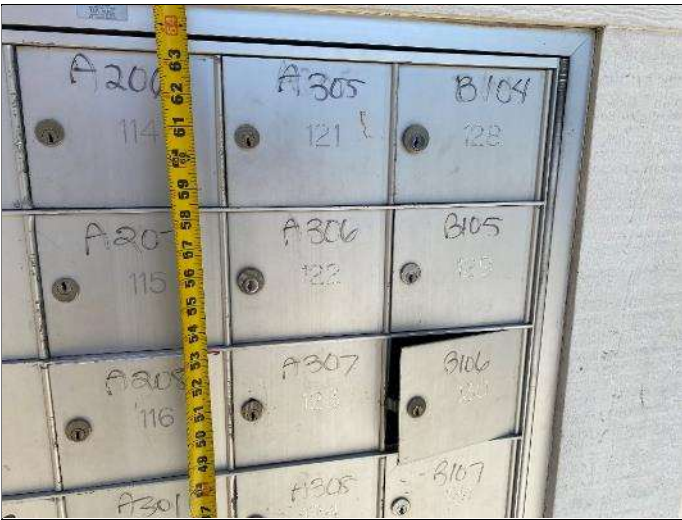
39. Detail view of mailboxes; note boxes outside of an accessible reach range

- Partner recommends property ownership/management prepare a Corrective Action Plan in order to adequately address the identified accessibility barrier issues. Additional analysis may be required by an architect/engineer in order to determine a proper course of action/correction, and/or to prepare an appropriate scope of work or related exhibits, drawings, diagrams or specifications.

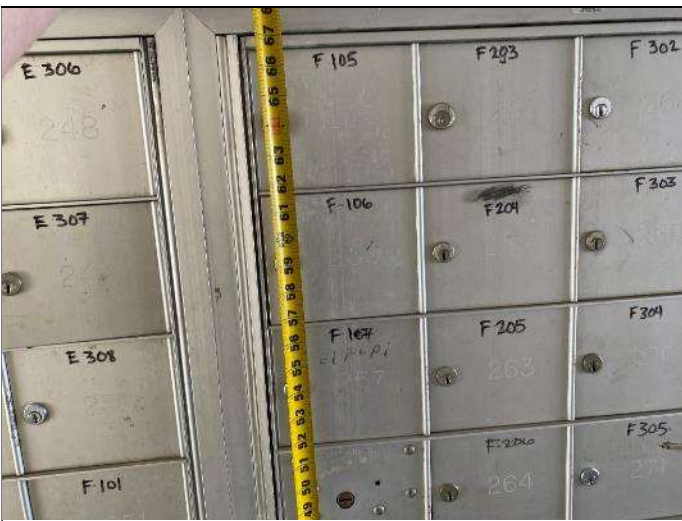
41. Detail view of mailboxes; note boxes outside of an accessible reach range

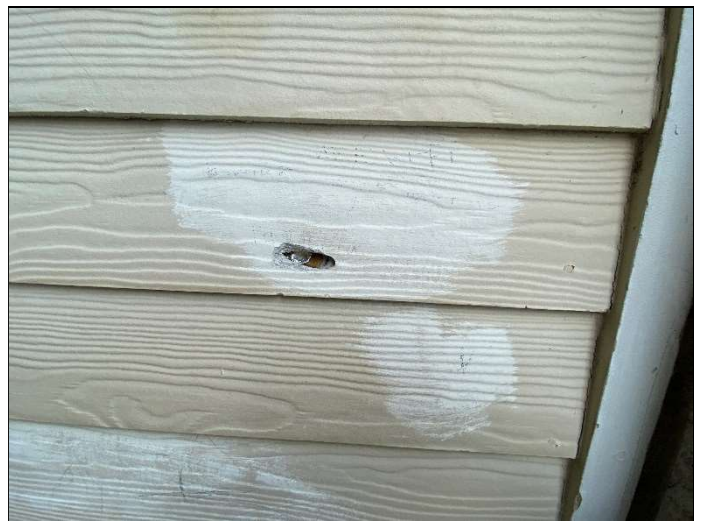
48. Siding with graffiti/mismatched paint finish

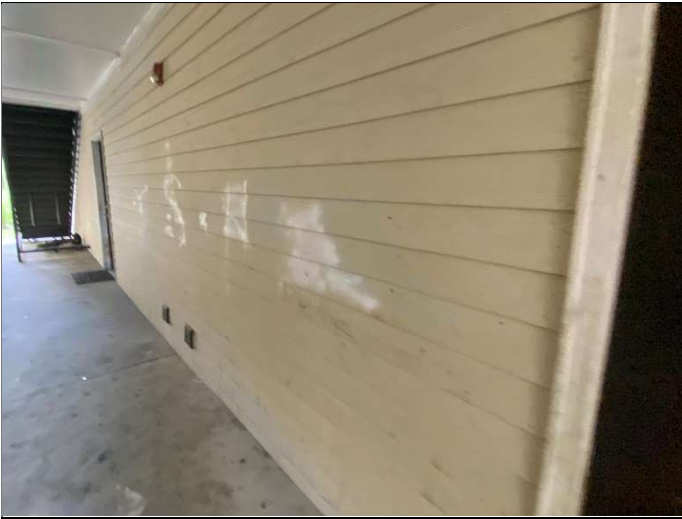
49. Siding with graffiti/mismatched paint finish

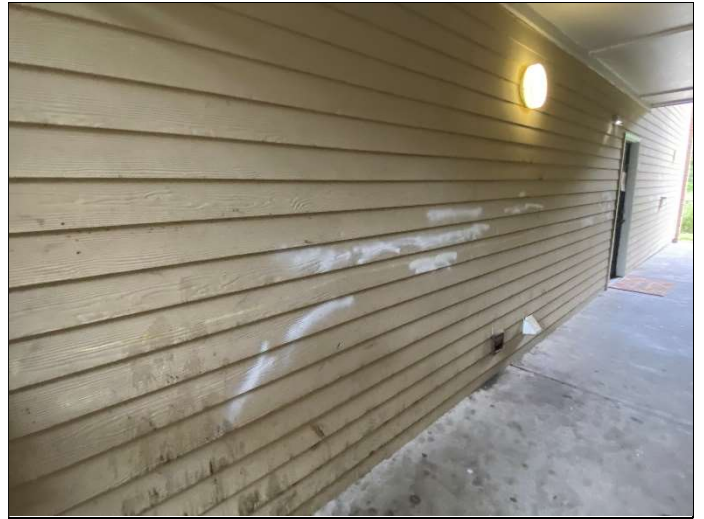
50. Siding with graffiti/mismatched paint finish

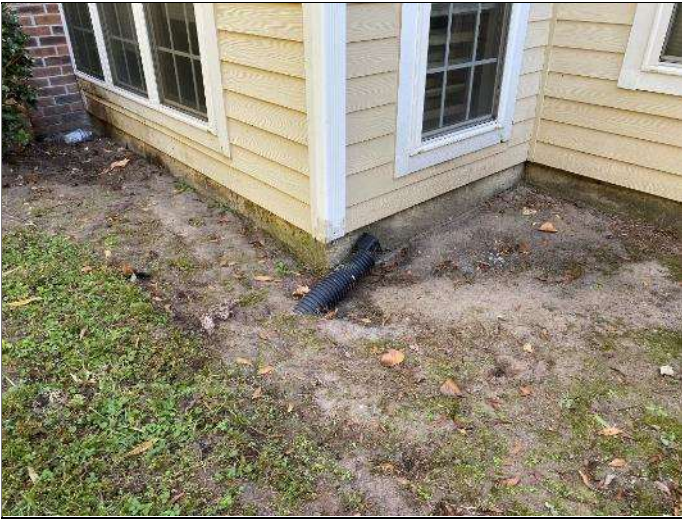
61. Building G downspout disconnected from discharge

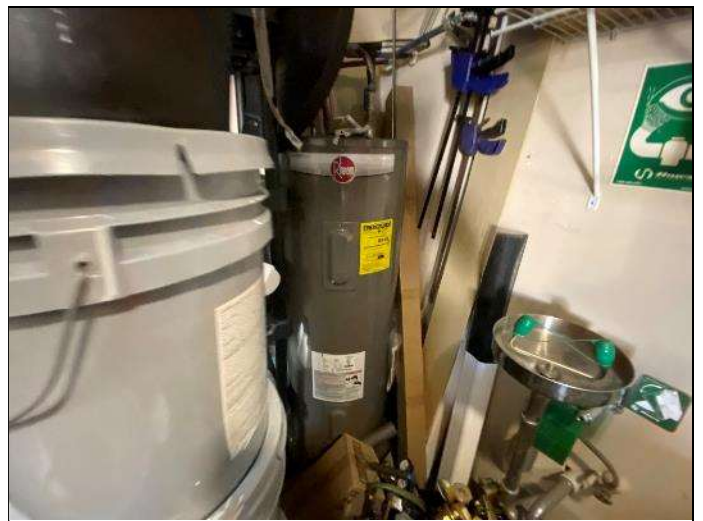
66. Clubhouse electric water heater

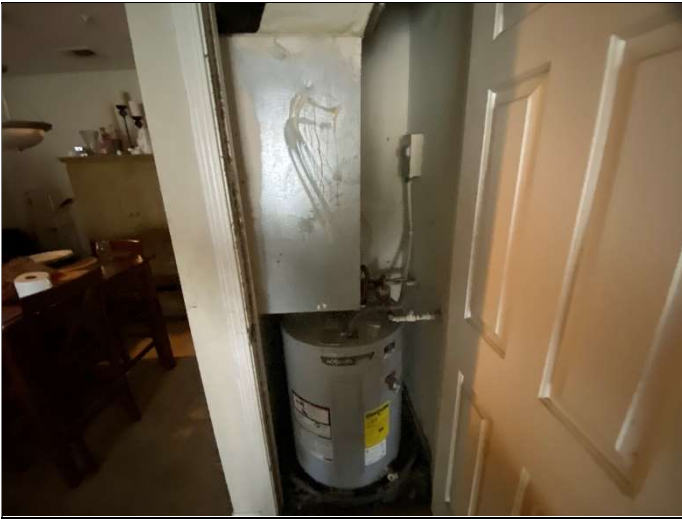
67. Dwelling electric water heater

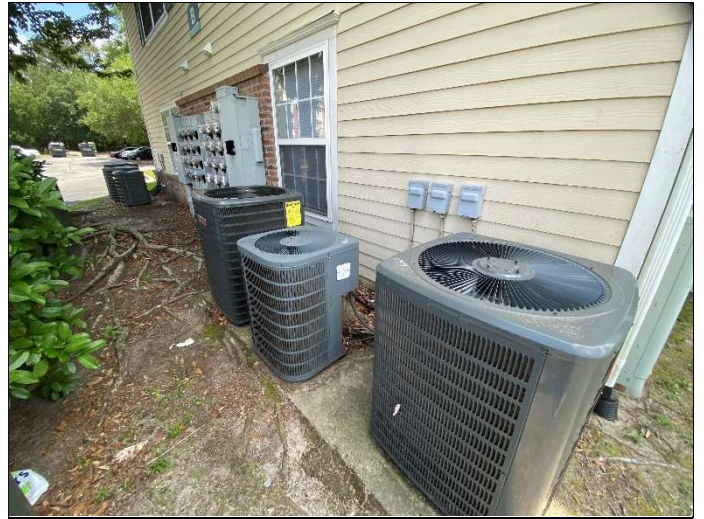
68. Heat pumps; note varied age

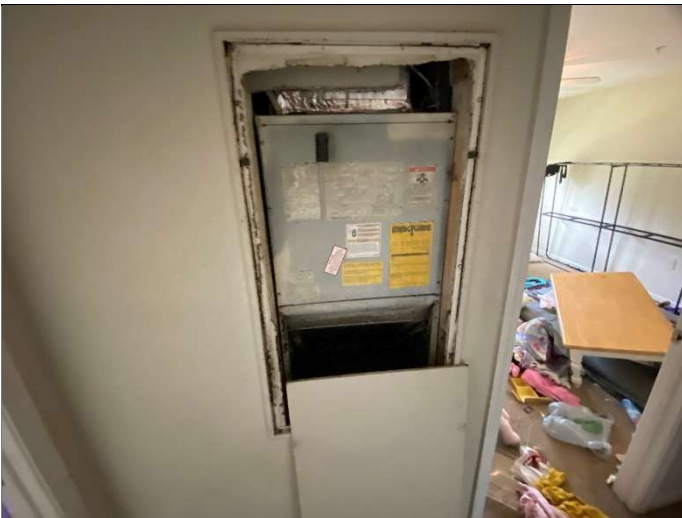
69. Air handler and electric furnace

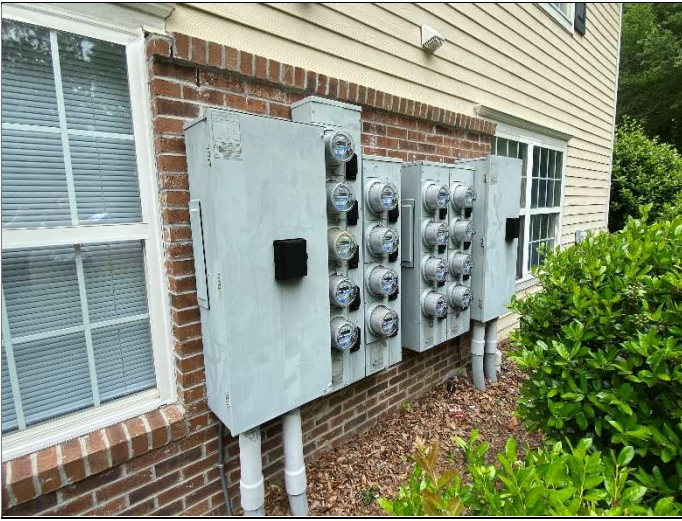
73. Electric distribution panels

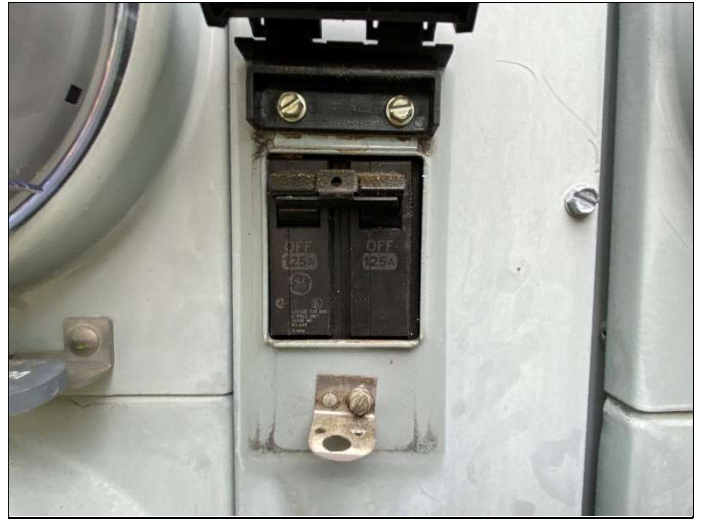
74. Dwelling service breaker

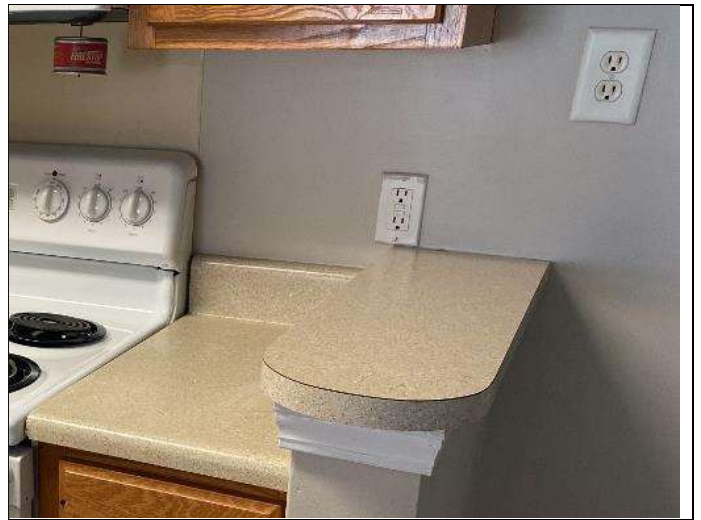
76. GFCI receptacle protection kitchen outlets

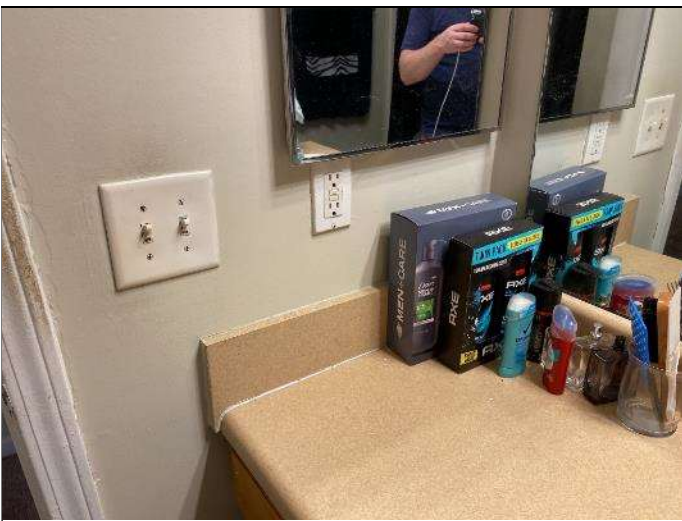
77. GFCI receptacle protection bathroom outlets

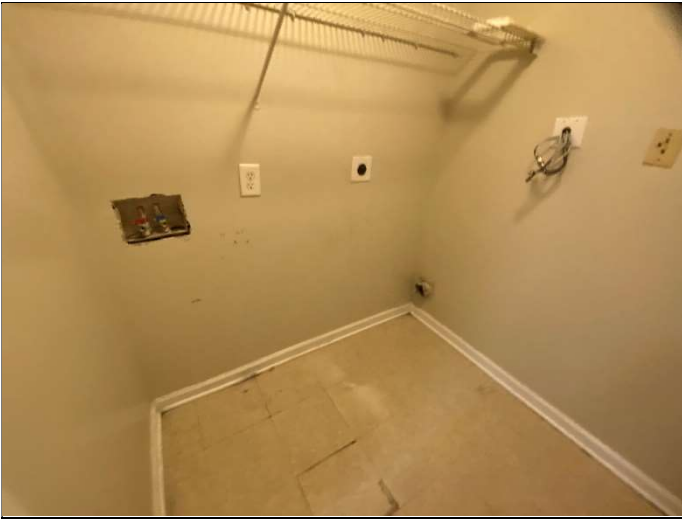
79. No GFCI protection at a laundry room washer outlet

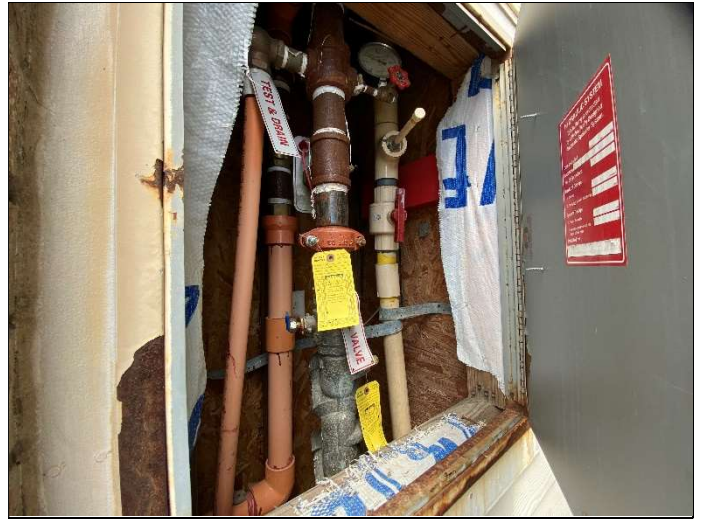
80. Wet-pipe fire sprinkler riser

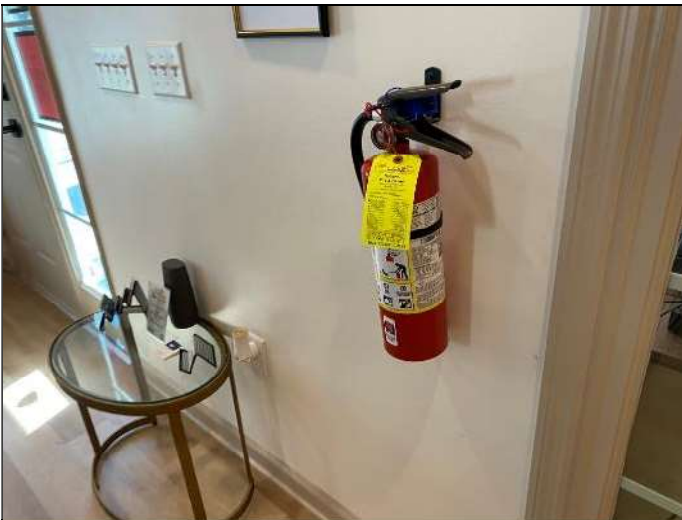
81. Fire extinguisher

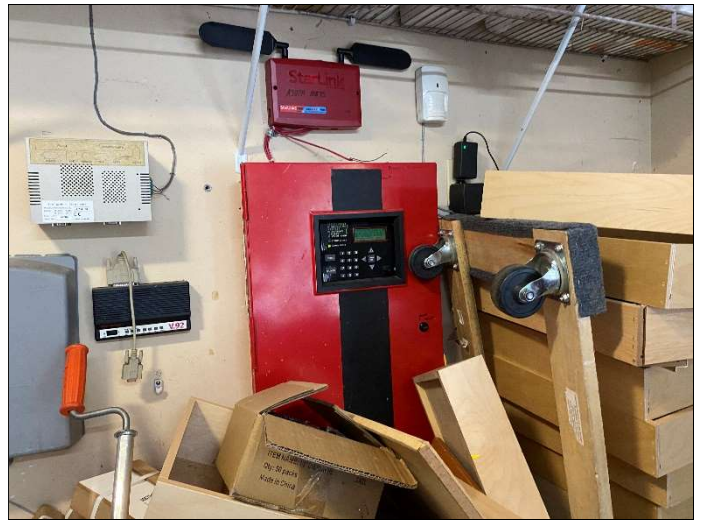
82. Central fire alarm panel in maintenance shop

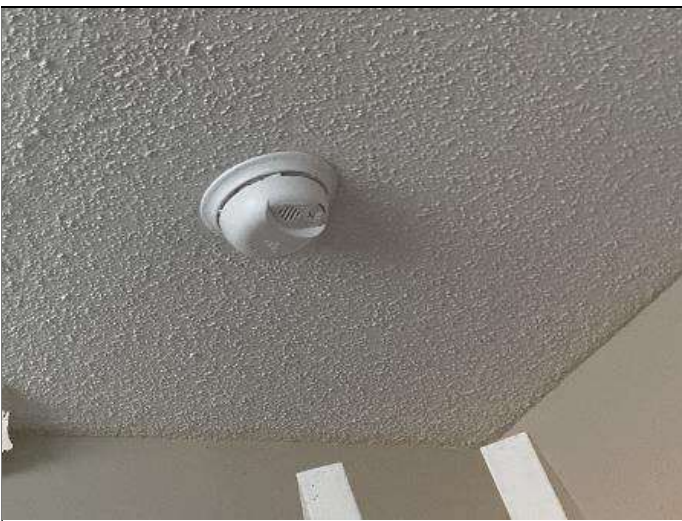
83. Hardwired smoke detector

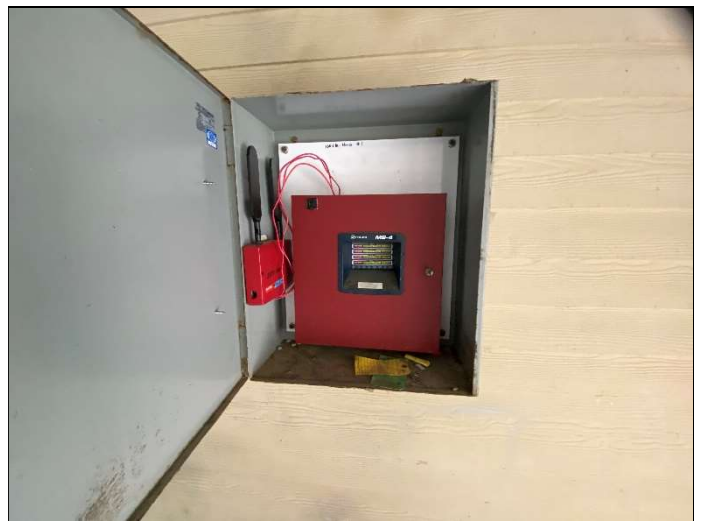
84. Central fire alarm panel in breezeway

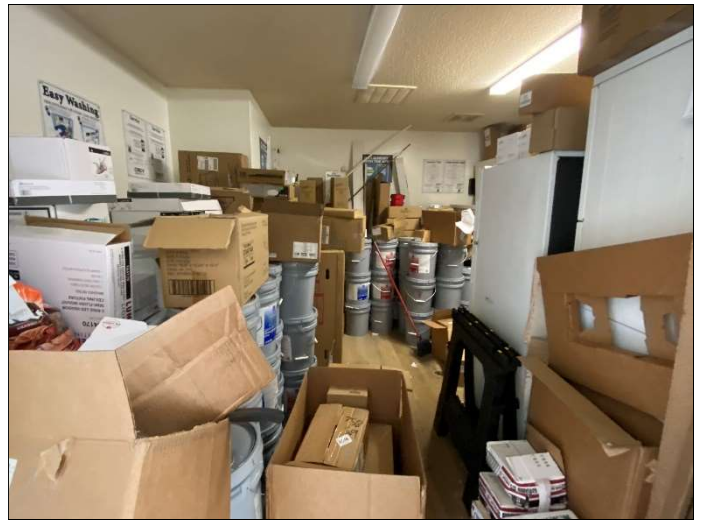
88. Laundry room; currently down and used as storage

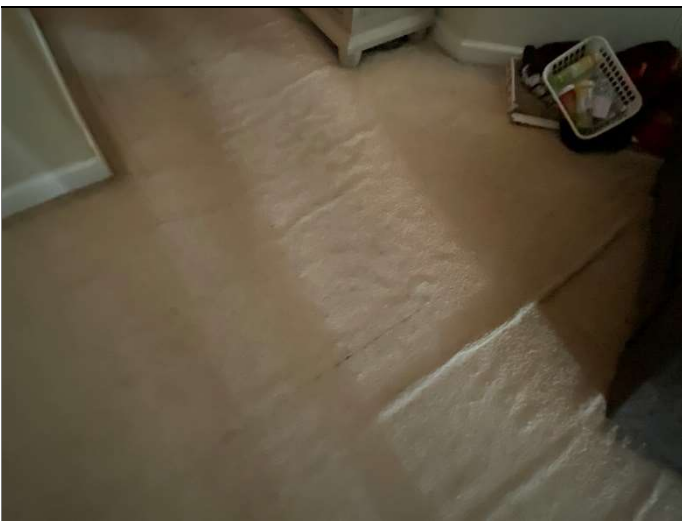
107. Blistering carpet

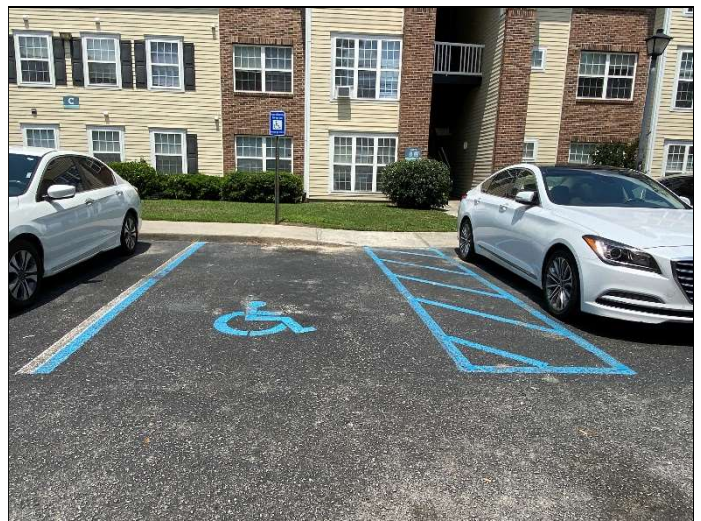
114. Several accessible stall access aisles less than 60" in width

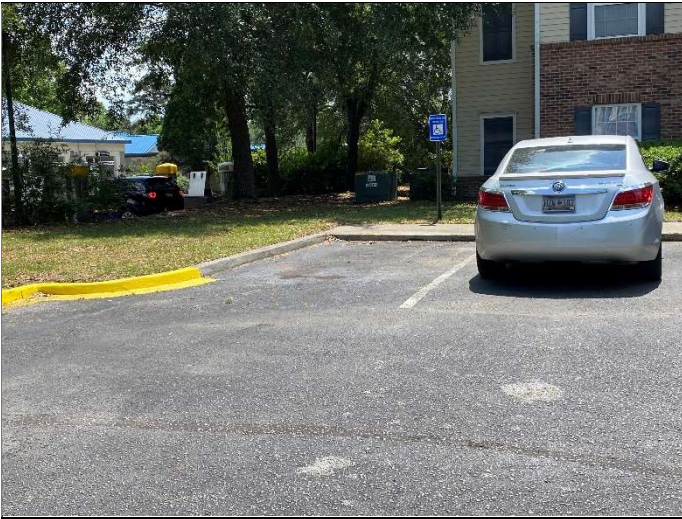
115. Accessible stall without an access aisle, ramp, nor signage

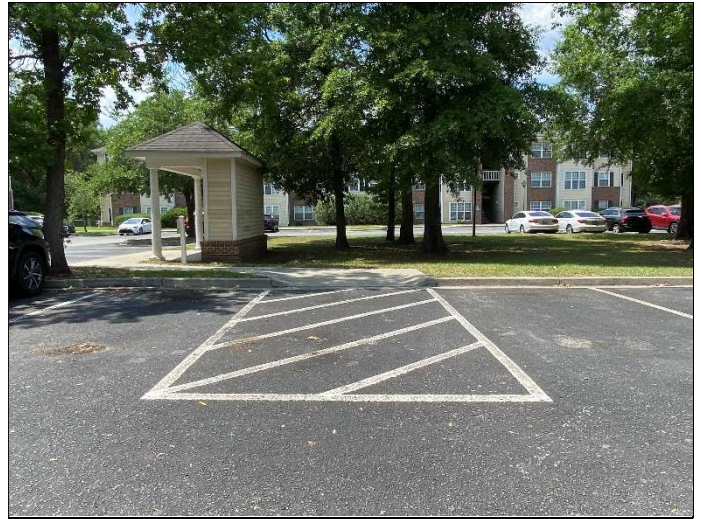
116. Accessible stall not provided near the Building A-C mail center

1.0	Requirement 1 – Accessible Building Entrance on an Accessible Route	Yes	No	N/A	Comments
1.1	Designated accessible parking spaces are provided in sufficient number		X		Some stalls have missing or non-compliant signage. Accessible parking not provided near the Building A-C mail center.

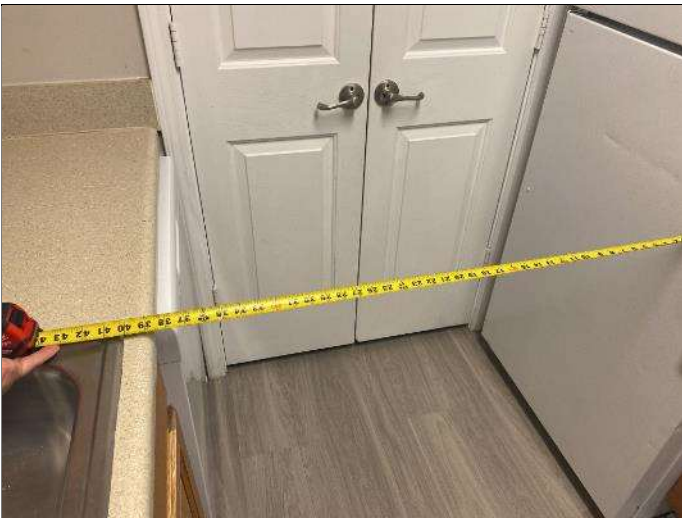
117. 2 BR kitchen galleys less than 40" between fridge and dishwasher

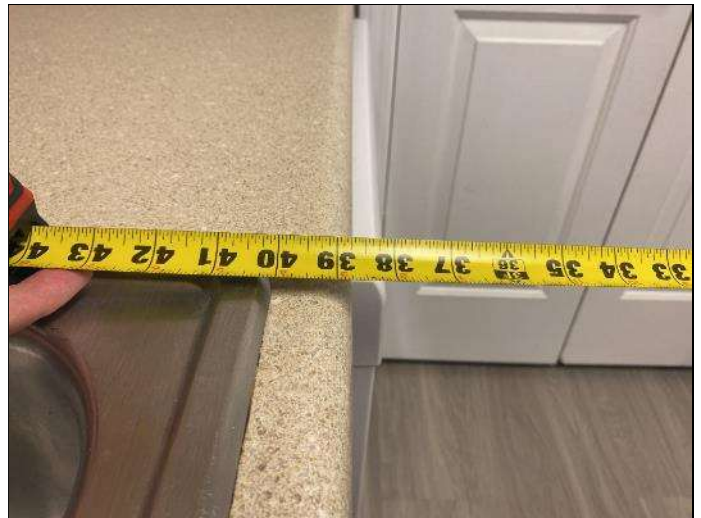
118. 2 BR kitchen galleys less than 40" between fridge and dishwasher

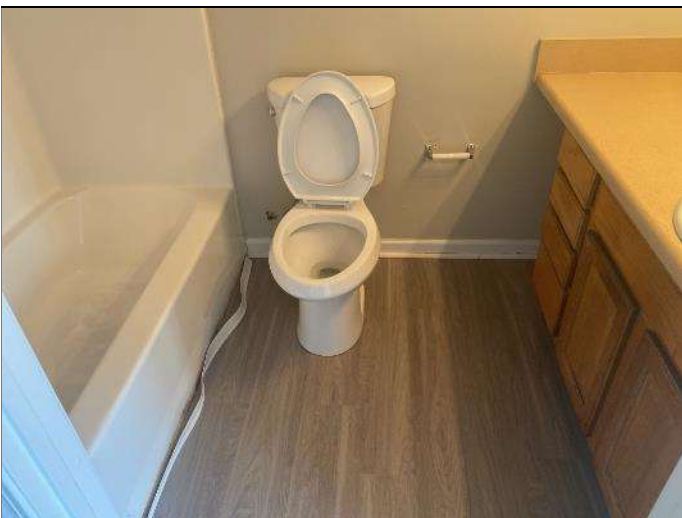
119. 3 BR master bathroom without a lavatory clear floor space

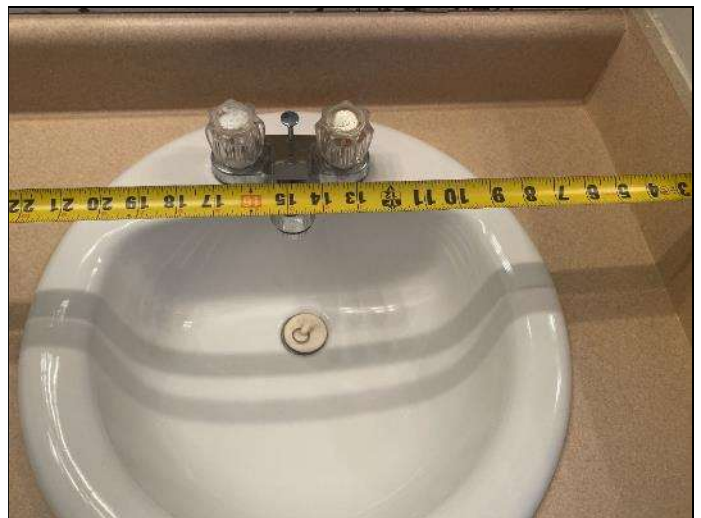
120. 3 BR master bathroom without a lavatory clear floor space

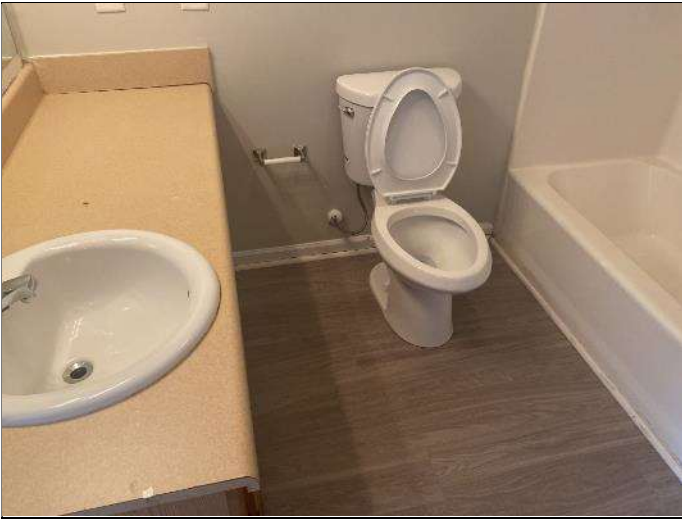
121. 3 BR hallway bathroom without a lavatory clear floor space

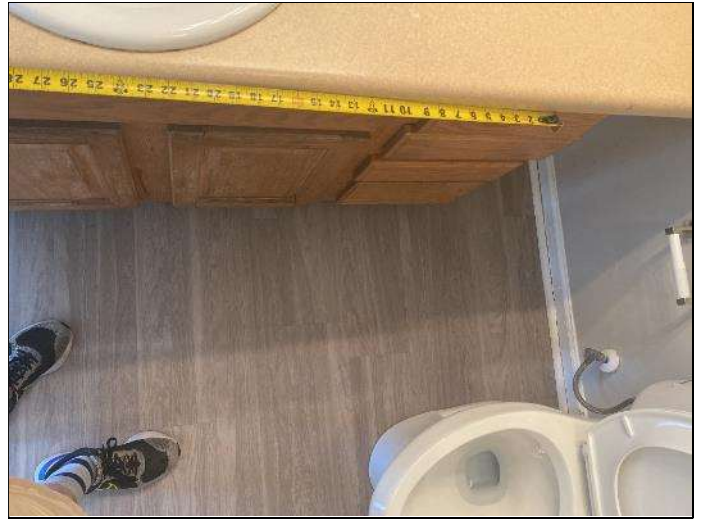
122. 3 BR hallway bathroom without a lavatory clear floor space

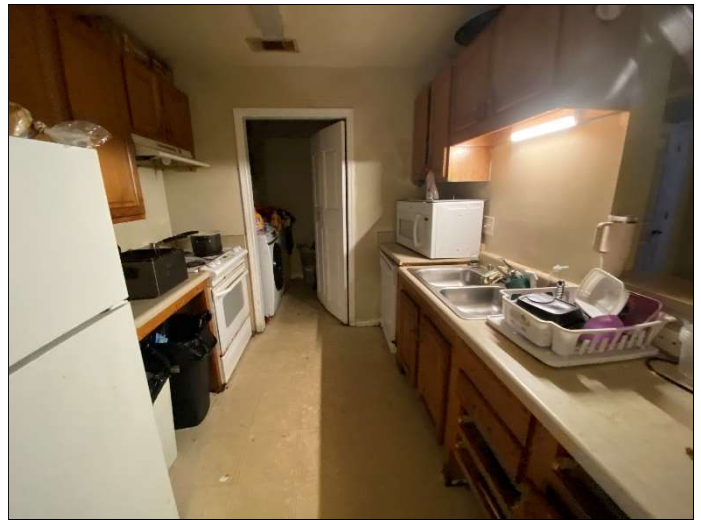
124. Type A/UFAS accessible dwelling kitchen without a range-oven clear floor space
