## PROPERTY CONDITION REPORT

### Appian Way Apartments

8465 Patriot Blvd  
North Charleston, South Carolina 29420

24-452279.1

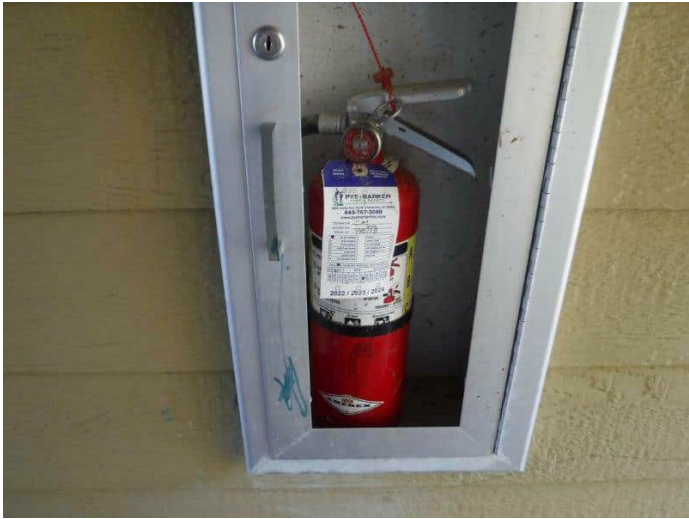
1. Typical breezeway fire extinguisher

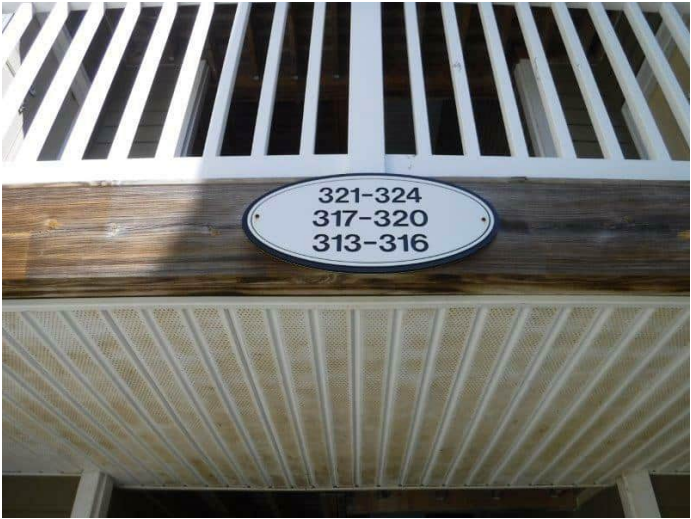
2. Typical signage

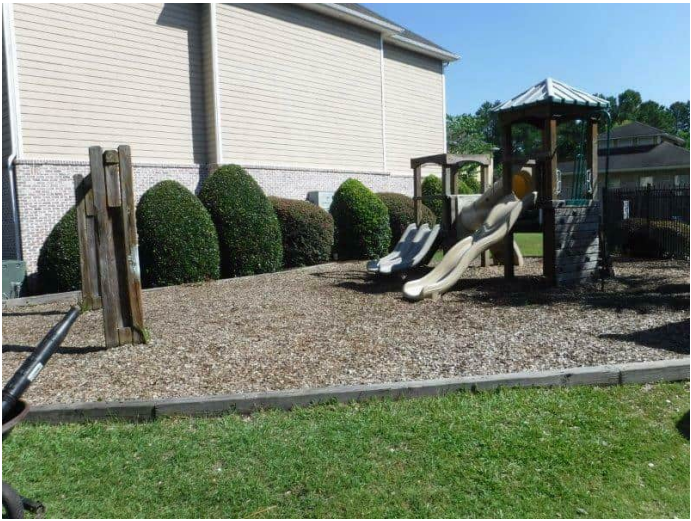
4. Tot Lot

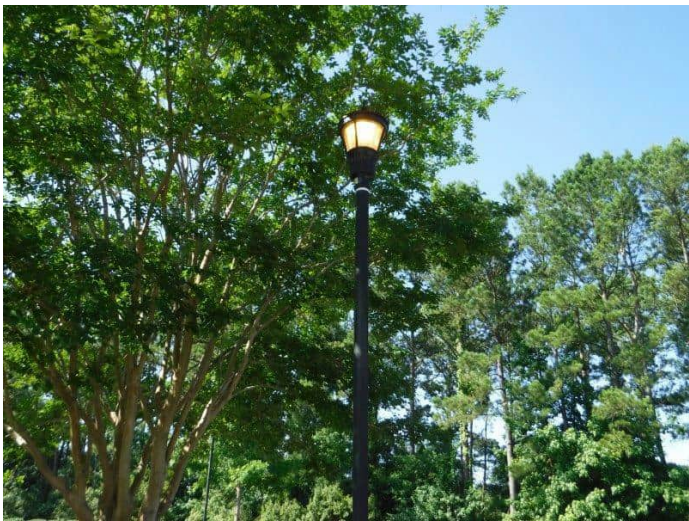
5. Typical pole mounted light

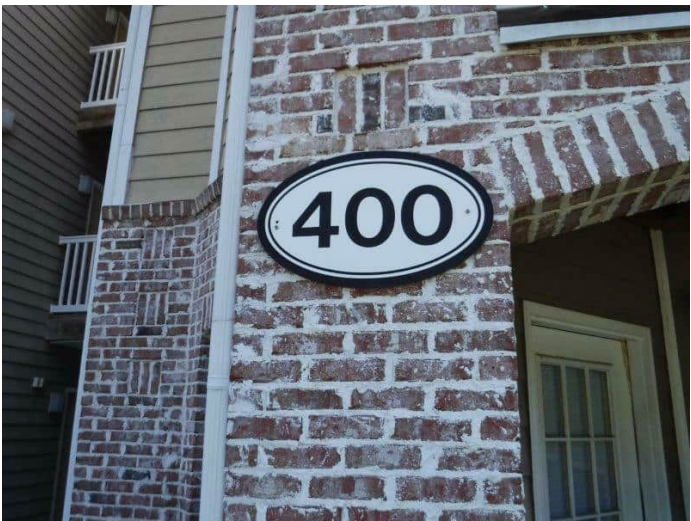
6. Typical signage

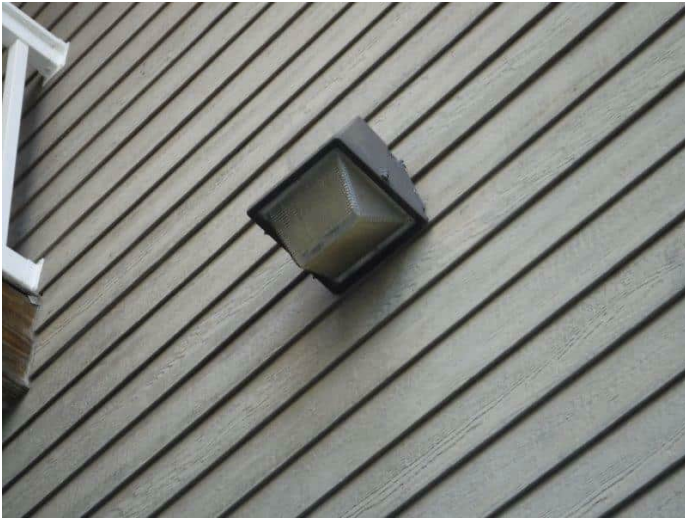
7. Typical building mounted light

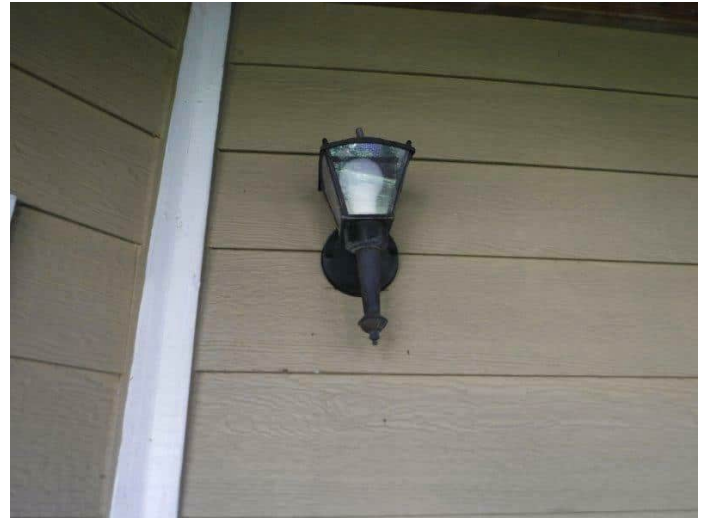
8. Typical porch/patio lighting

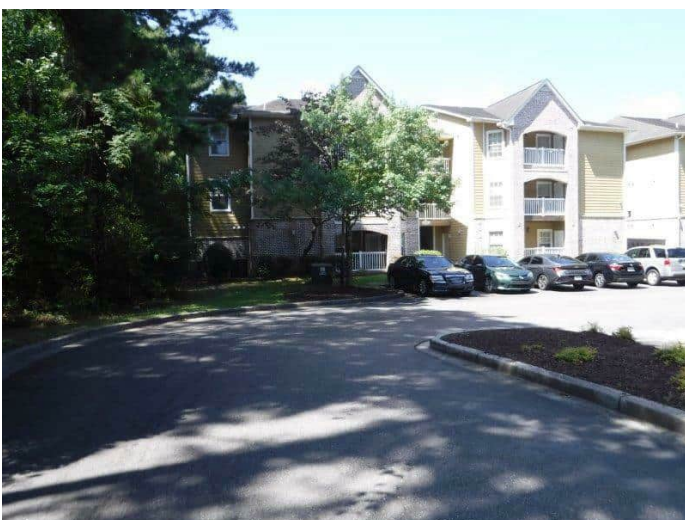
11. Subject property from the north

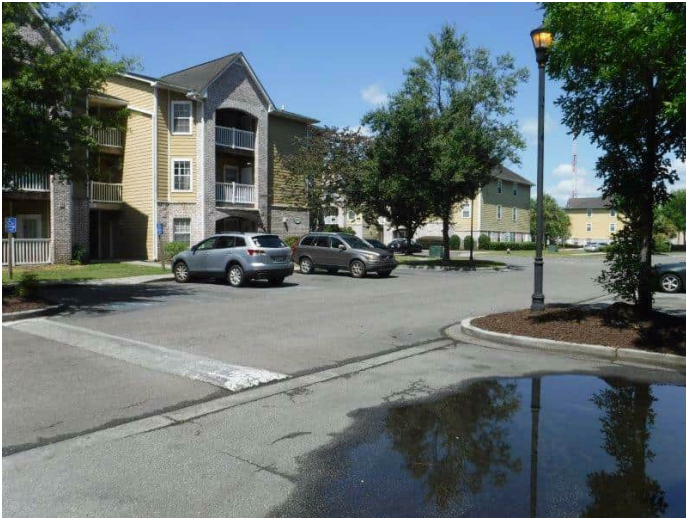
13. Subject property from the north

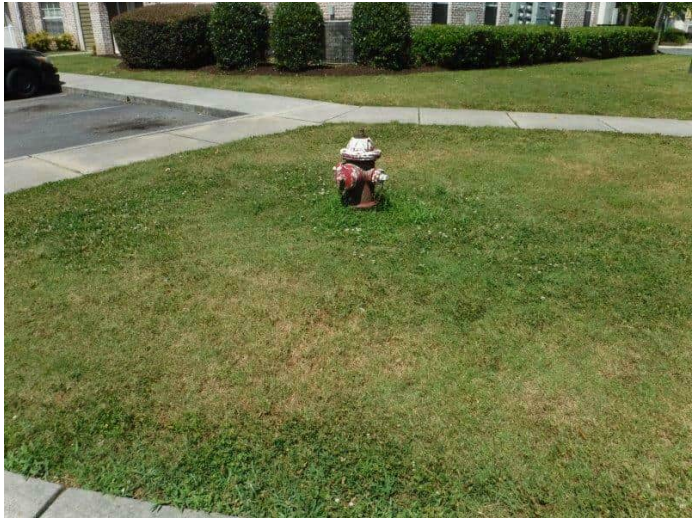
14. Typical fire hydrant

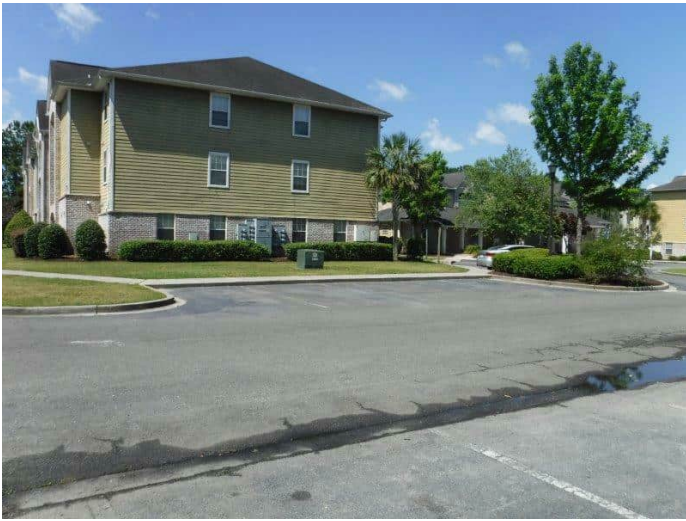
15. Subject property from the north

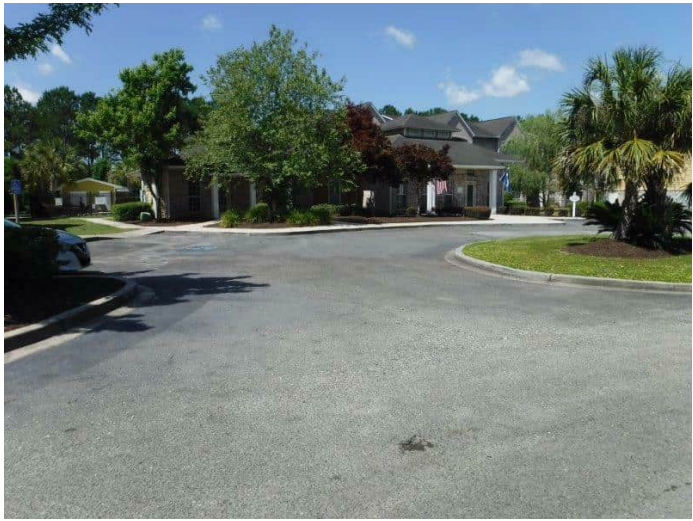
16. Subject property from the north

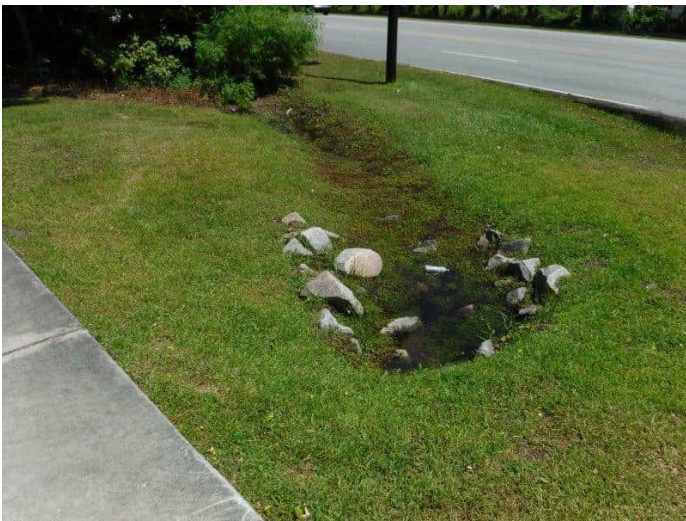
17. Typical drainage ditch

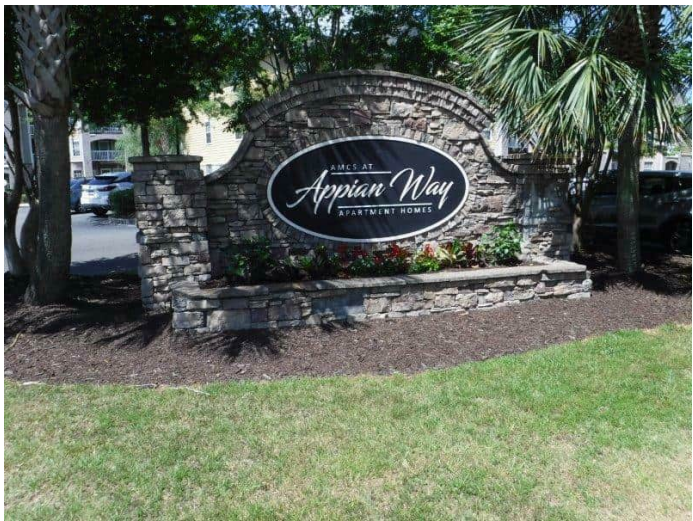
18. Signage

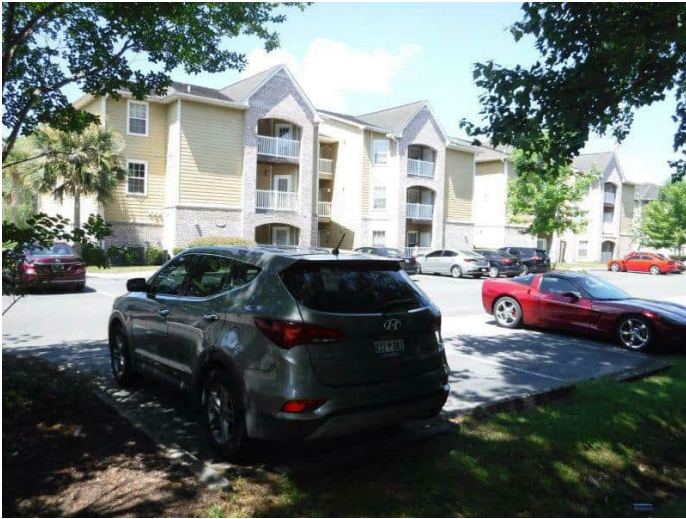
19. Subject property from the north

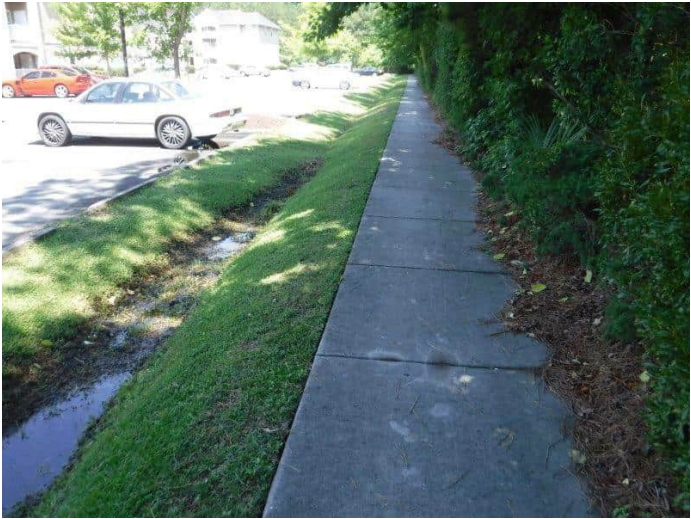
20. Flatwork

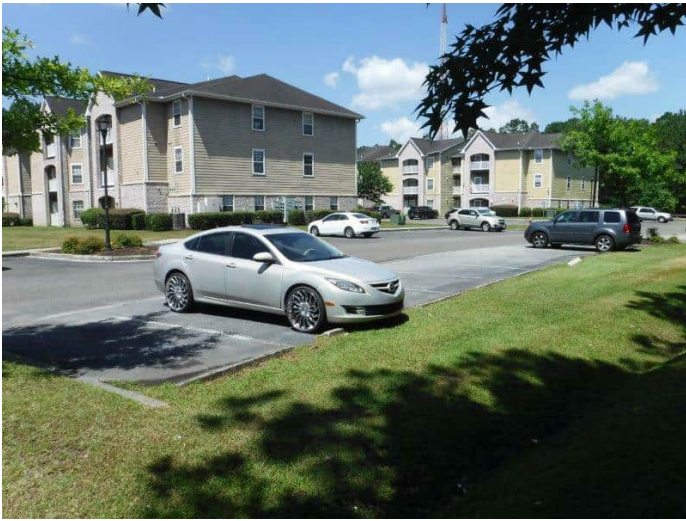
21. Subject property from the north

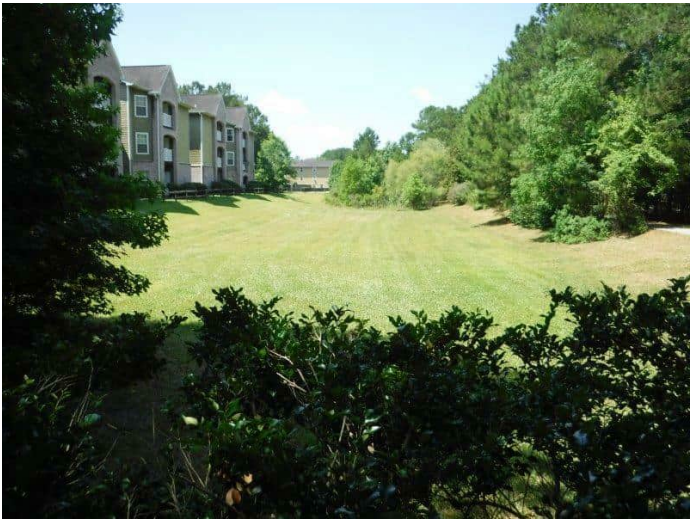
22. Subject property from the north

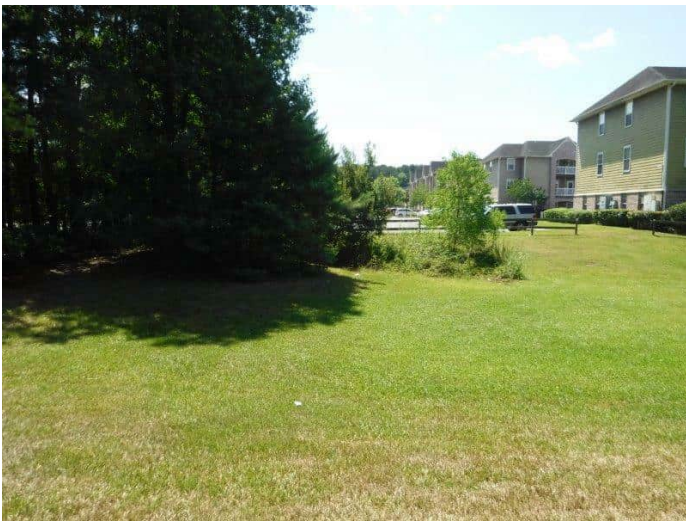
23. Subject property from the west

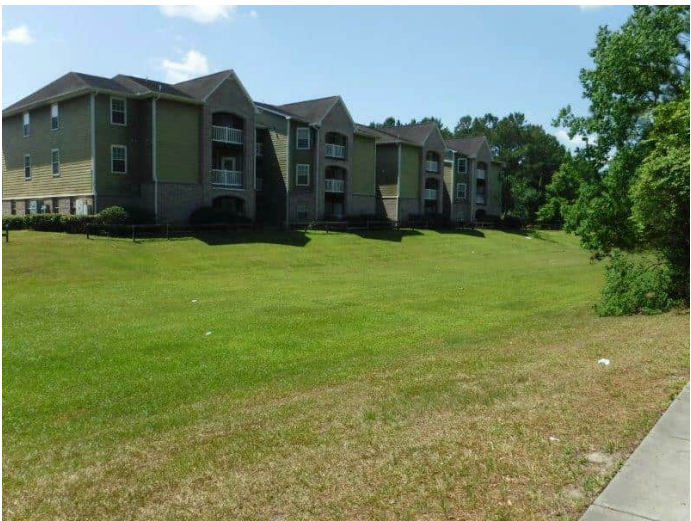
24. Subject property from the west

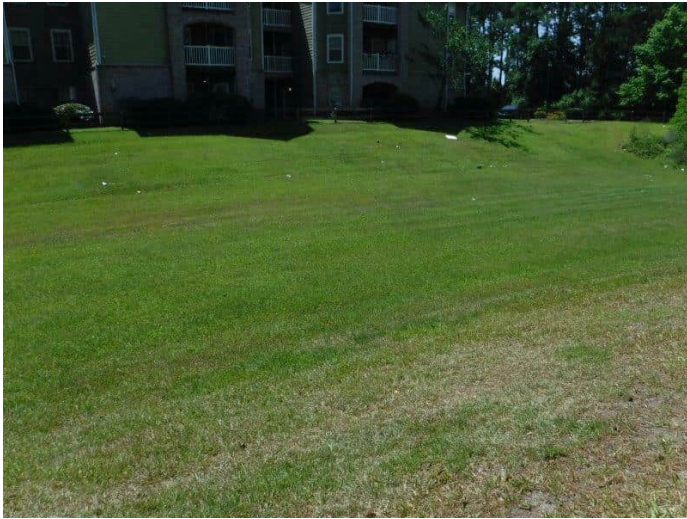
25. North detention basin

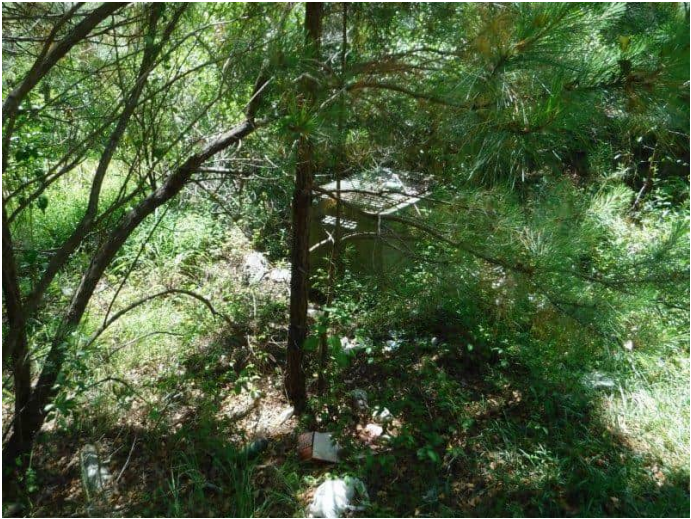
26. Stand pipe in the north detention basin

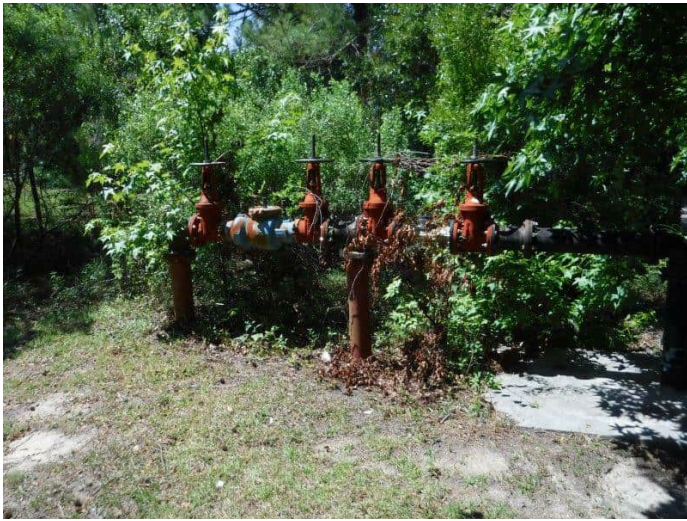
27. Backflow prevention device on the south side of the north detention basin

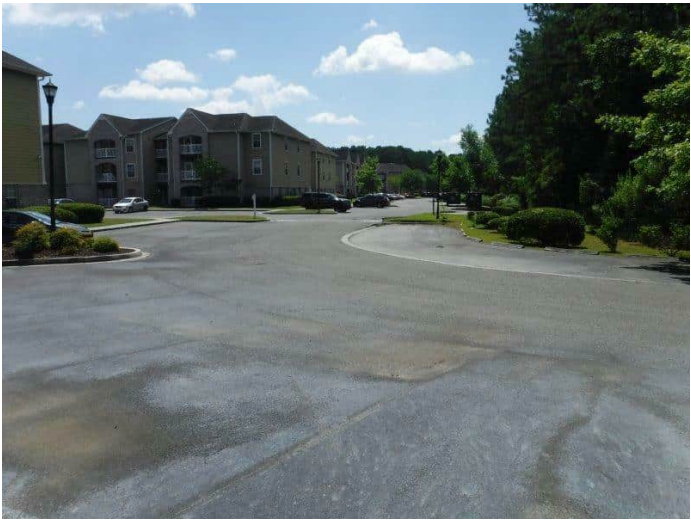
28. Subject property from the west

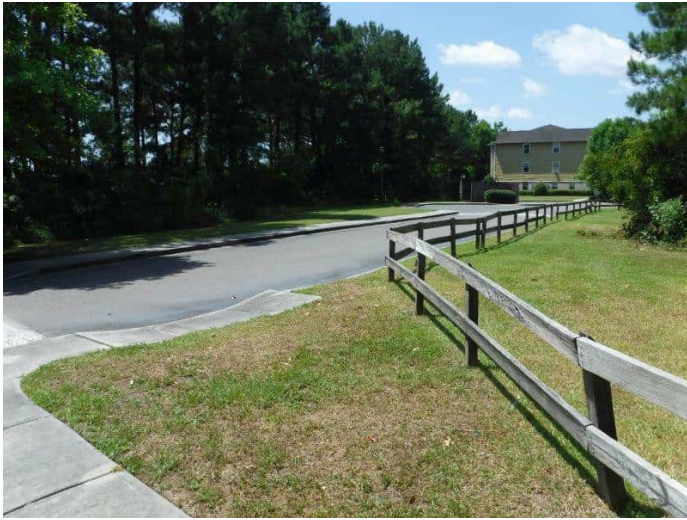
29. Subject property from the west

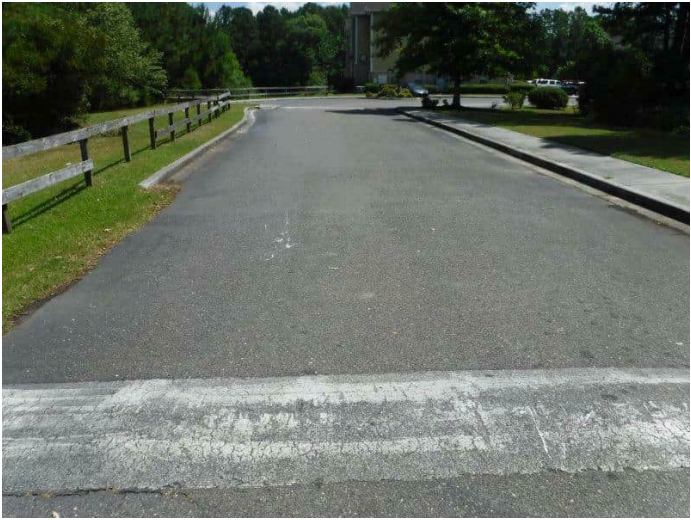
30. West drive aisle

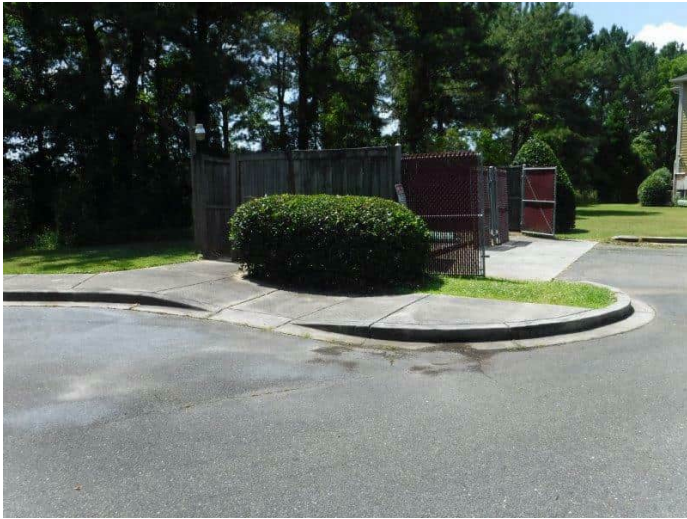
31. Dumpster enclosure by Building 900

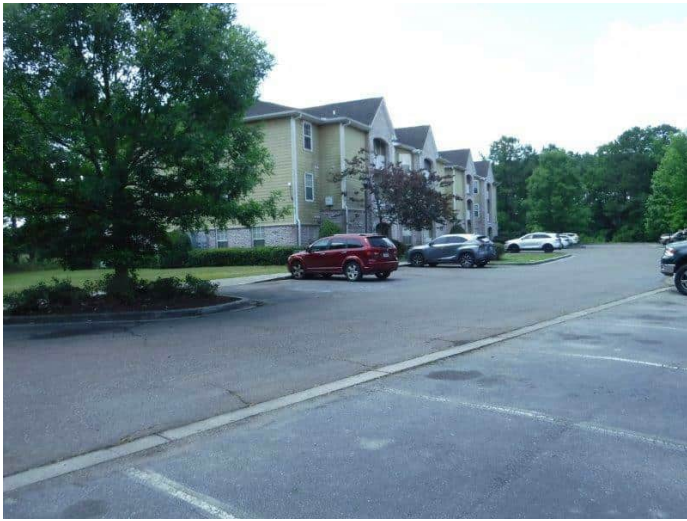
33. Subject property from the west

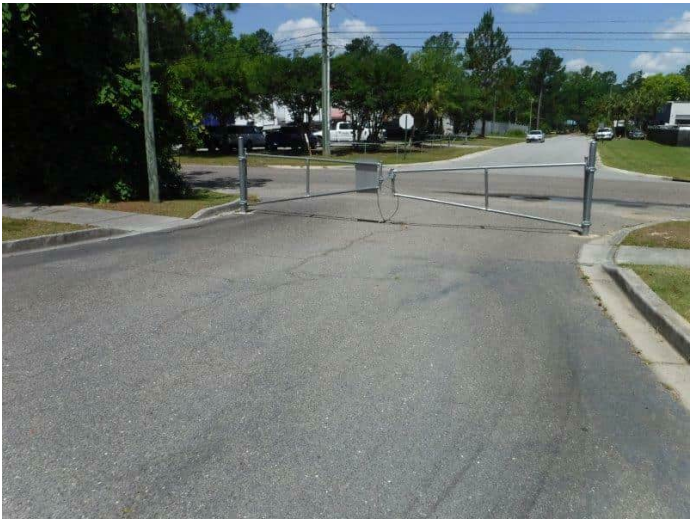
34. Gate by Building 900

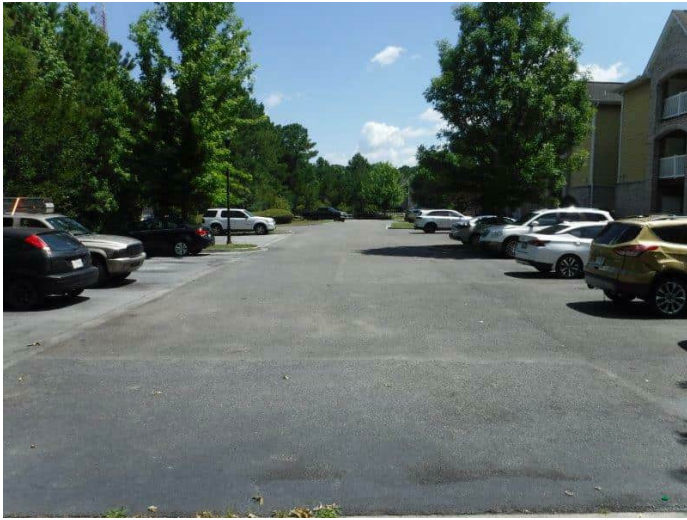
35. Subject property from the south

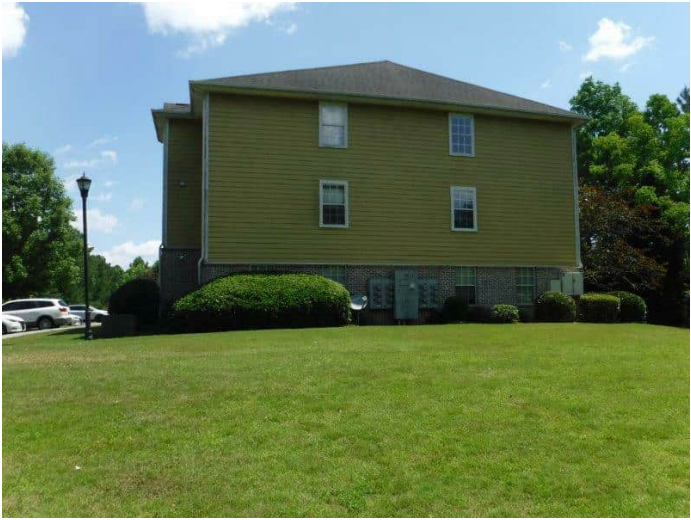
36. Subject property from the south

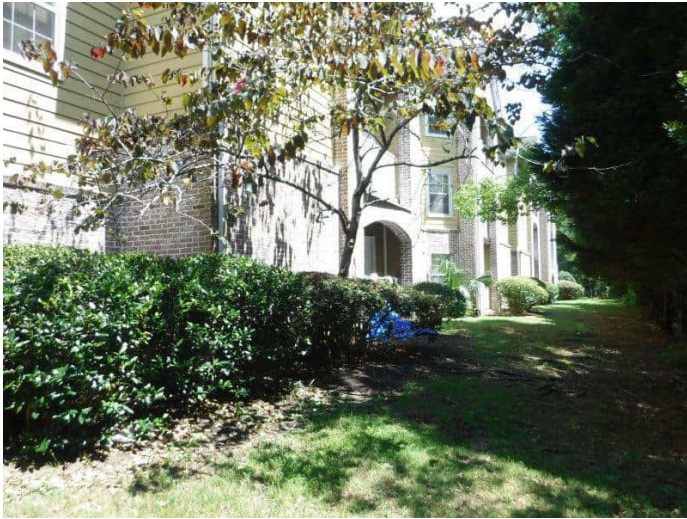
37. Subject property from the east

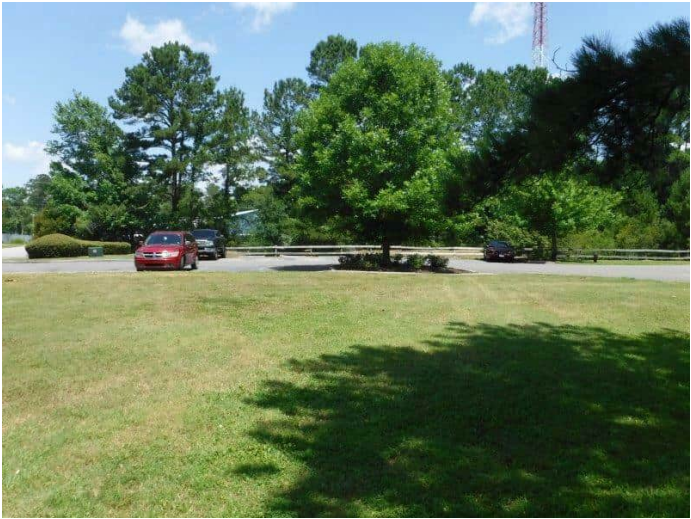
38. Subject property from the east

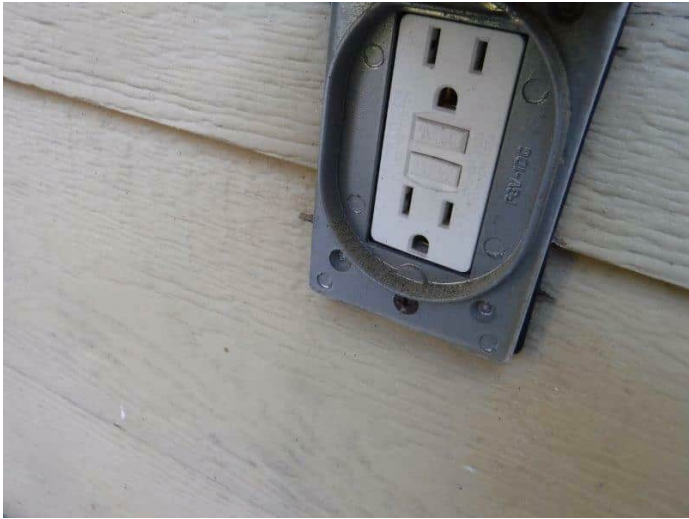
79. Typical patio/porch GFCI

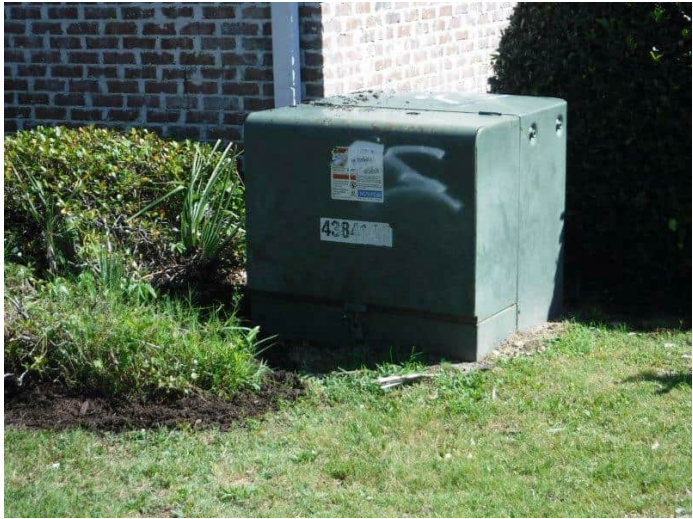
80. Typical transformer

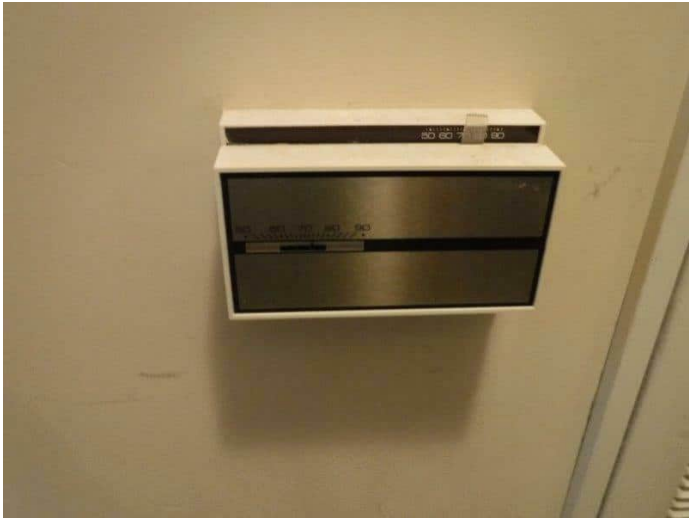
103. Older mercury thermostat in Unit 402

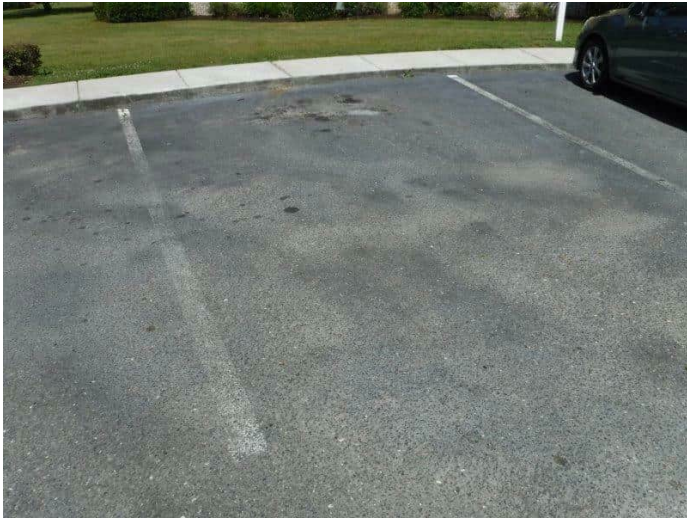
114. Typical asphalt pavement with minor linear cracking

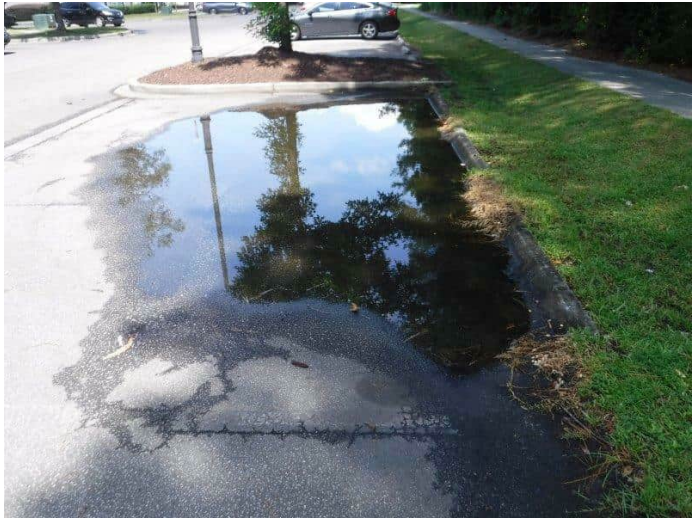
116. Ponding in the north drive aisle

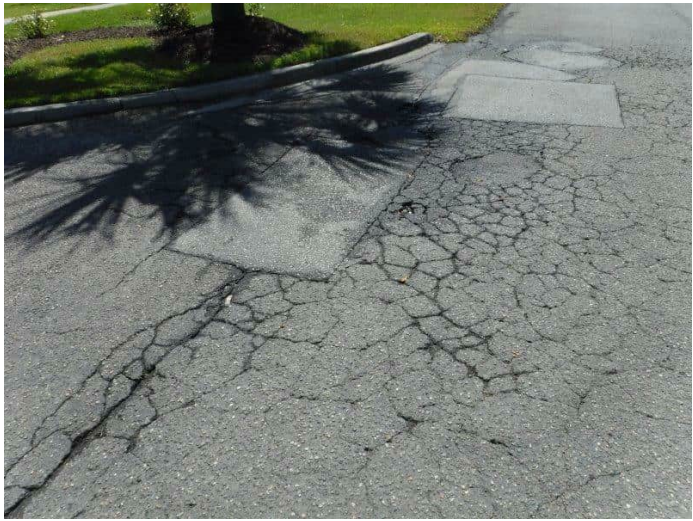
118. Alligator cracking at the entry drive aisle near the clubhouse

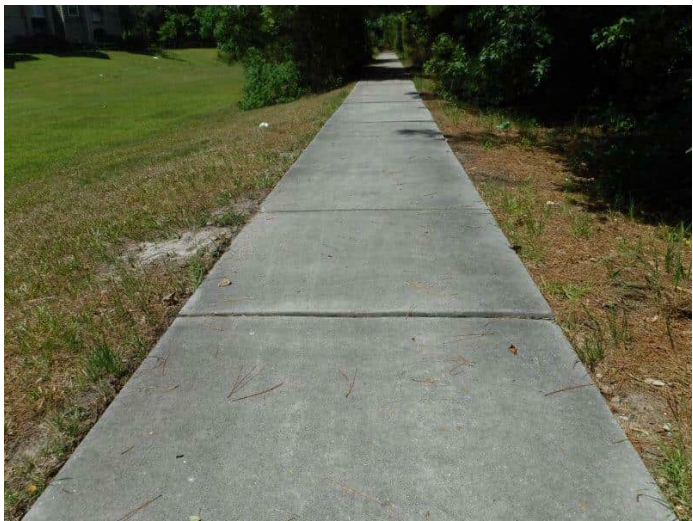
120. Trip hazards on the west side of the north detention basin

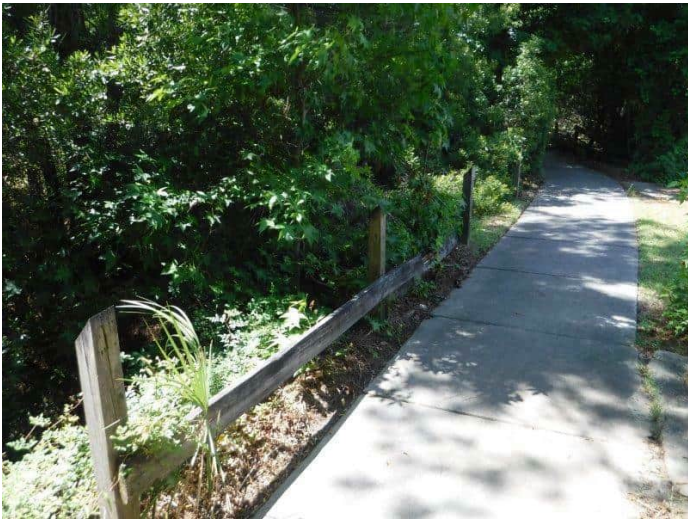
124. Detached fencing near the backflow prevention device

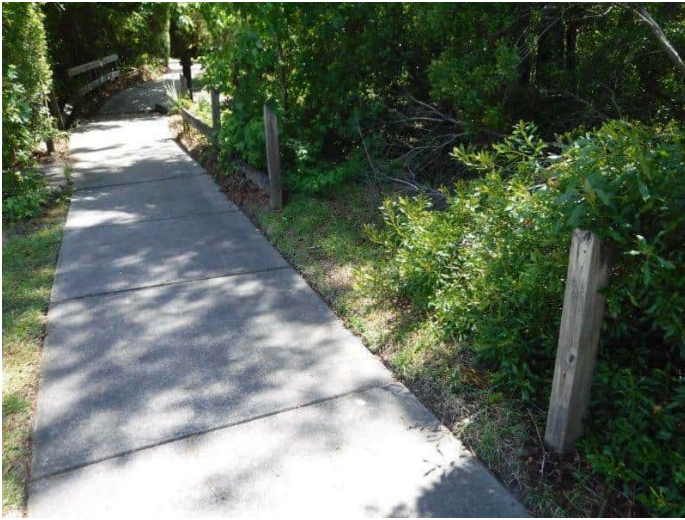
125. Detached fencing near the backflow prevention device

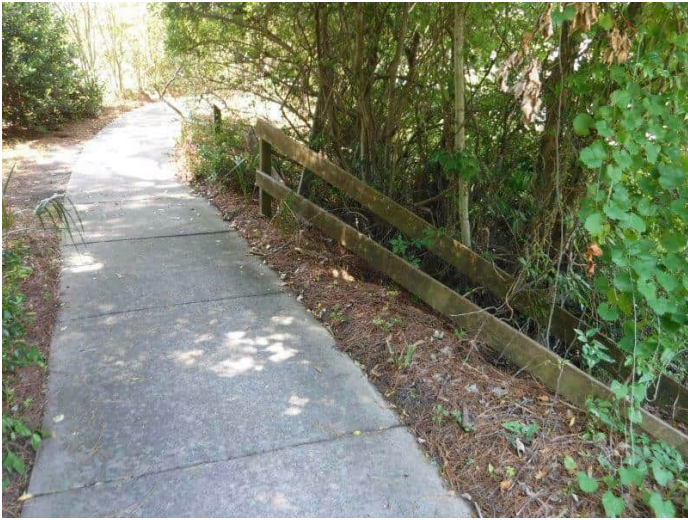
126. Detached fencing near the backflow prevention device

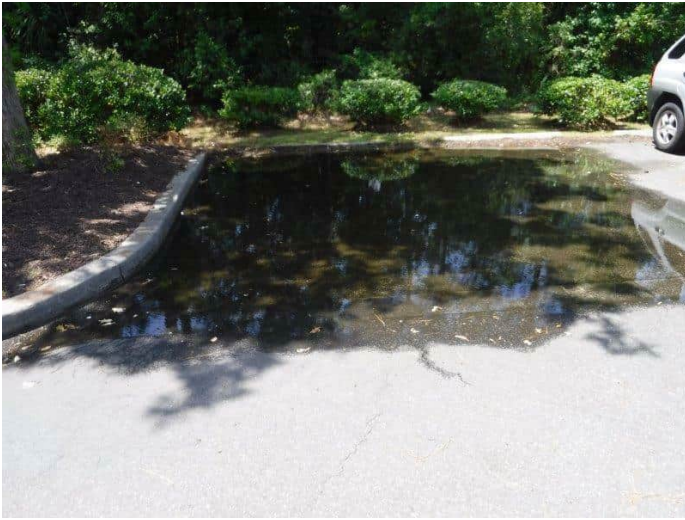
131. Ponding in the south drive aisle by Building 100
